UNITED HYDRAULICS

(Hampton, Iowa)

GENERAL DESCRIPTION

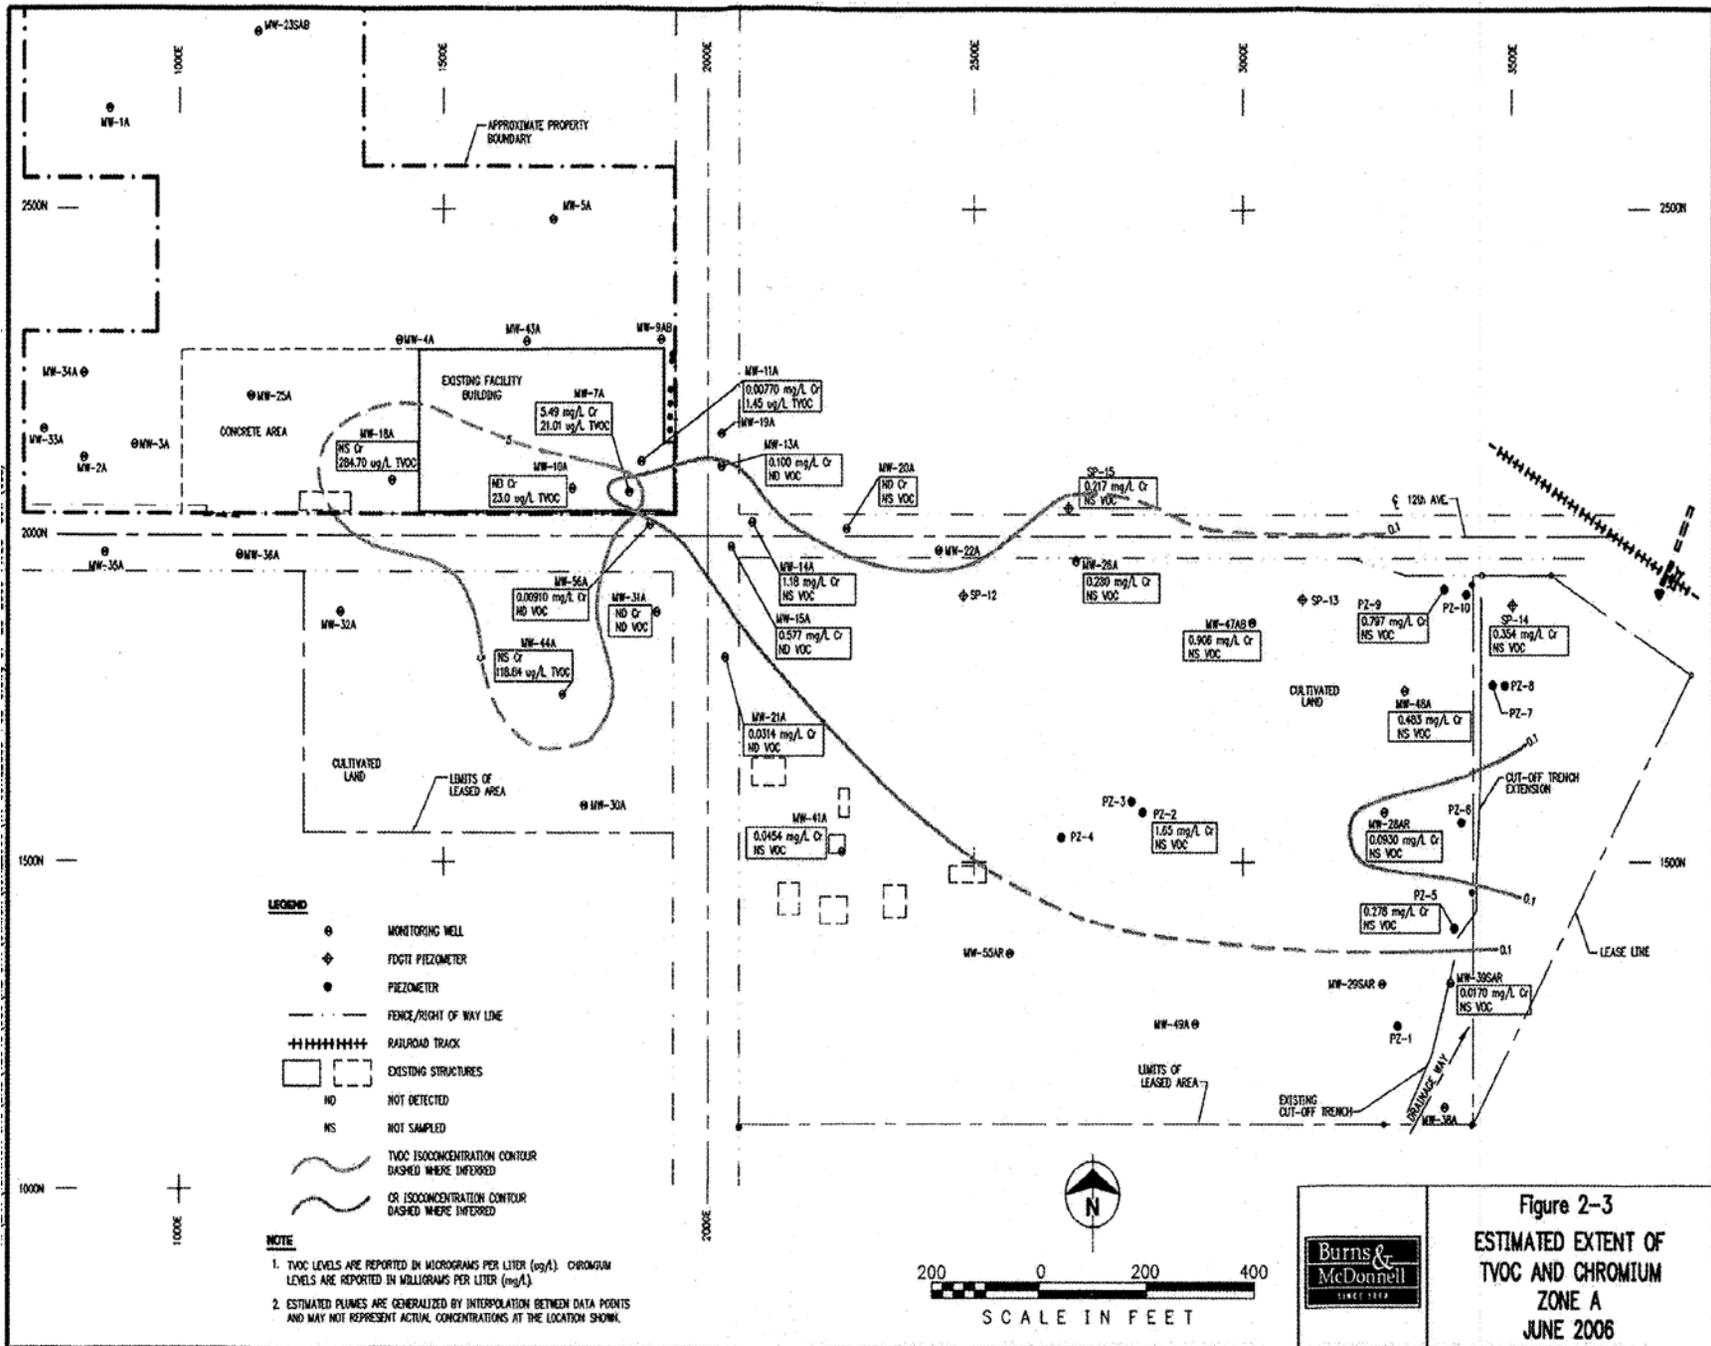
Figure 2-3
 ESTIMATED EXTENT OF
 TVOC AND CHROMIUM
 ZONE A
 JUNE 2006

Annual ground water monitoring through June 2006 for total volatile organic compounds (TVOC) and chromium indicated generally declining concentration trends; however, chromium concentrations in MW-7A started to increase in the 2007 sampling event. In 2008, the groundwater monitoring program was reduced by limiting the groundwater analysis to chromium and collecting samples from 13 monitoring wells and two private wells. In 2012, the Hemmen well was dropped from the sampling protocol as the well pump becoming nonoperational and Mr. Hemmen has no plans on replacing the pump. Chromium concentrations in MW-7A continued to increase to the all time high in June of 2013.
