PHOTO LOG OF LOCATION DAY OF EXPLOSION

PHOTO LOG OF TANKS BEING PULLED ON 09/07/11

CONCLUSION:

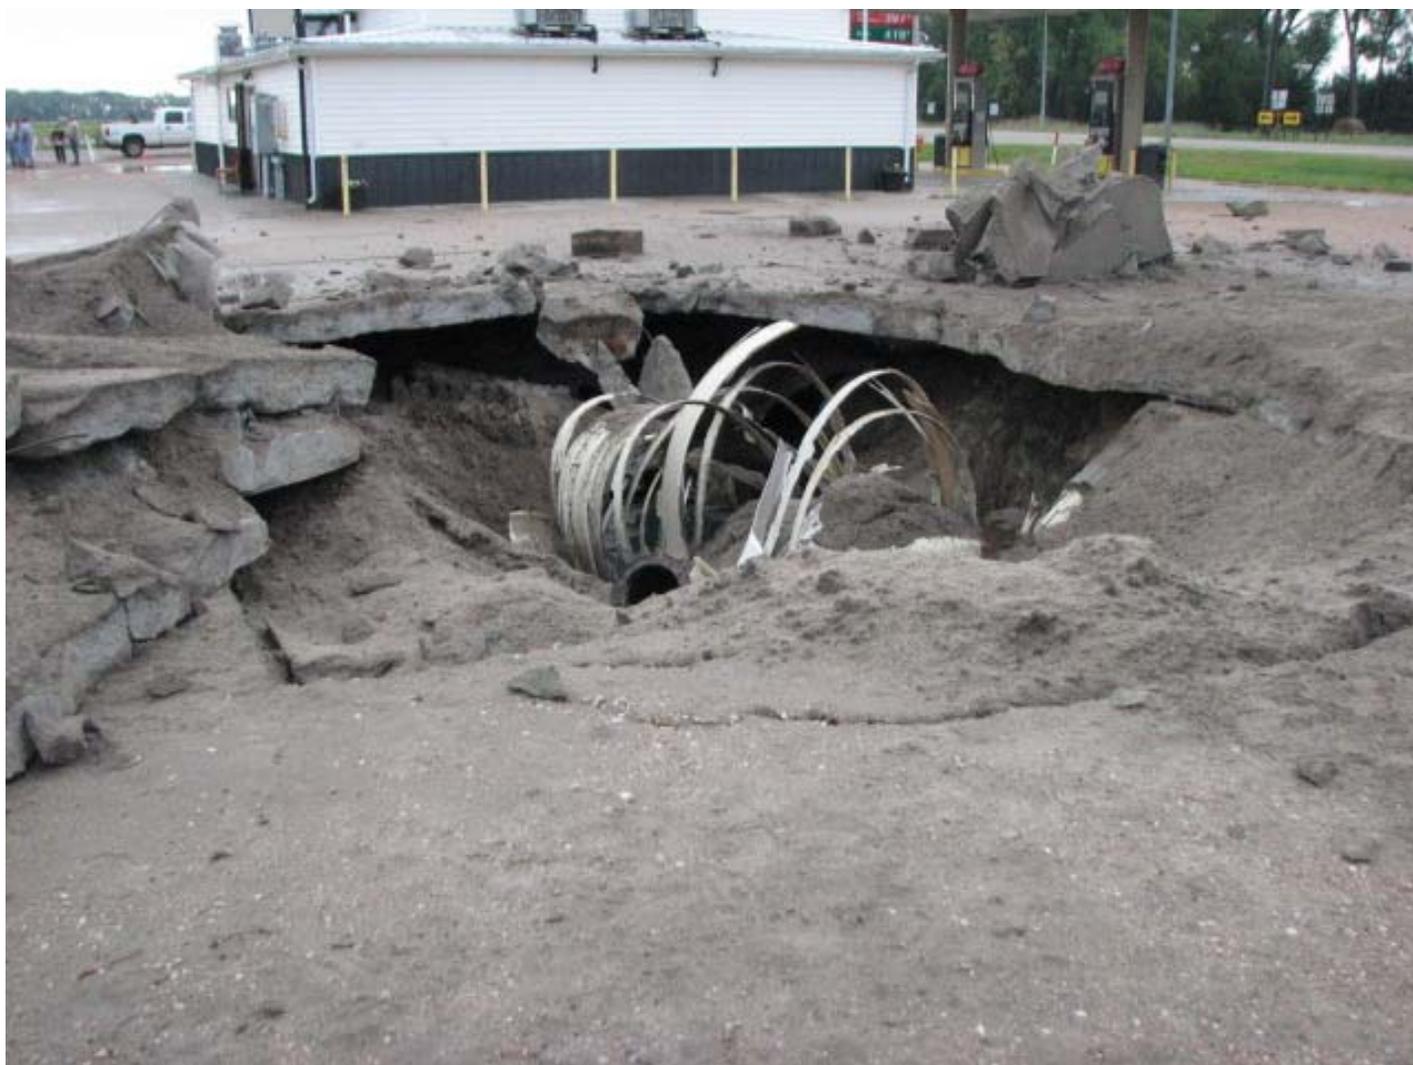
#211

This picture is looking to the East toward the store and shows the hole from the explosion. The large pieces of 9 ½ inch thick concrete with rebar upside down to the North side of the hole. The large pile to the Southeast of the hole shows the damage caused by the explosion of the 10,000 gallon fiberglass diesel tank. No concrete was moved or piled up before the pictures were taken.

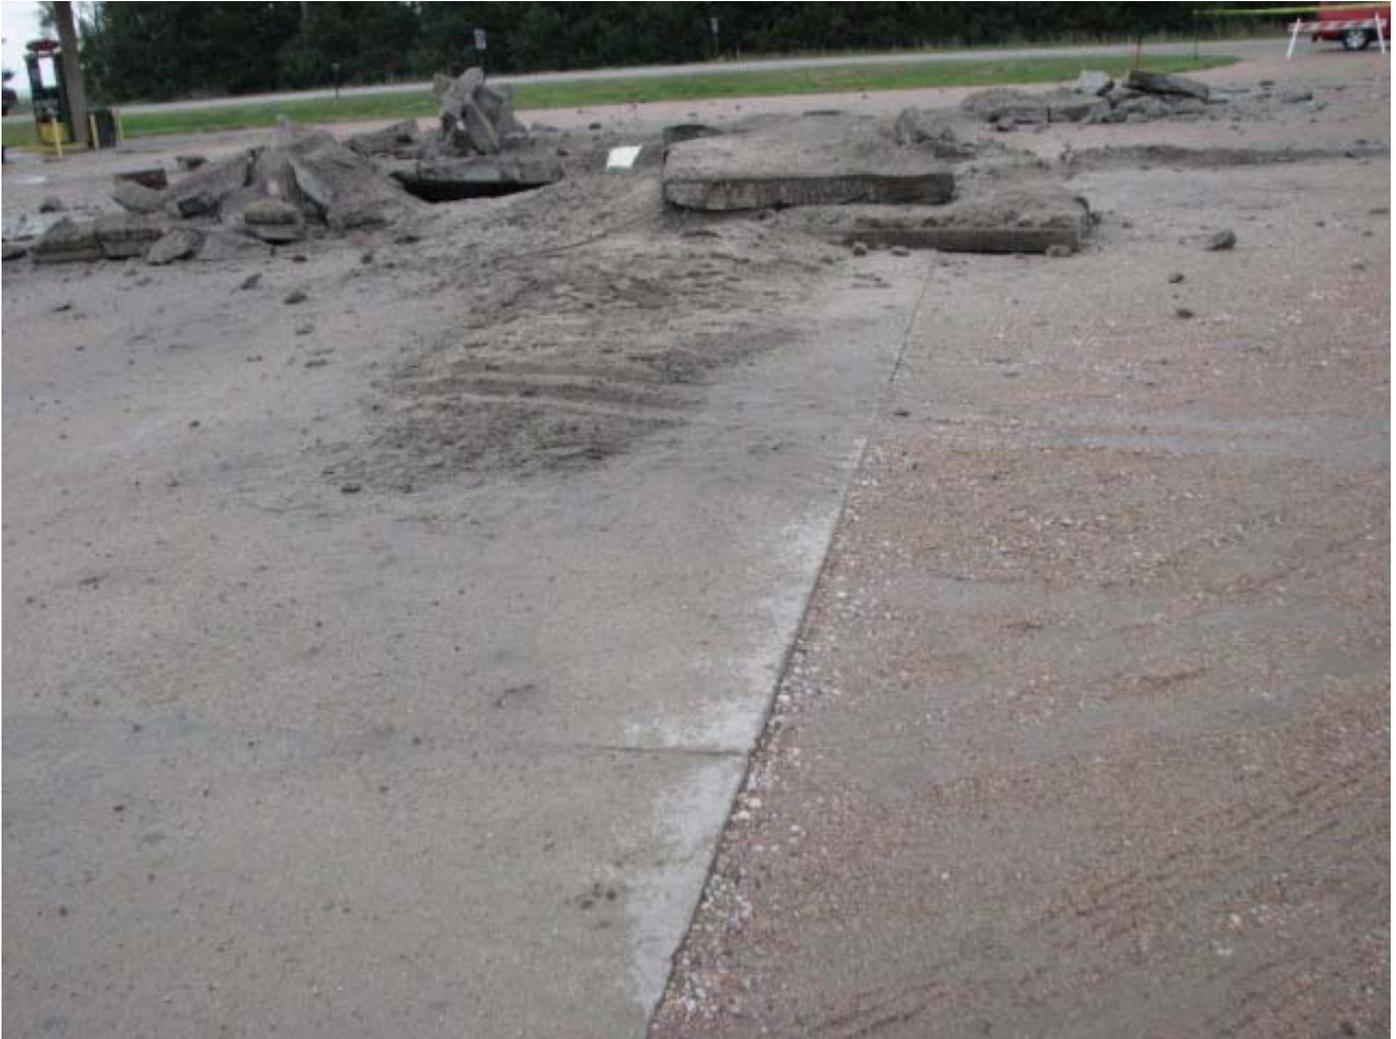
#212

This picture is looking to the South and shows a large area where the concrete and sand laid after the explosion.

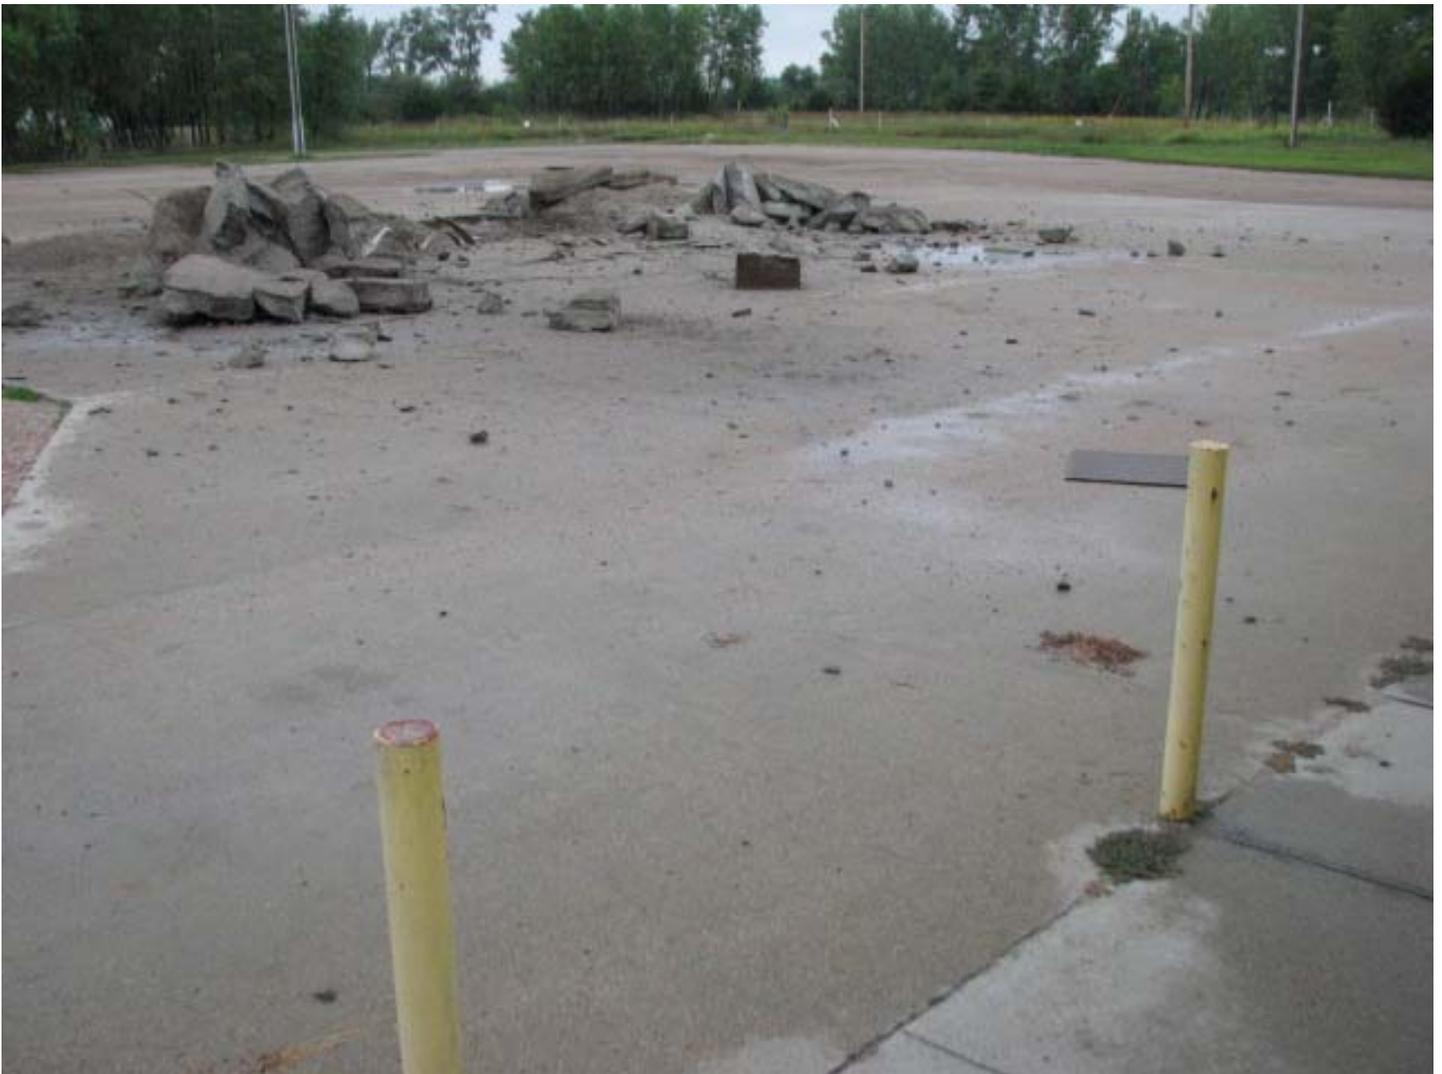
#218

This picture is looking to the West from the West side of the store. It shows the flat square steel cover from the ATG man hole which was in the center of the diesel tank.

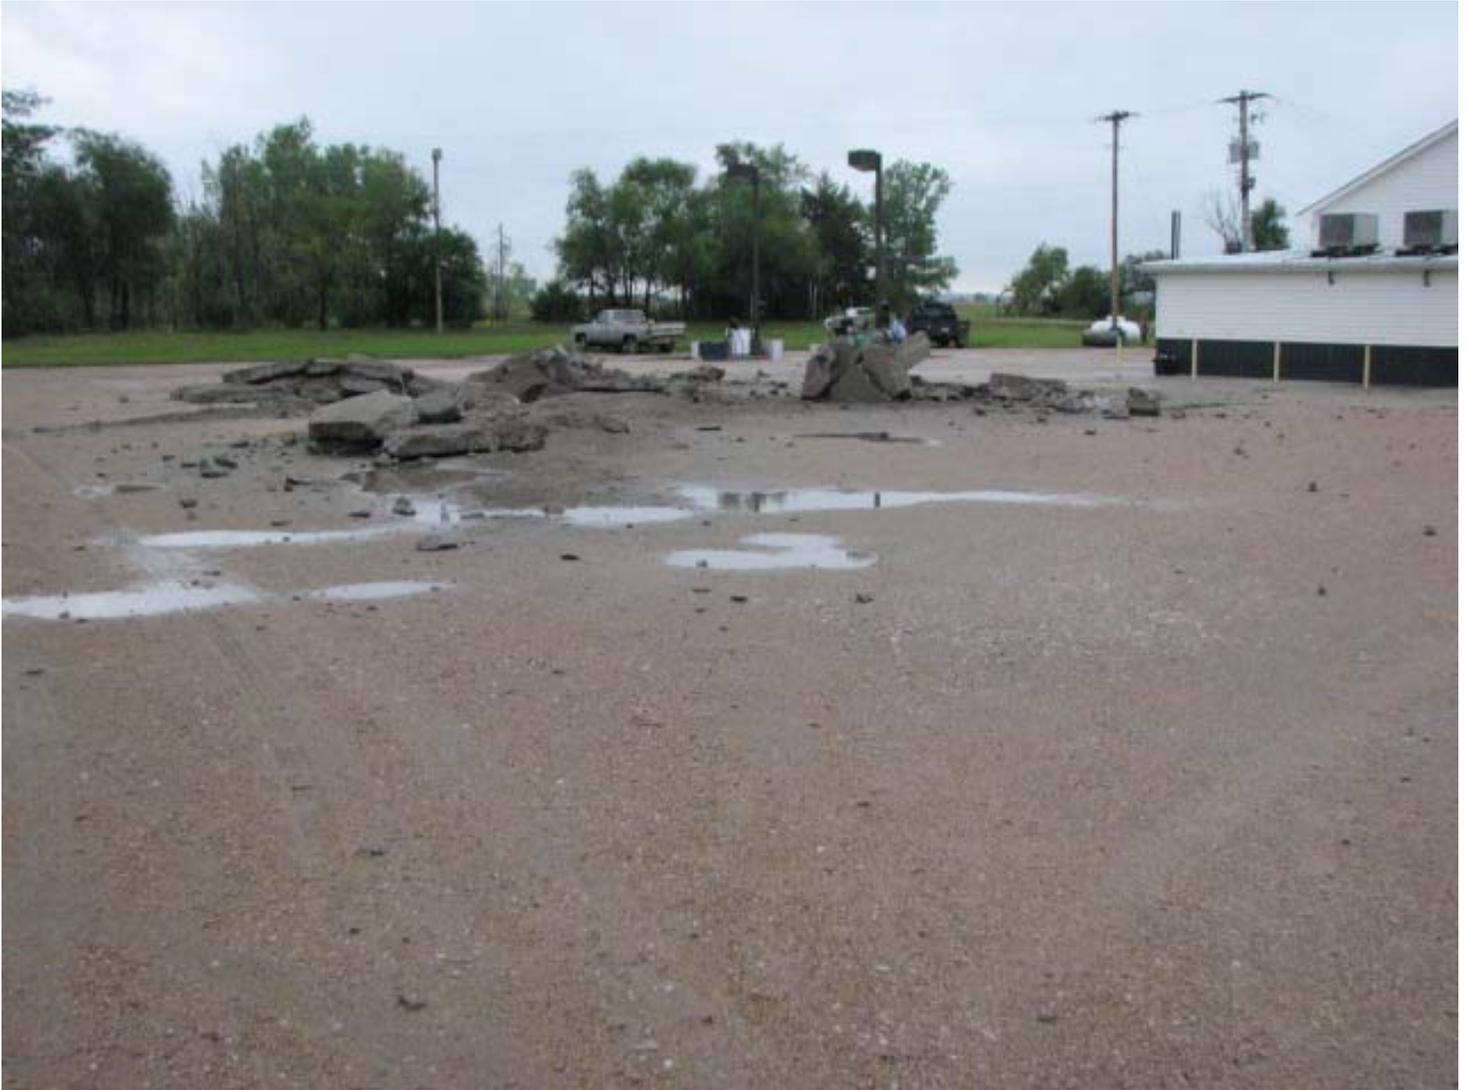
#222

This picture is looking to the North and shows the concrete piled up from the explosion of the diesel tank.

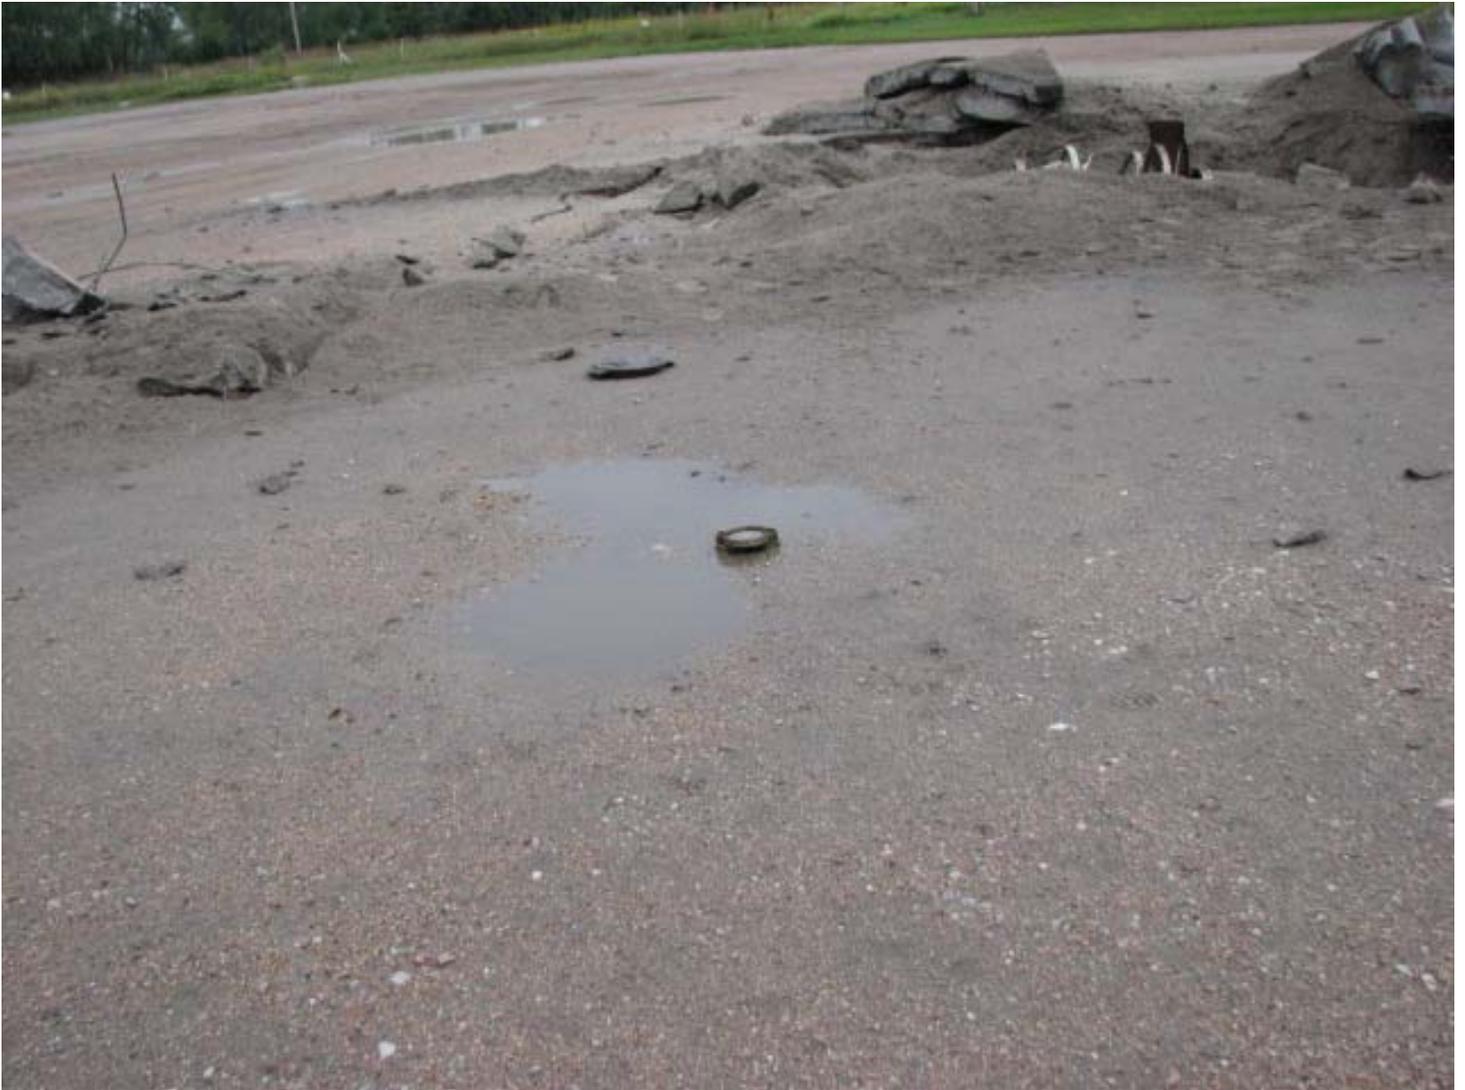
#224

This picture is looking to the North and shows the fill cap from the diesel tank upside down. To the North farther the steel cover from the spill bucket on the diesel tank can be seen.

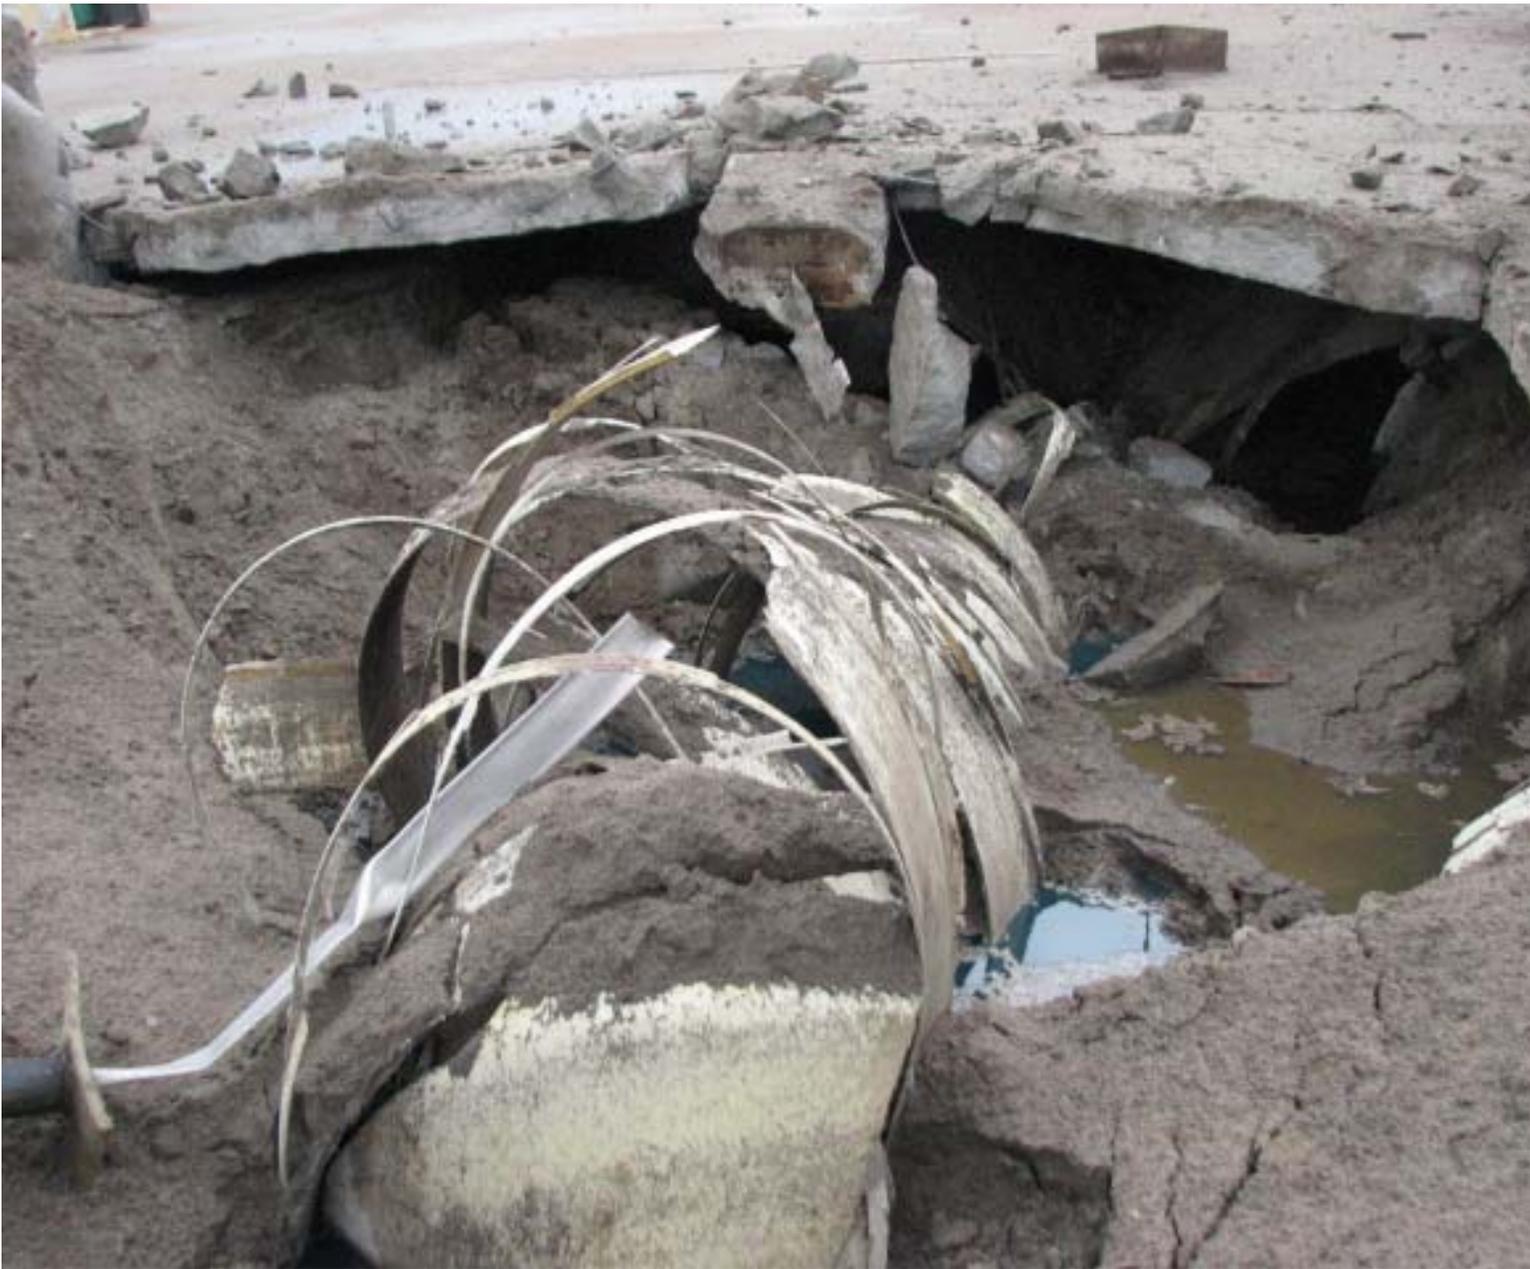
#225

This picture shows a close up view of the diesel tank. On the right side just under the concrete it shows the hole in the Super unleaded gasoline tank caused by the explosion of the diesel tank. It also shows how high the water table is. The water level is four feet below the top of the concrete.

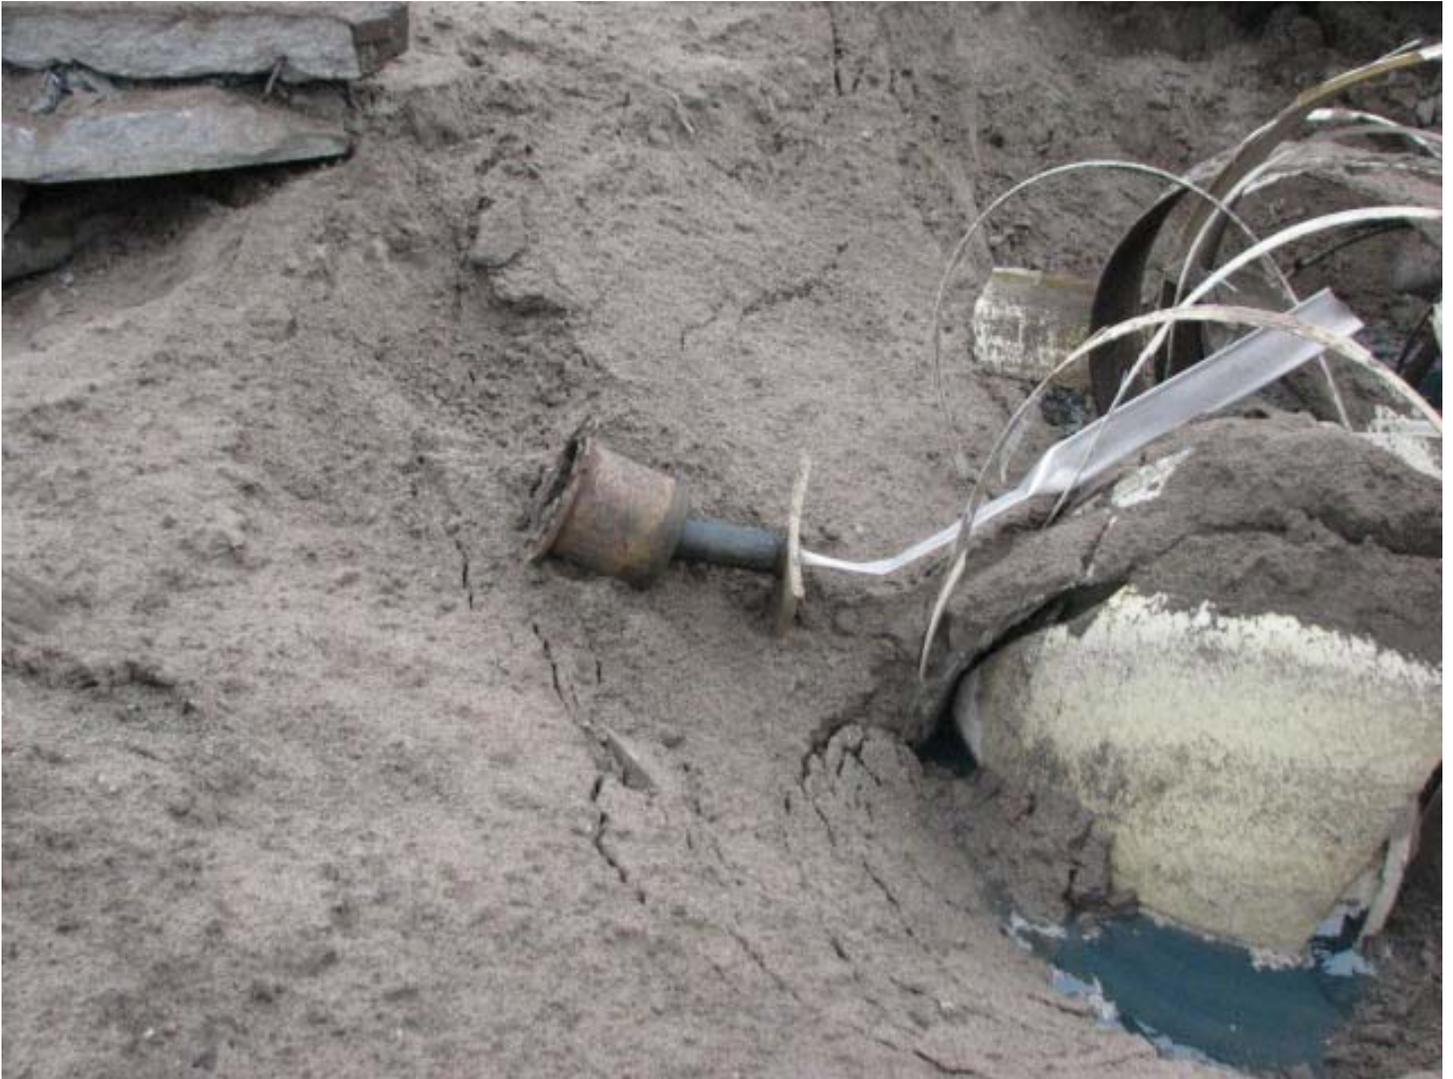
#226

This picture shows the damage to the drop tube by the explosion. It also shows the product on the ground water at the West end of the tank.

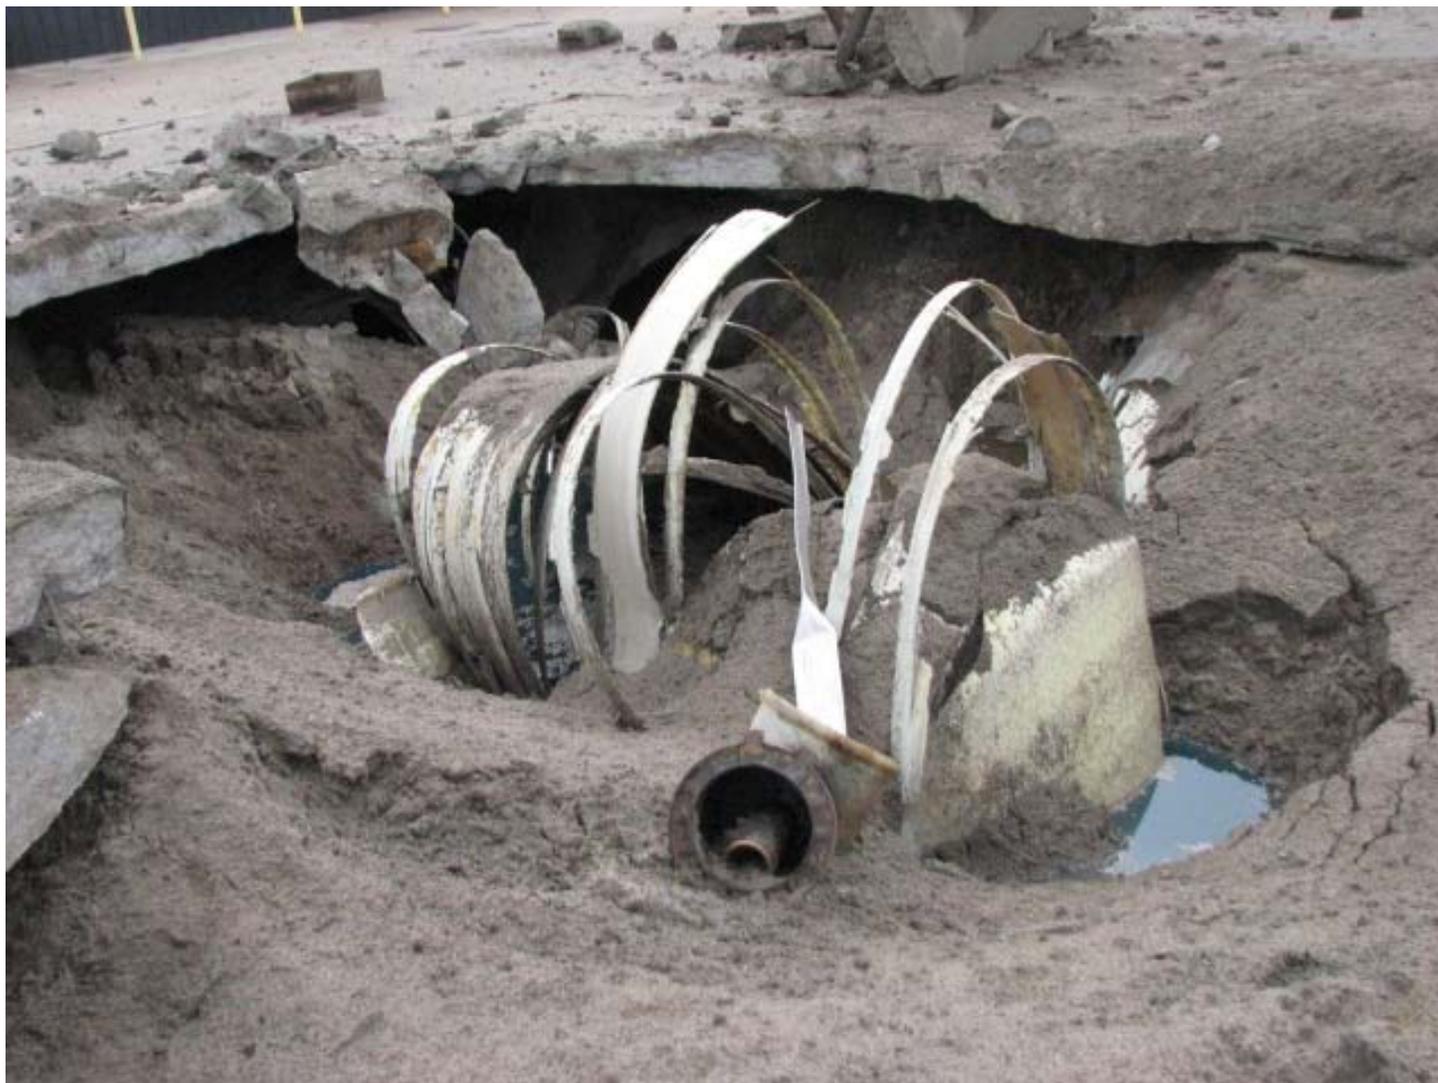
#227

This picture shows the diesel and gasoline on the ground water.

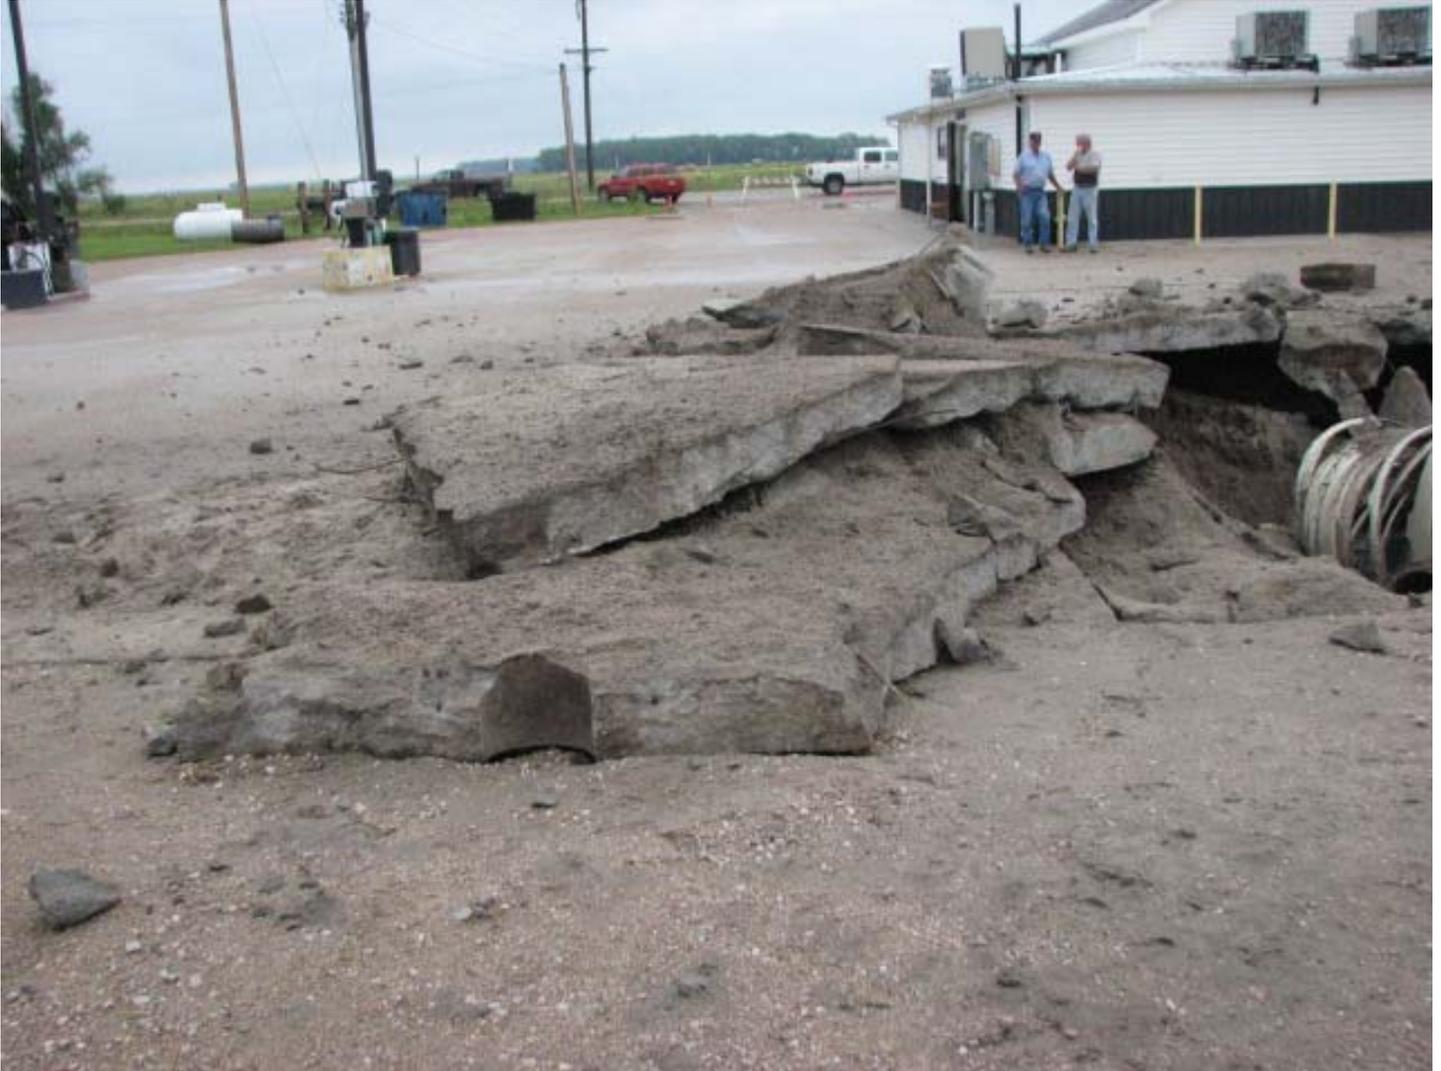
#228

This Picture looking East shows the two large concrete slabs from the top of the diesel tank that were blown up and landed upside down on top of each other.

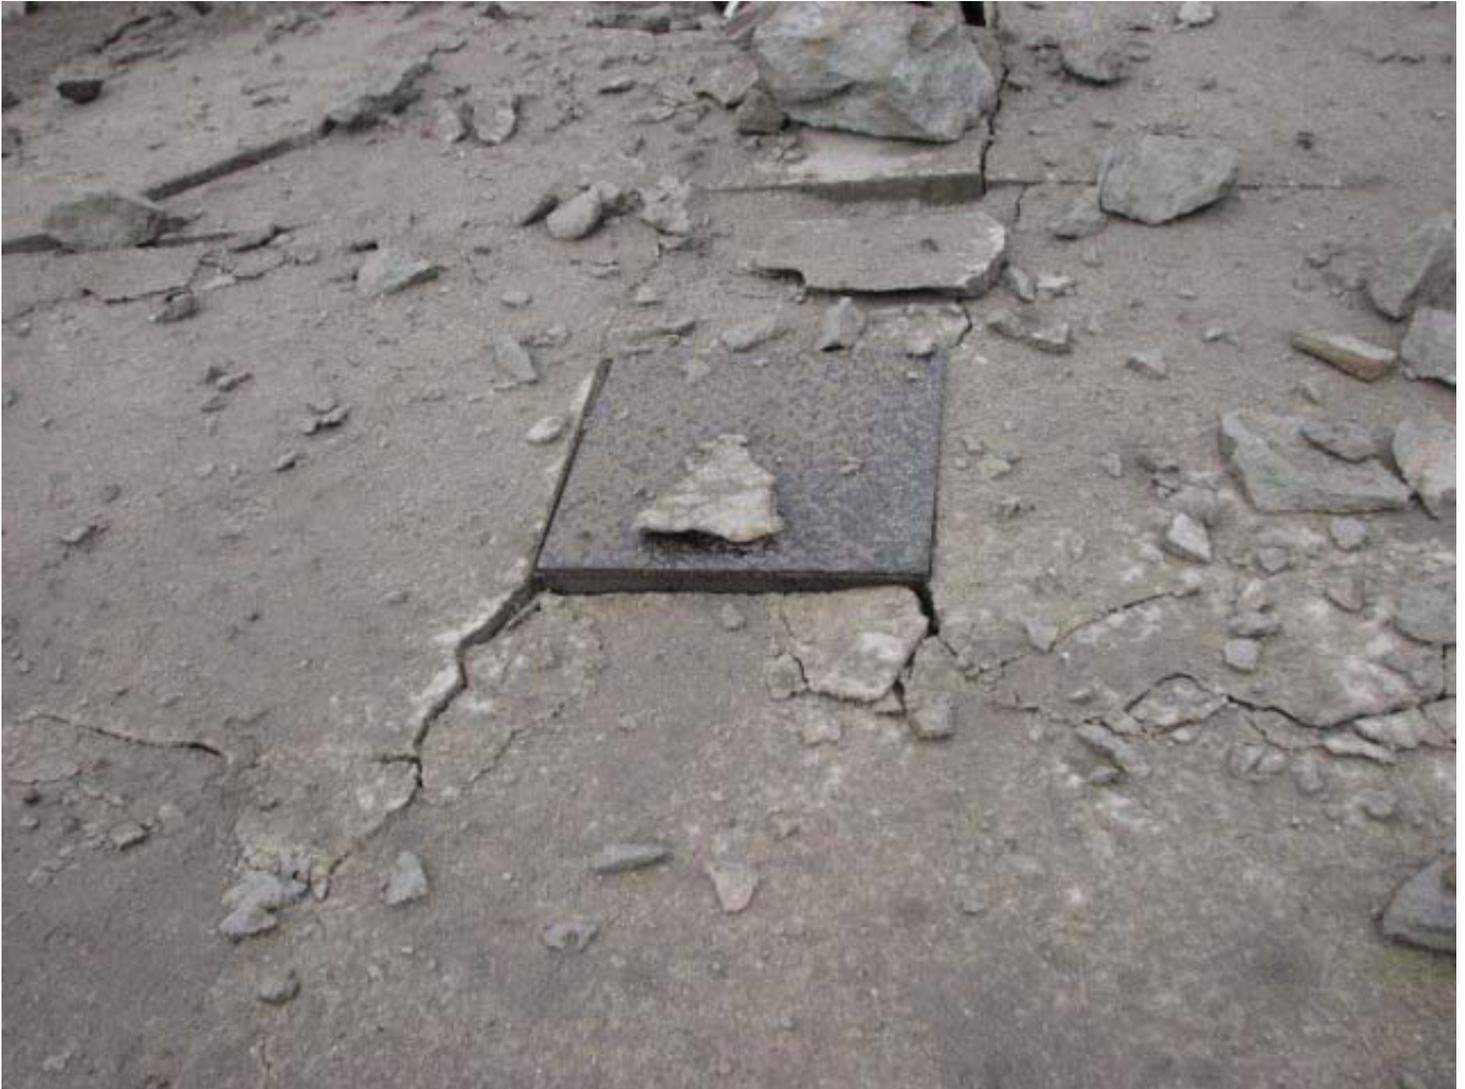
#229

This picture shows the ATG manhole cover and damage to the concrete on top of the Super unleaded tank.

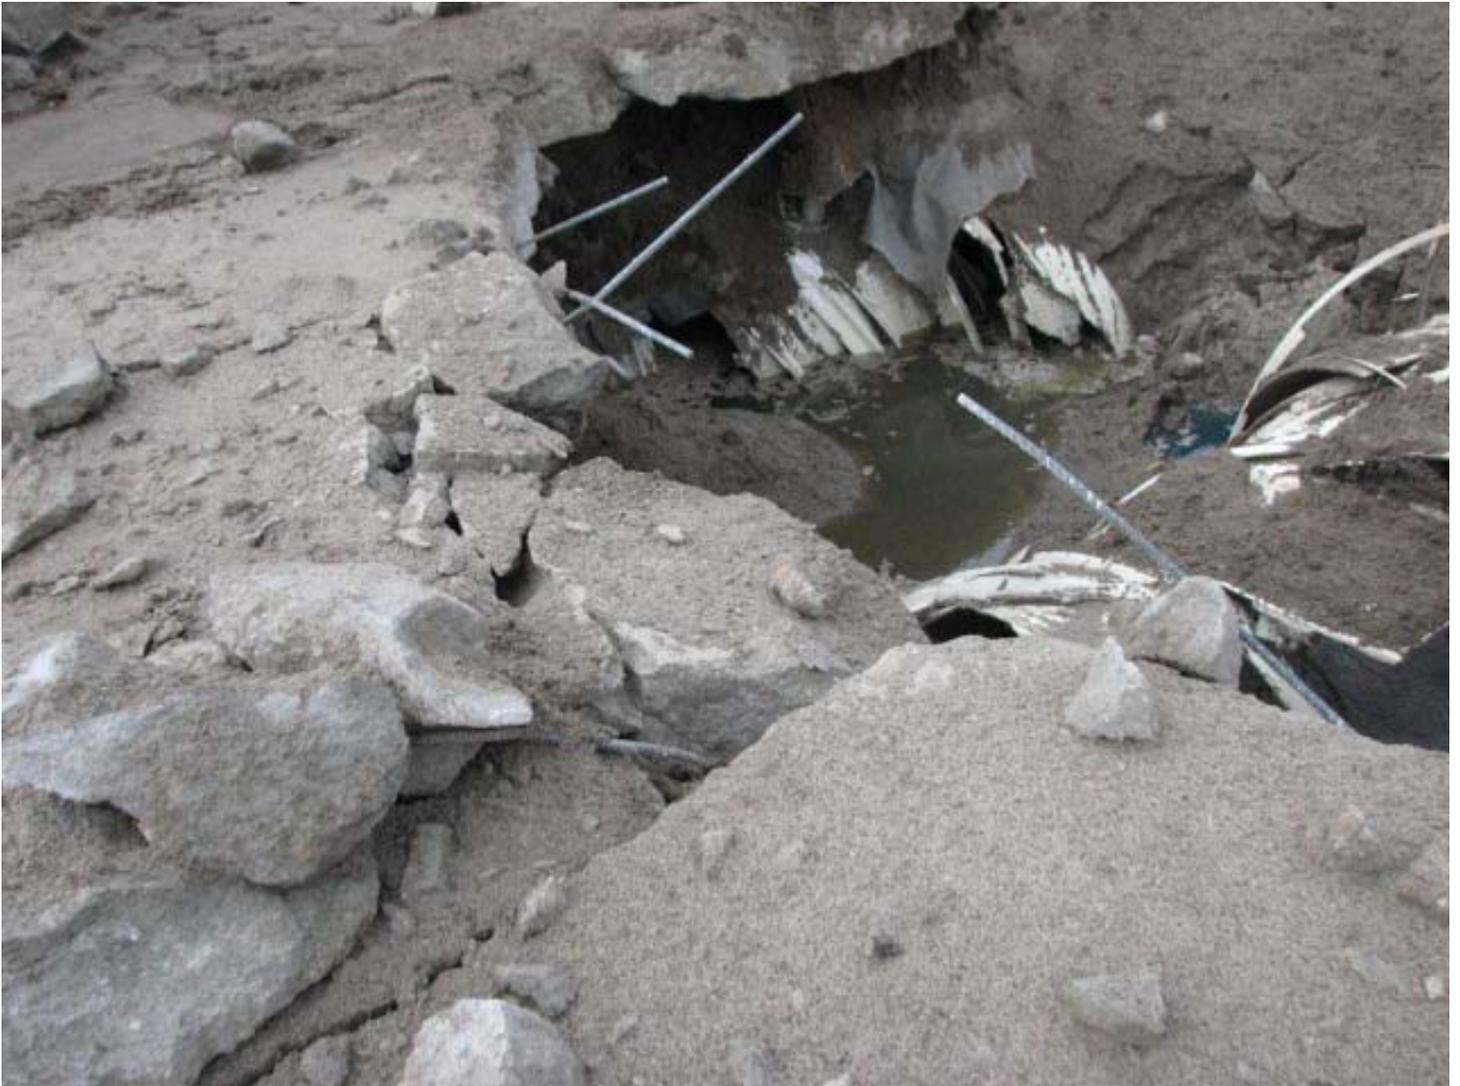
#238

This Picture shows the hole blown into the North side of the Super unleaded tank. The Super unleaded tank was on the South side of the diesel tank.

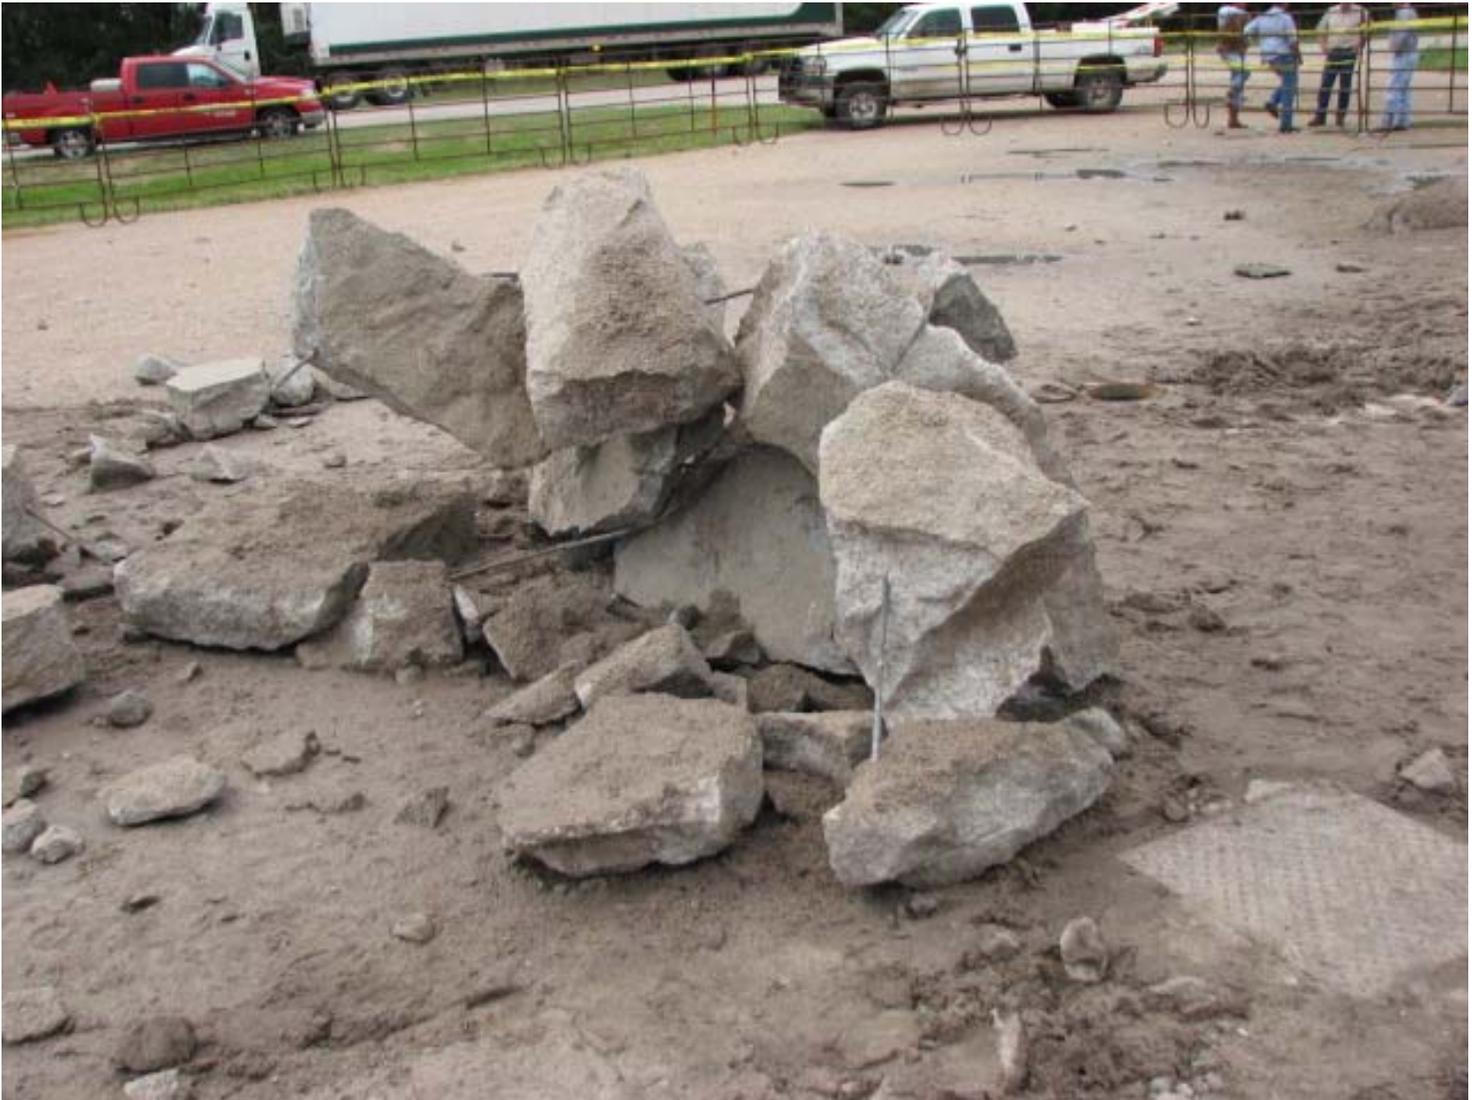
#249

This picture shows a close up of the concrete piled up by the explosion.

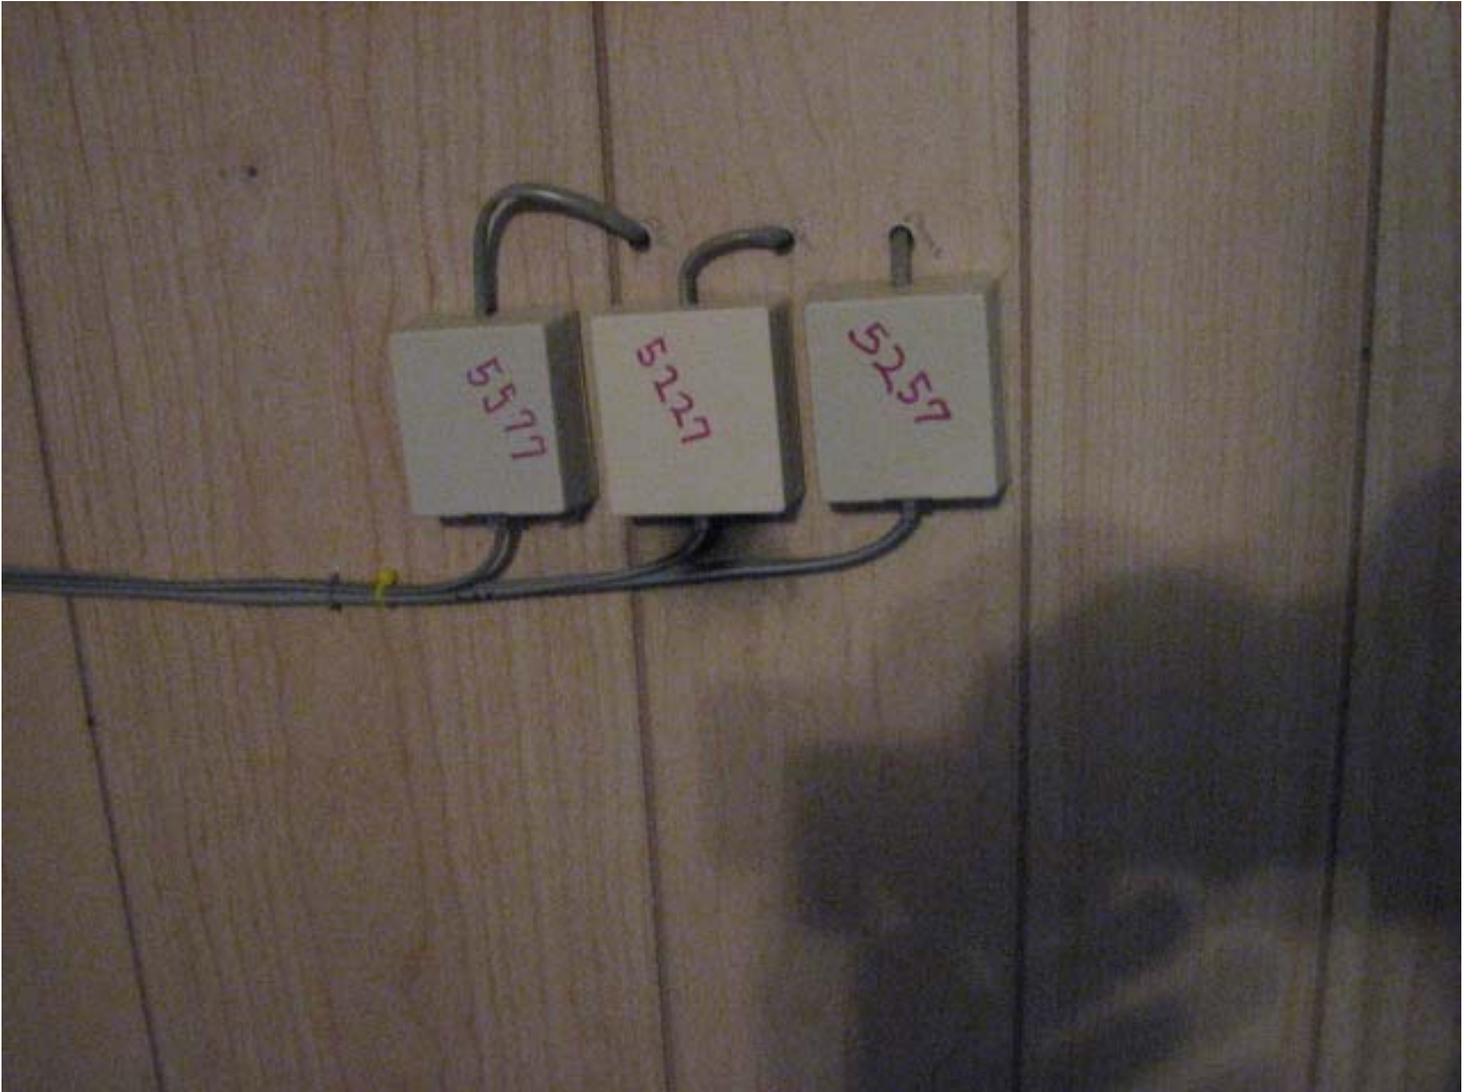
#251

It was discovered the lightning had come into the building on the telephone line going to the fax and credit card machine.

This Picture shows the black soot on the wall by the fax line in the upstairs office.

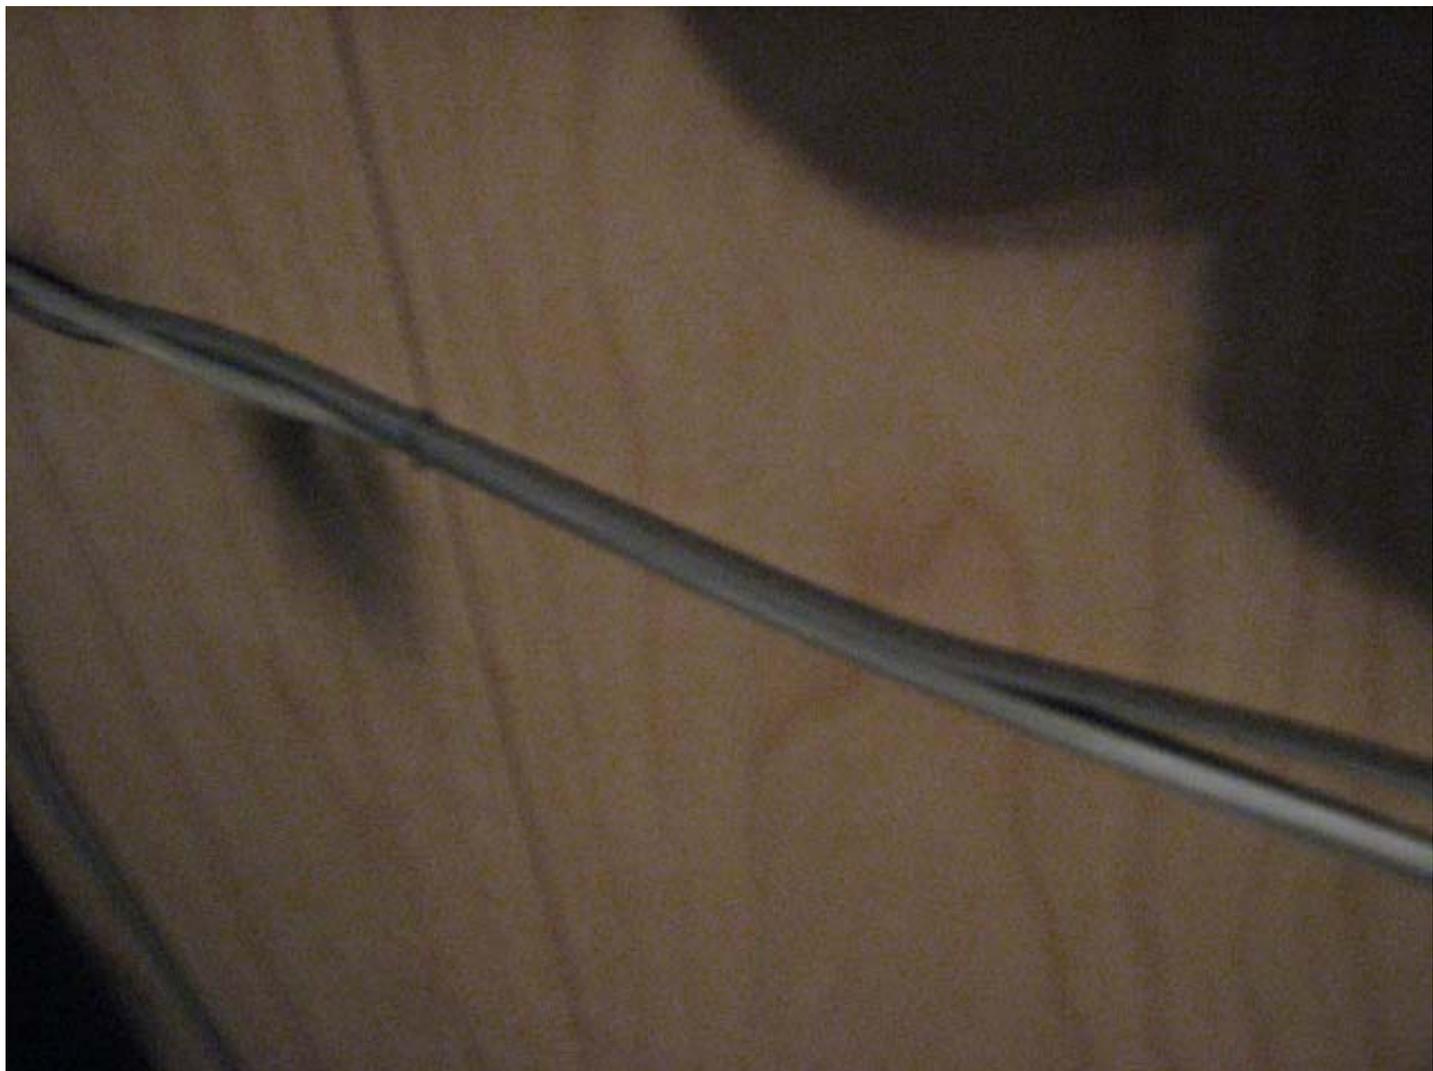
#255

This Picture shows the black soot by the junction box going to the fax machine in the upstairs office.
