PHOTO LOG OF LOCATION DAY OF EXPLOSION

PHOTO LOG OF TANKS BEING PULLED ON 09/07/11

CONCLUSION:

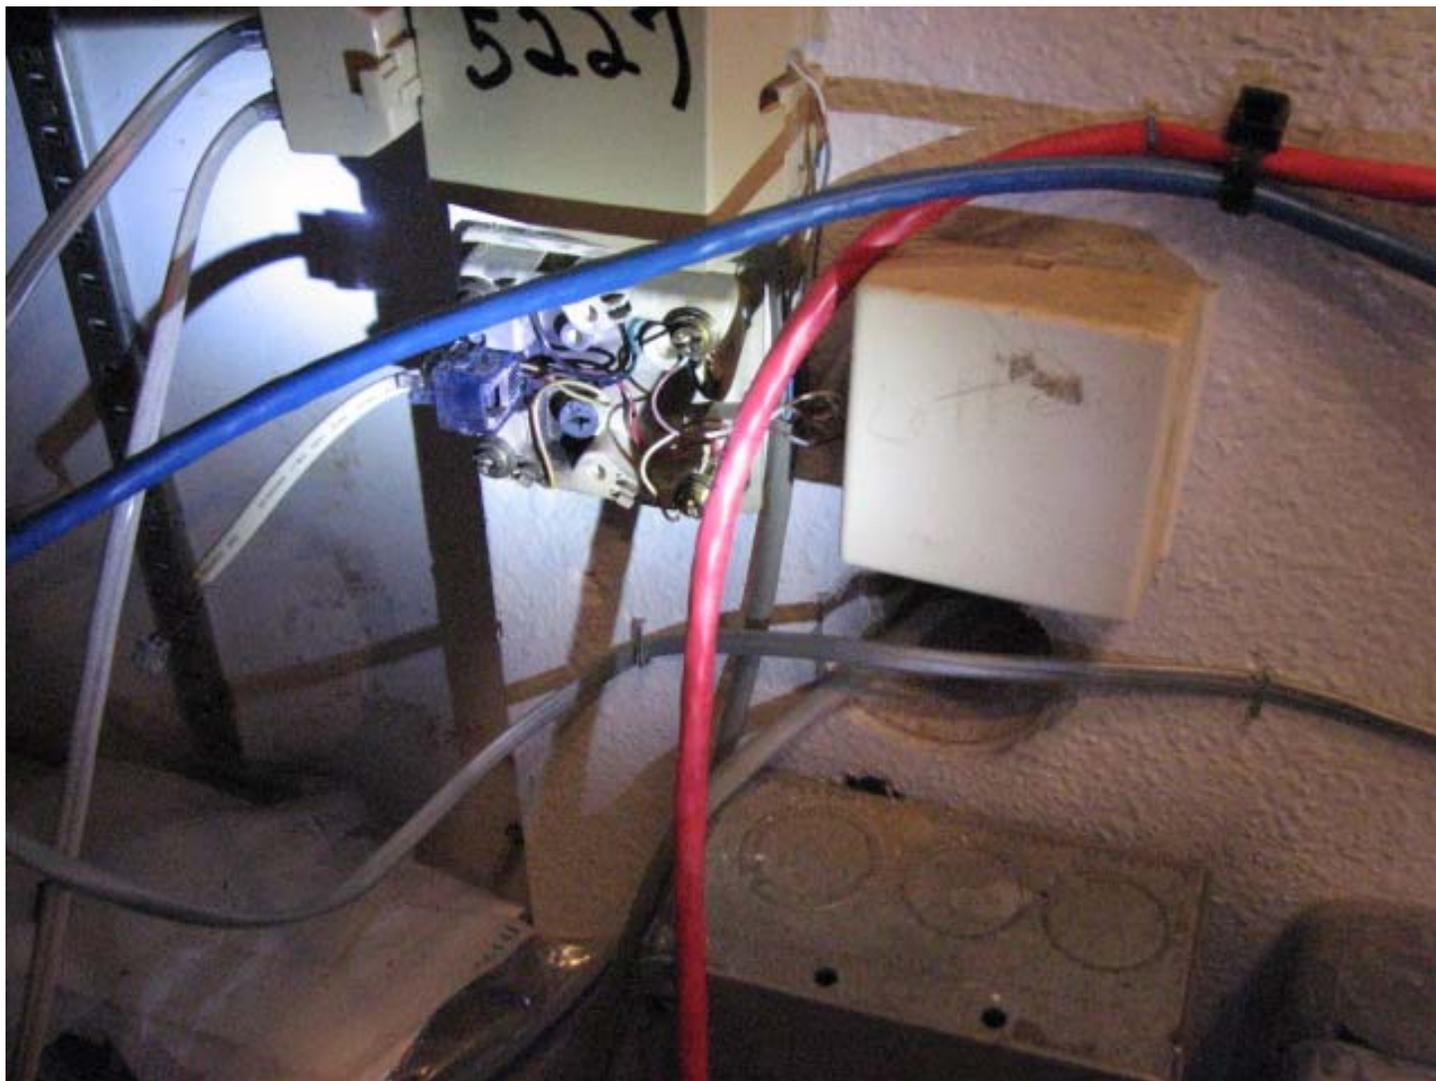
#257

This Picture shows the telephone junction box with the cover missing.

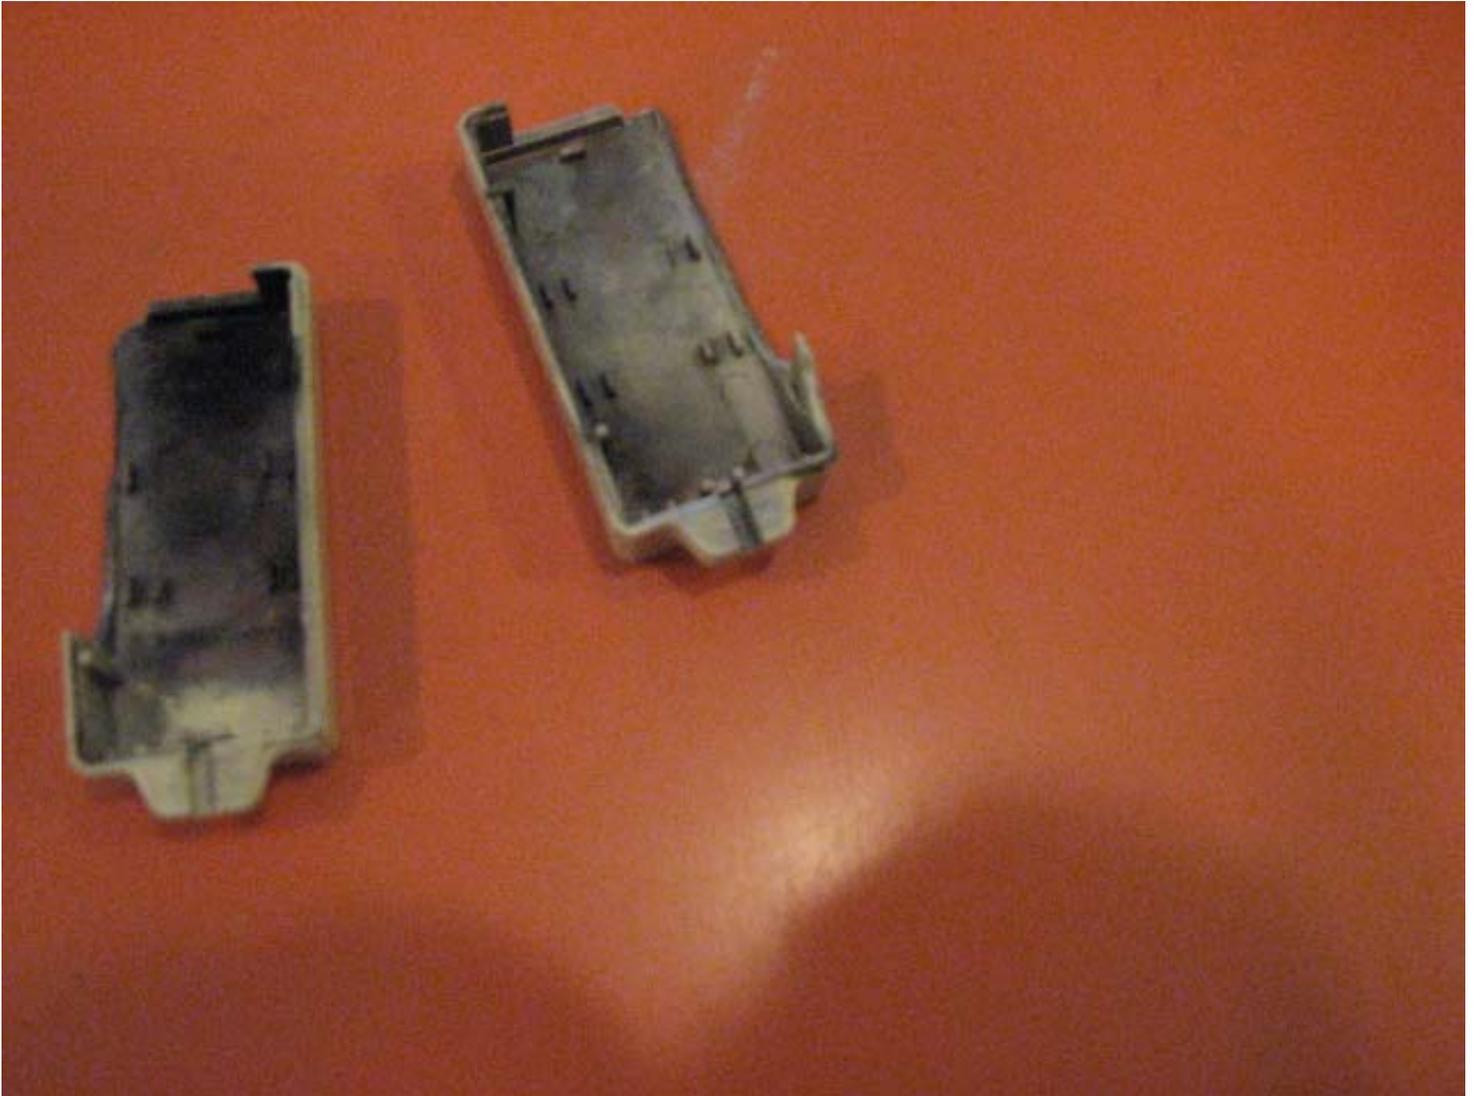
#259

This picture shows the junction box cover that was blown off and broken in half. It shows the black soot on the inside of the cover.

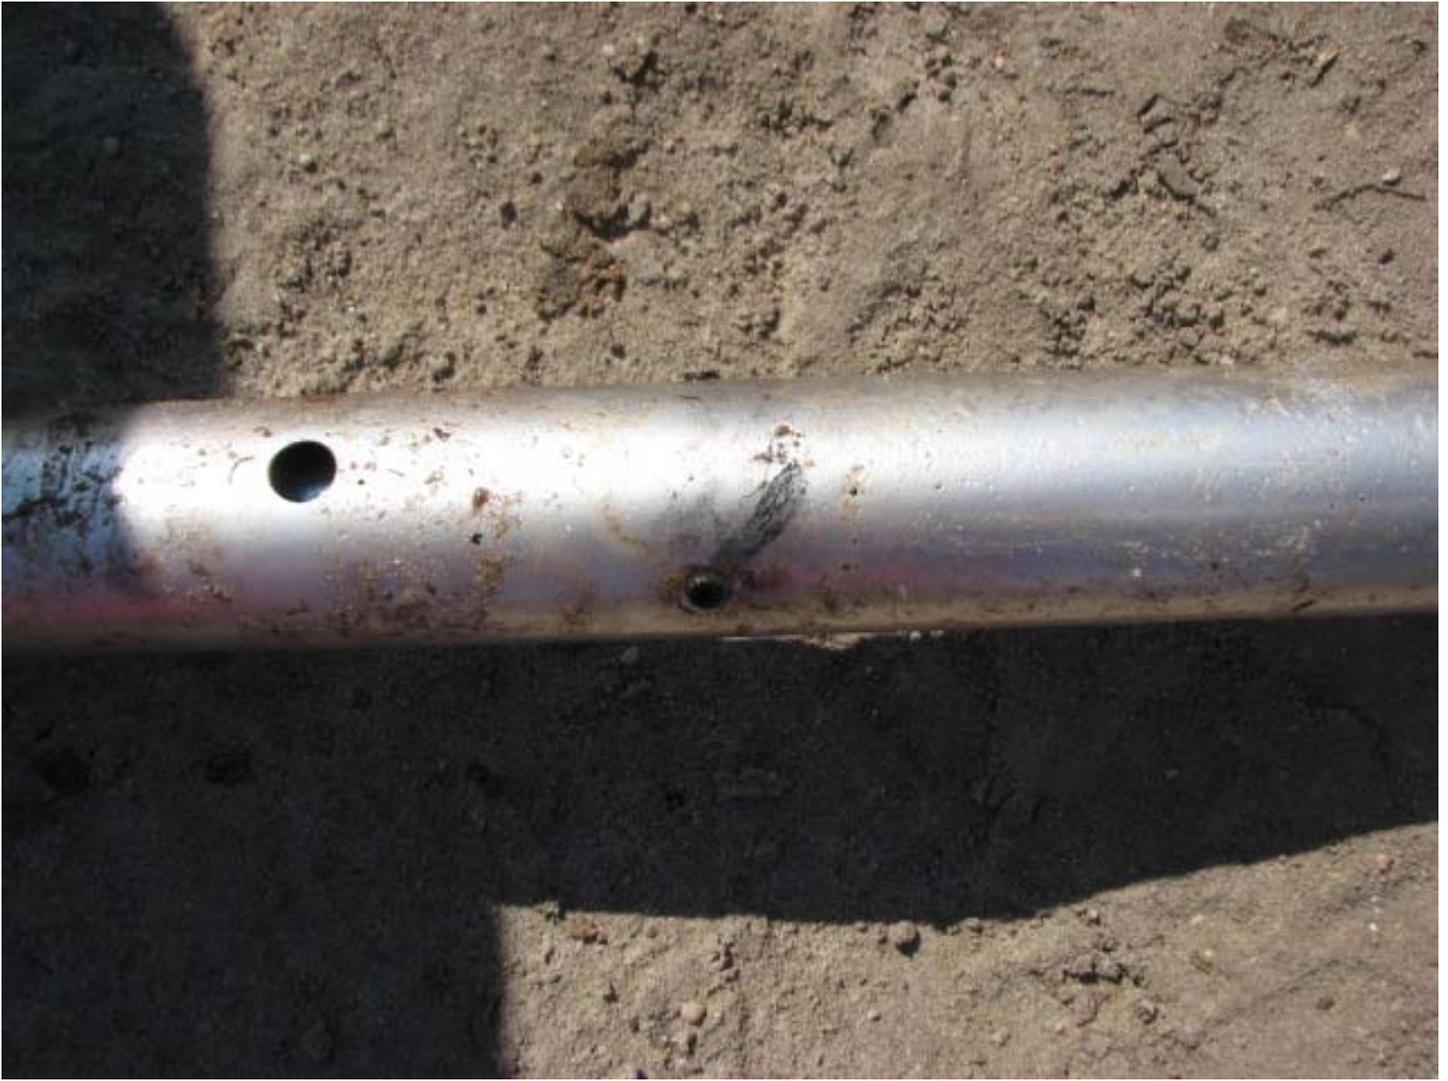
#32

This is a picture of the ATG probe from the diesel tank with the arcing mark on the probe tube. The arcing is by the hole in the center of the picture.

All Evidence and information gathered at the location of the explosion of the diesel tank would lead to the conclusion that it was caused by a lightning strike.

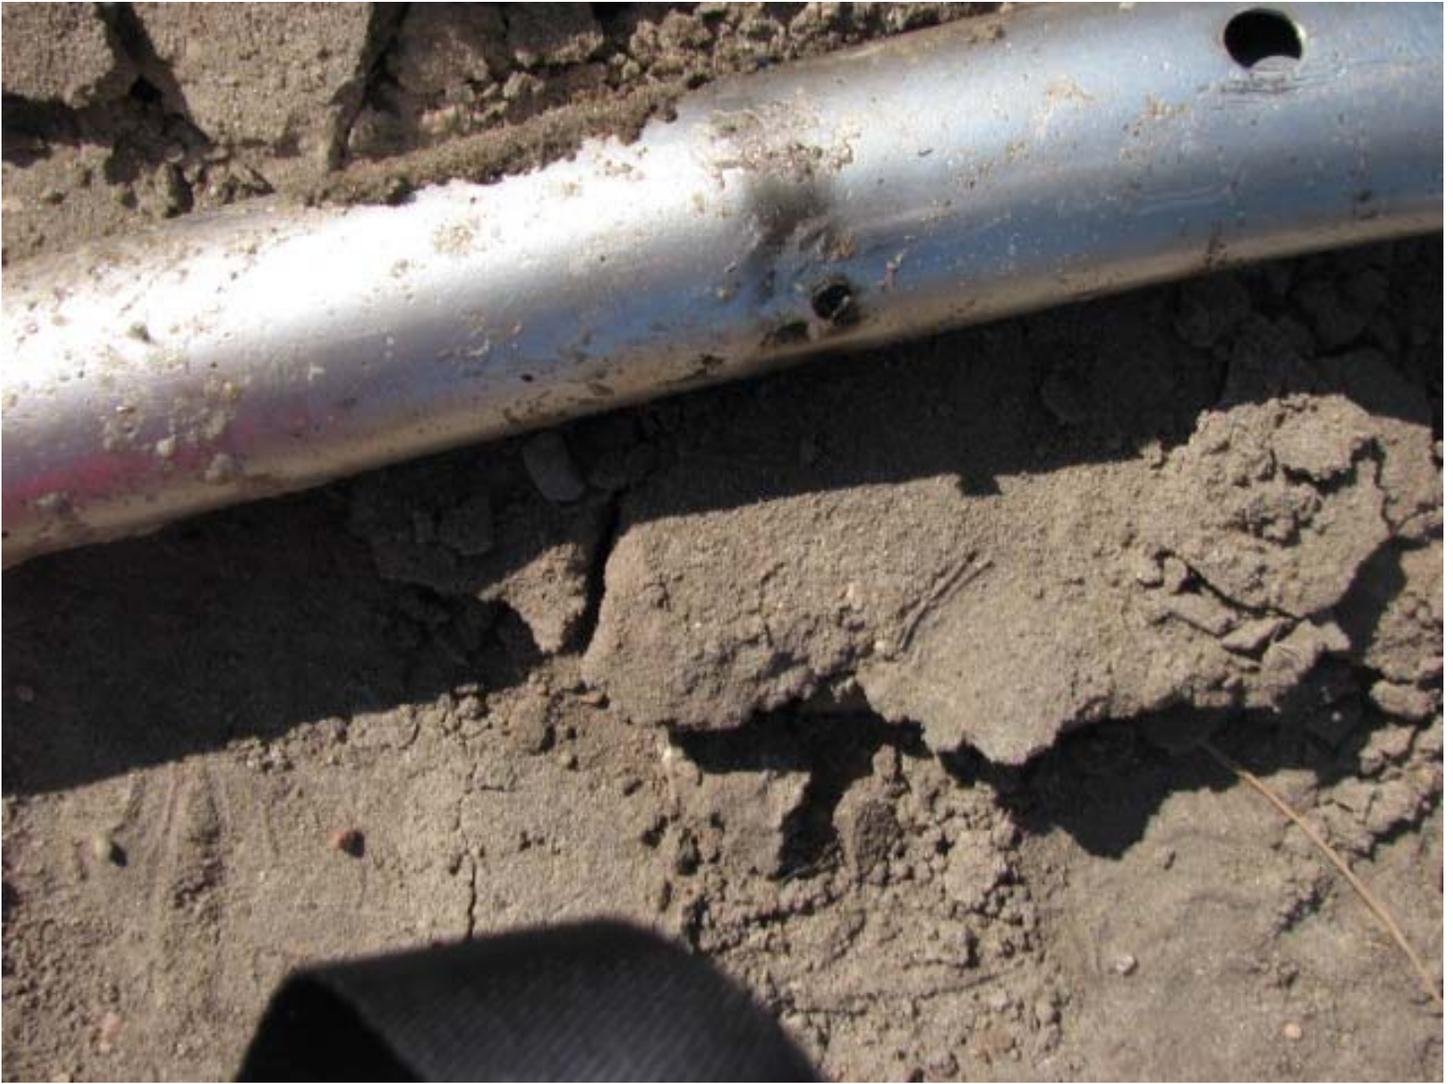
#34

This picture shows the second area of arcing on the diesel ATG probe tube. The arcing is by the small hole in the center of the picture.

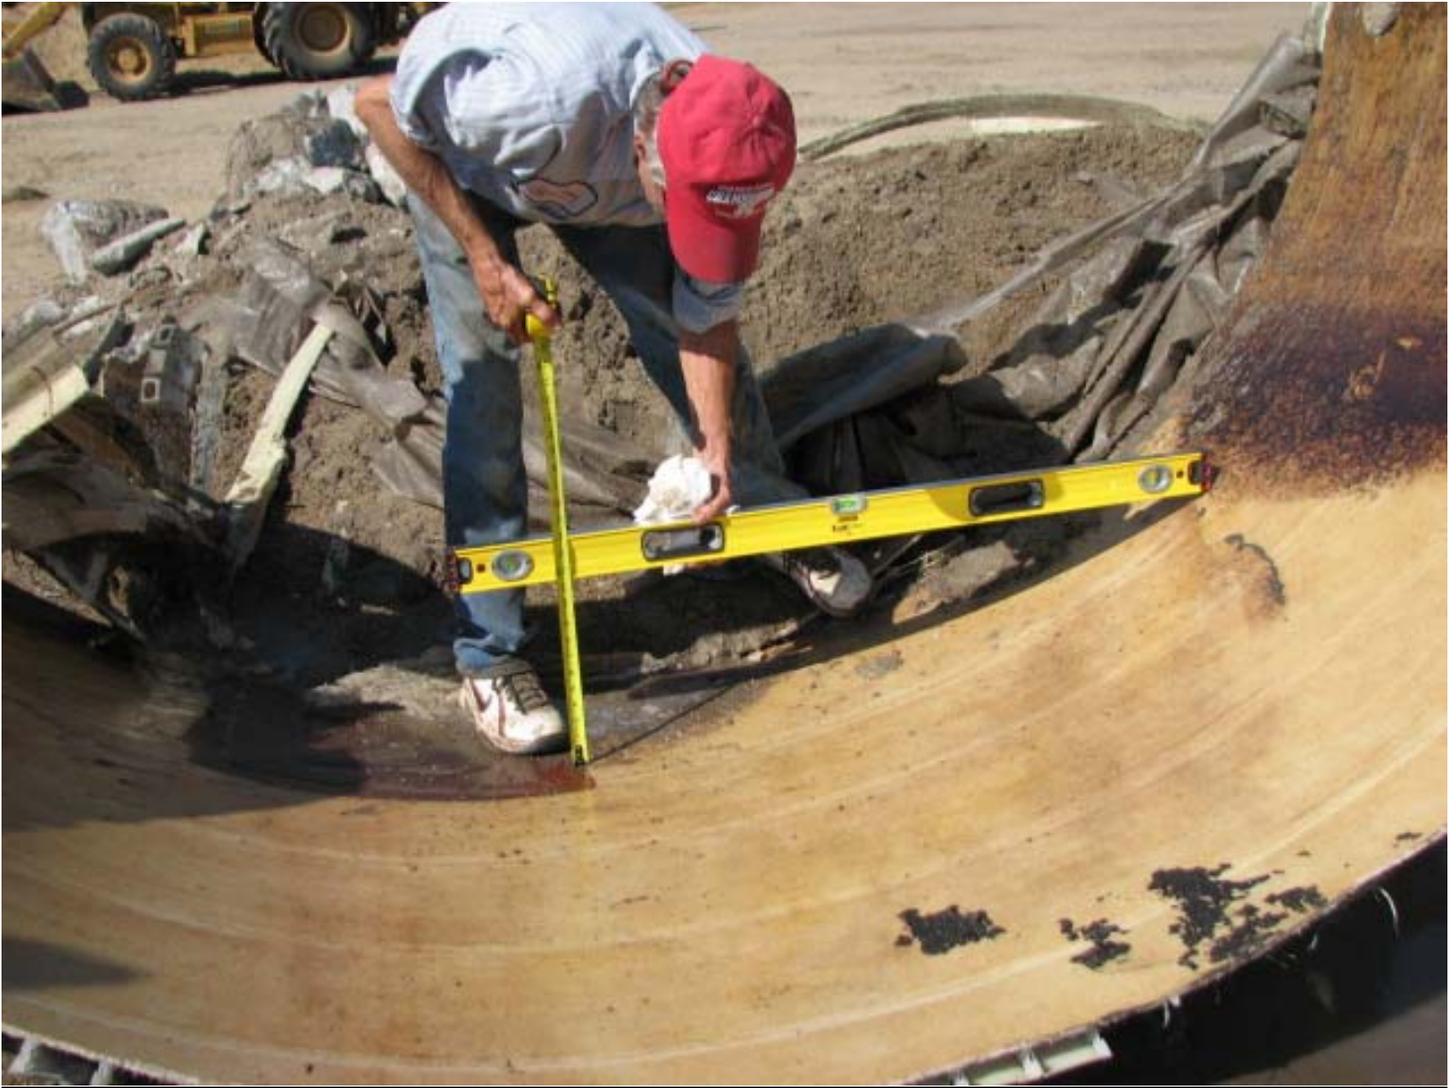
#35

This picture shows the fireball burn area in the diesel tank, starting 11 inches from the bottom. The diesel tank had 9.9 inches of product before the explosion.

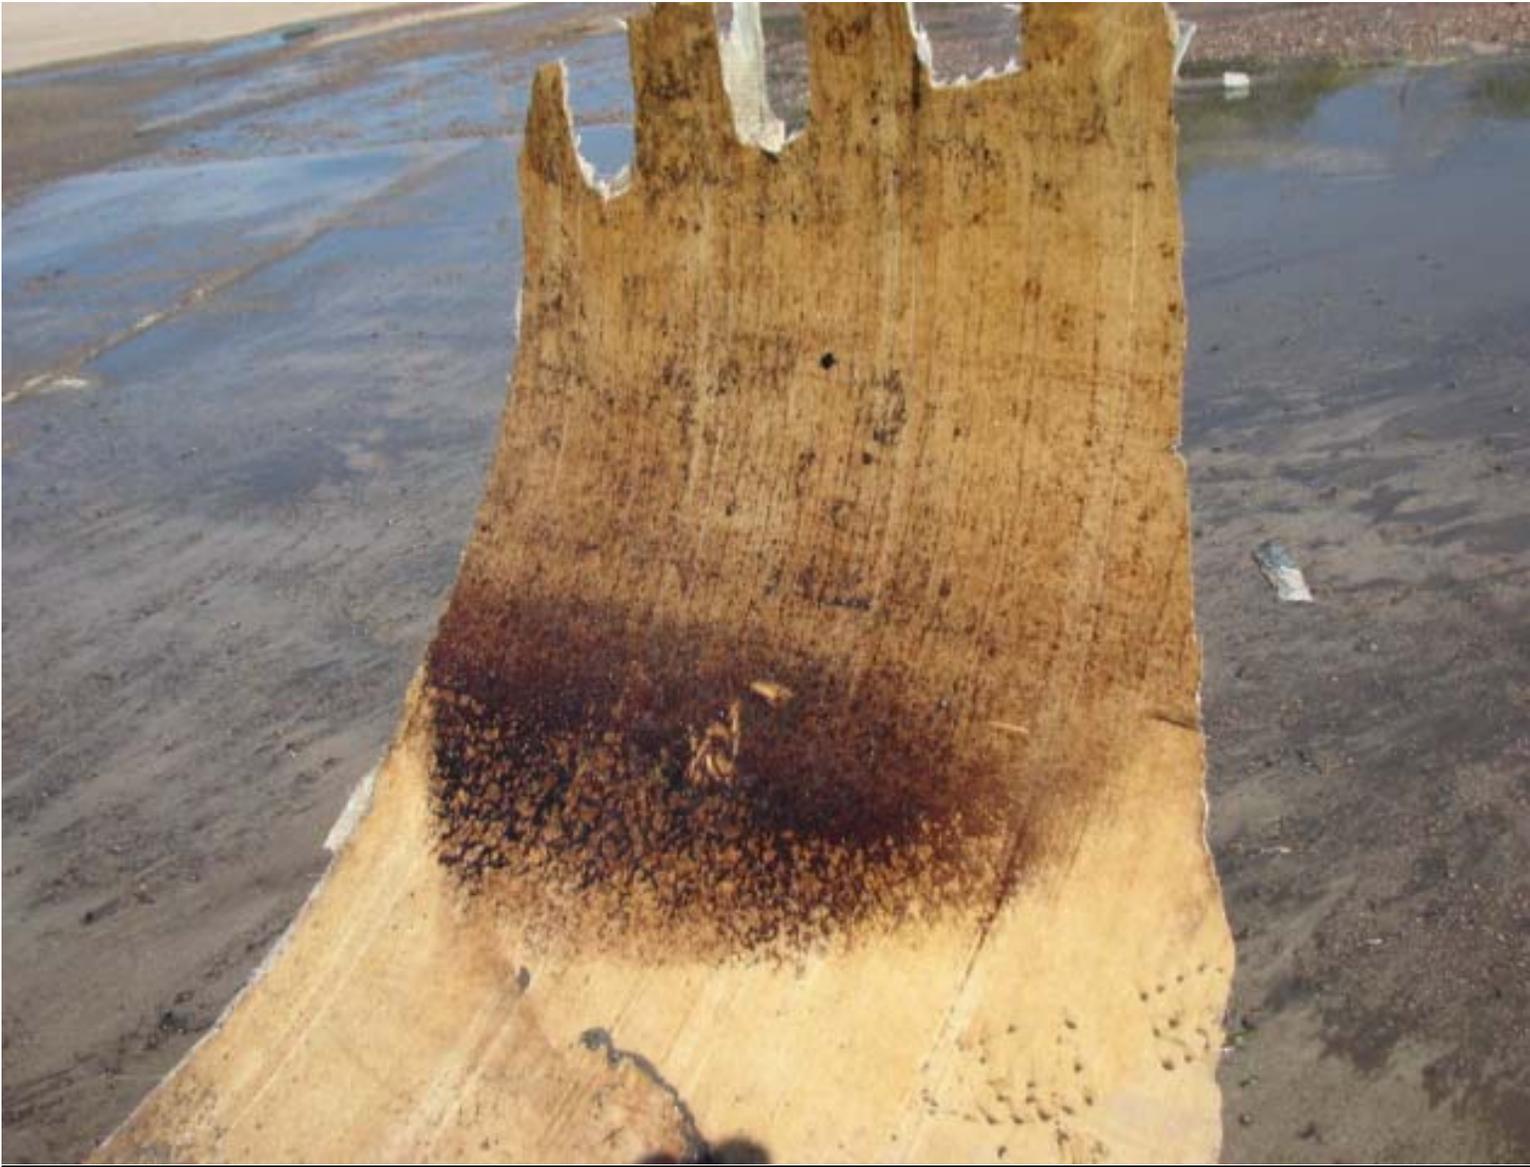
#37

This picture shows the burned area to the side of the area the ATG probe was installed in the diesel tank.

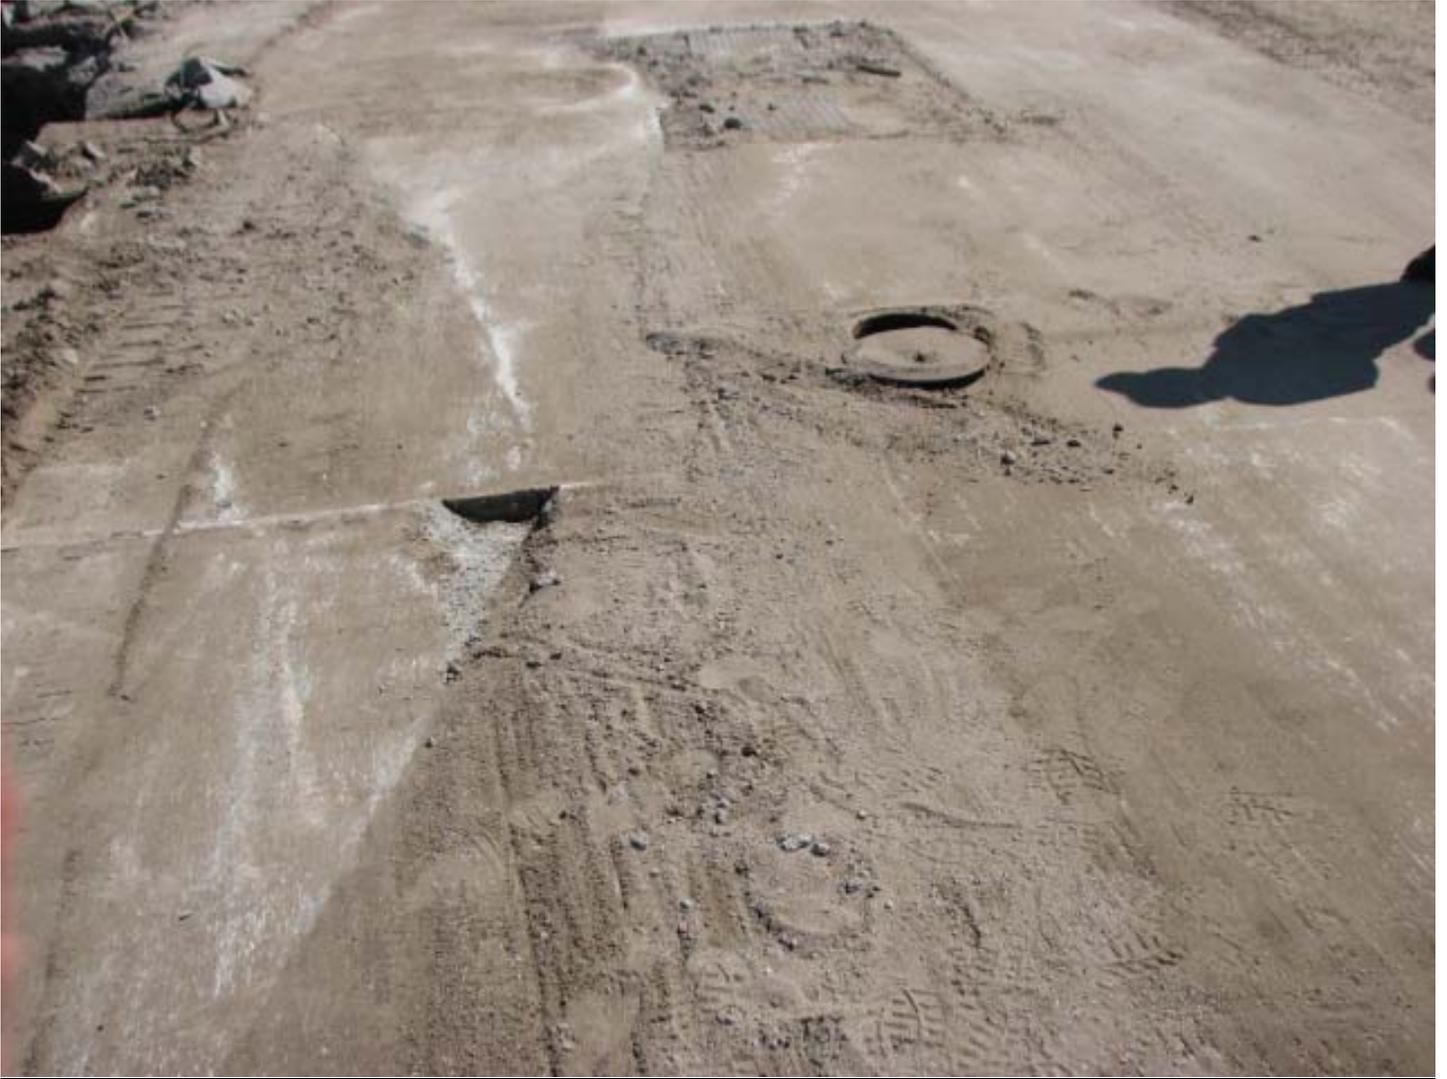
#44

This Picture shows the damage to the concrete above tank #3.

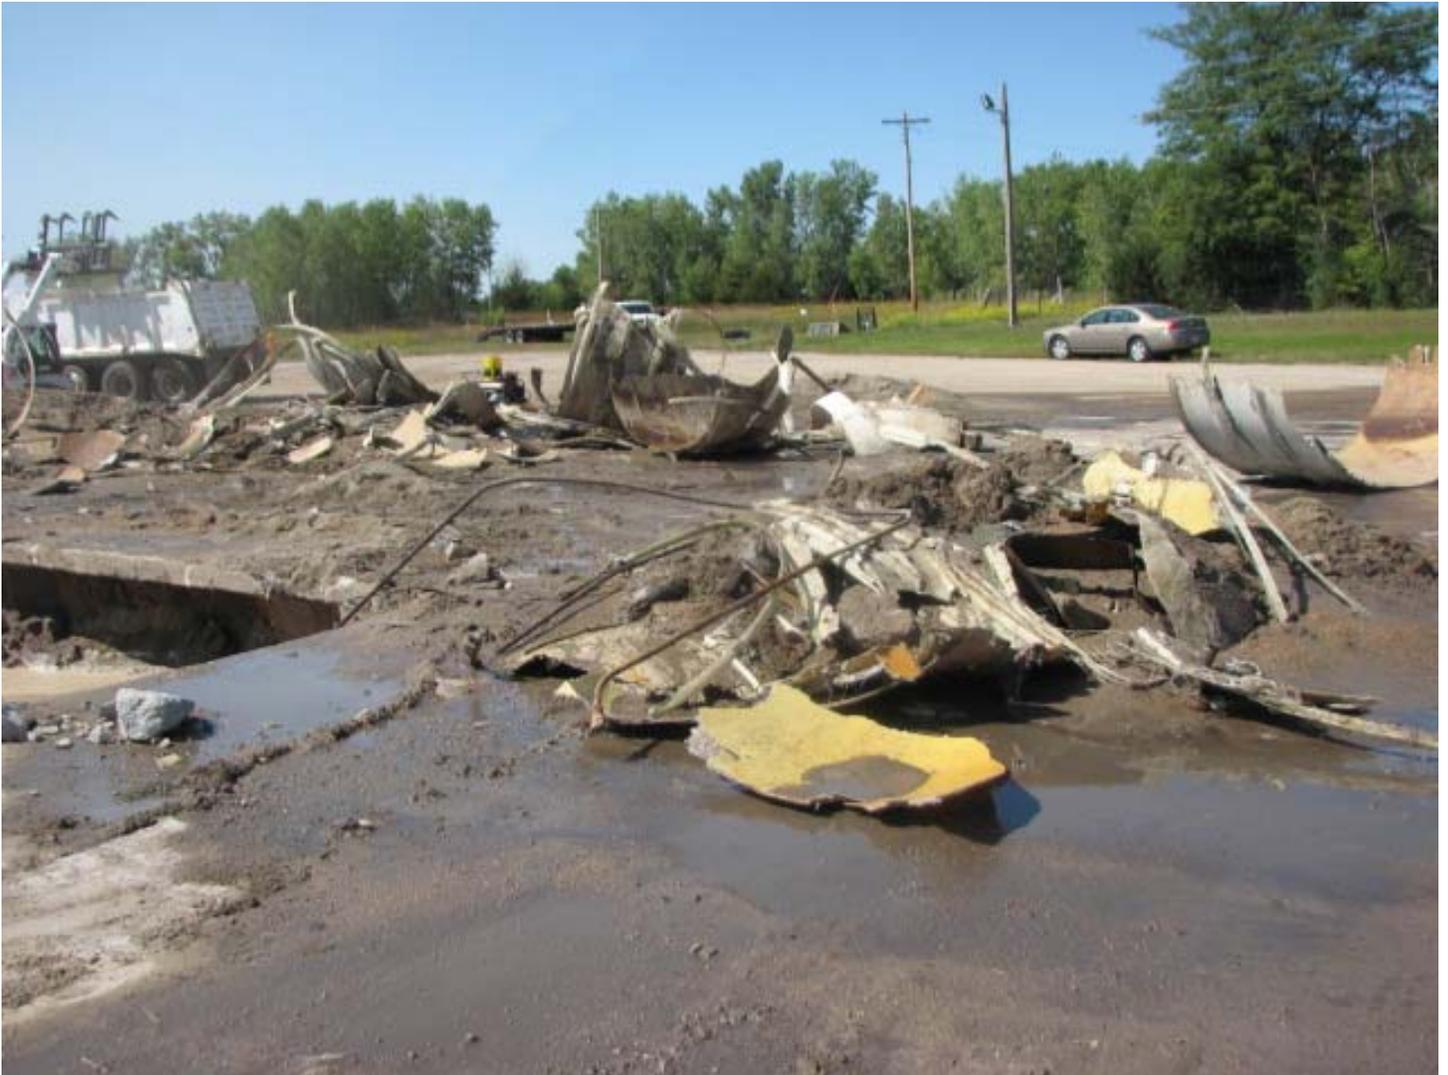
#46

This picture shows the damage that was done to tank #1 and Tank #2. All three tanks and other debris was taken to the Valentine land fill.

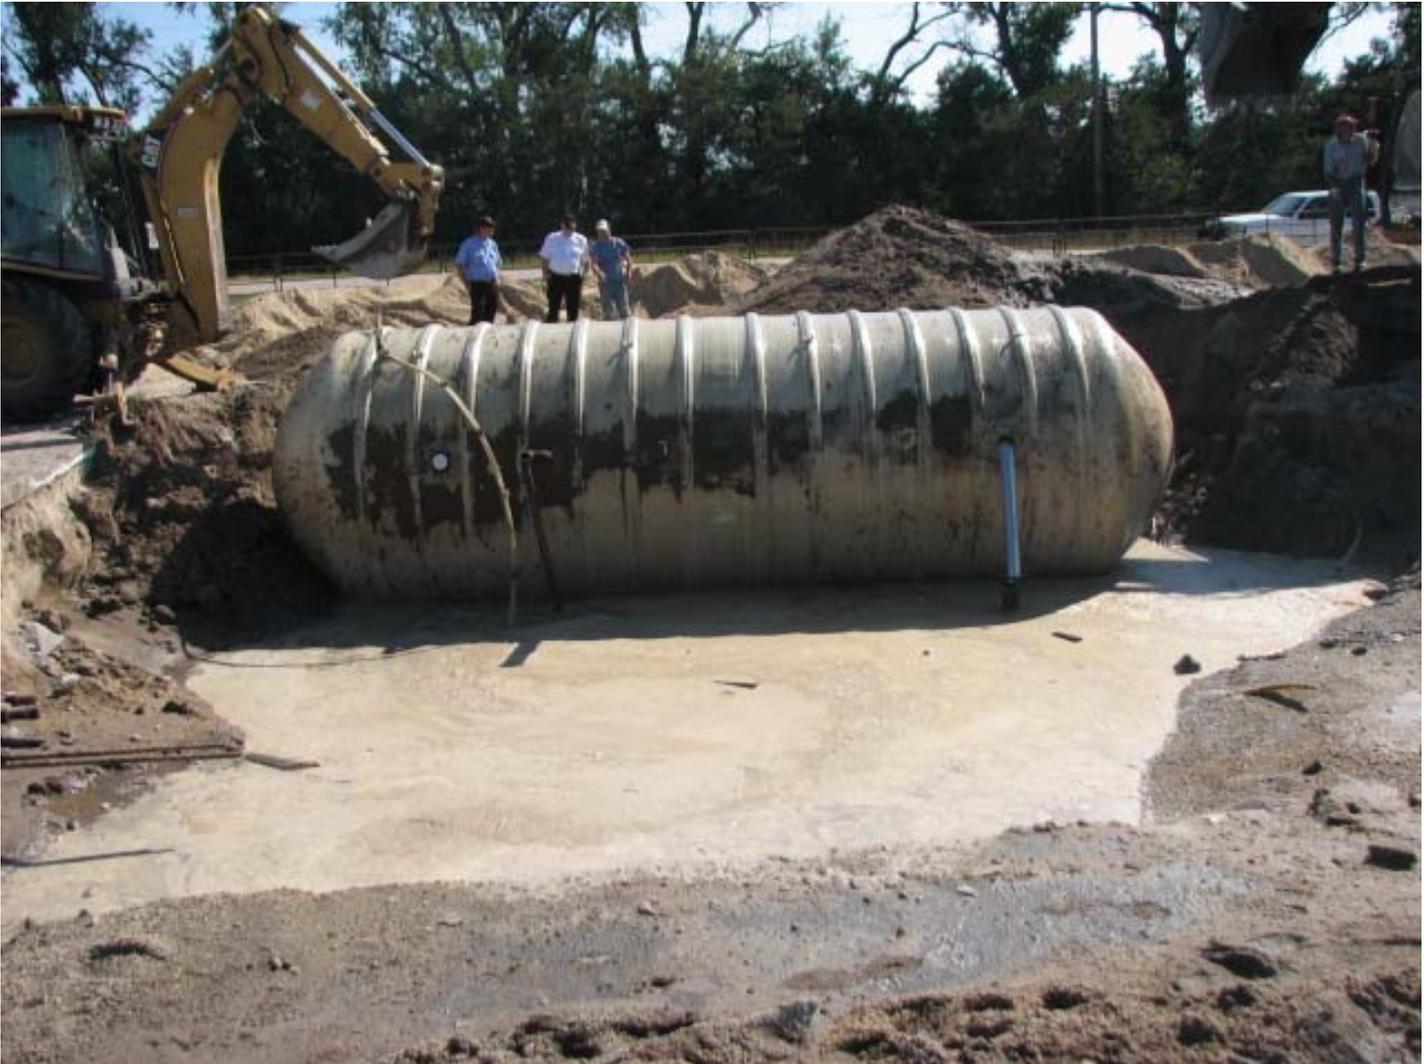
#56

This picture shows tank #3 being removed. It was intact when it was removed.
