APPENDICES

APPENDIX A

Delhi Dam
Project Drawings and Construction Photographs

Photos During the Flood of July 24, 2010
Ongoing deterioration and breach of the Right (South) Embankment

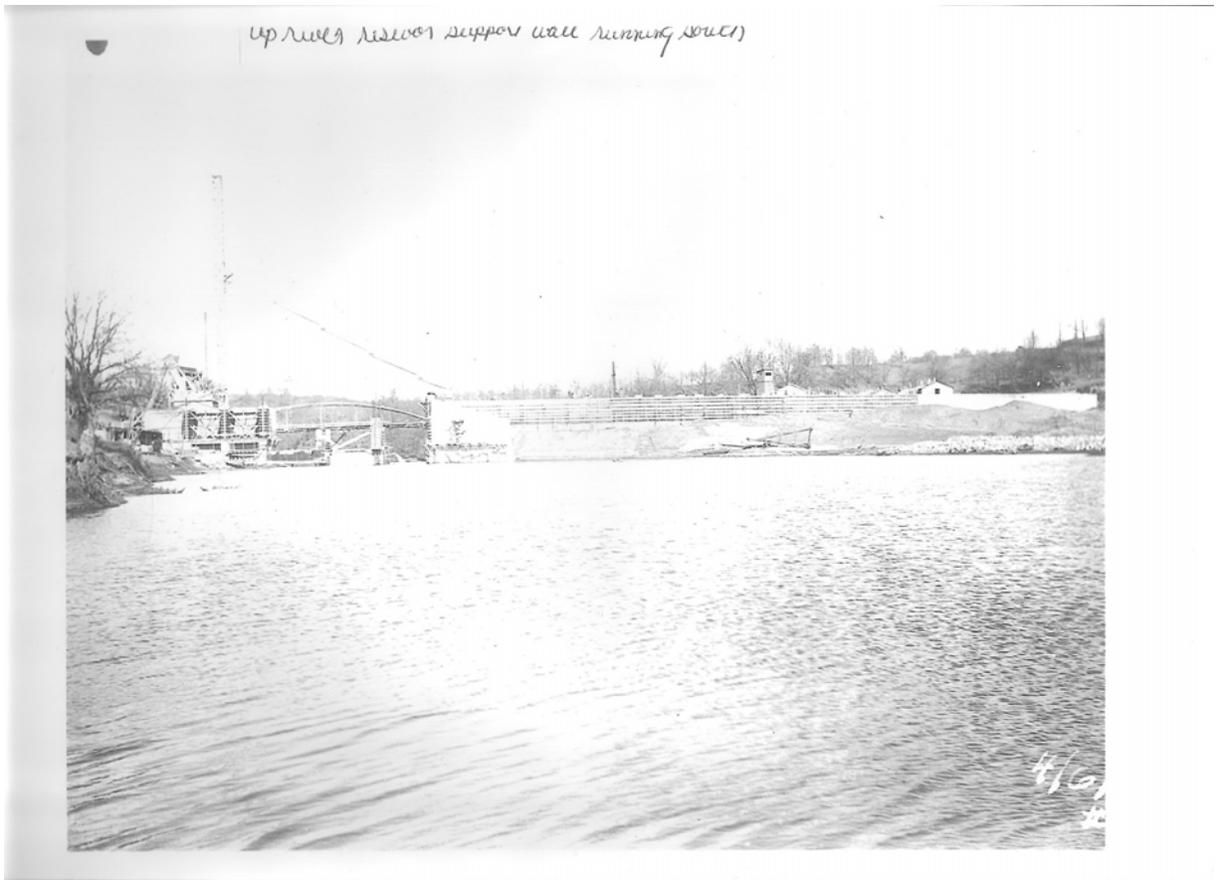
Construction Photograph

Note construction of Concrete Core Wall and right (south) embankment fill

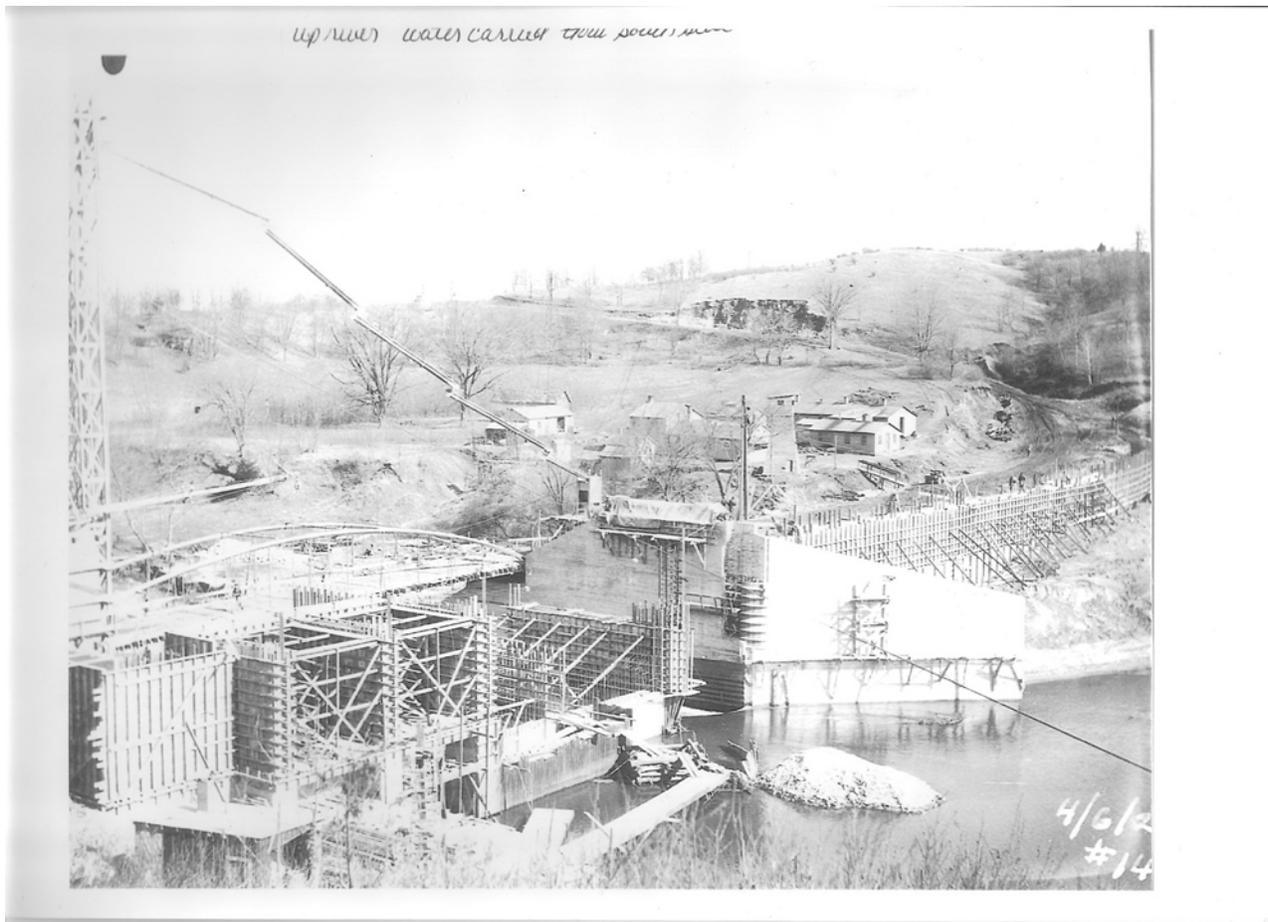
Construction Photograph

**Note Construction of core wall and right (south) embankment fill
Suspected borrow source in background**

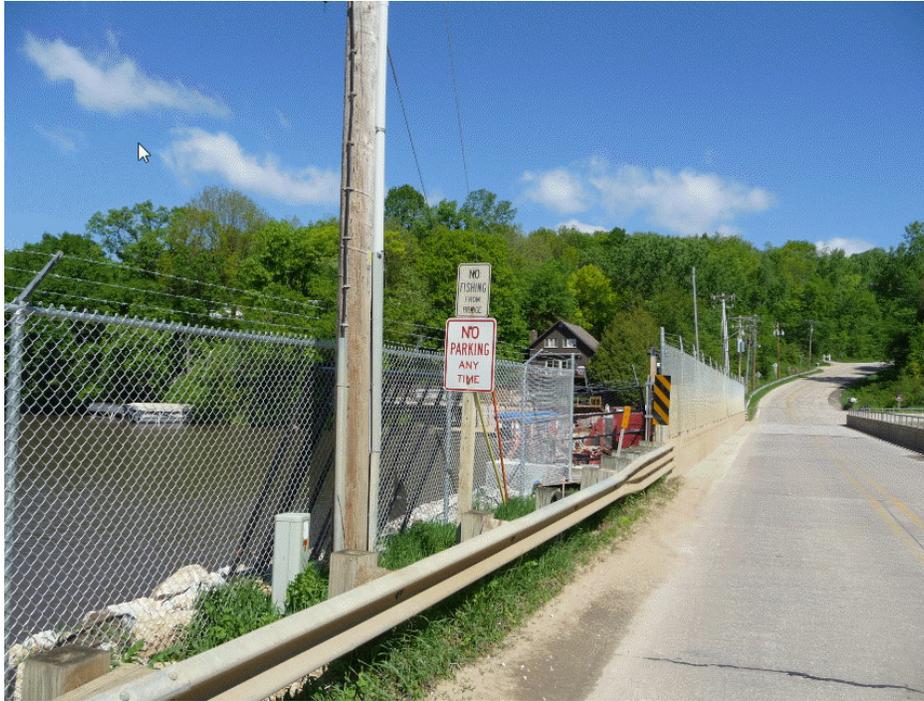
Crest of dam from right (south) embankment in area of initial breach (looking north)The double section of guardrail is 16 ft long, with posts spaced about 3 feet apart, the single guardrail sections are 20 ft. long with posts spaced at about 5 ft

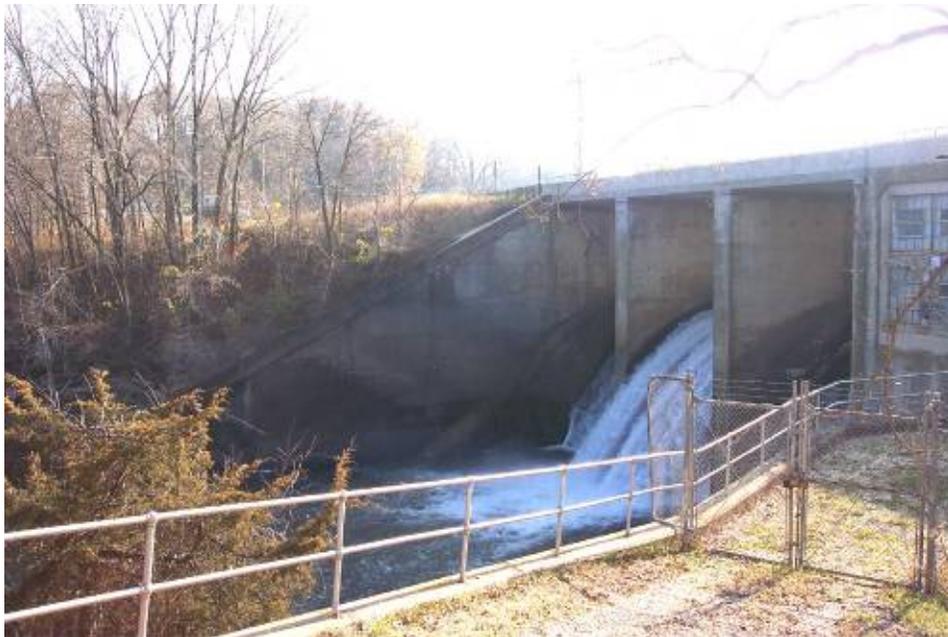
Downstream view looking south towards the right (southern) embankment
Note the trees in the section where the initial breach occurred.

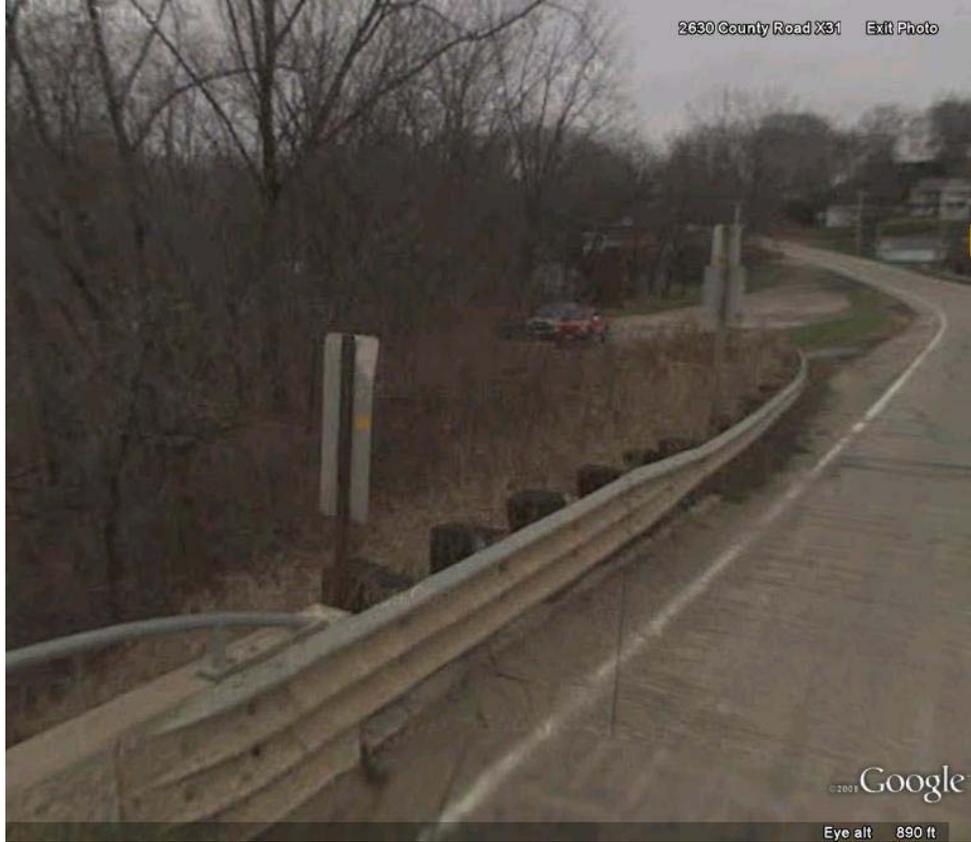
Downstream guardrail and crest shoulder in breach area
(Google)

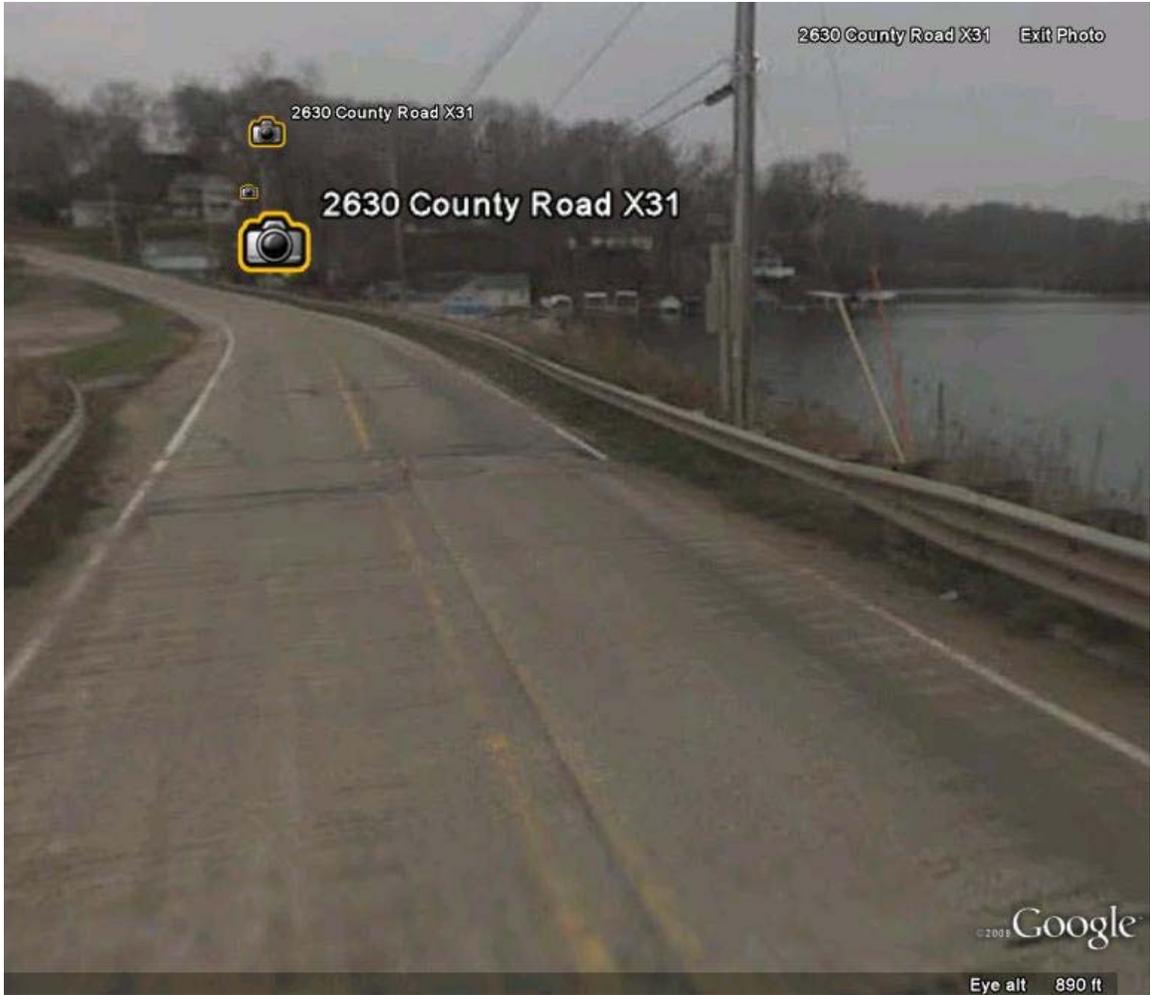
Crest of embankment in breach area
(Google)

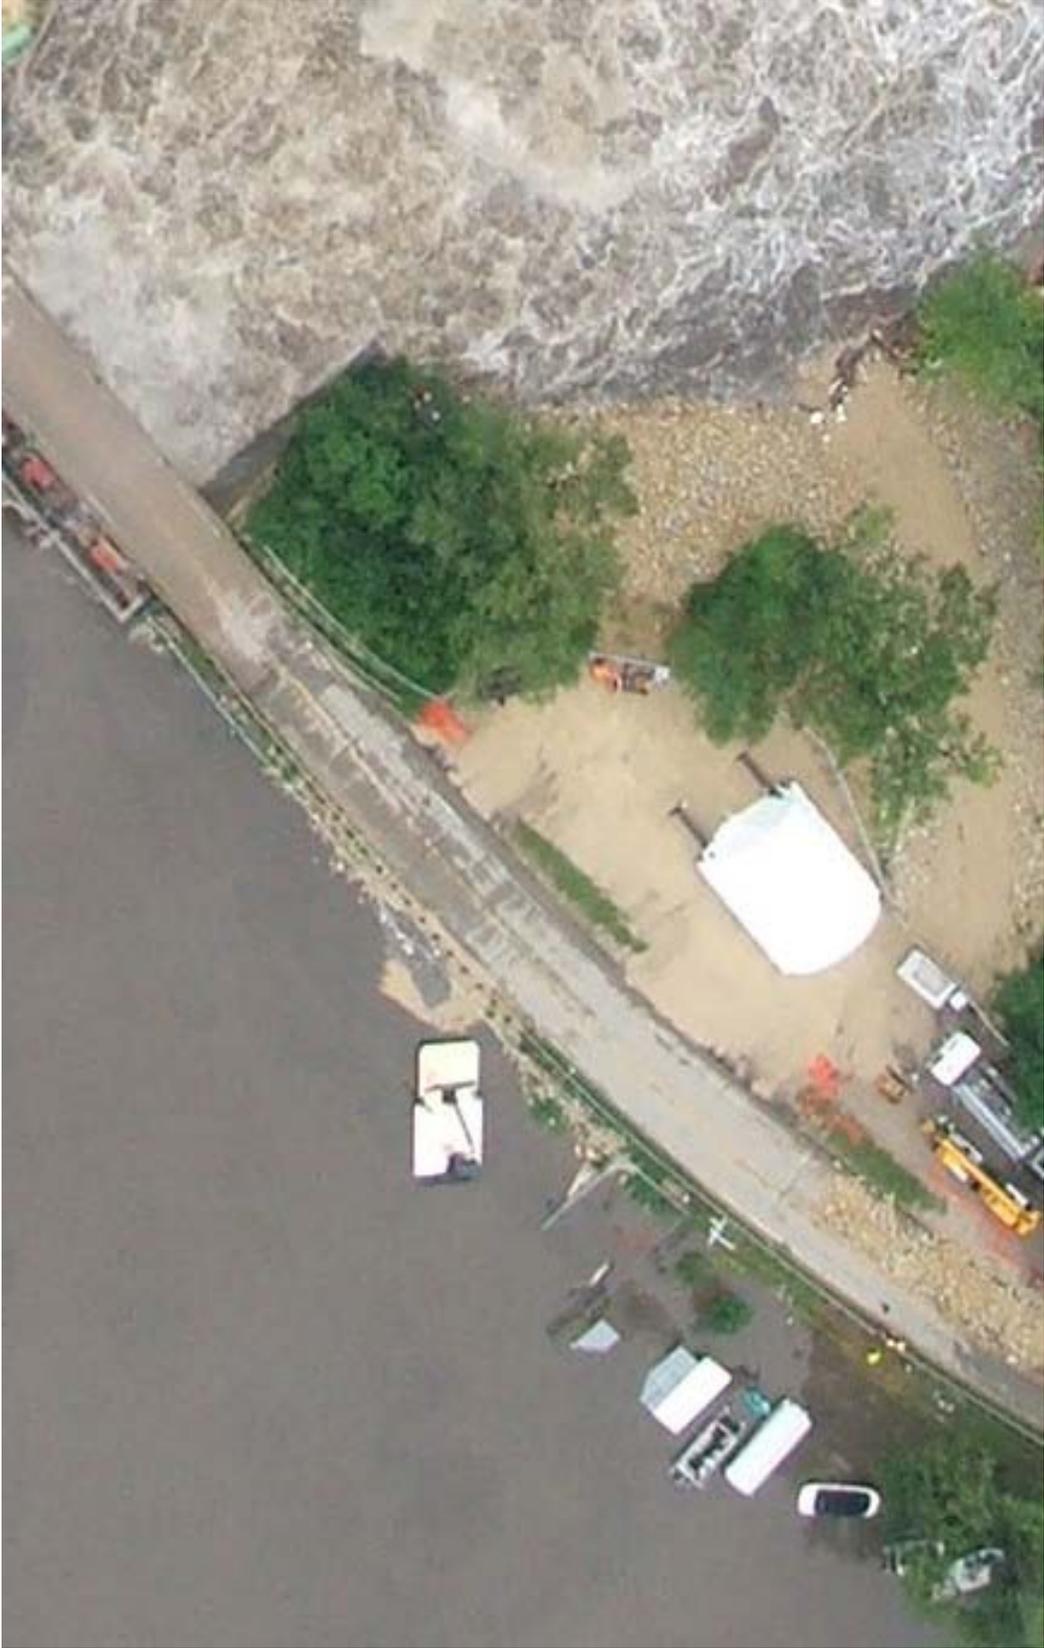
Aerial view of right embankment in the area of the breach

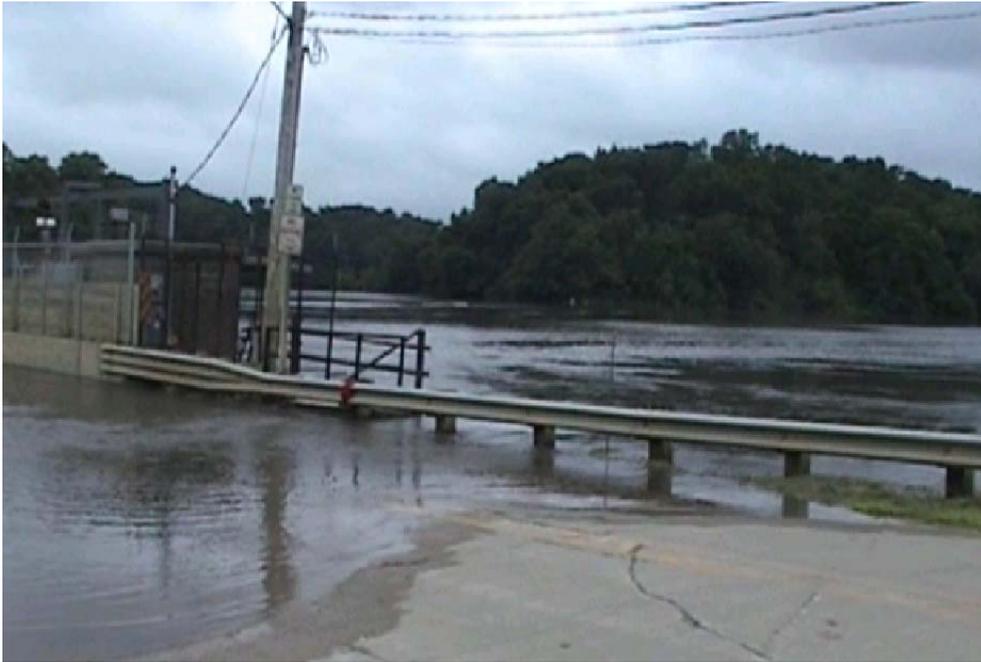
Overtopping of left end of powerhouse and left embankment section

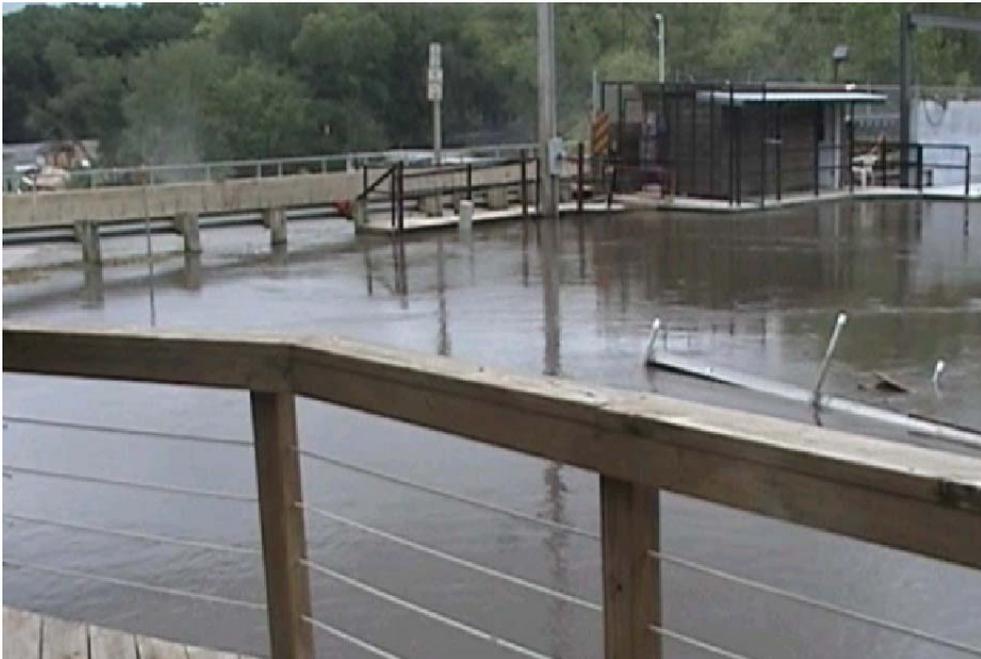
Overtopping of left embankment

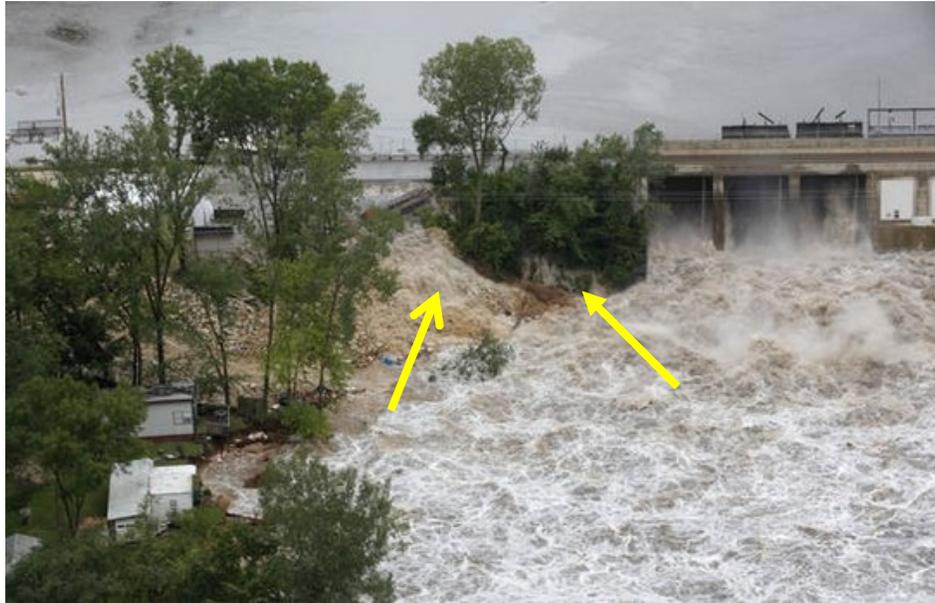
Aerial view of downstream side
Note Flow

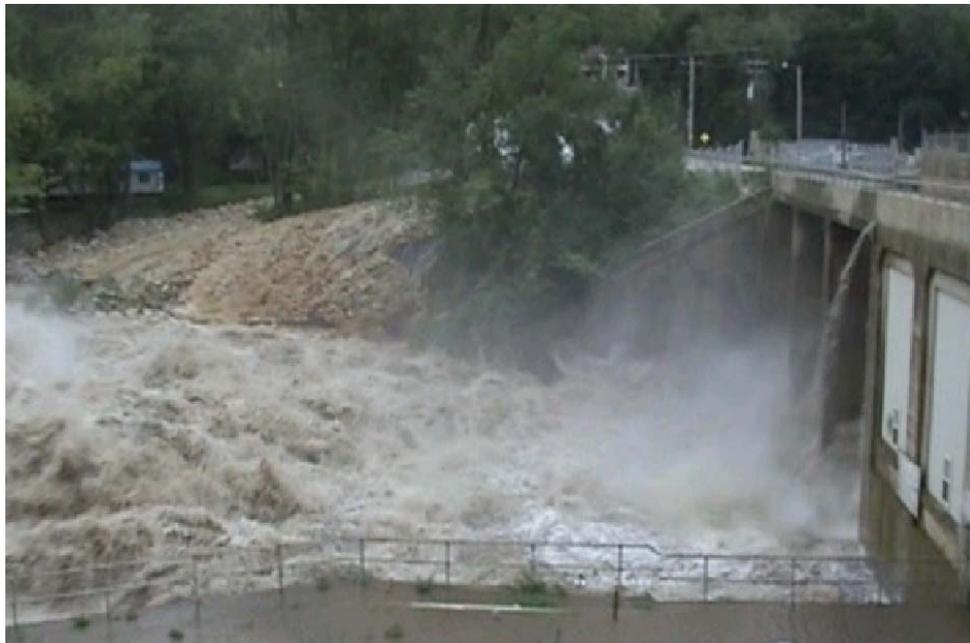
View of right Spillway training wall, vegetation on the downstream slope and recent riprap placement over the berm/parking area fill

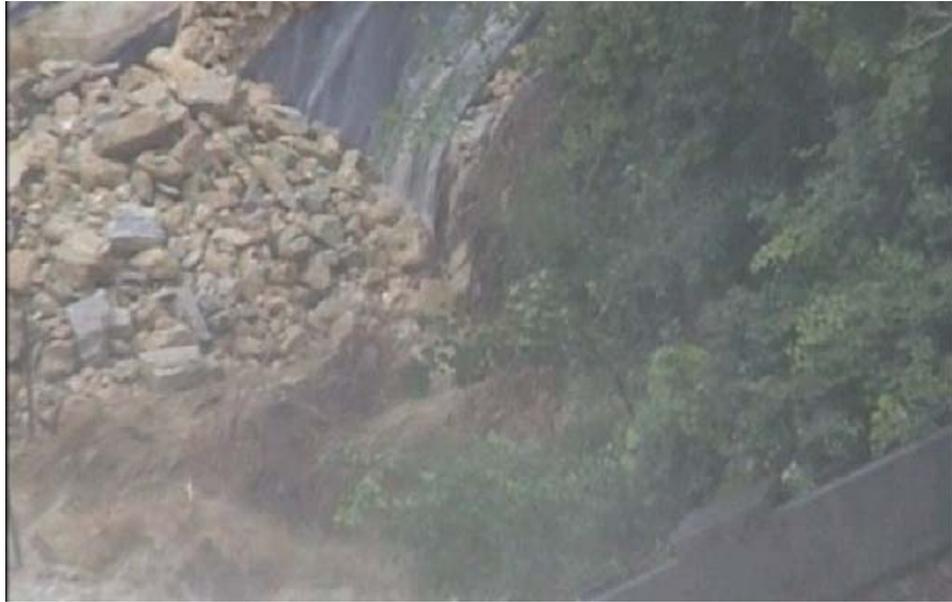
Deterioration of right embankment toe
Note scarp in recent riprap overlay and cloudy flow

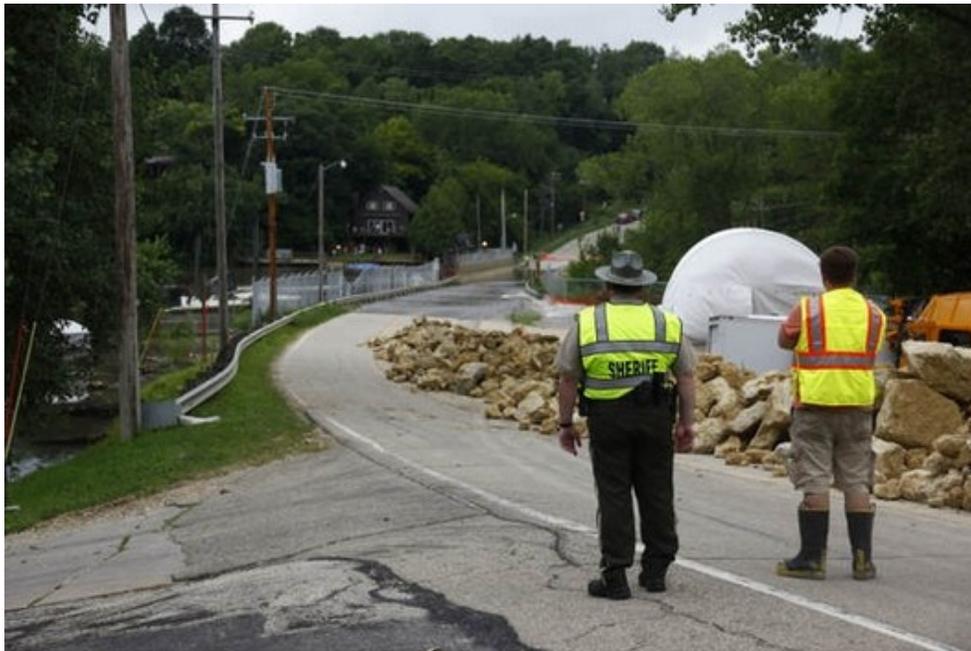
Overtopping before deterioration at the crest

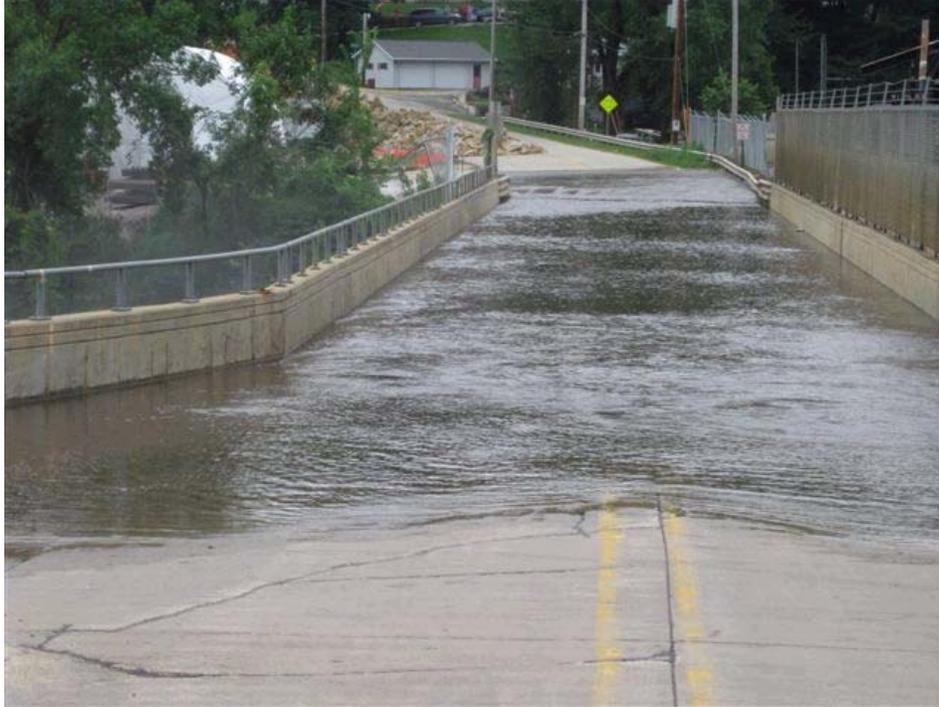
Overtopping and progression of tunnel roof collapse through the crest as viewed from left abutment
Note alignment of guardrail and distortion in downstream shoulder chainlink fence and water receding from bridge deck

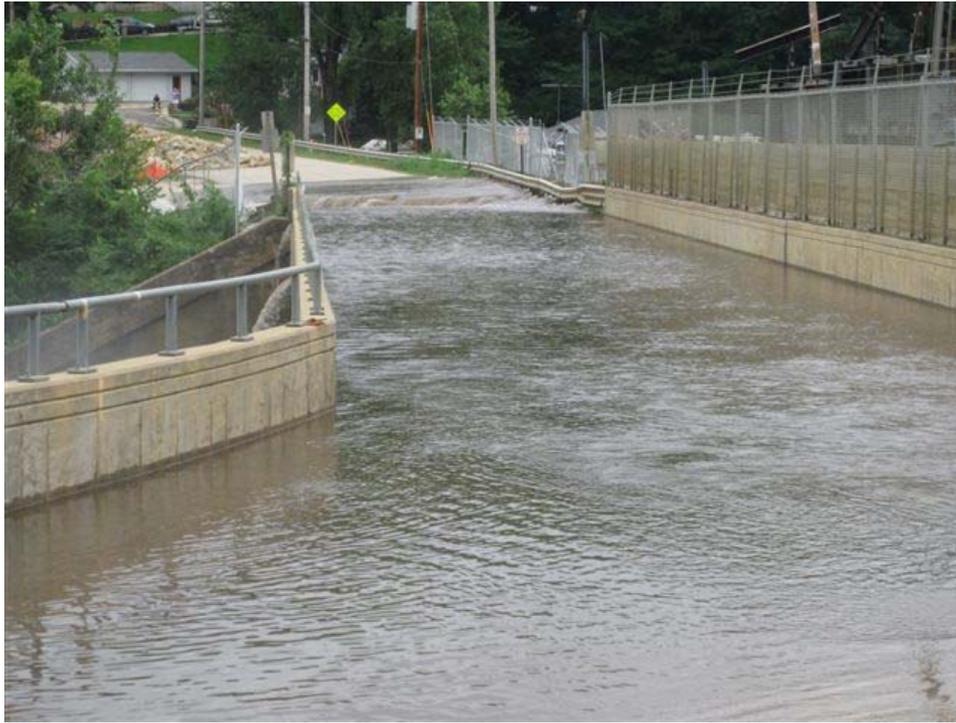
Overtopping and progression of tunnel roof collapse

Note the alignment of the upstream guardrail

The double section of guardrail is 16 ft long, with post spaced about 3 feet apart
Single guardrail sections are 20 long with posts spaced about 5 ft apart

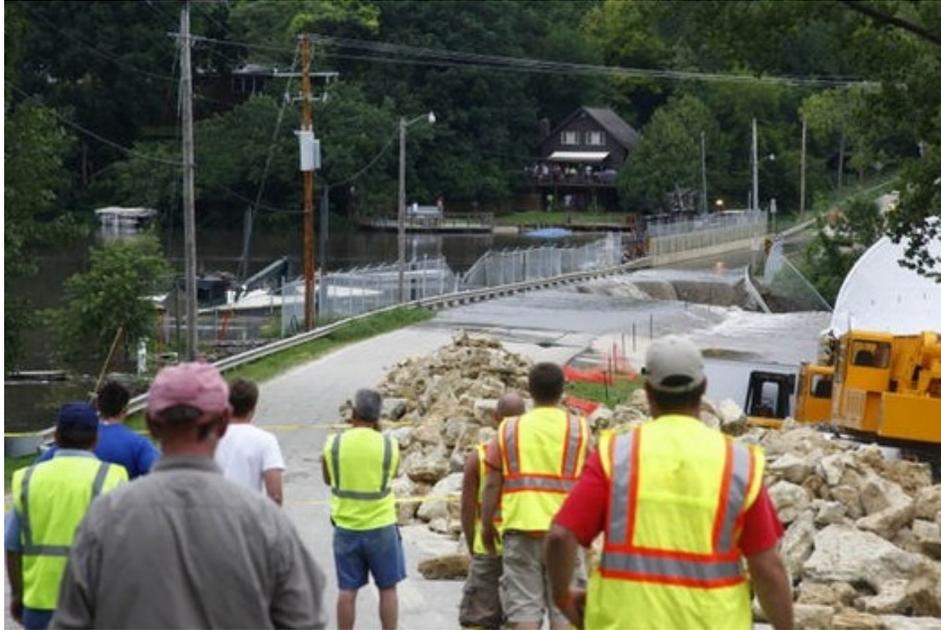
Progression of breach through the right embankment as viewed from right abutment
Note about 10-15 feet of pavement is still adjacent to the spillway training wall at the crest

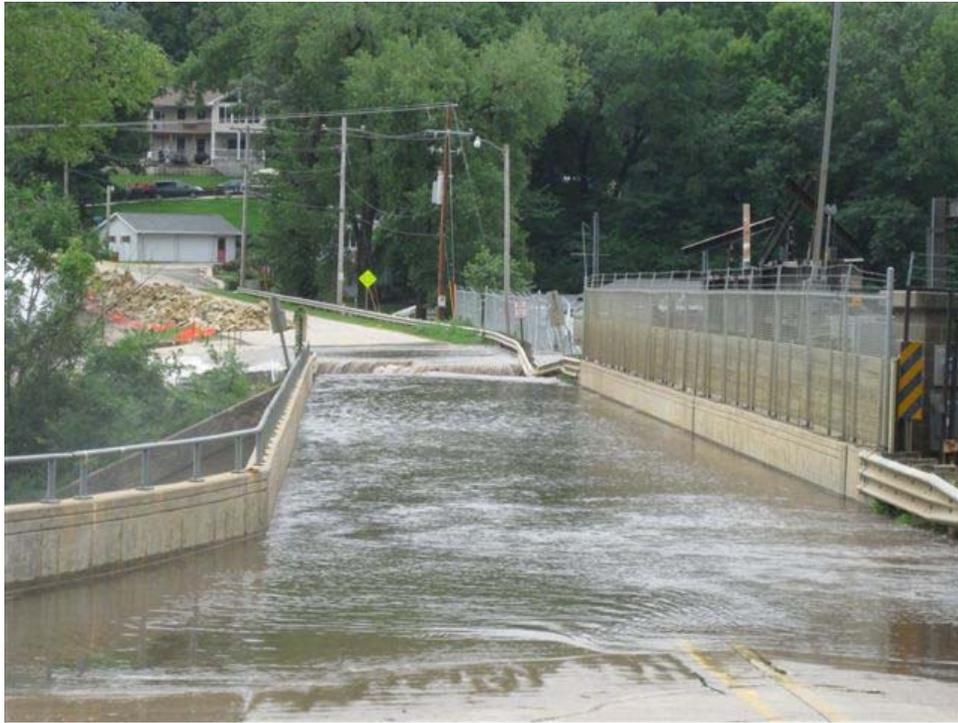
Progression of breach as viewed from left abutment

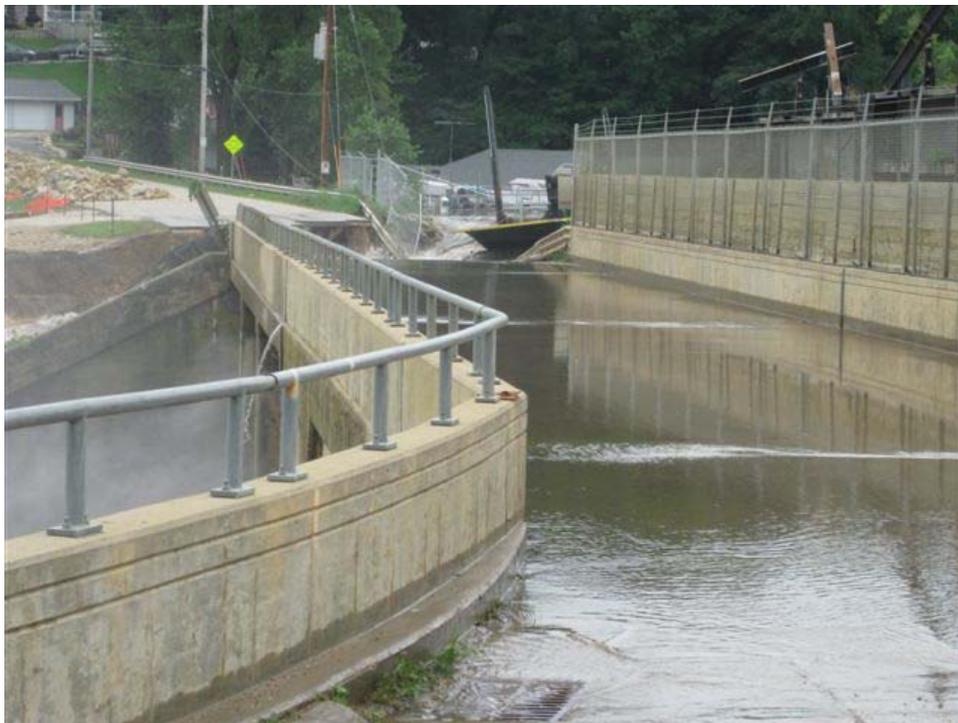
Complete breach as viewed from left abutment
(McCarthy)

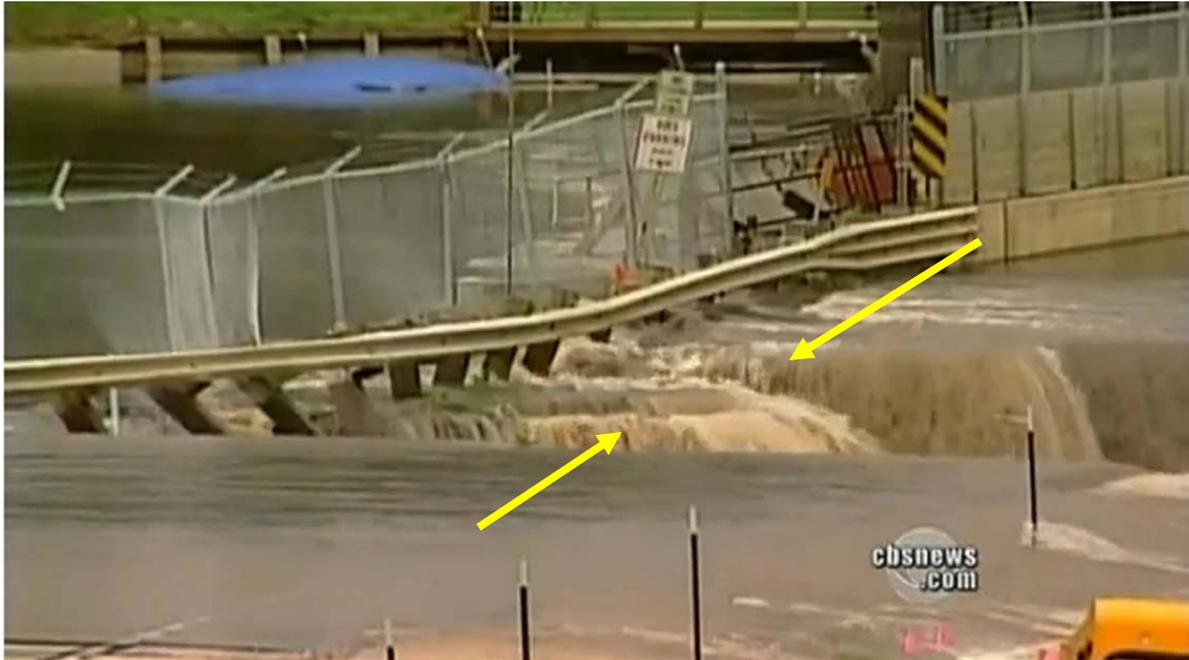
View from right abutment during last seconds before complete breach
Note what appear to be two collapsed tunnel roofs
(Sniped from CBS News Video)

For reference, the double section of guardrail is 16 ft long, with post spaced about
3 feet apart

Single guardrail sections are 20 long with posts spaced about 5 ft apart

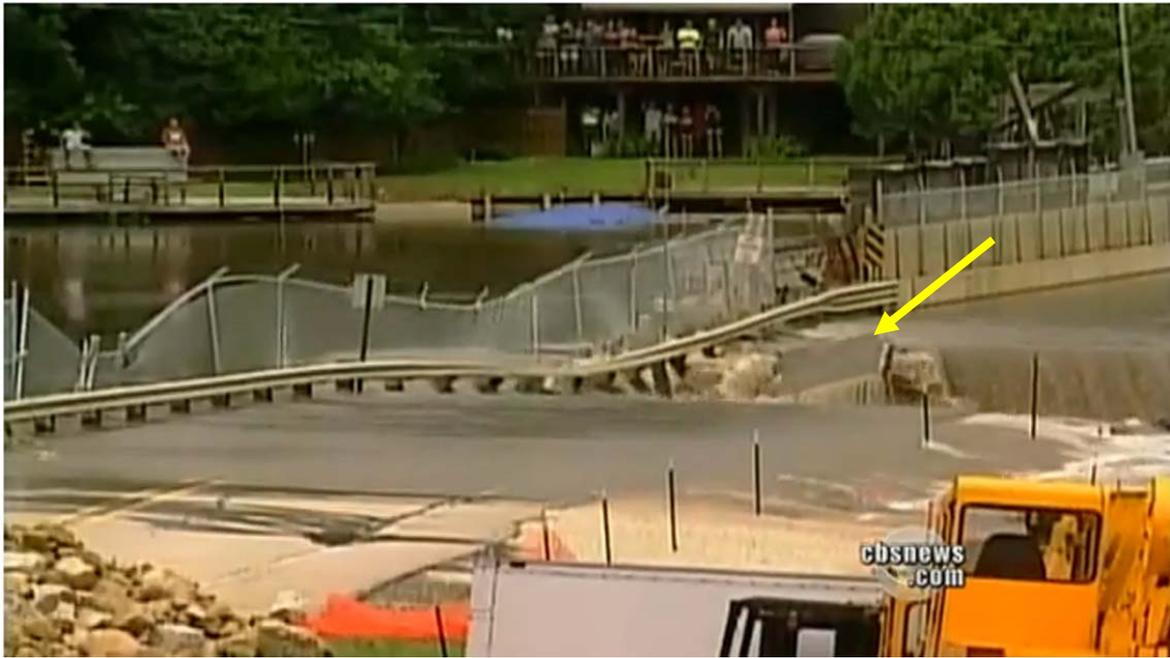
View from right abutment as completed breach was forming
Note active deterioration
(Sniped from CBS News Video)

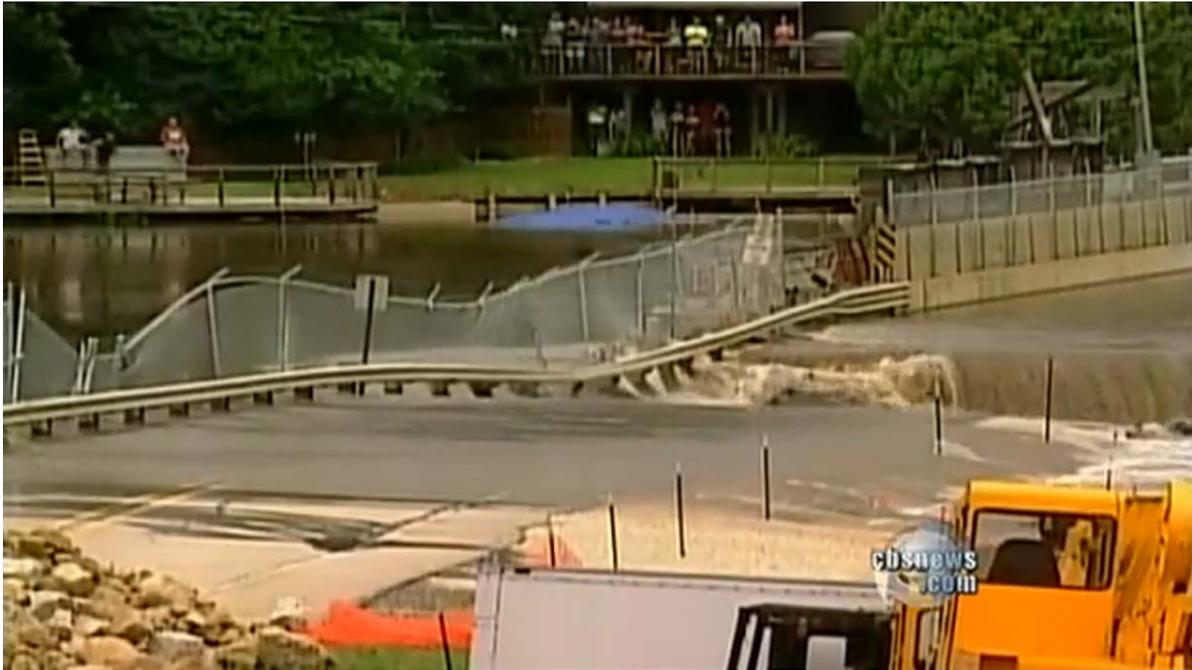
View from right abutment of embankment as complete breach was forming
(Sniped from CBS News Video)

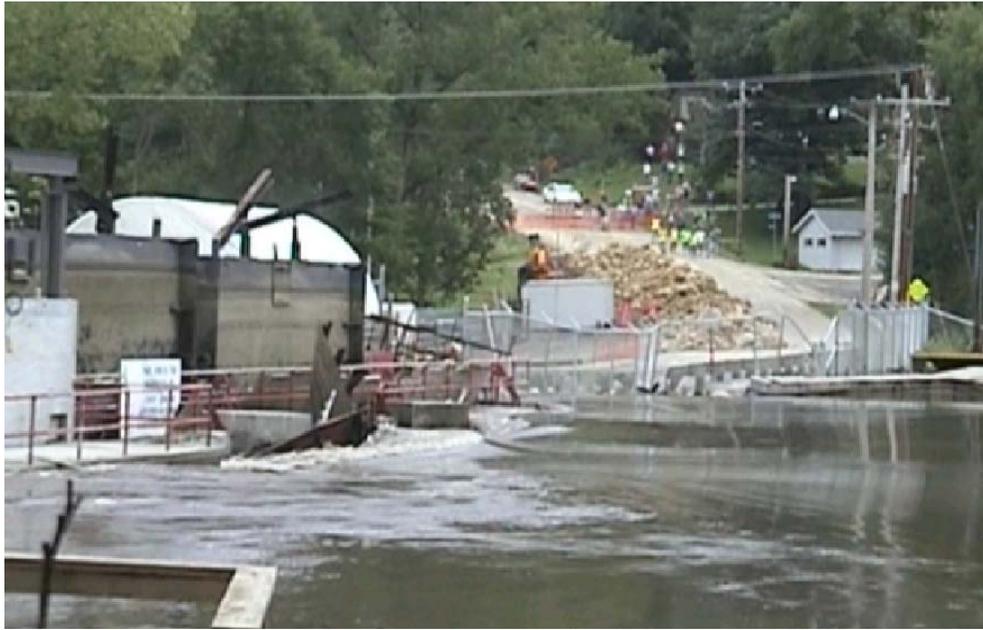
Upstream view just prior to complete breach
(Sniped from local resident video)

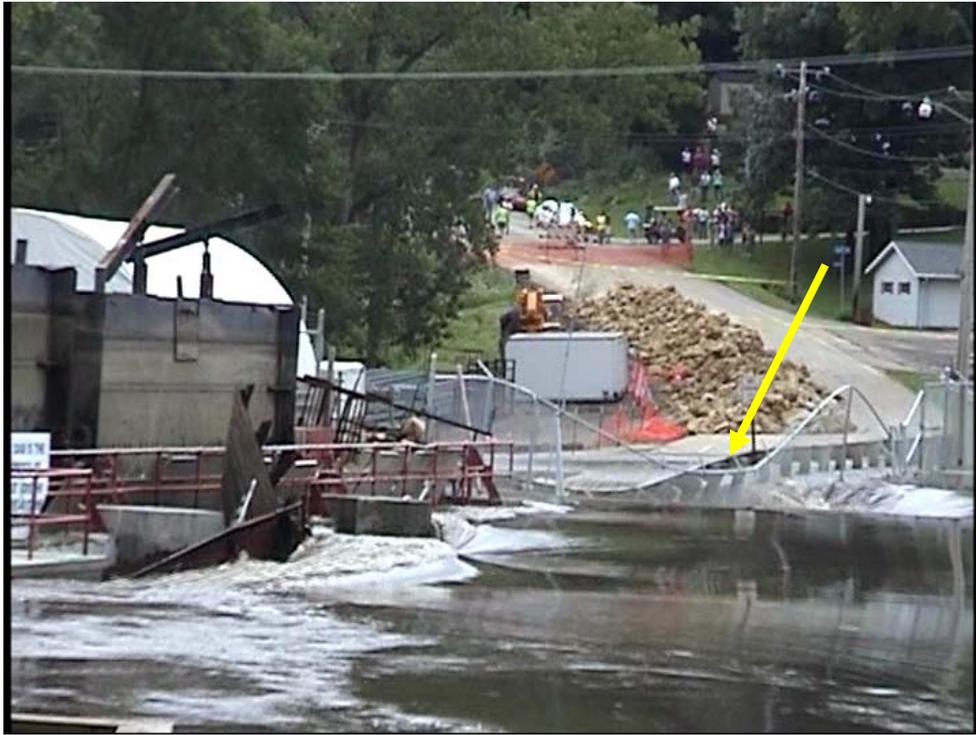
Upstream view just after complete breach
(Sniped from local resident video)

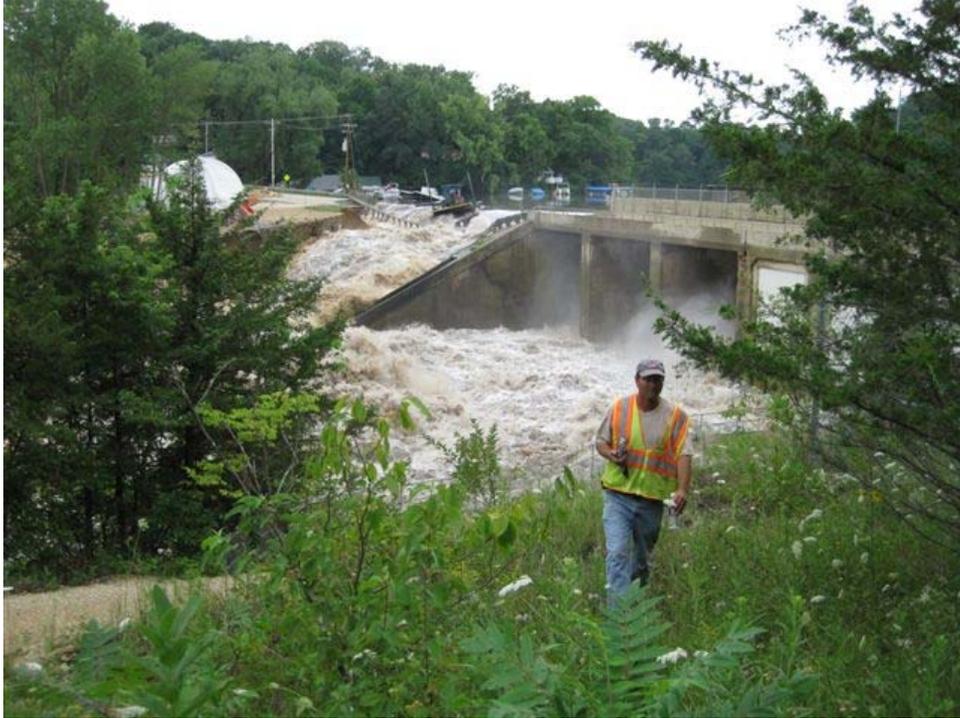
Breach viewed from left (north) abutment

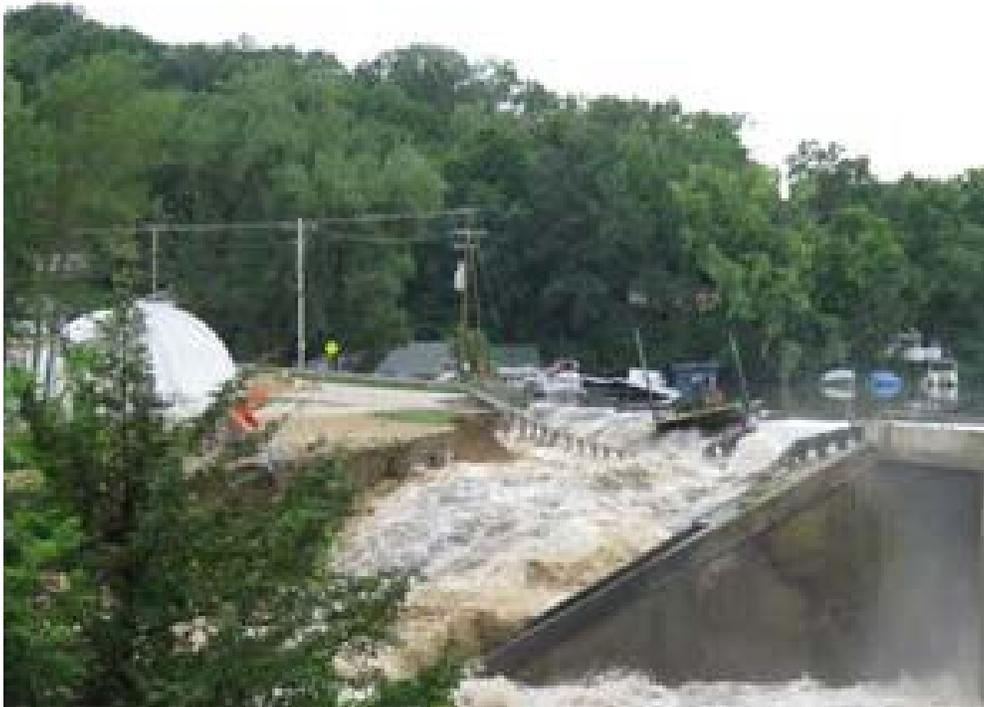
Continuing embankment breach flow erosion
Note advanced erosion in original embankment along guard rail and concrete core
wall compared to the 1960s berm/parking area
(McCarthy)

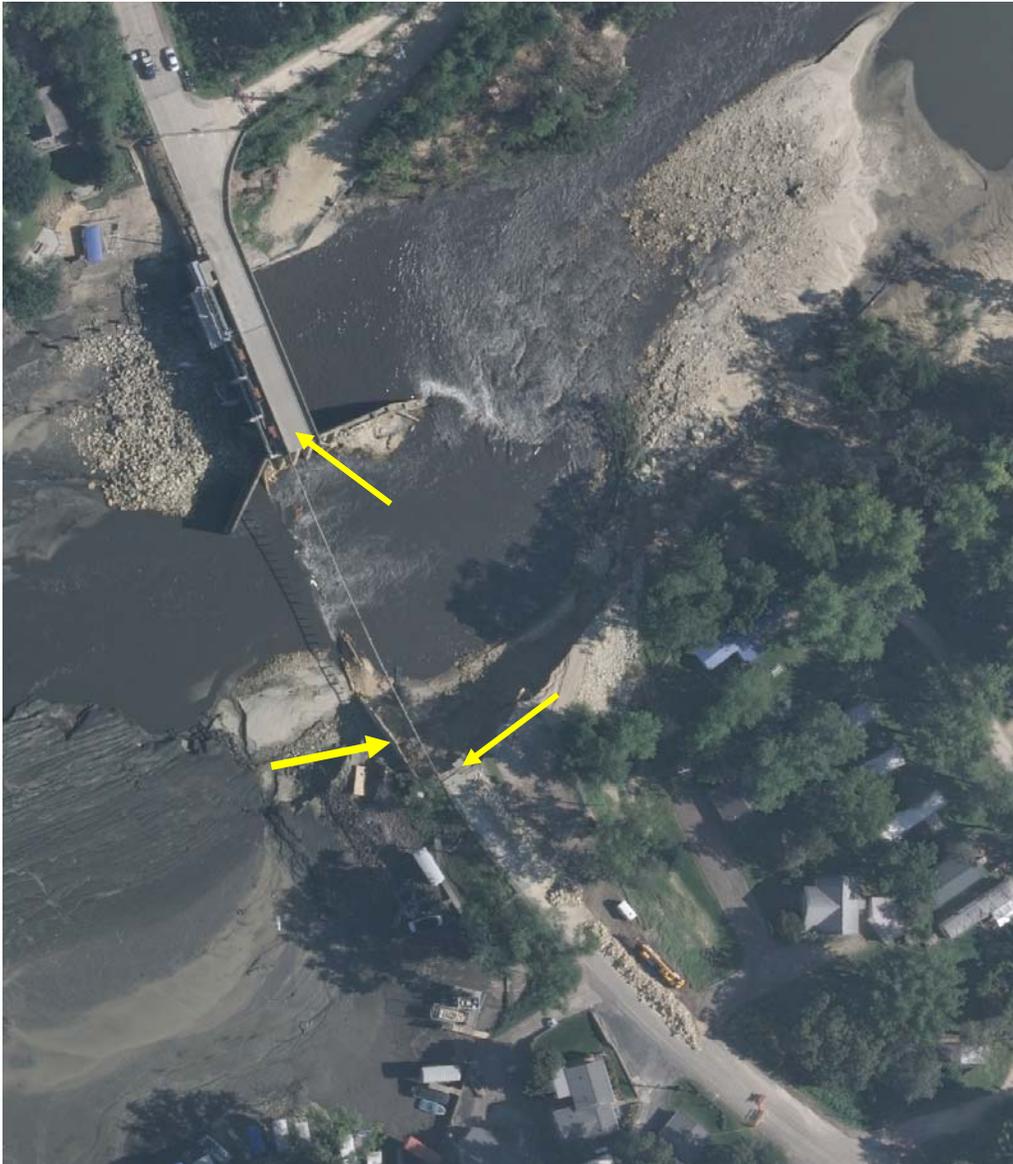
Post breach conditions
(Courtesy Iowa DNR)
Elevations NAVD88

Road at edge of right embankment remnant- 905.17 FT.
Top of Concrete core wall 898.7 FT
Center of Spillway deck road 904.7 FT
