APPENDIX G

Hydraulic and Hydrology Analysis

Report on Mechanical Equipment

Lake Delhi Dam Mechanical and Electrical Observations and Report

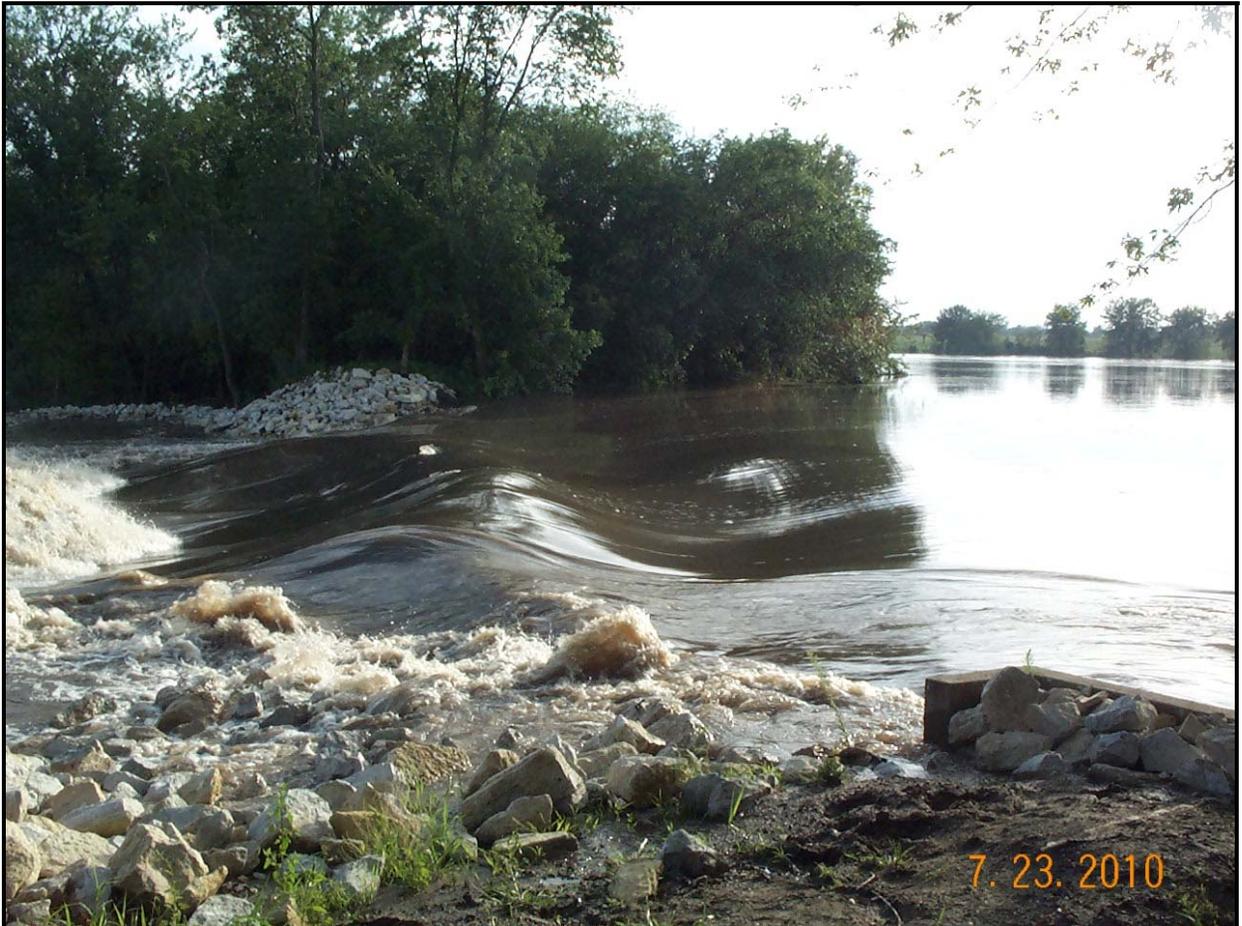
Figure 4: Overtopping of the rock dike at Quaker Mill Dam

The USGS hydrograph does not show a well-defined breach surge from the failure/overtopping of the rock dike at Quaker Mill Dam in the morning hours of July 23, 2010 (see Figures 4-5). The surge was either drowned out by the additional flow from the unnamed tributary to the Maquoketa River (denoted by the yellow arrow in Figure 5), or attenuated at the Manchester Mill Dam, or a combination of both. Since the downstream USGS gauge data at Manchester, IA did not have any reported problems, one can conclude that its usage as the inflow hydrograph in to the HEC-RAS model is appropriate.

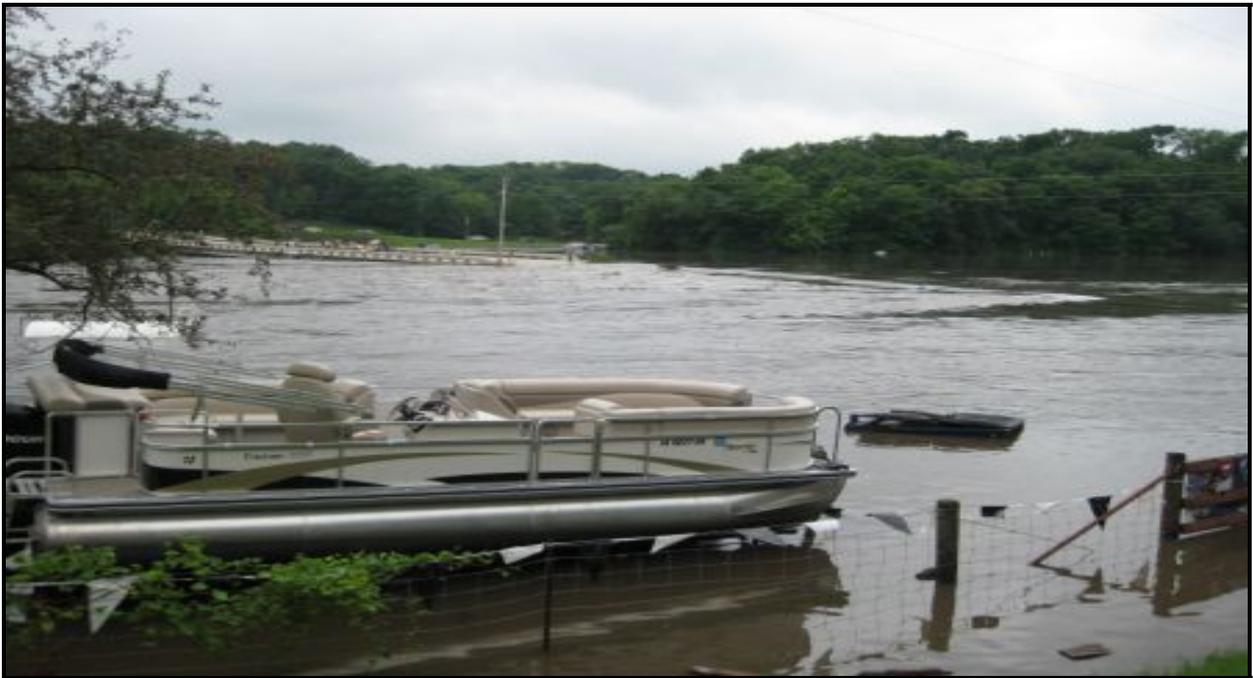
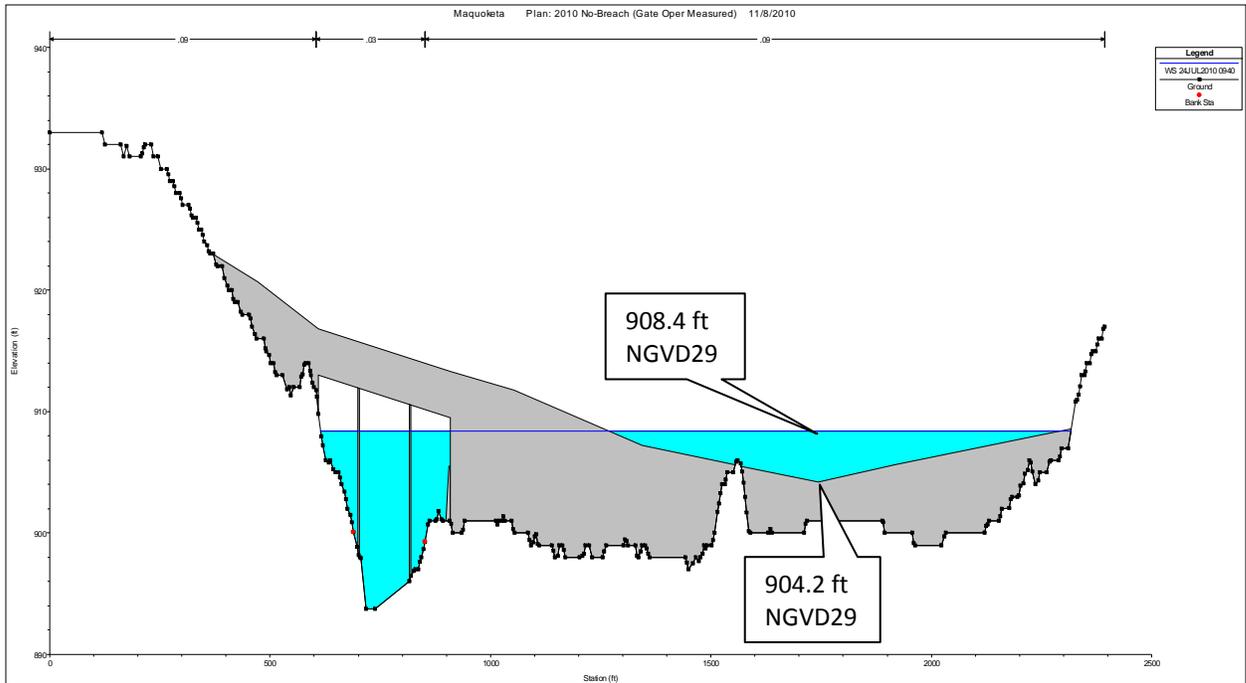
Figure 13: Photograph and Iowa DNR HEC-RAS Model Comparison

Although there are no eyewitness accounts of the reservoir lowering as far as shown on July 23, the weir flow conditions that produce it are a result of replicating the operator’s logbook.

The revised model based on the operator’s logbook and measured final gate openings matches the observed timing and water surface elevations well up to the point where breach progression is underway. As such, the revised model peaks after the actual time of failure.

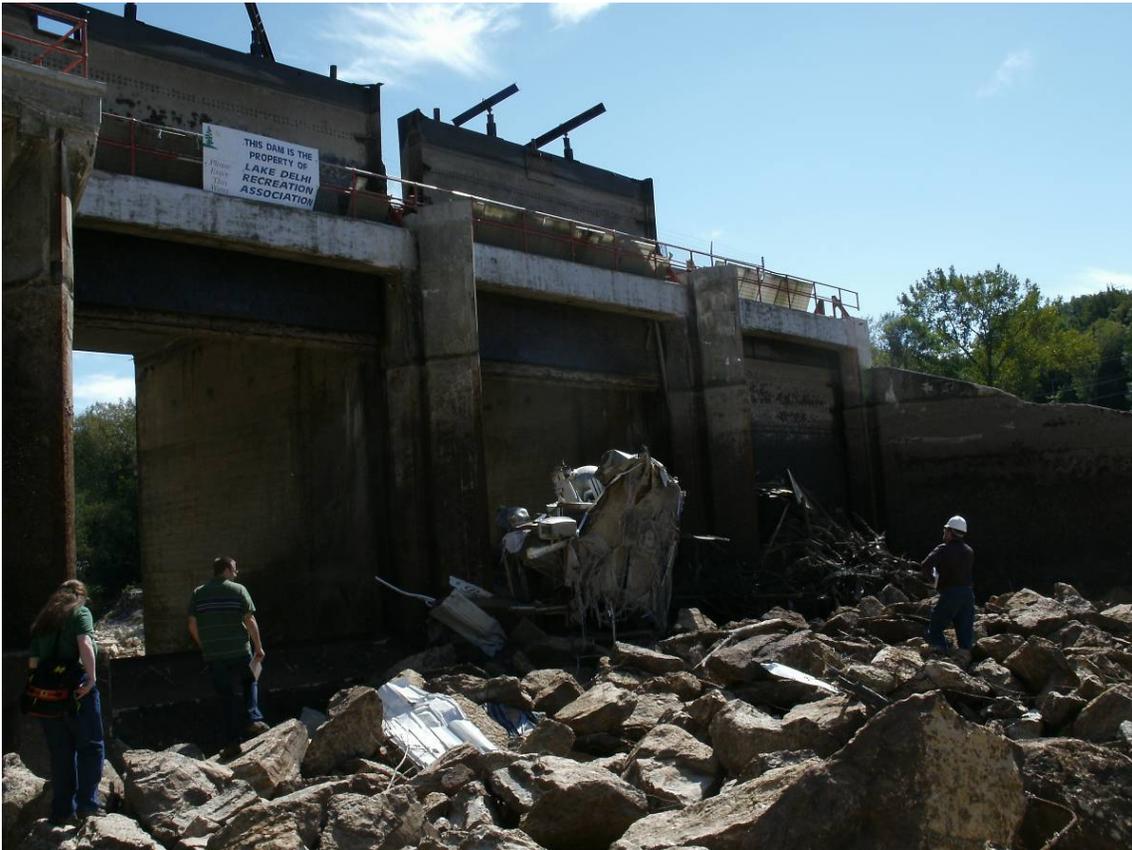
View of the three spillway gates or vertical lift gates. Gate 1 is the north gate to the left in the picture. Gate 3 is the south gate to the right in the picture.

Note the debris in front of the gates. The debris in front of Gate 2 consists of several boats and pontoons.

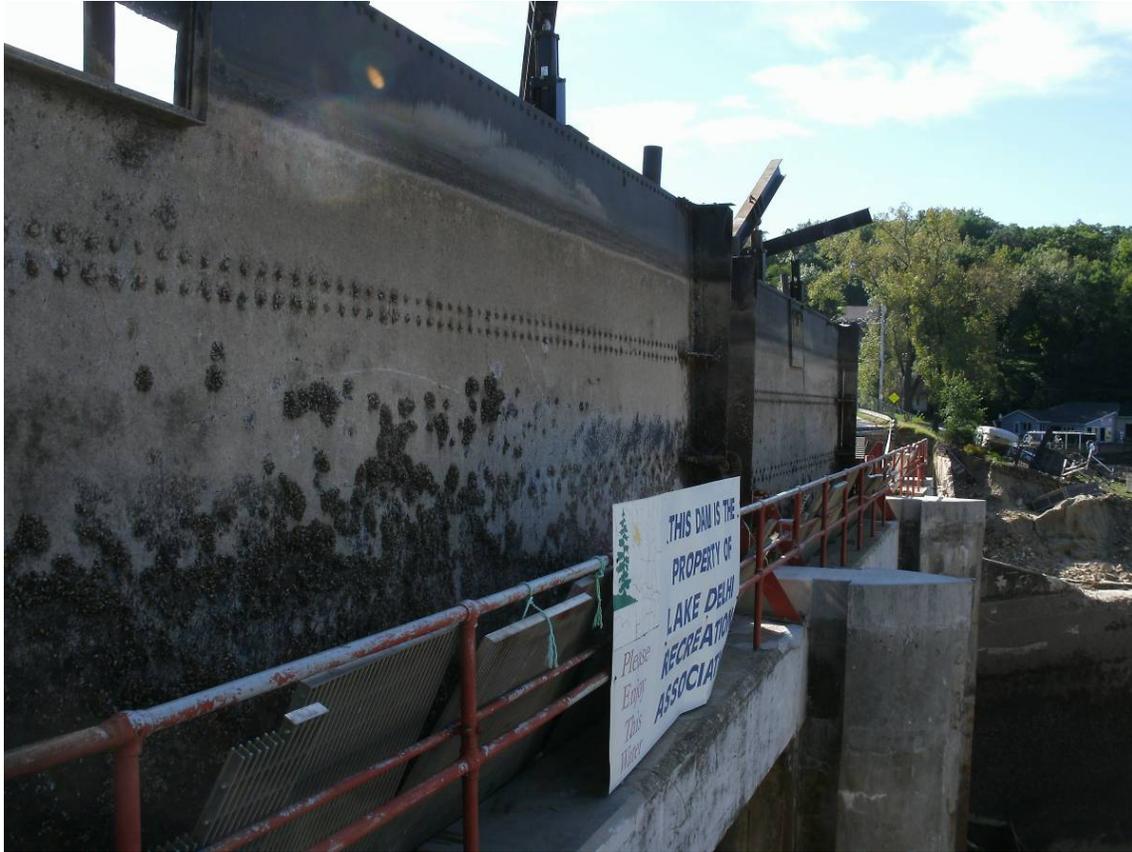
This picture shows gates 1 and 2 in the up position. These gates were raised prior to the flood event and are fully opened. Gate 3 is in the background. Again, the gates were left in the same position and not moved since the dam failure.

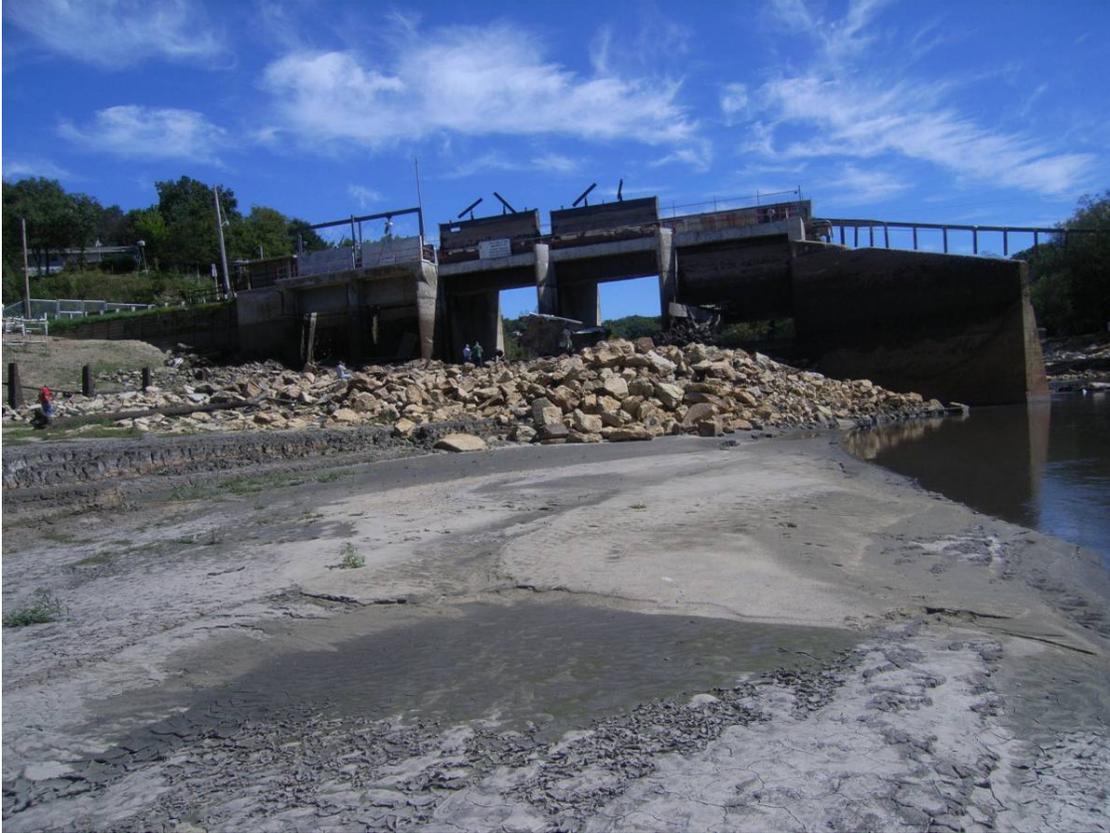
This picture shows the opening into the hydropower facility on the left side of the picture and adjacent to the three spillway gates. The hydropower facility is at the left(north) end of the dam and adjacent to the number 1 spillway gate.

Again, note all the debris in front of the gates including the hydropower facility. Since the lake is drained, there is full access to the entire area in front of the dam.

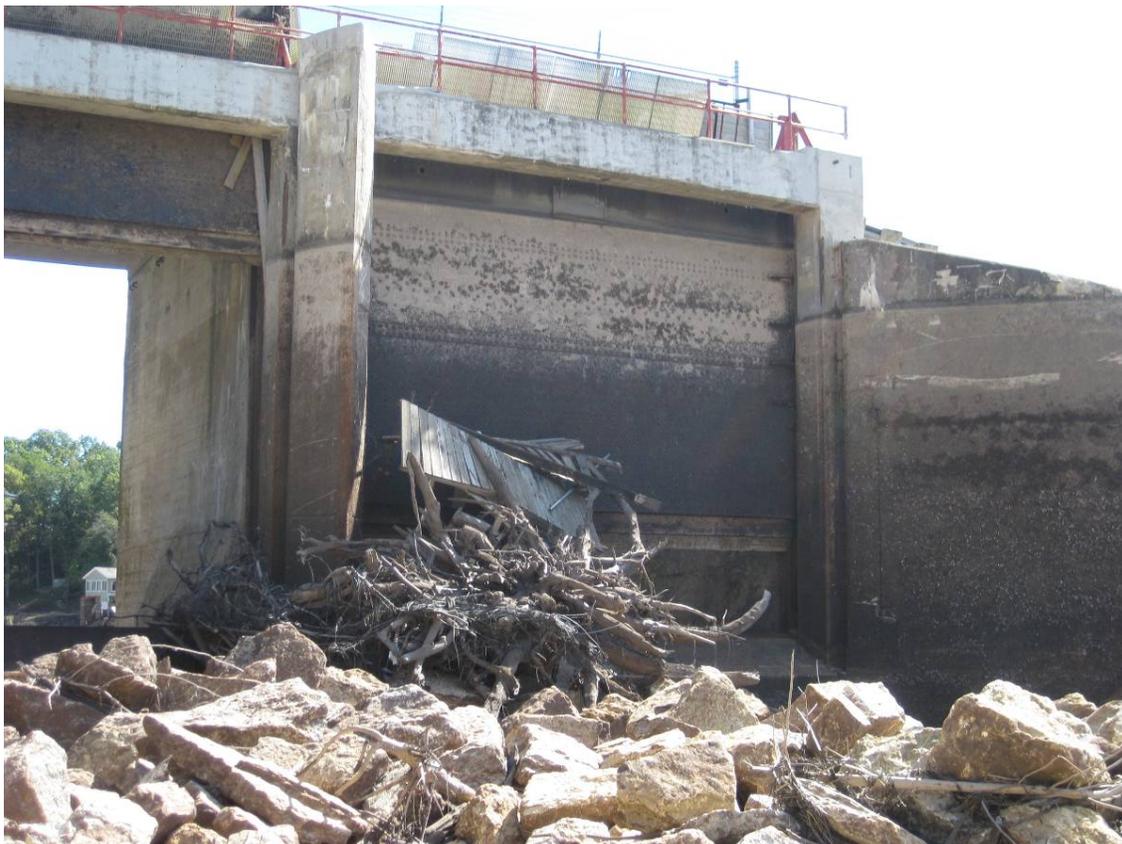
View of Number 3 Spillway Gate in the position during the September 8th, 2010, inspection

C. Gate 3 Operating Issues. The vertical lift gate number 3 failed to open *completely* during the July 2010 flood event. Mr. Fink said the gate was able to be opened approximately 6 feet. However, measurements taken during the September 8th inspection showed the gate open only 4.3 feet. Whether the gate was open 4 feet or 6 feet, this then reduced the overall spillway capacity. However, according

The issues with the Gate 3 have been prevalent since 2008 according to Mr. Fink. There is an embedded rail at the bottom of the gate (north side) that was damaged. The rail is shifted and binds the gate as it opens and closes.

Mr. Fink said the first 1 foot opening of the gate is the most critical and usually the gate will fully open after that. During the July flood event, the Gate 3 was unable to be opened any further then the 4 or 6 foot travel. One of the sheave blocks was actually pulled out of the concrete and broke off trying to open the gate according to Mr. Fink.

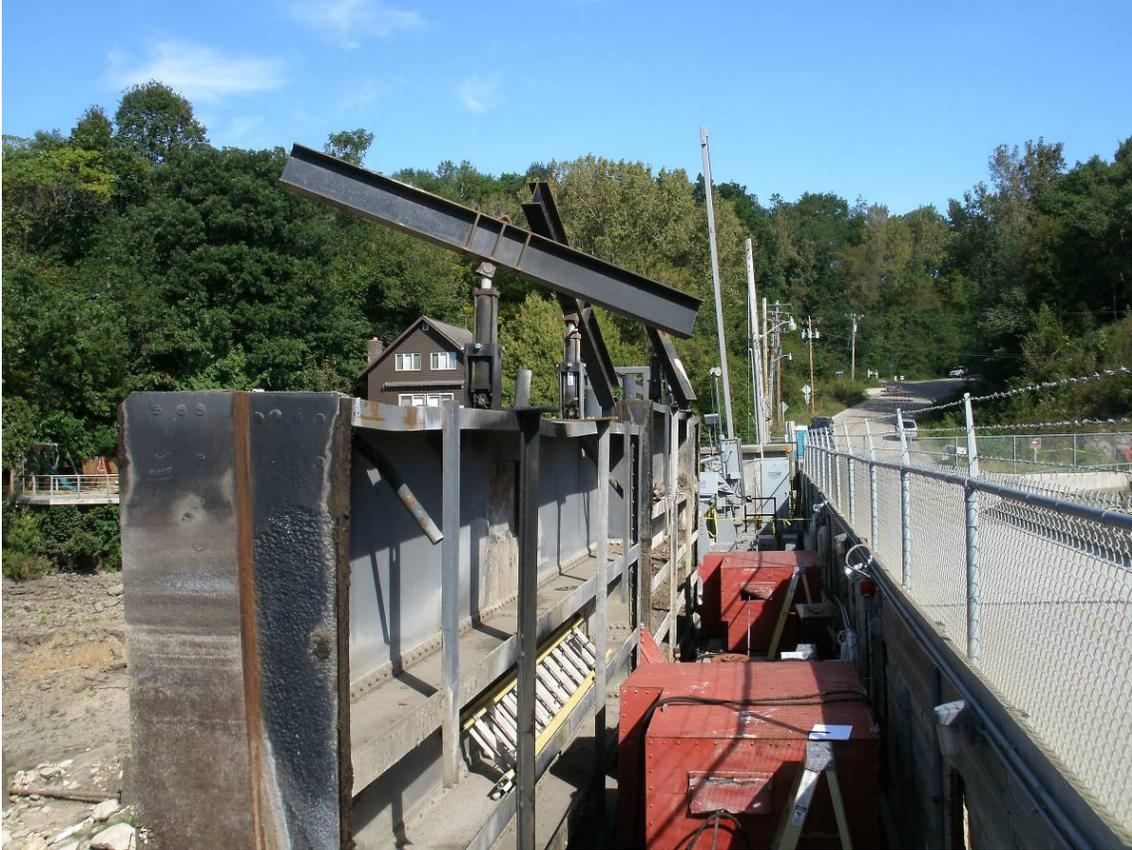
This picture shows the vertical lift gates and the hydraulic cylinders installed on top of the gates. The dam operators use the hydraulic cylinders to help seat the gate in place after they are closed by the machinery. The I-beam is set on the underside of the concrete walkway and the cylinder is then extended. This forces the gate down into the seating position on the sill.

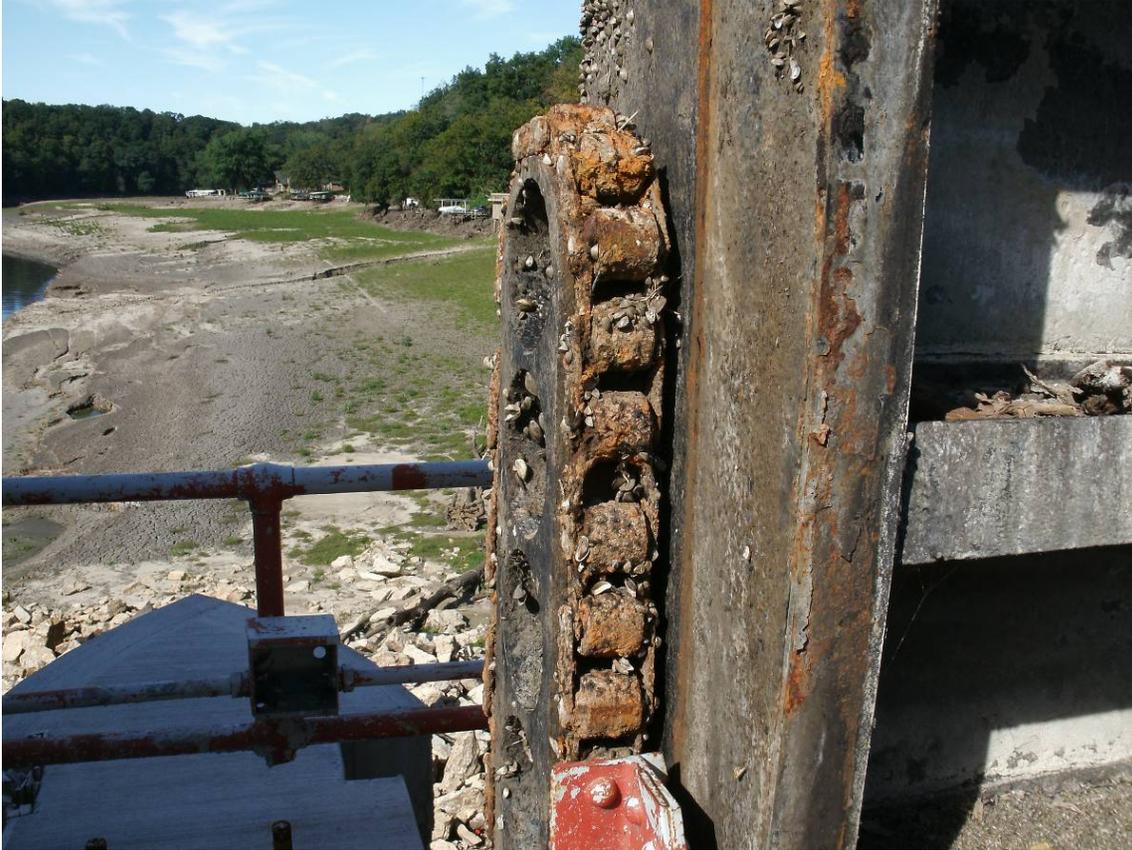
This picture shows the rollers on the end of the lift gates. The rollers on both gates 1 and 2 were inoperable and severely corroded. It was reported that the rollers on gate 3 were recently replaced. The site had one set of rollers in the hydro facility ready to be installed on one of the spillway gates. New rollers are stainless steel. Note all the zebra mussels on the gate and rollers. Even with the rollers severely corroded on gates 1 and 2, the site is still able to move the gates up and down. The rollers assist in opening and closing the gate under flow conditions.
