Use Attainability Analysis

1 Water Body Name	Dry Mill Creek
2 Segment Description	Mouth to West line of S9, T93N, R4W, Clayton County
3 Segment Length (mi)	5.0
4 Drainage Area (sq. mi.)	22.1
5 Segment Start Latitude, Longitude (DD)	42.84194, -91.37356
6 Segment End Latitude, Longitude (DD)	42.88085, -91.32945
7 Route of Flow (Next Downstream Adopted Designated Use)	Dry Mill Creek (A1, proposed, A2, BCW1, HH, existing) to Roberts Creek (A1, BWW2)
8 NPDES Facility and Permit Number (If Applicable)	Scenic Acres Care Facility (2200901)
9 Sample Site ID(s)	1290-4
10 Segment County Name(s)	Clayton
11 Field Work Date(s)	9/21/2017

13 Recreational Use Attainability Analysis - Conclusion

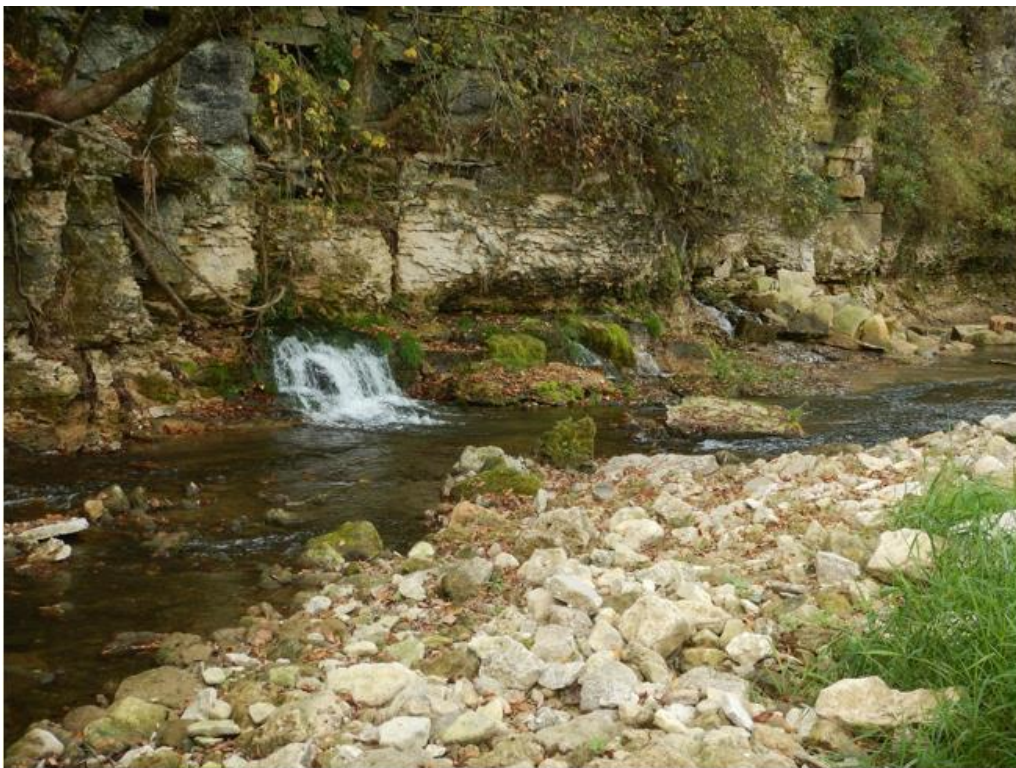
Use	Site parameter	Site ID # 1290-4
AL/R	15 Latitude, Longitude (DD)	42.84868, -91.36242
AL/R	16 Average Depth (in)	10
AL/R	17 Maximum Depth (in)	>39
AL/R	18 Stream Width (ft)	17.5
AL/R	19 Pools Observed?	Yes
AL only	20 Non-Game Fish Present and Counts (Species: Number)	N/A
	21 Game Fish Present and Counts (Species (Size Range): Number)	N/A
	22 Stream Habitat (See also: #29 Site Photos)	N/A
R only	23 Evidence of Use for Primary Contact Recreation? (Yes*/No)	No
	24 Evidence of Use by Children? (Yes*/No)	No
	25 Evidence of Use for Secondary Contact Recreation? (Yes*/No)	No
AL/R	26 Additional Description	Spring discharges to the creek. See Figure 8.

Figure 8. 1290-4. Recreational use assessment downstream looking downstream - springs flowing from the base of the bedrock outcrop into Dry Mill Creek.
