General Use Field Evaluation

NPDES Facility and Permit Number	Pilot Travel Centers #496 (1600201)
NPDES Outfall Latitude, Longitude (Decimal Degrees)	41.64515, -91.14809
Water Body Name	Unnamed Tributary to Cedar River
Segment Description	Mouth to Pilot Travel Centers #496 STP outfall
Segment Length (ft)	3,708
Segment Start (Downstream) Latitude, Longitude (Decimal Degrees)	41.64496, -91.13484
Segment End (Upstream) Latitude, Longitude (Decimal Degrees)	41.64515, -91.14809
Number of Sites	4
County Name(s)	Cedar
Field Work Date(s)	9/26/2025

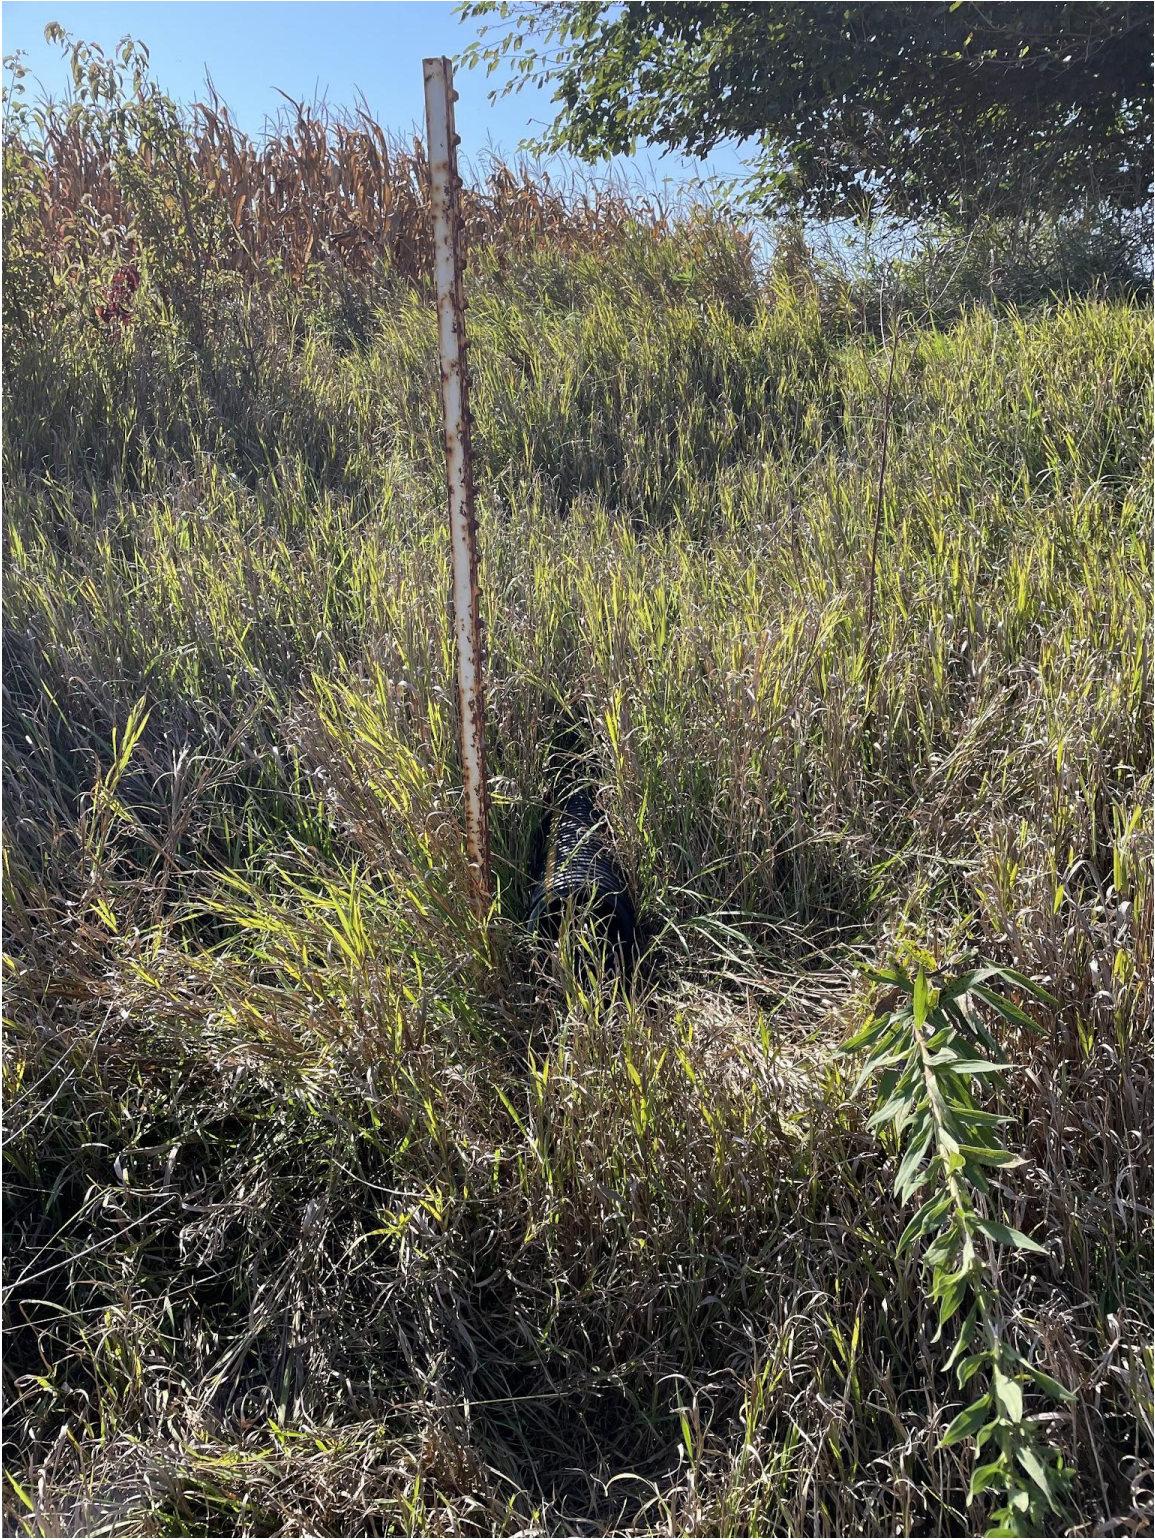
Figure 1. Outfall.

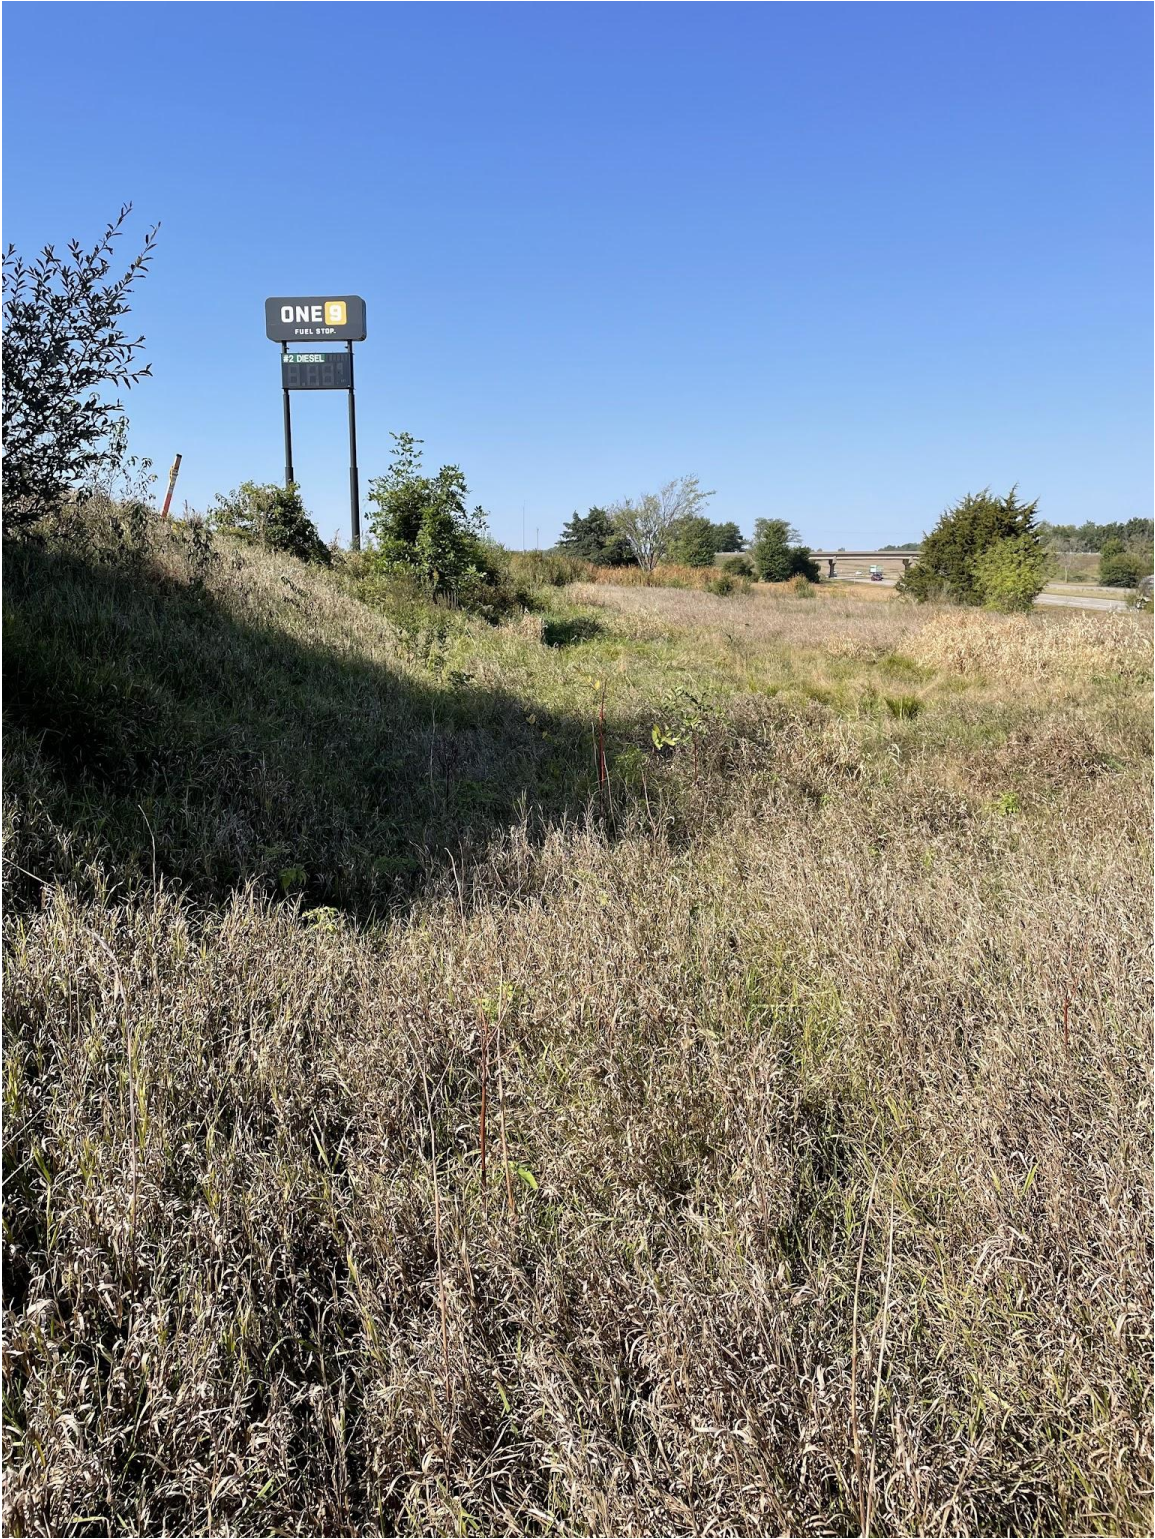
Figure 2. Outfall looking upstream from the outfall.

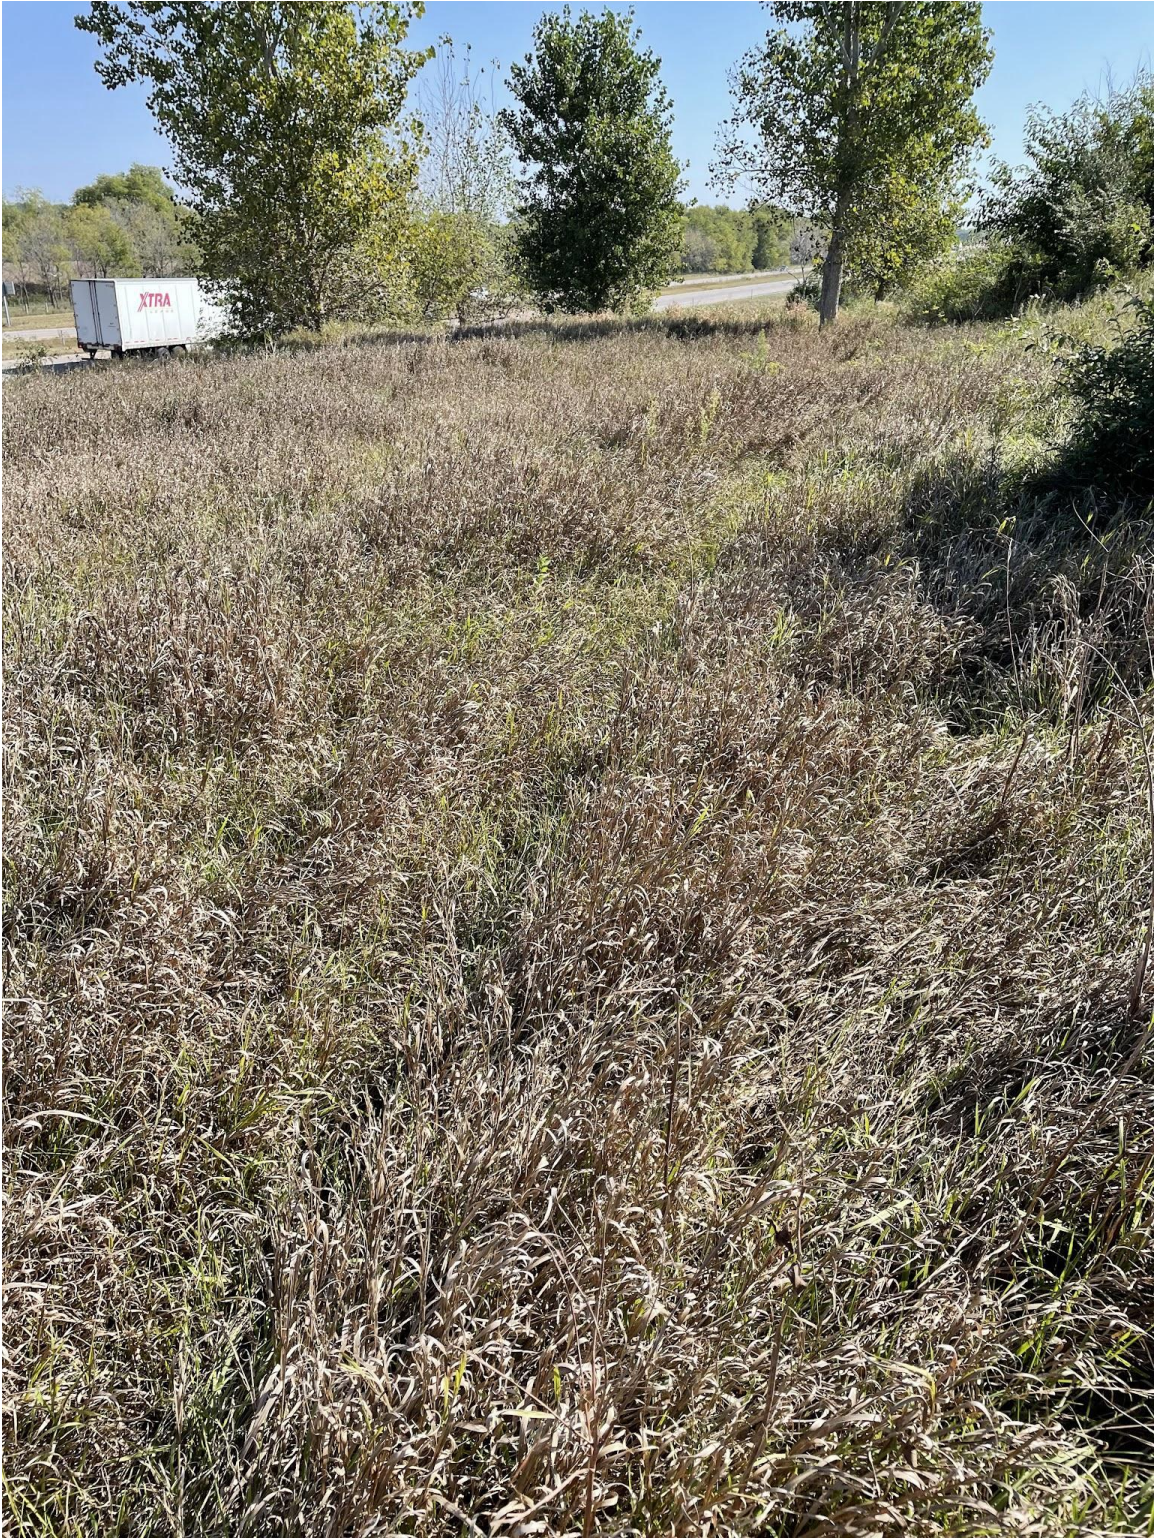
Figure 3. Outfall looking downstream from the outfall.

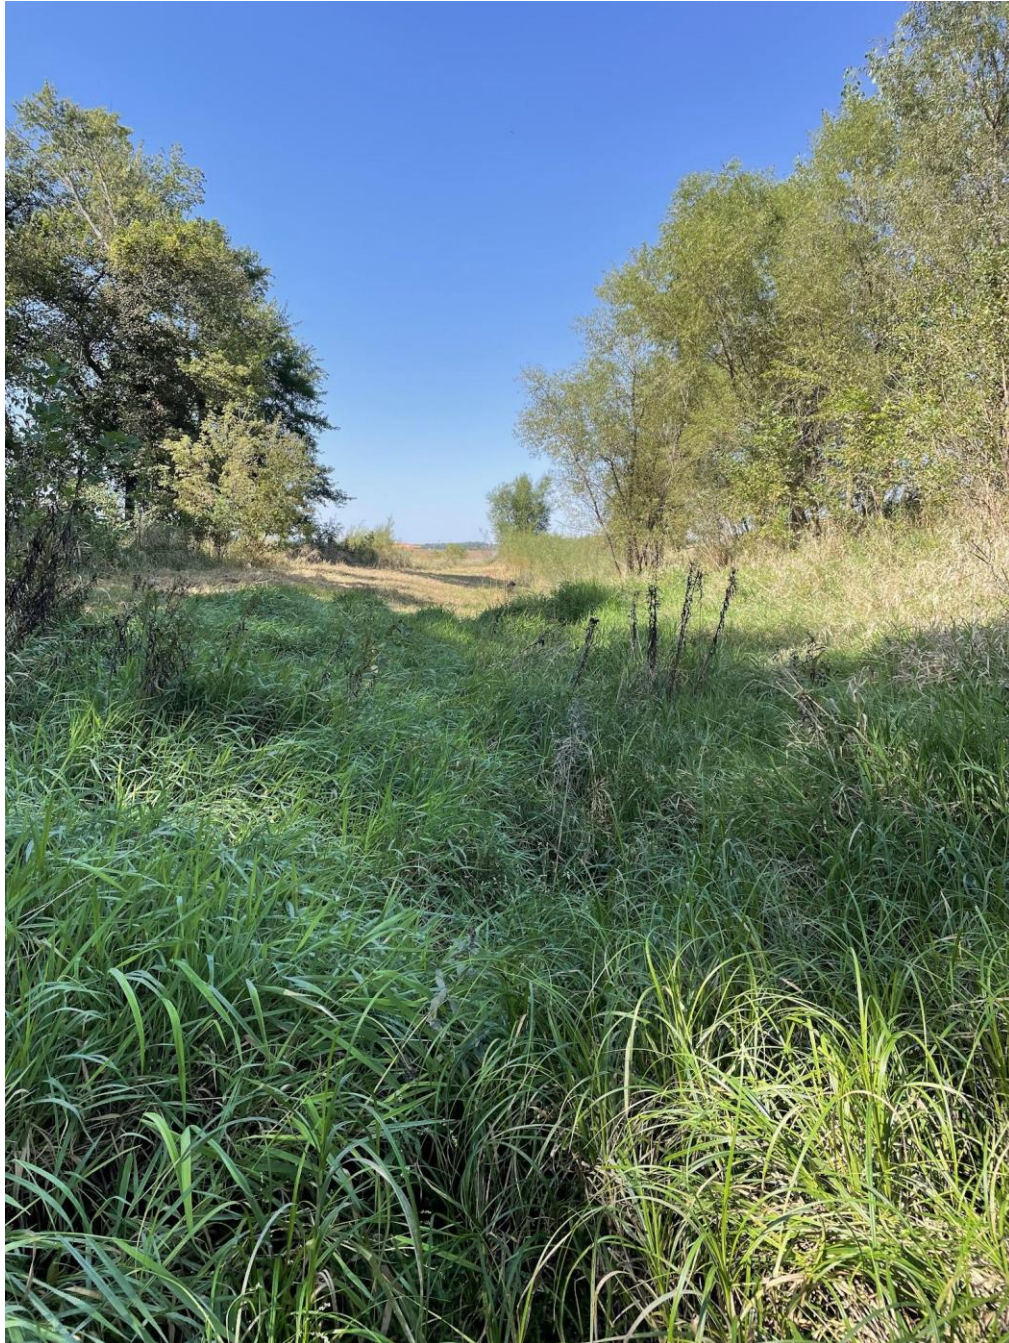
Description/location	41.64506, -91.13797
Water conditions	None
Average/max depths	None
Aquatic life present	None
Unusual conditions	None
Channel description	Manmade, roadside ditch. Dry, poorly defined channel. Overgrown with grass and willows.
Physical barriers/objects of significance	None
Human activity/evidence of recreation	None

Figure 4. Site #1 Looking upstream

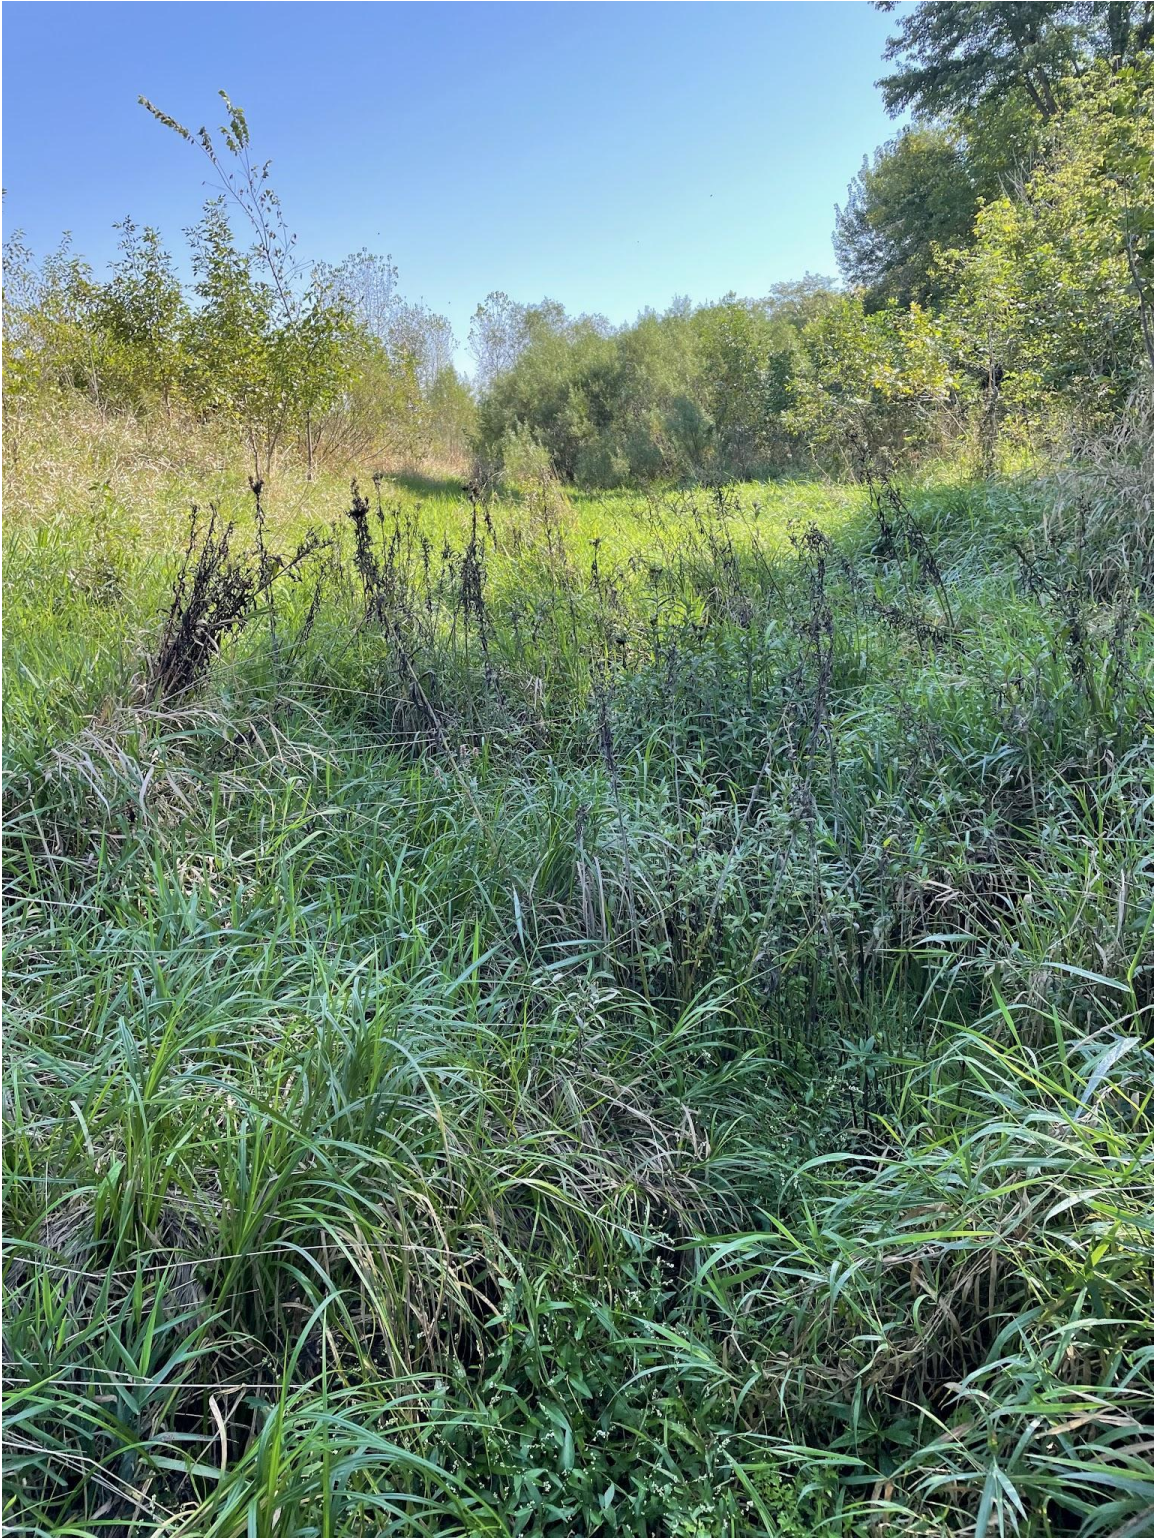
Figure 5. Site #1 Looking downstream.

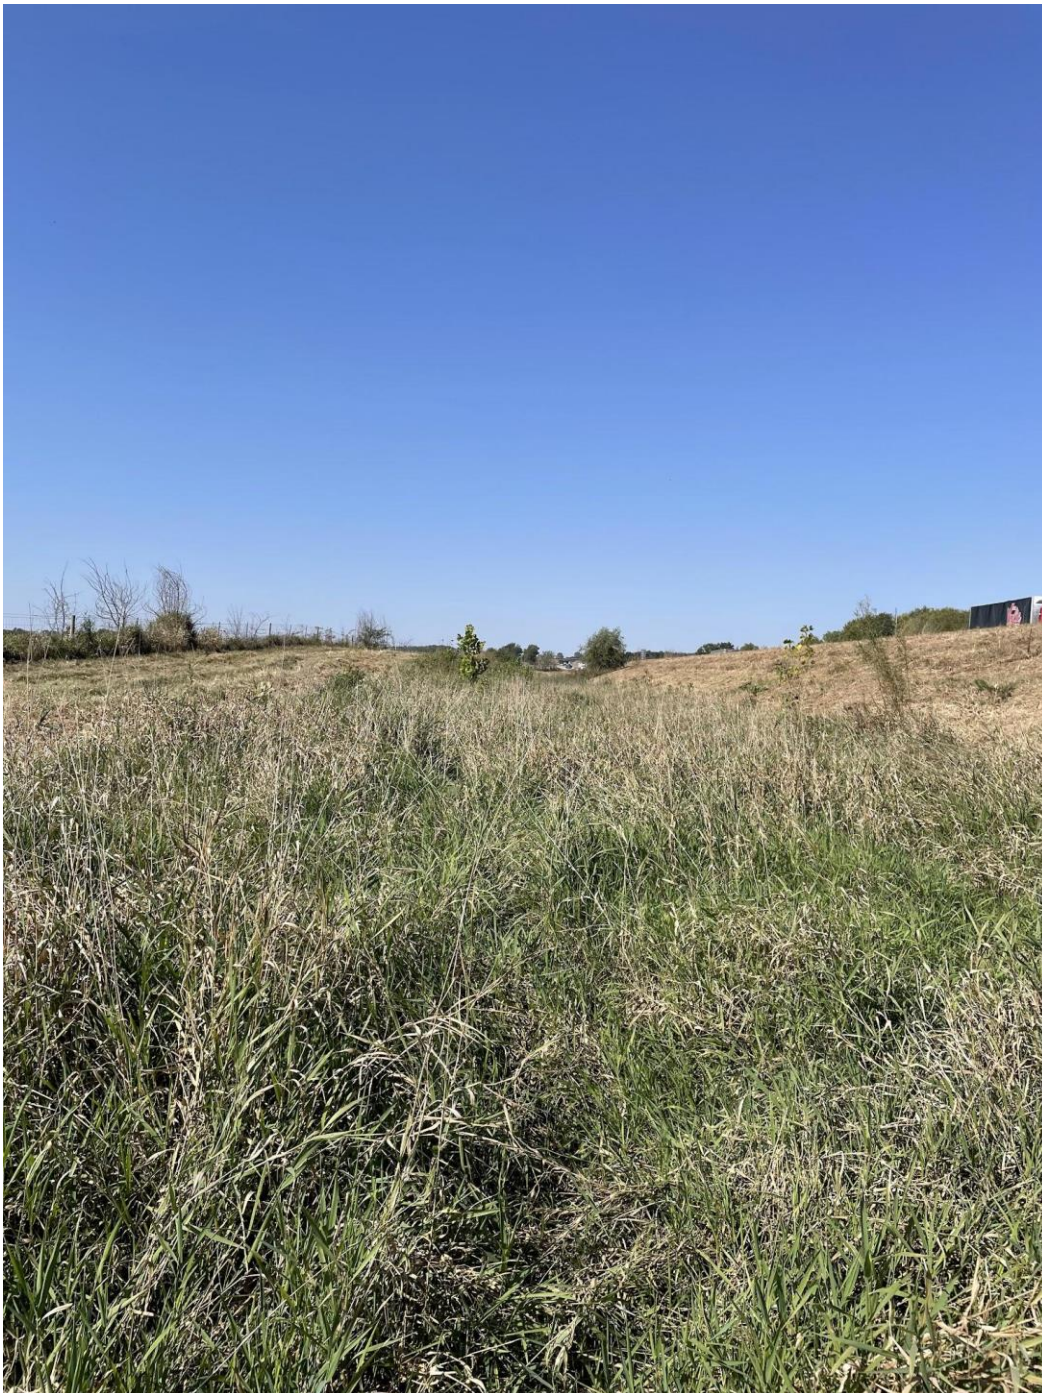
Description/location	41.64519, -91.13908
Water conditions	None
Average/max depths	None
Aquatic life present	None
Unusual conditions	None
Channel description	Manmade, roadside ditch. Dry, poorly defined channel. Overgrown with grass.
Physical barriers/objects of significance	None
Human activity/evidence of recreation	None

Figure 6. Site #2 Looking upstream.

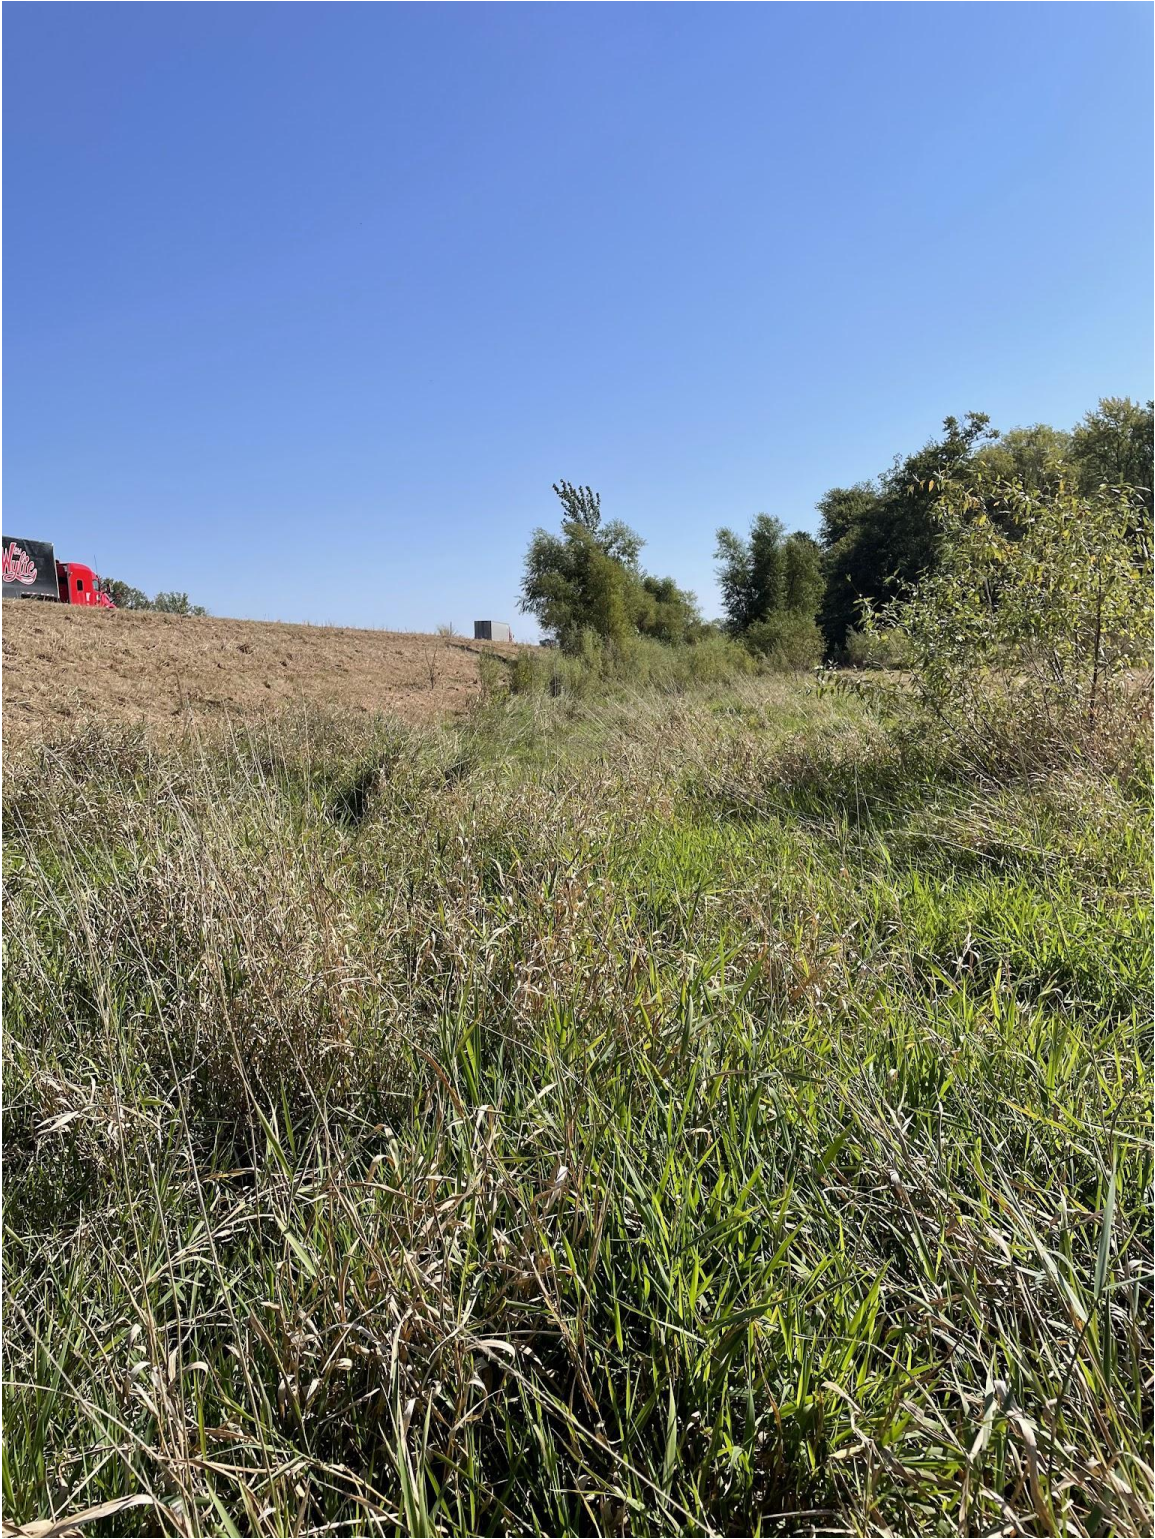
Figure 7. Site #2 Looking downstream.

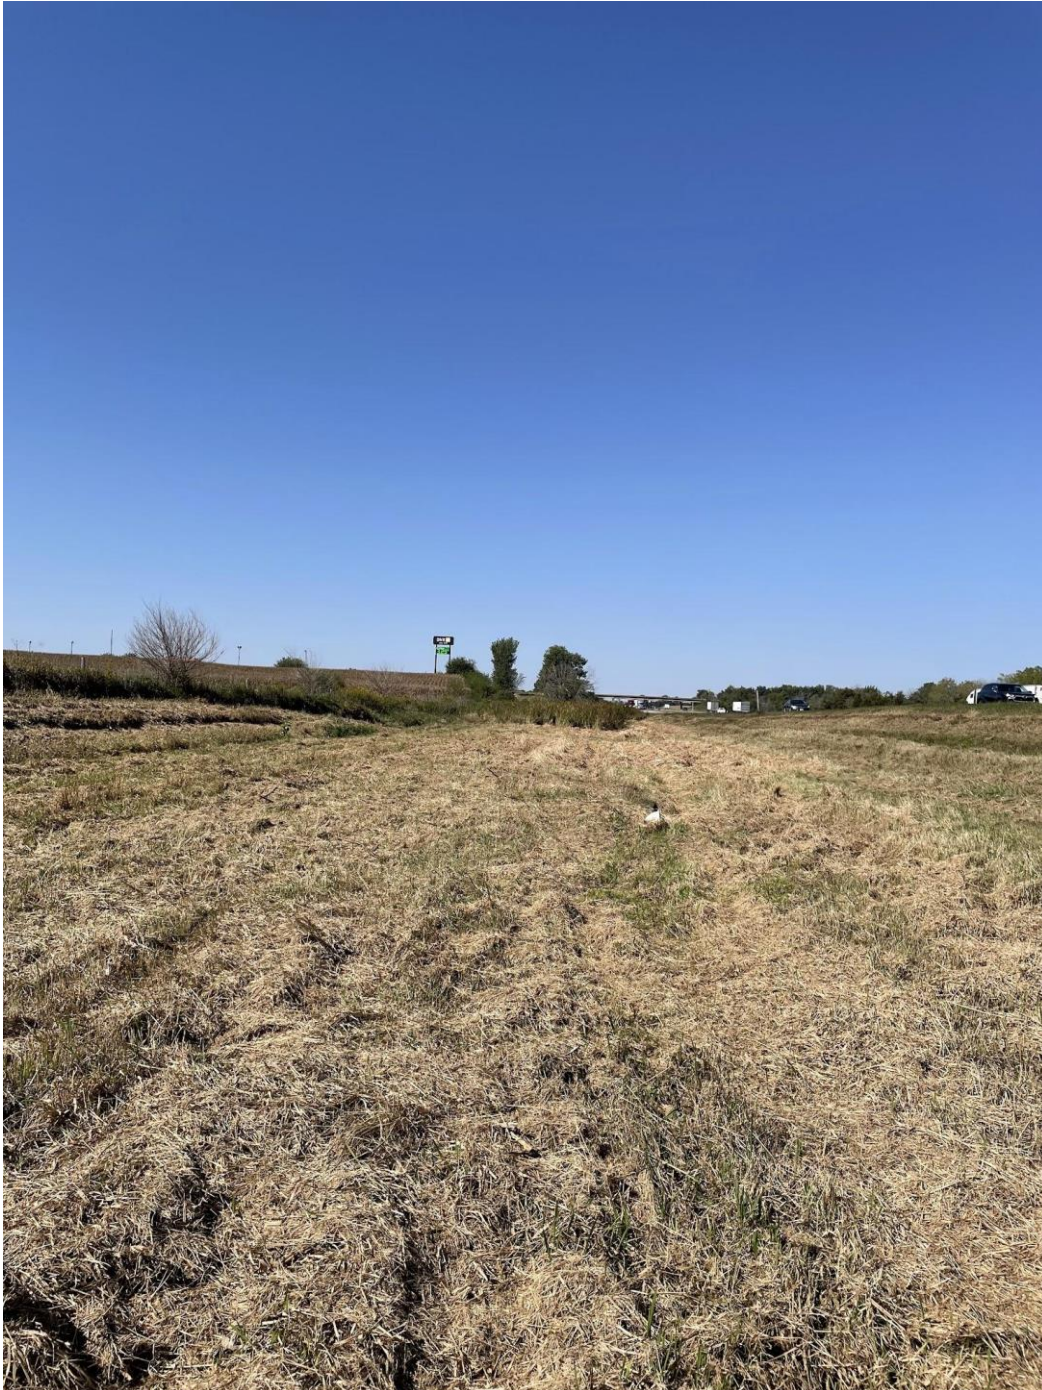
Description/location	41.64555, -91.14555
Water conditions	None
Average/max depths	None
Aquatic life present	None
Unusual conditions	None
Channel description	Manmade, roadside ditch. Dry, poorly defined channel. Overgrown with grass and willows.
Physical barriers/objects of significance	None
Human activity/evidence of recreation	None

Figure 8. Site #3 Looking upstream.

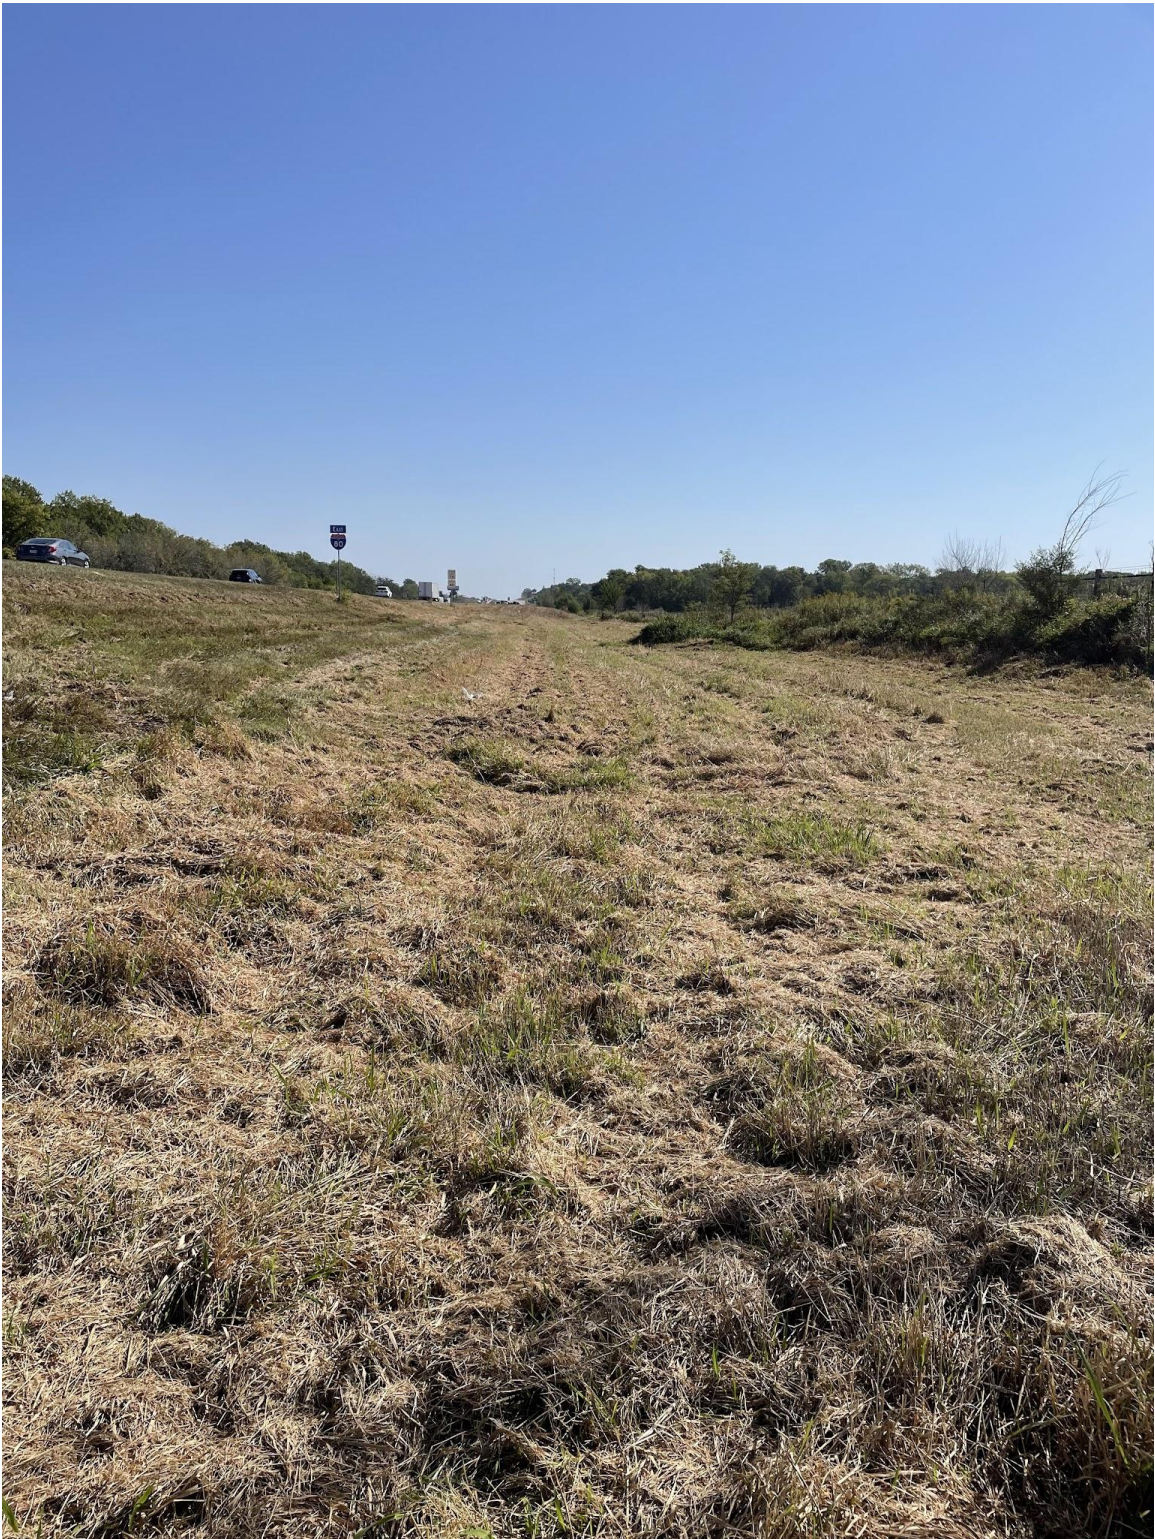
Figure 9. Site #3 Looking downstream.

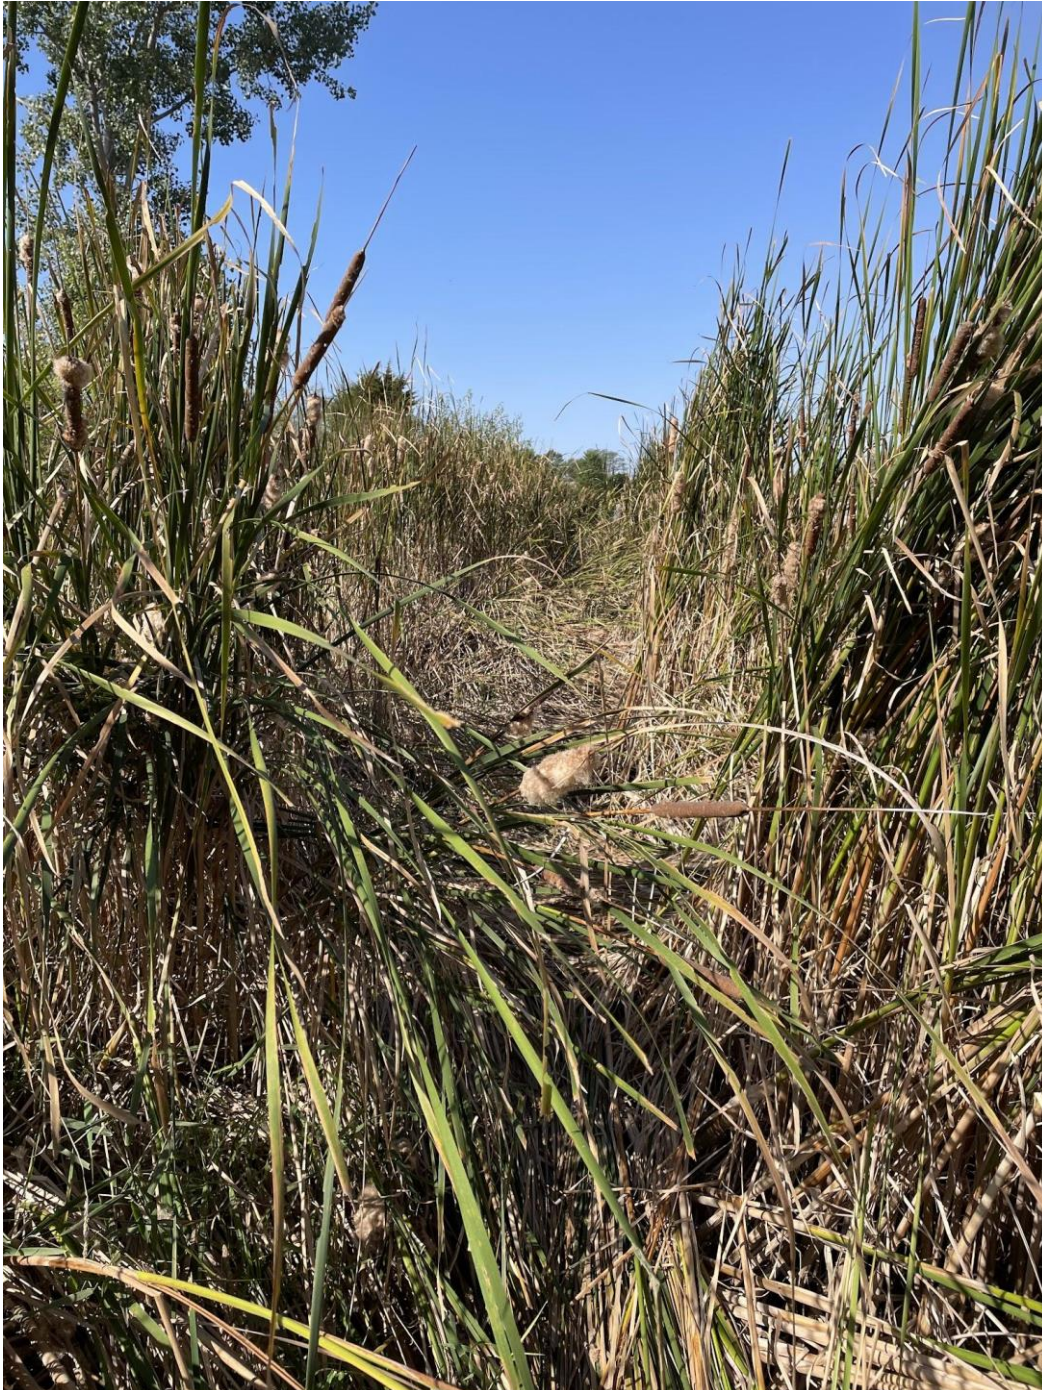
Description/location	41.64563, -91.14800
Water conditions	None
Average/max depths	None
Aquatic life present	None
Unusual conditions	None
Channel description	Manmade, roadside ditch. Wet soil, with cattails growing. No visible channel.
Physical barriers/objects of significance	None
Human activity/evidence of recreation	None

Figure 10. Site #4 Looking upstream.

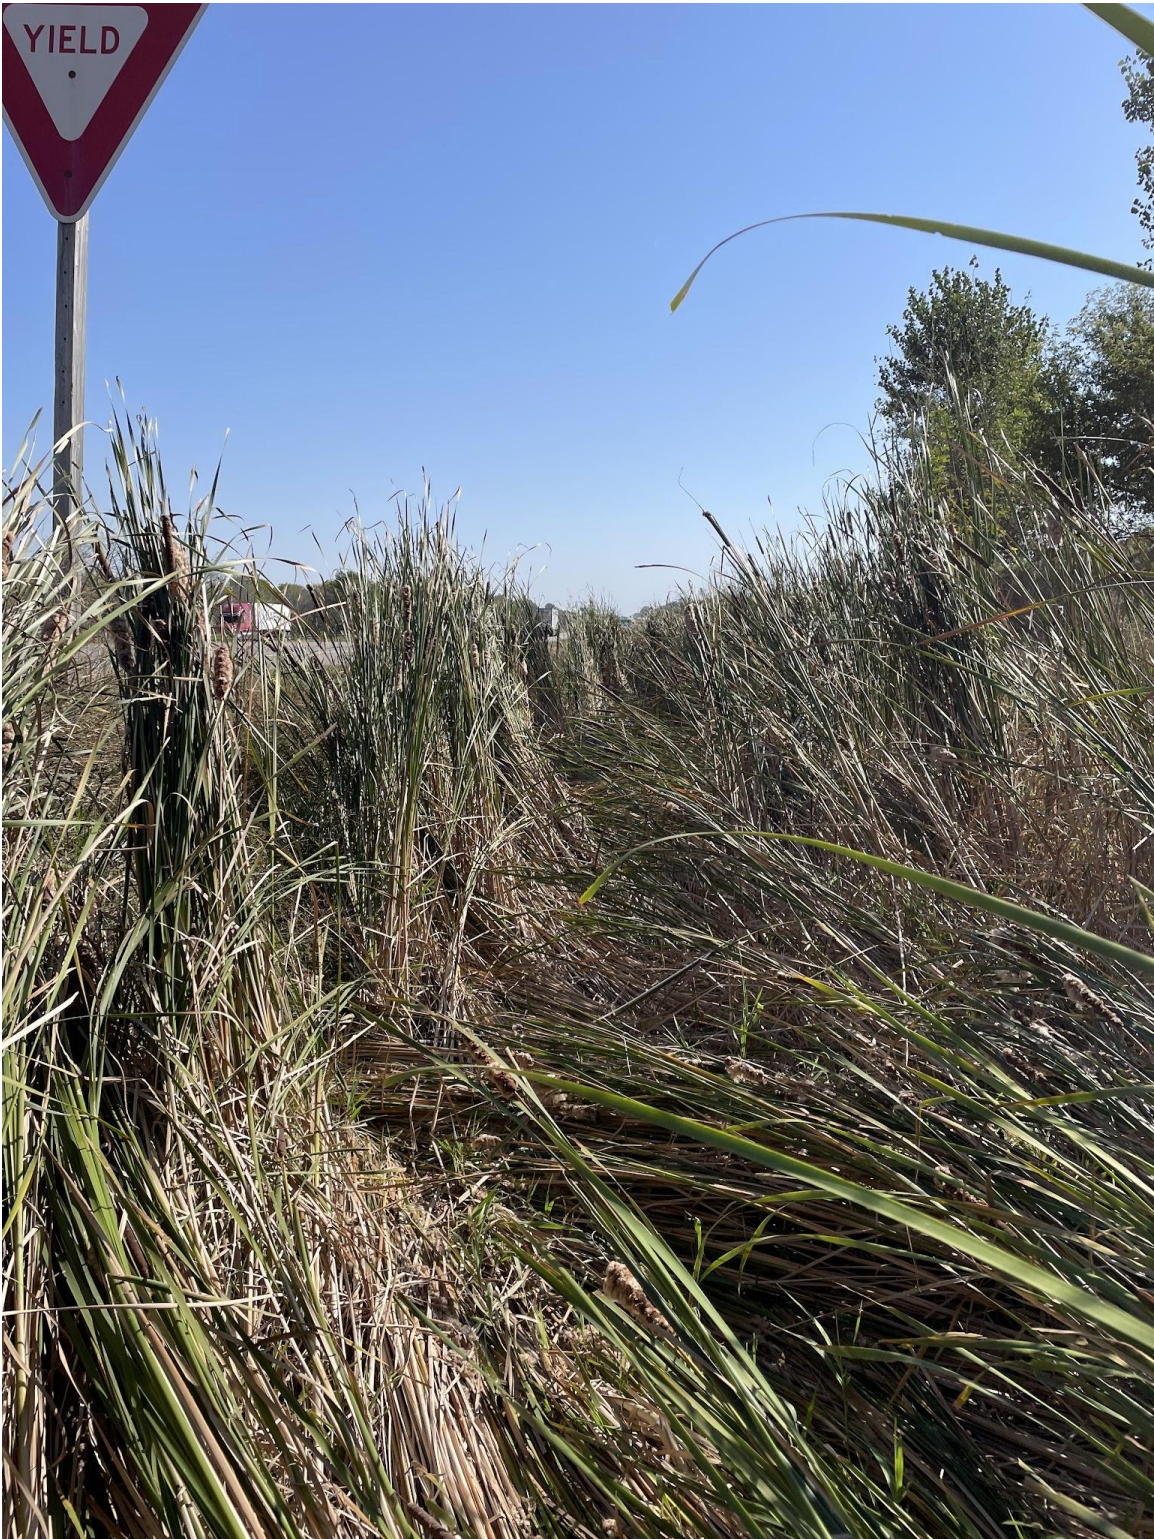
Figure 11. Site #4 Looking downstream.
