General Use Field Evaluation

| NPDES Facility and Permit Number | U.S. Army - Coralville Dam (5200908) |
| Water Body Name | Unnamed Tributary to Iowa River |
| Segment Description | Mouth to U.S. Army - Coralville Dam outfall |

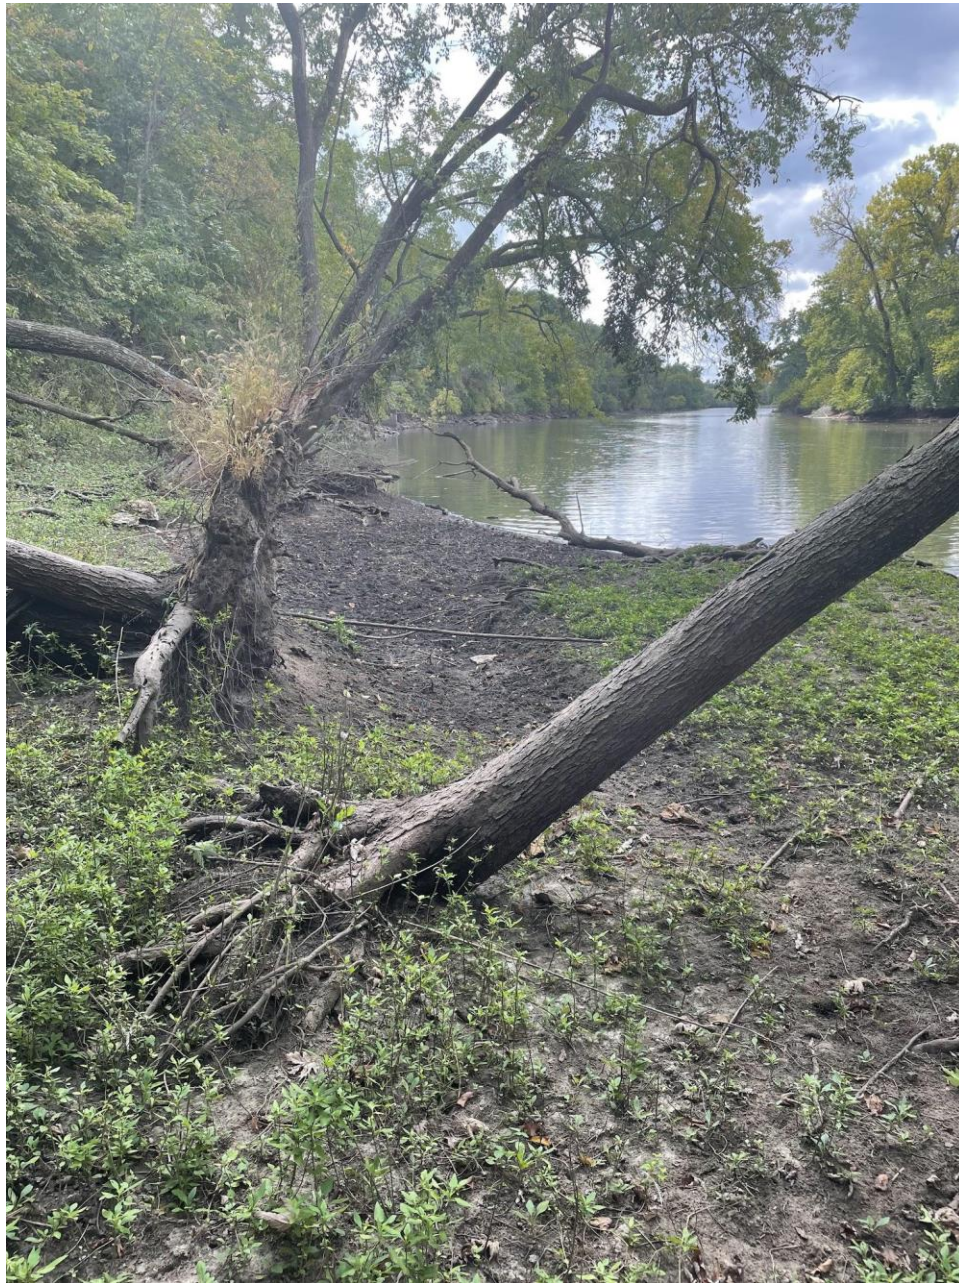
| Channel description | Dry and filled with leaf litter. No signs of recent flow. Sharp drop off into the Iowa River. |

Figure 1. Site 1. Downstream towards the receiving stream.

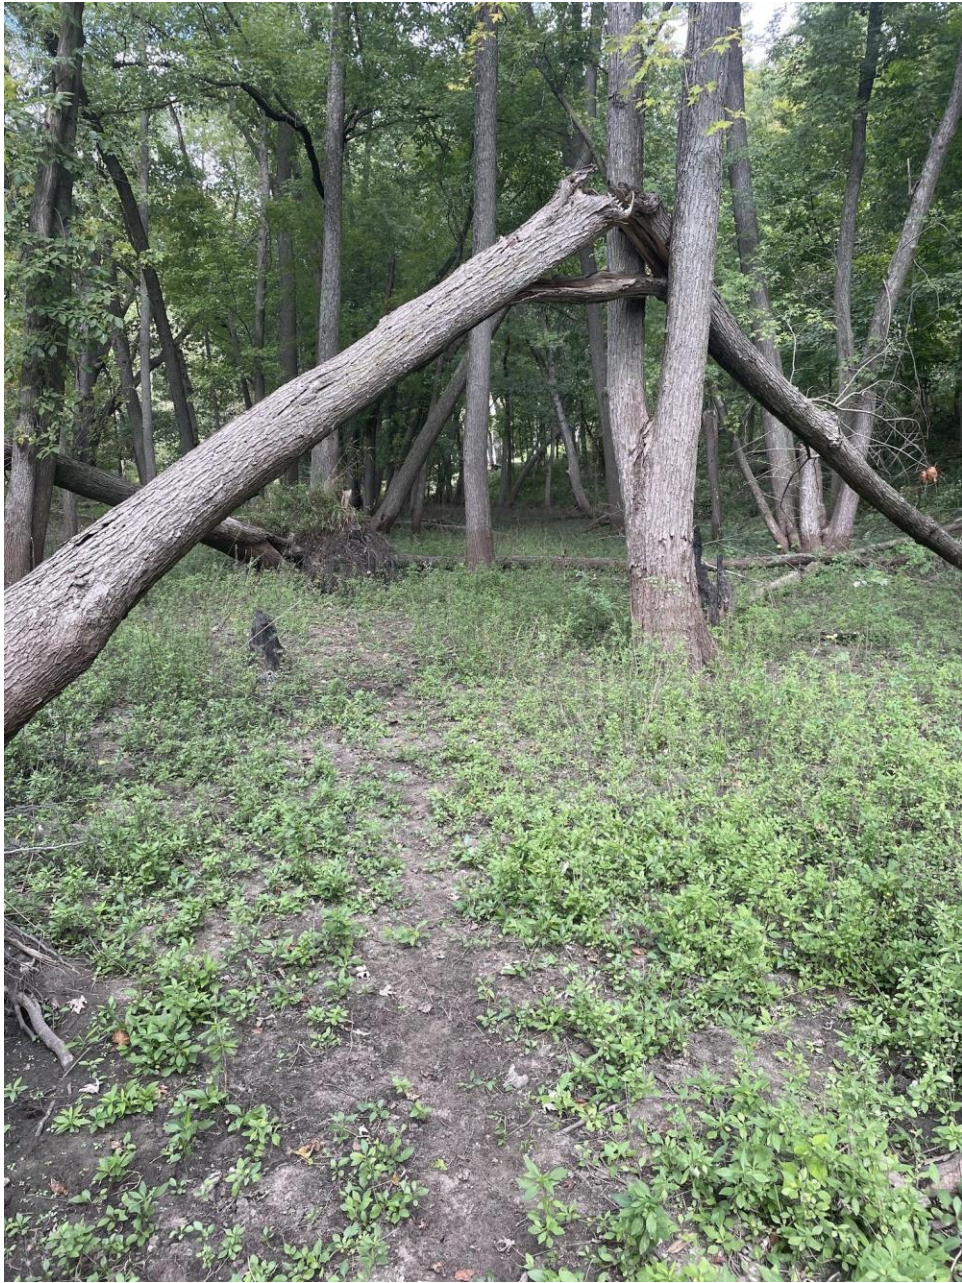
Figure 2. Site 1. Upstream.

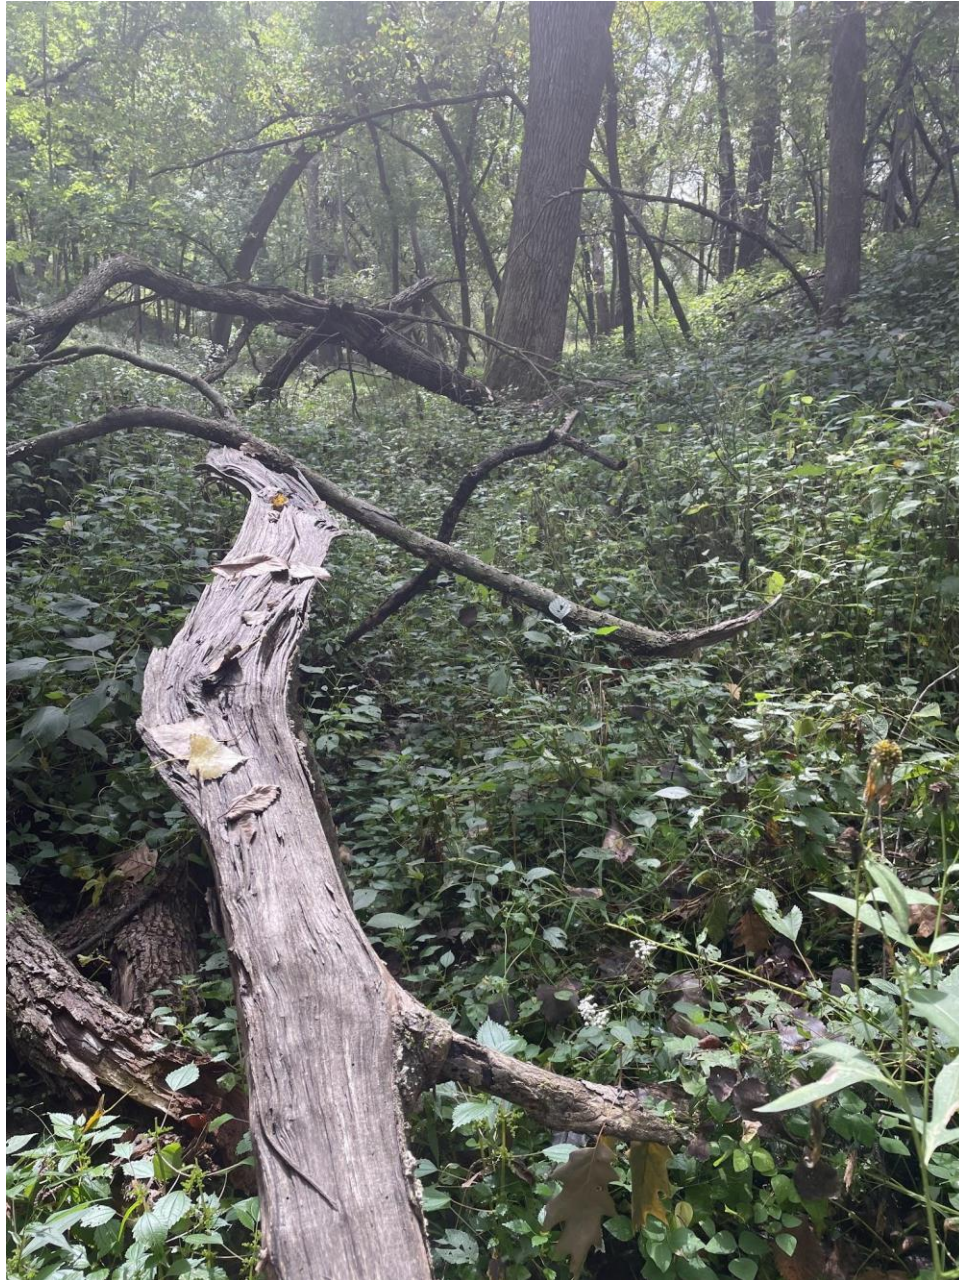
| Channel description | Dry and filled with leaf litter. No signs of recent flow. |

Figure 3. Site 2. Upstream.

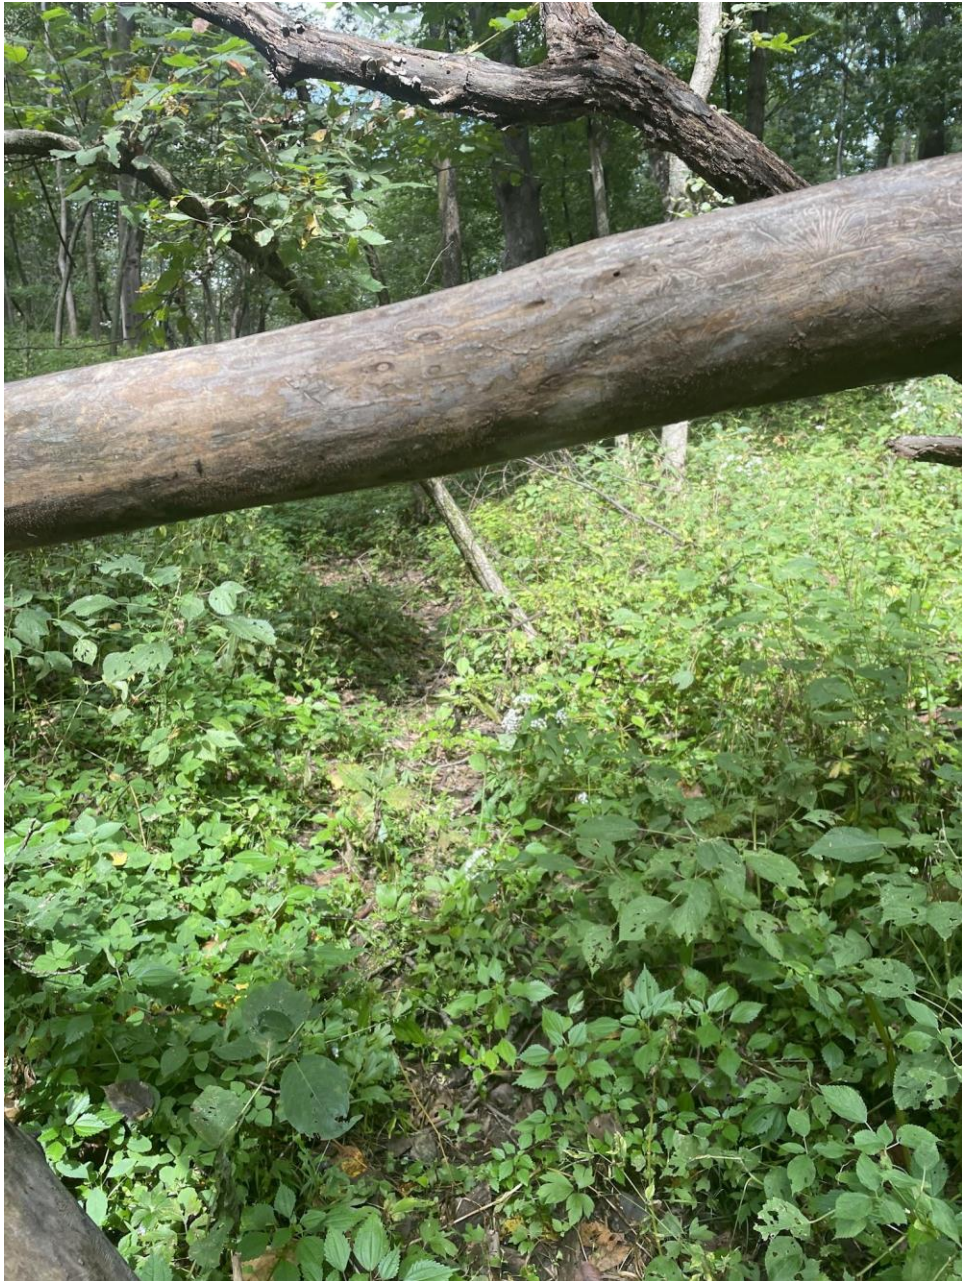
Figure 4. Site 2. Downstream.

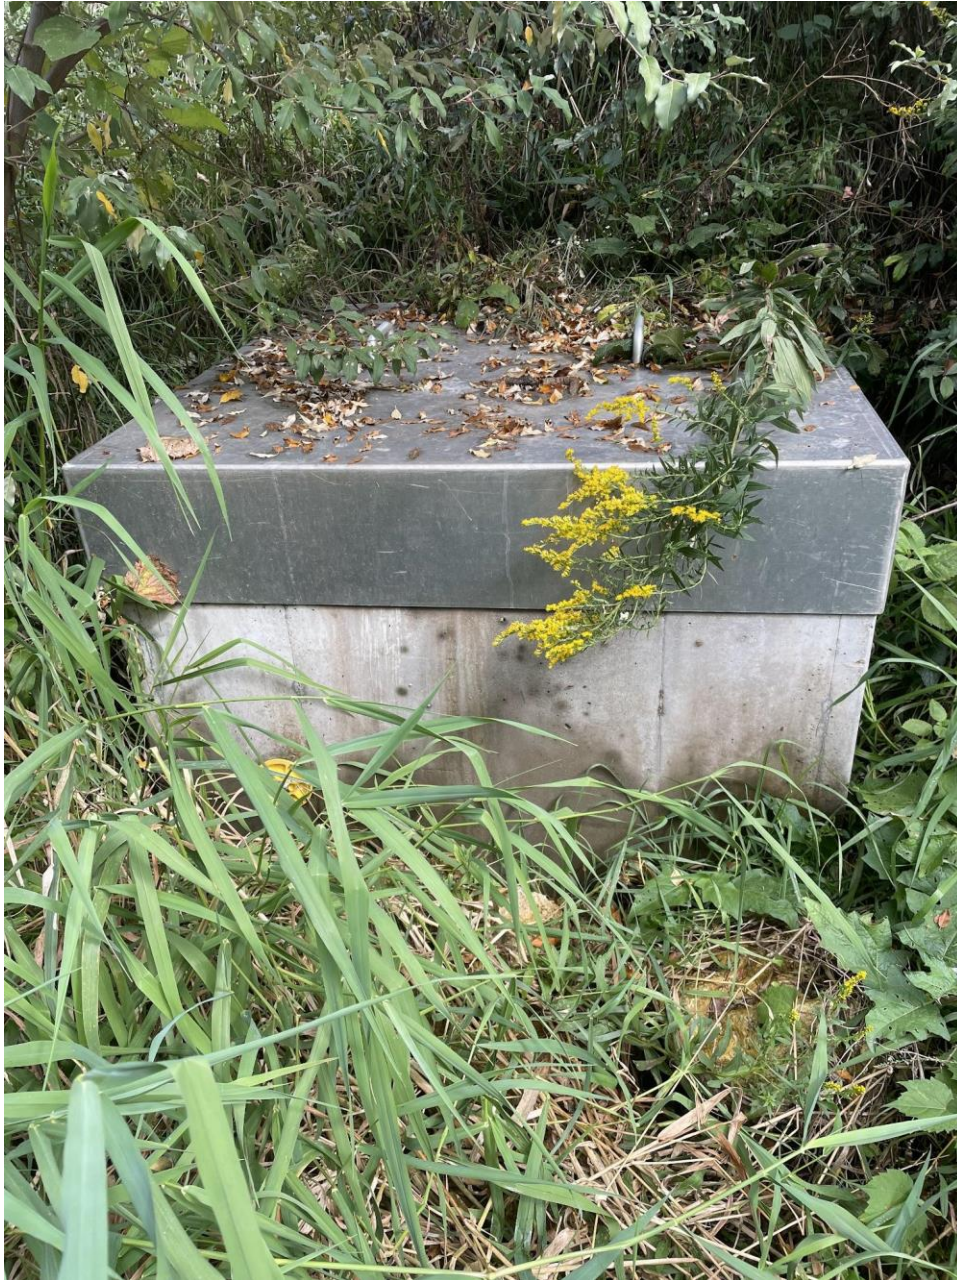
| Channel description | Steep hillside. Dry and filled with leaf litter. No signs of recent flow. |

Figure 5. Site 3. Outfall upstream.

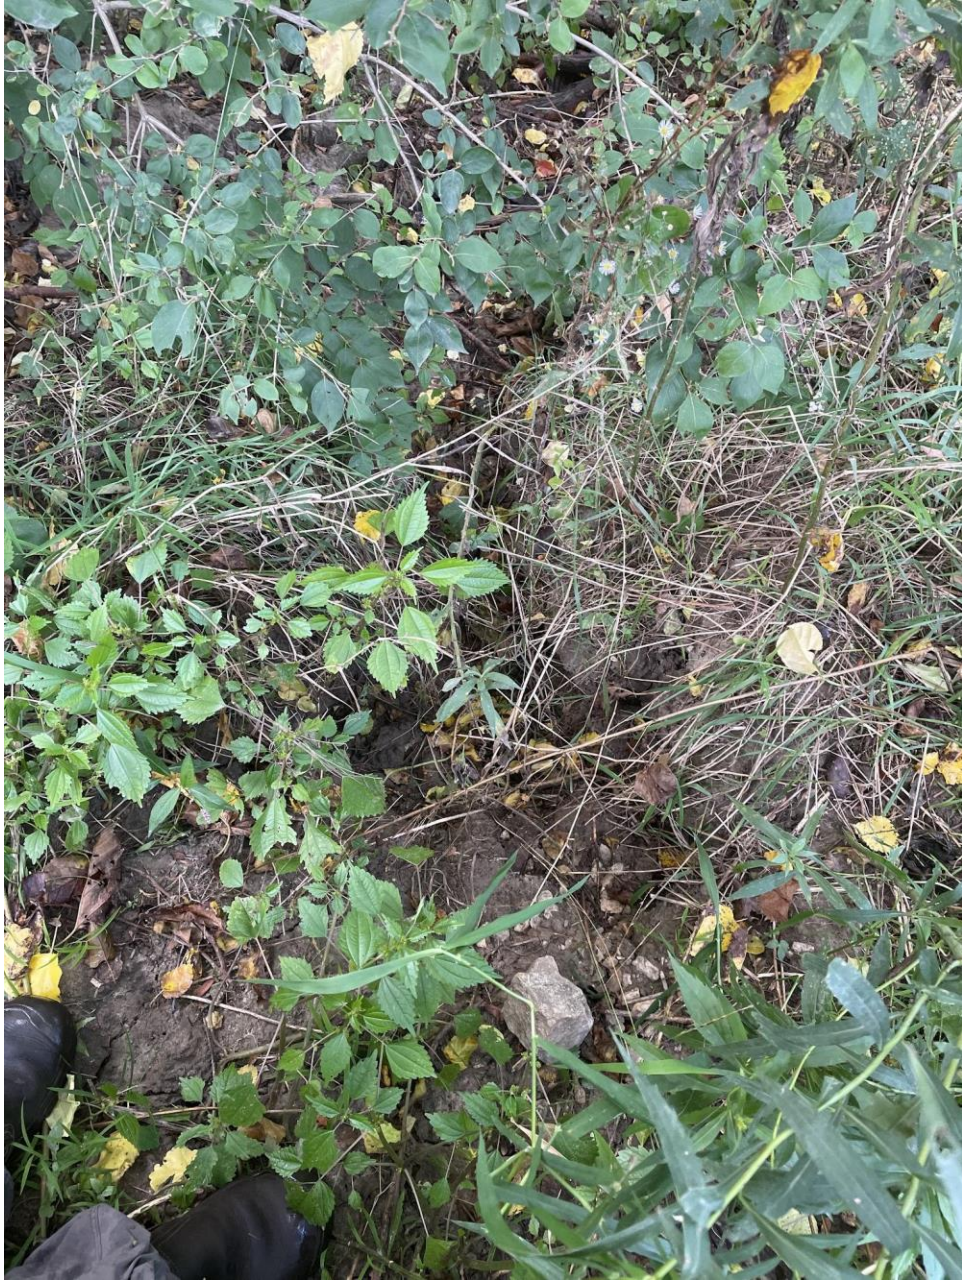
Figure 6. Site 3. Outfall downstream.
