Use Attainability Analysis

1 Water Body Name	Devils Creek
2 Segment Description	Mouth to confluence with unnamed tributary
3 Segment Length (mi)	4.7
4 Drainage Area (sq. mi.)	21.2
5 Segment Start Latitude, Longitude (DD)	40.59936, -91.42498
6 Segment End Latitude, Longitude (DD)	40.64689, -91.40943
7 Route of Flow (Next Downstream Adopted Designated Use)	Devils Creek (General Use, General Use) to Devils Creek (A1, BWW2)
8 NPDES Facility and Permit Number (If Applicable)	Hidden Oak Estates (5600301)
9 Sample Site ID(s)	614-1, 614-1.5, 614-2
10 Segment County Name(s)	Lee
11 Field Work Date(s)	8/20/2007, supplemental visit 10/31/2025

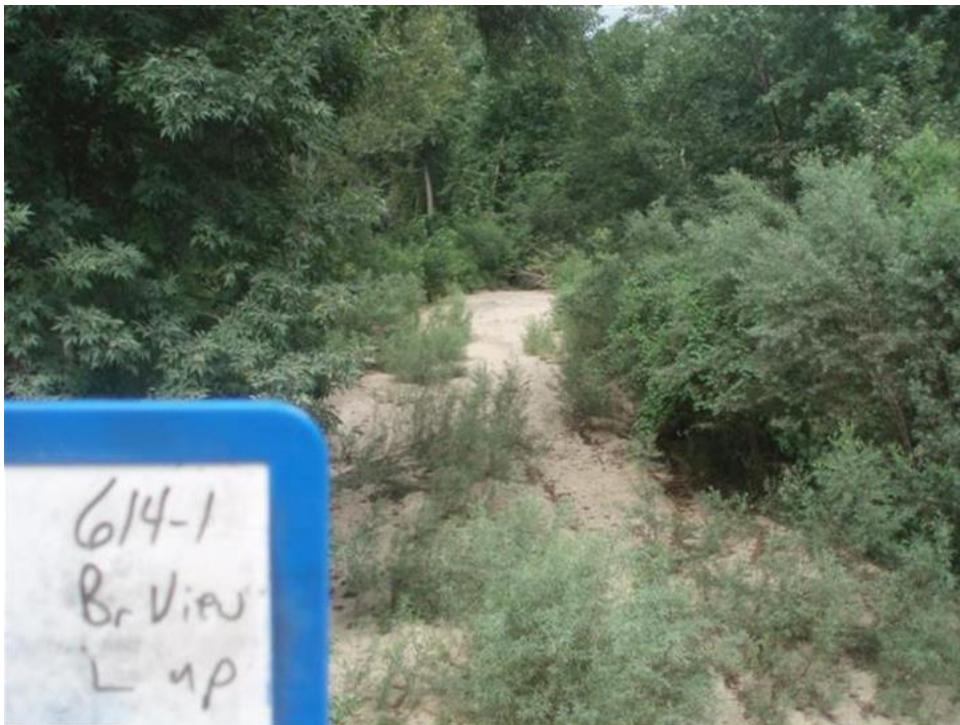
Figure 1. 614-1 Bridge looking upstream.

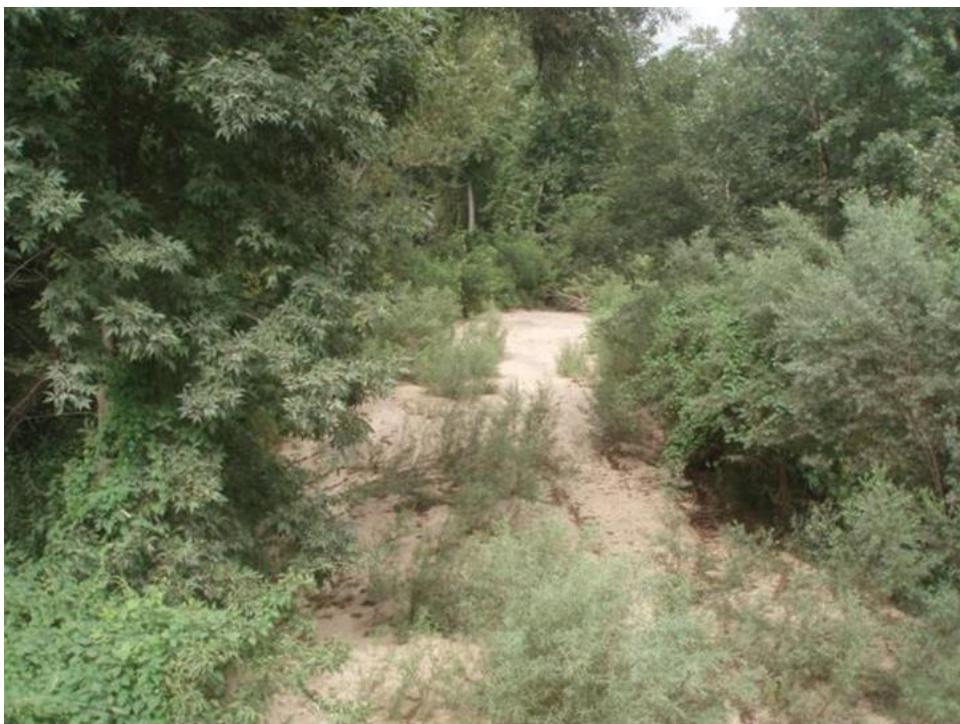
Figure 2. 614-1 Bridge looking upstream #2.

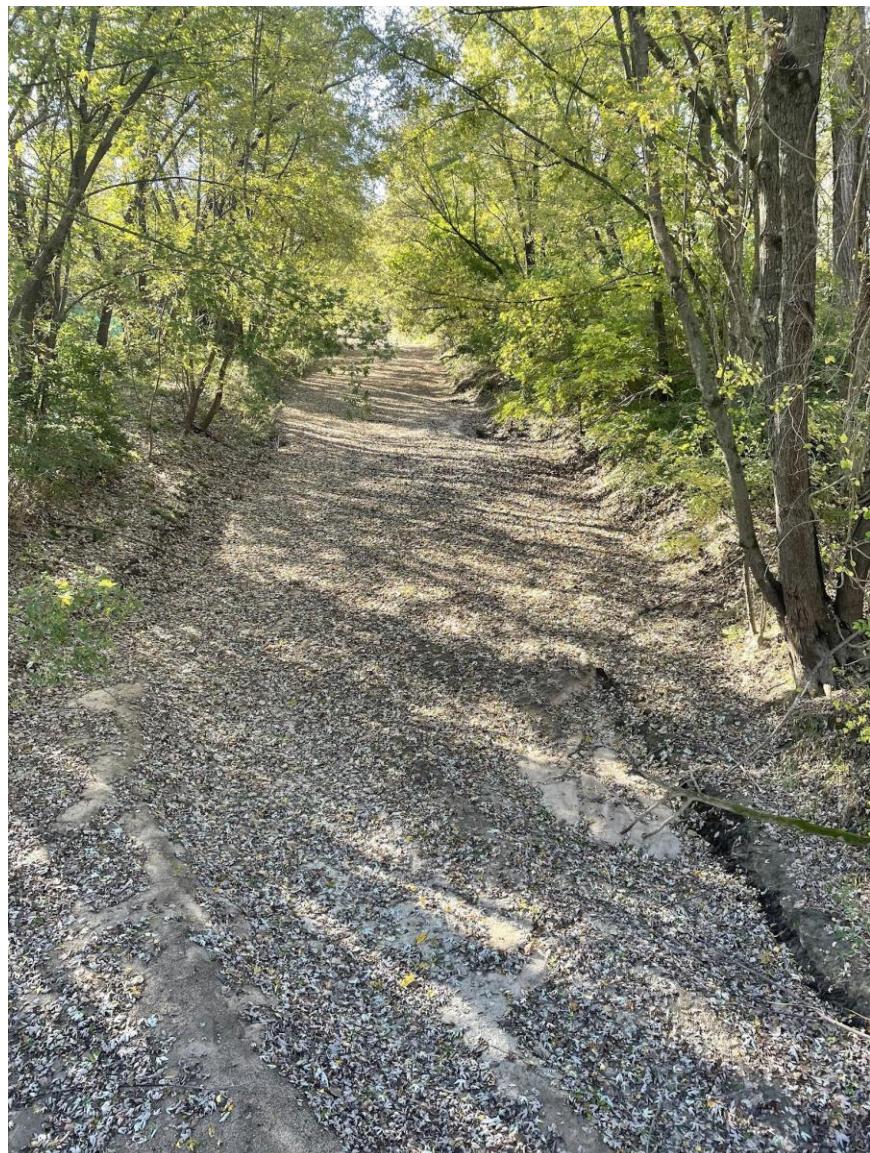
Figure 3. 614-1 Bridge looking upstream, supplemental visit.

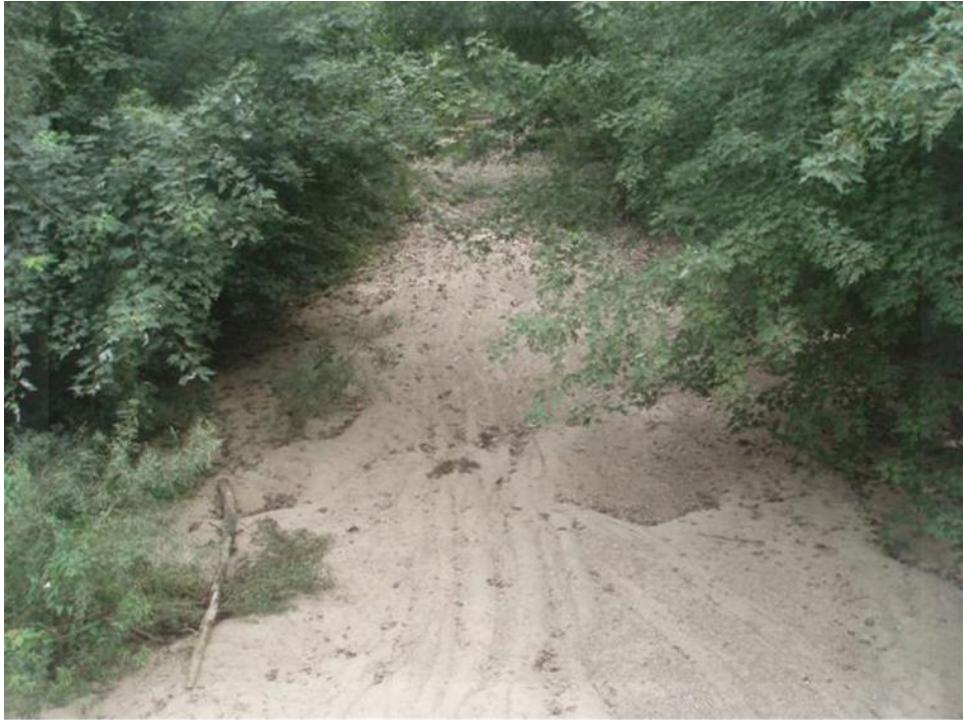
Figure 4. 614-1 Bridge looking downstream.

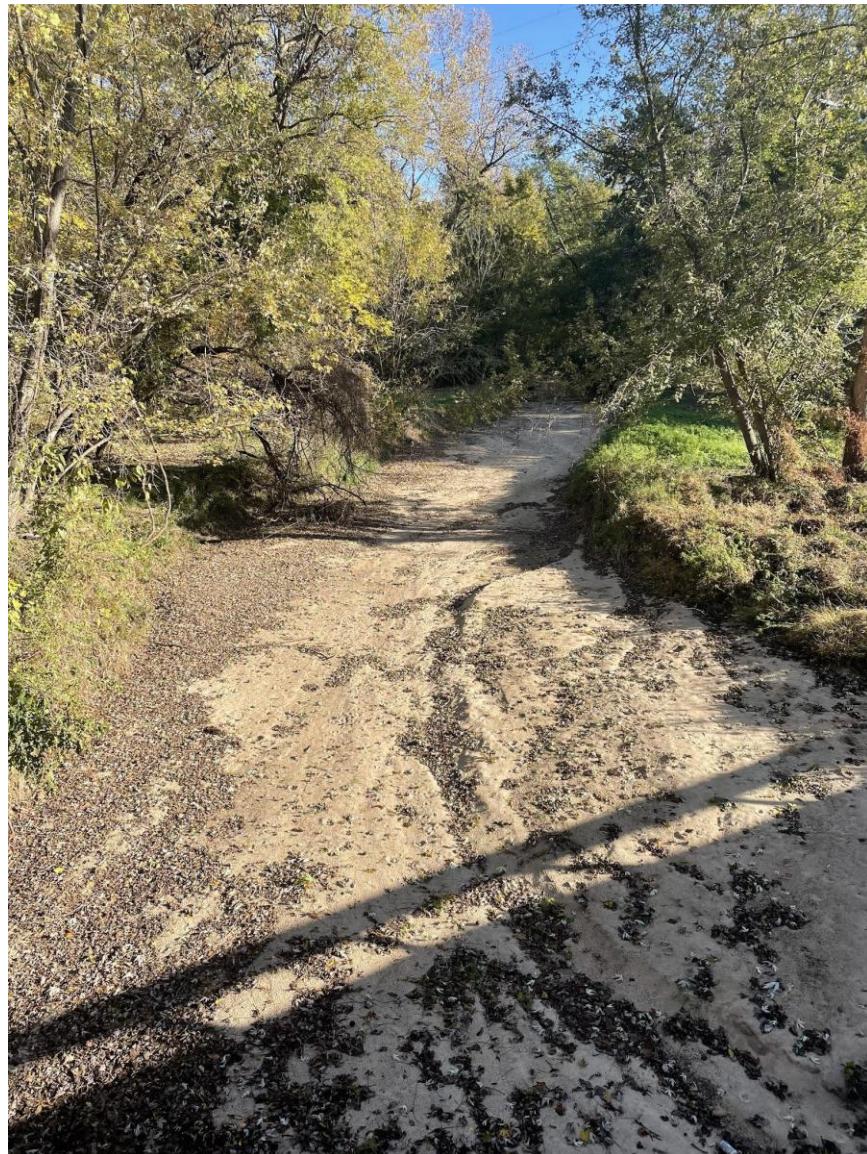
Figure 5. 614-1 Bridge looking downstream, supplemental visit.

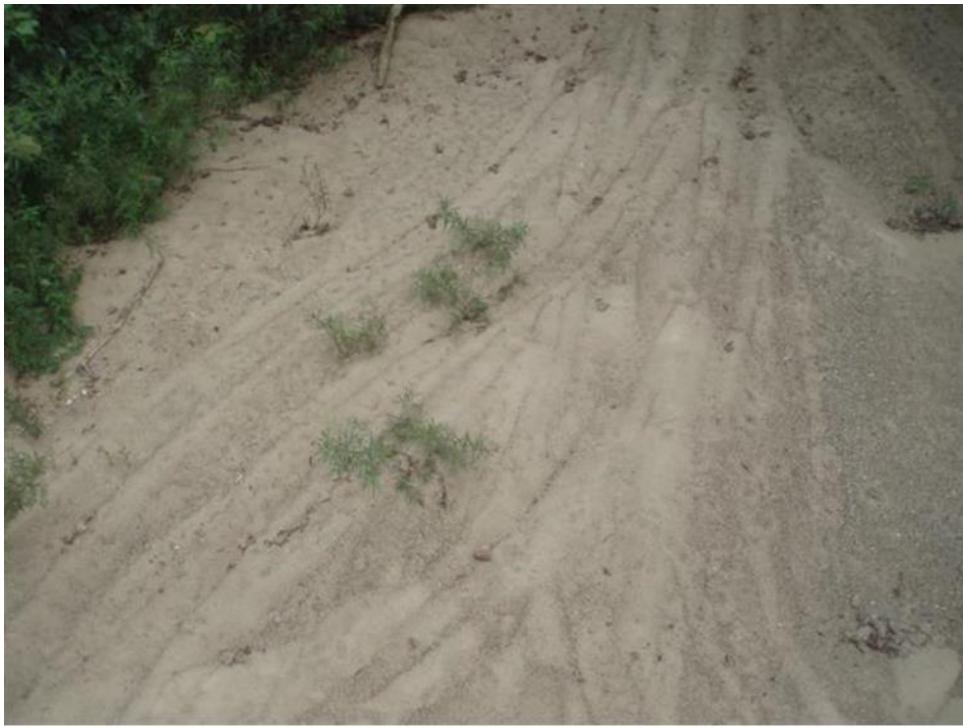
Figure 6. 614-1 ATV tracks present at the assessed location.

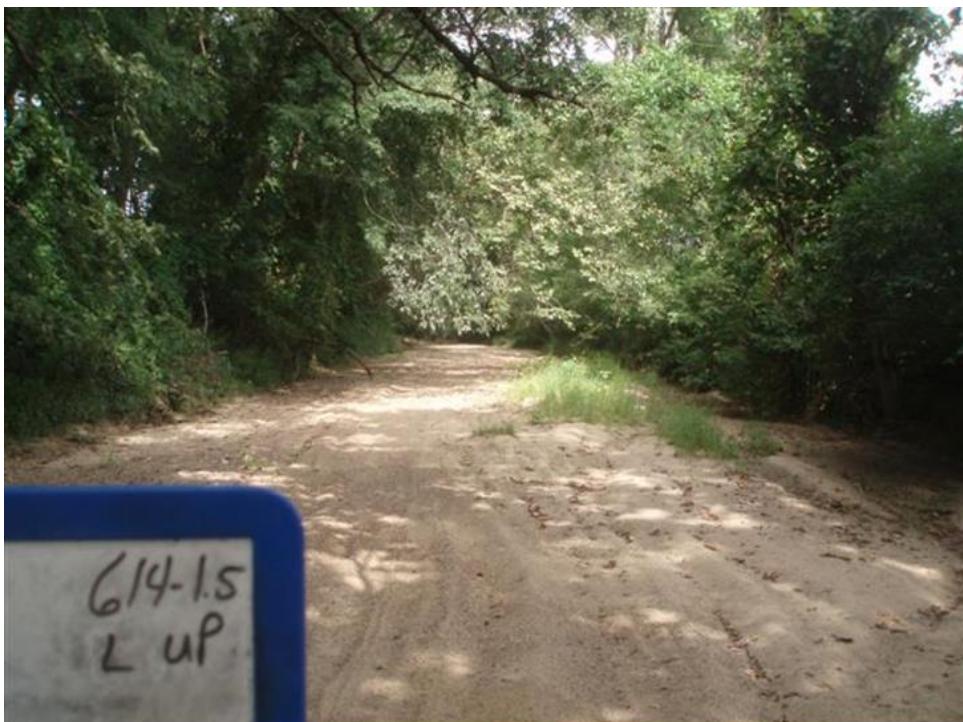
Figure 7. 614-1.5 Instream looking upstream.

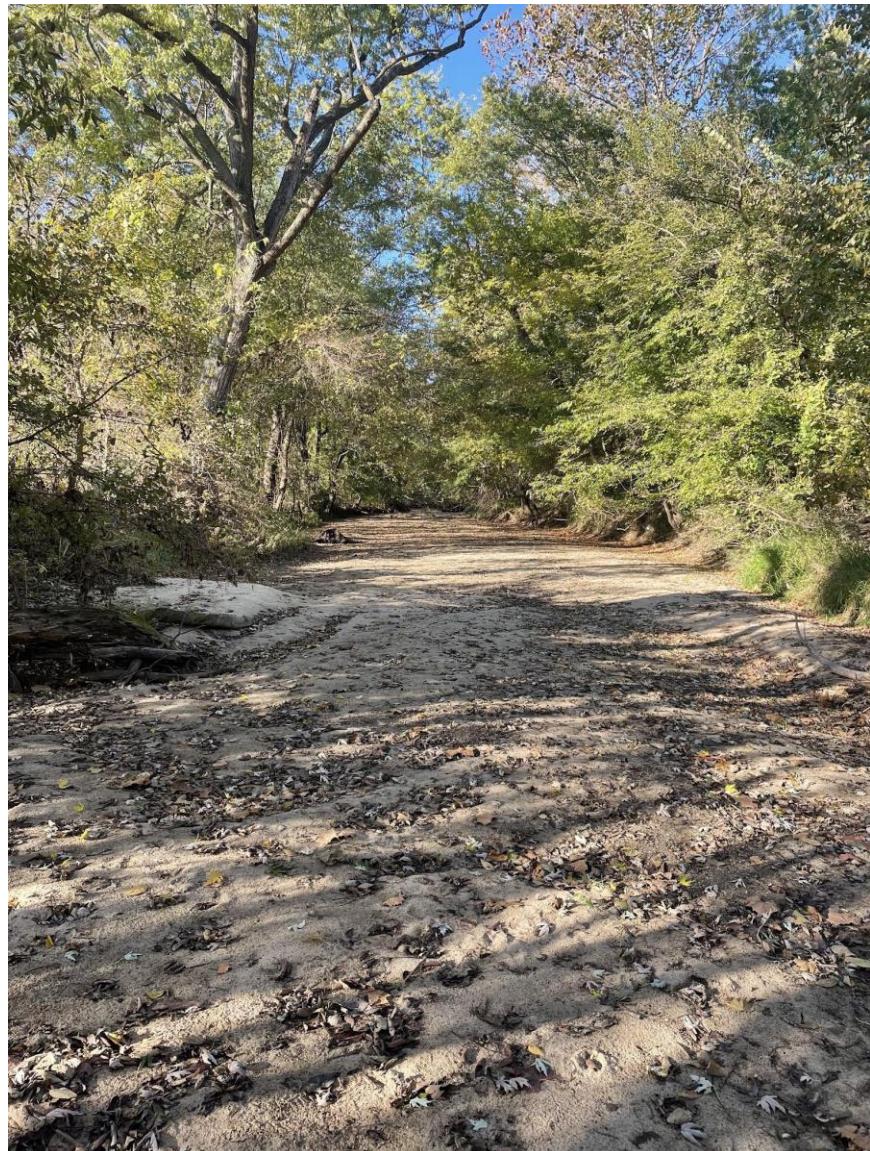
Figure 8. 614-1.5 Instream looking upstream, supplemental visit.

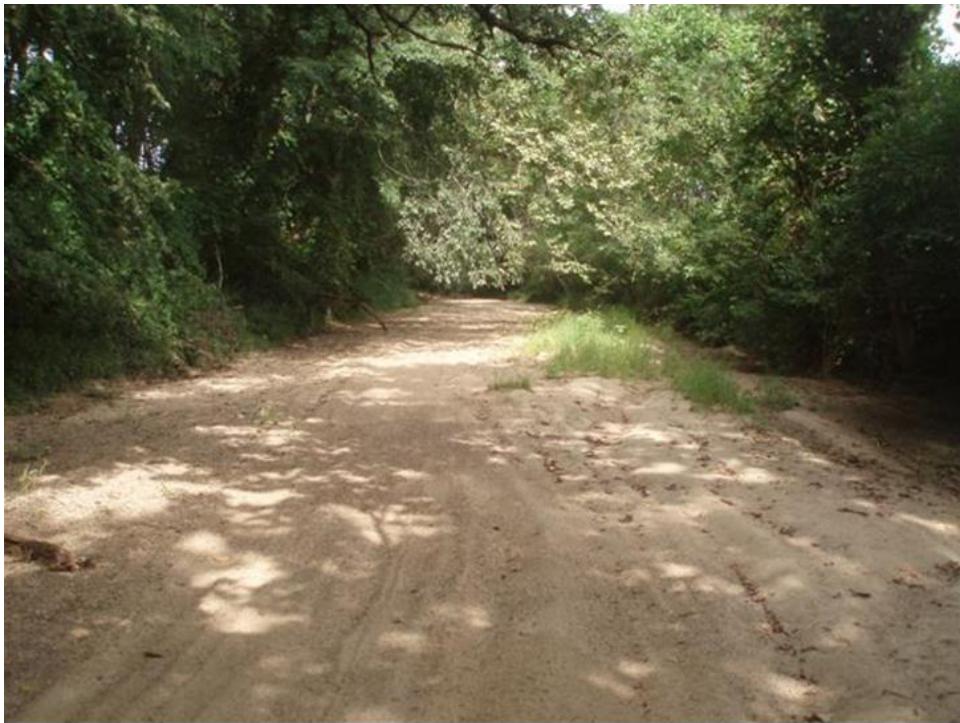
Figure 9. 614-1.5 Instream looking upstream #2.

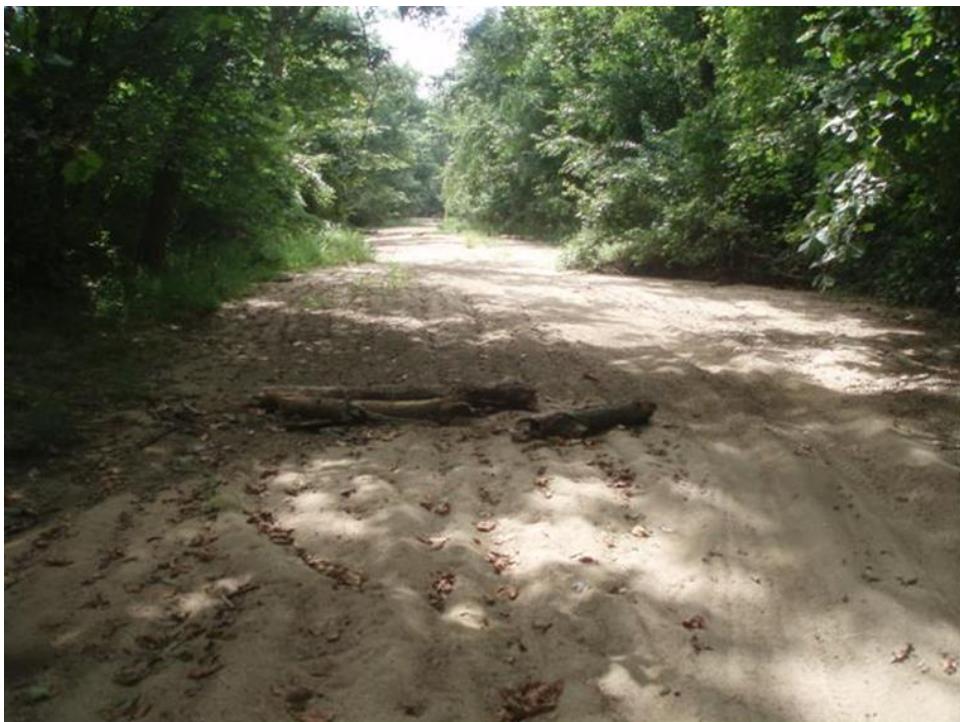
Figure 10. 614-1.5 Instream looking downstream.

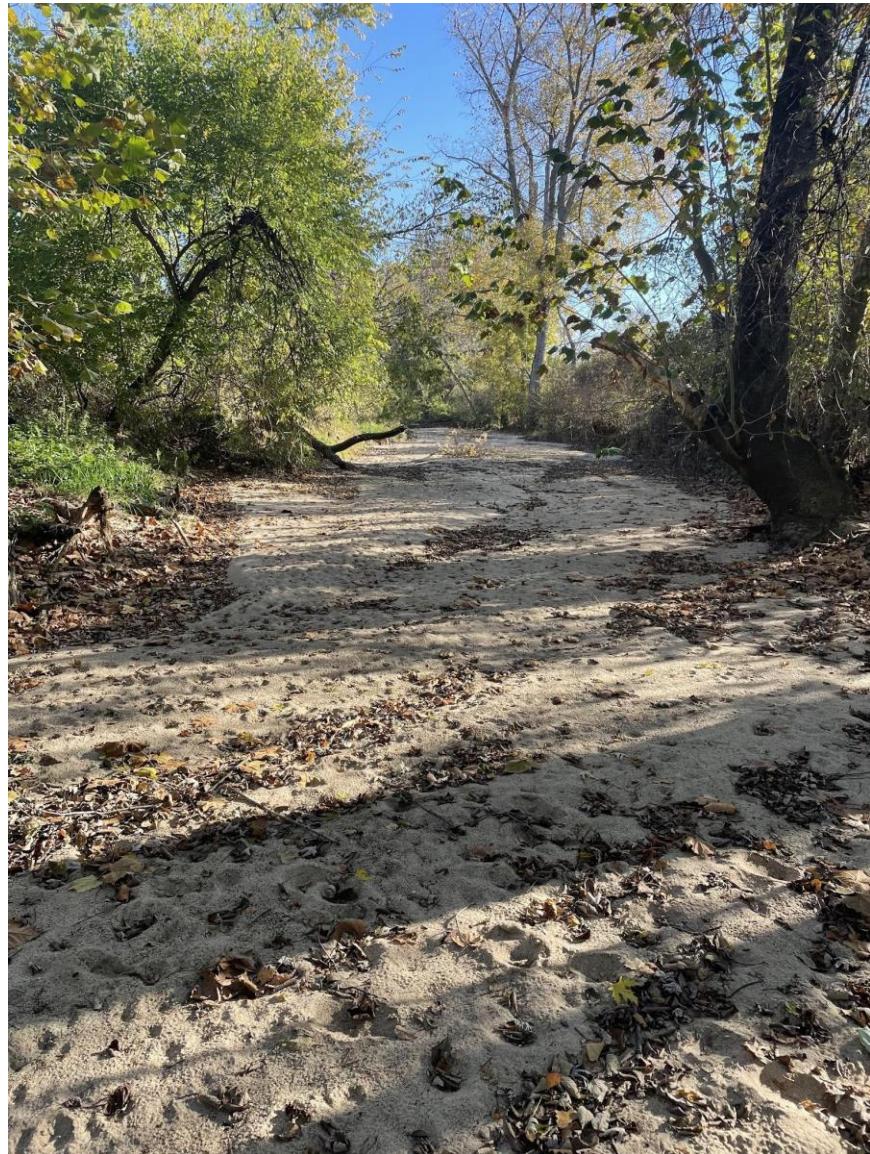
Figure 11. 614-1.5 Instream looking downstream, supplemental visit.

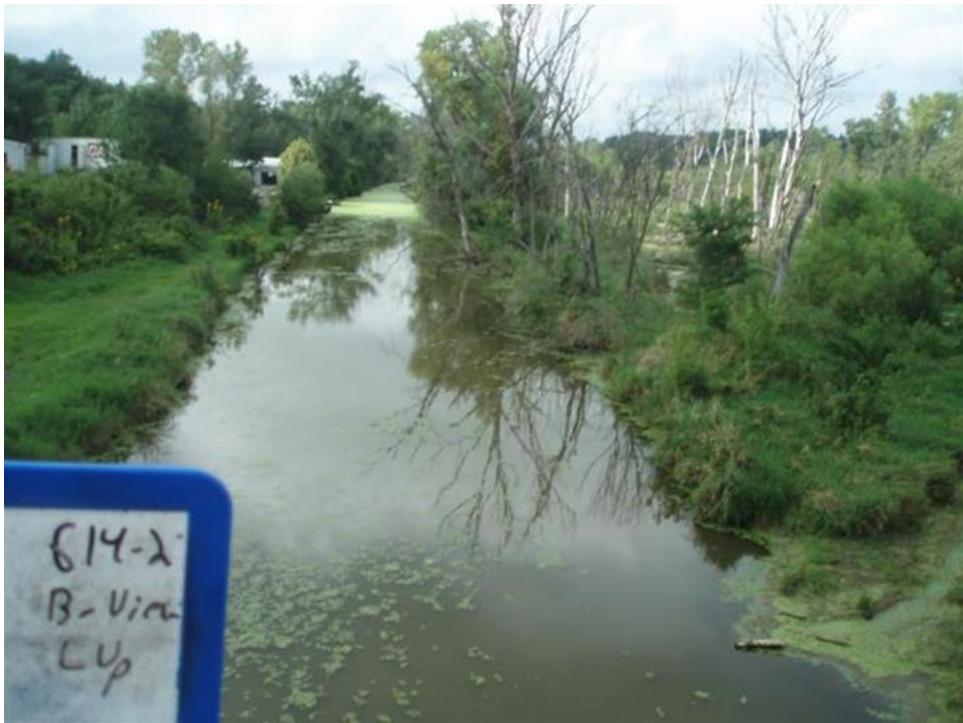
Figure 12. 614-2 Bridge looking upstream.

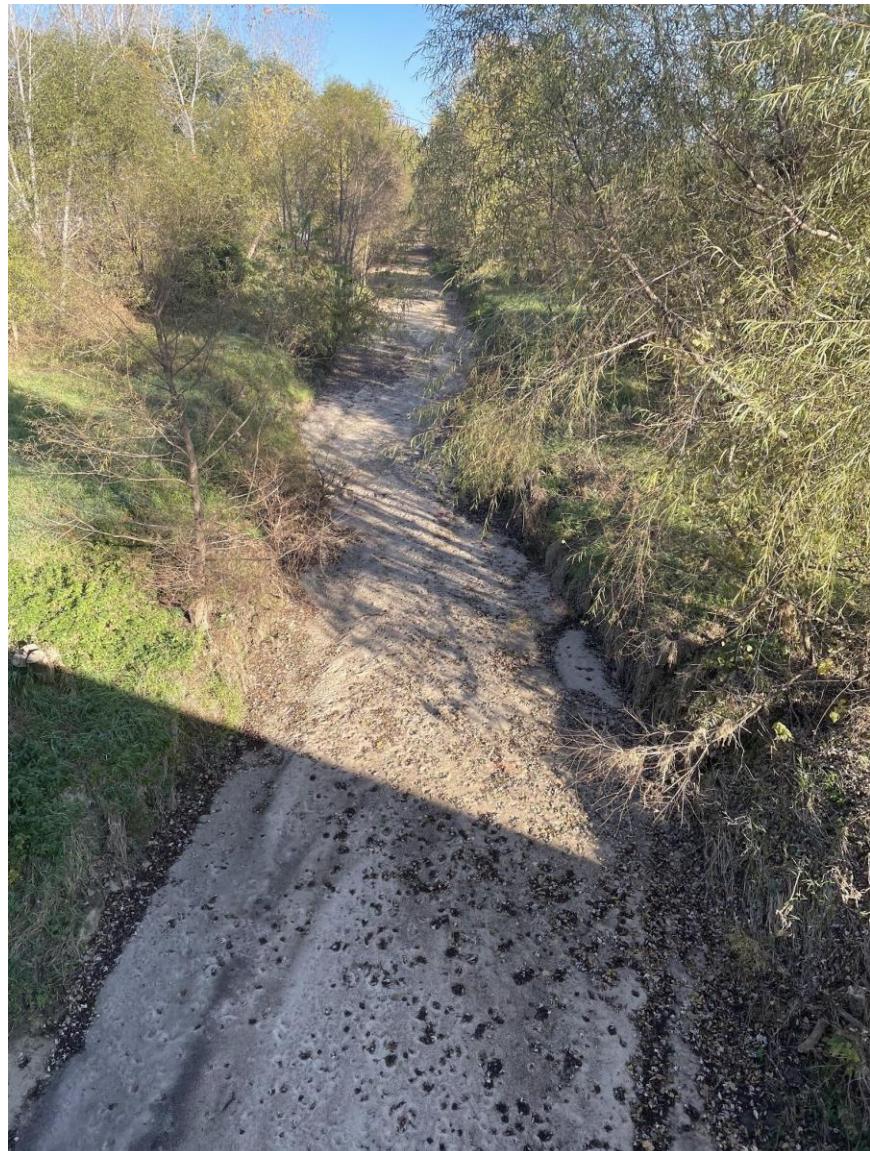
Due to the time that has elapsed since the initial fieldwork was conducted on 8/20/2007 a supplemental site visit was conducted on 10/31/2025. On that visit it was observed that the beaver dam that was creating the large pool no longer existed. The stream bed in that location was completely dry with no pools at all. The furthest upstream site (#614-3) had continuously flowing water.

Figure 13. 614-2 Bridge looking upstream, supplemental visit.

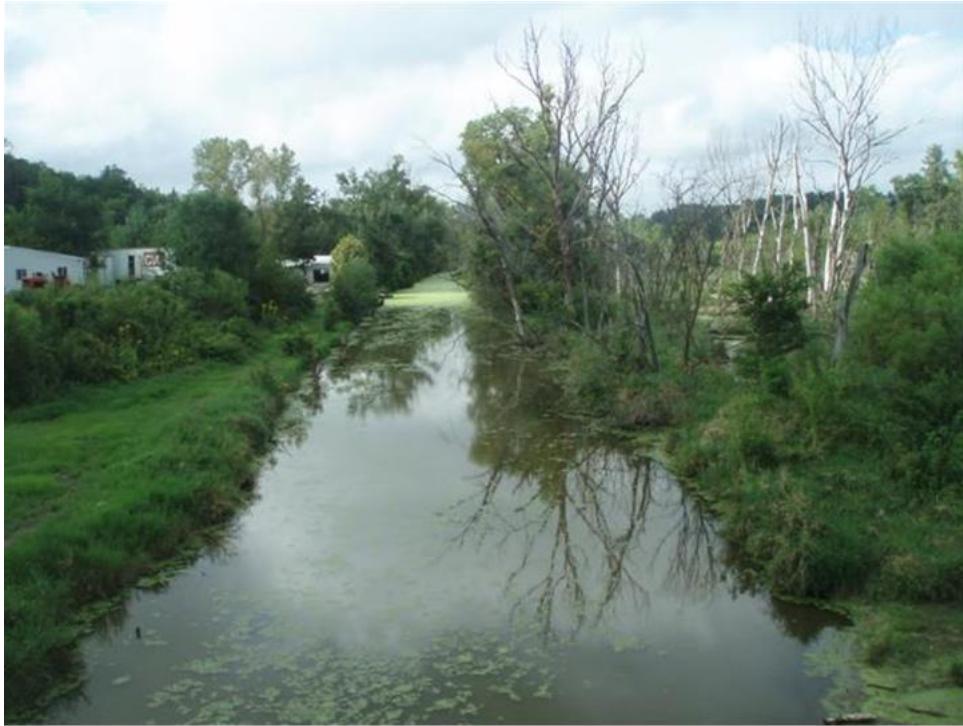
Figure 14. 614-2 Bridge looking upstream #2.

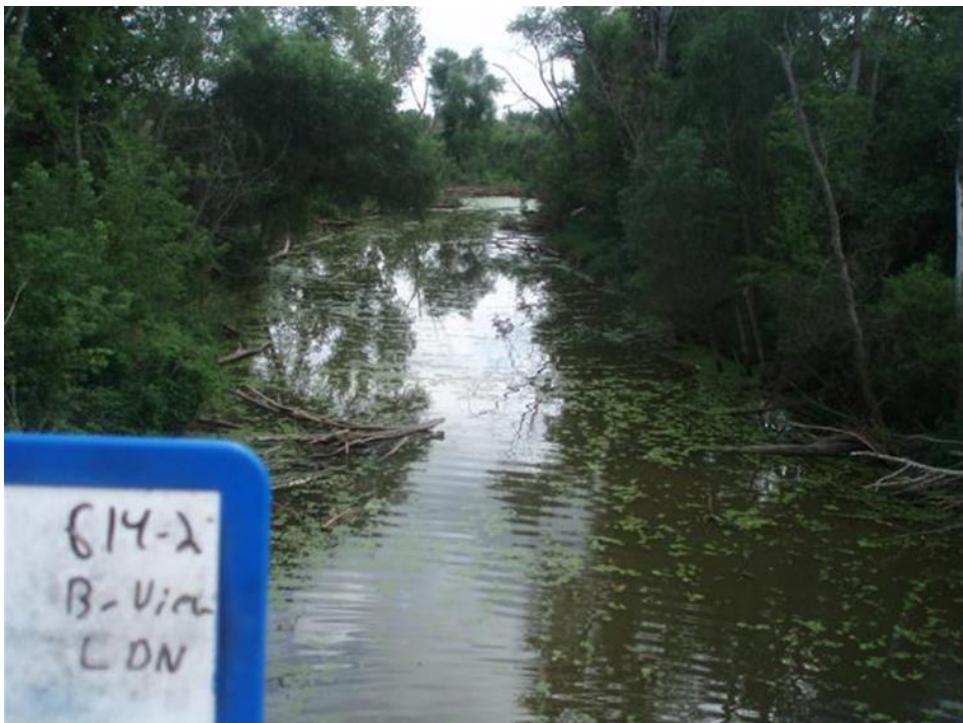
Figure 15. 614-2 Bridge looking downstream.

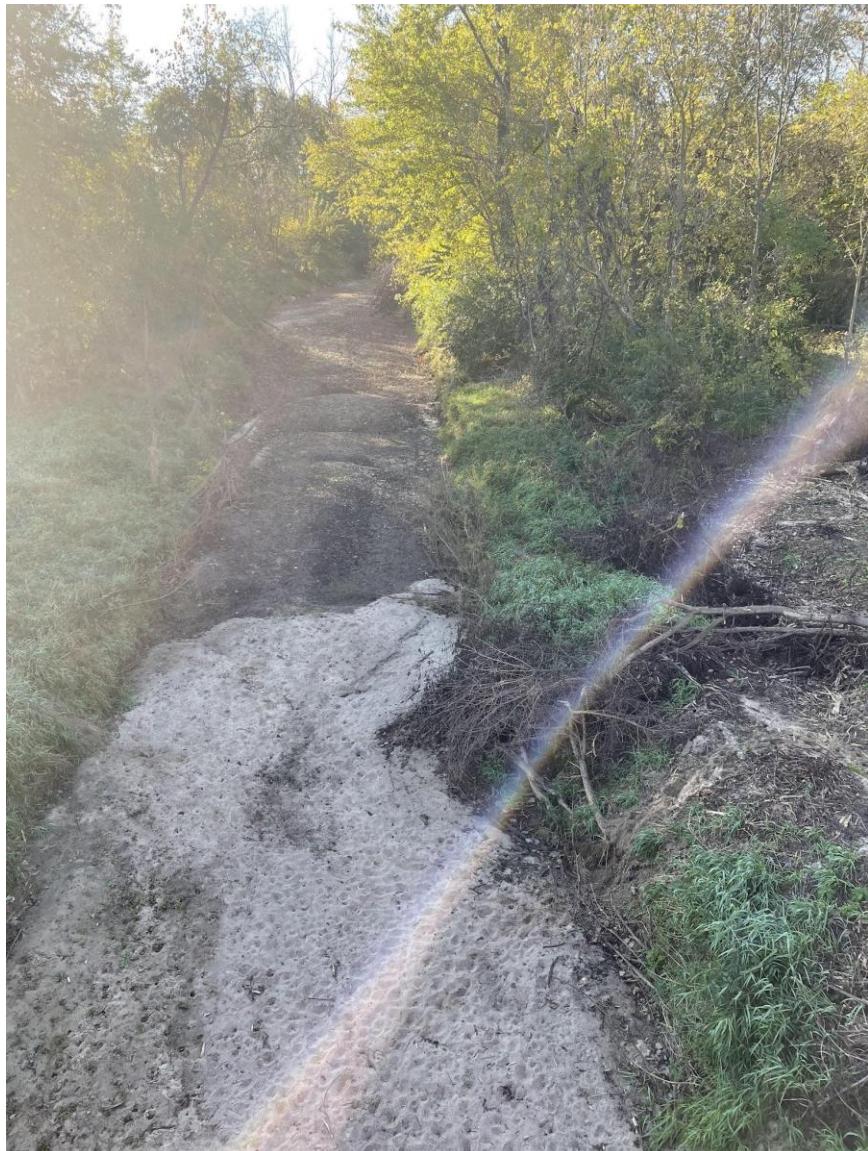
Figure 16. 614-2 Bridge looking downstream, supplemental visit.

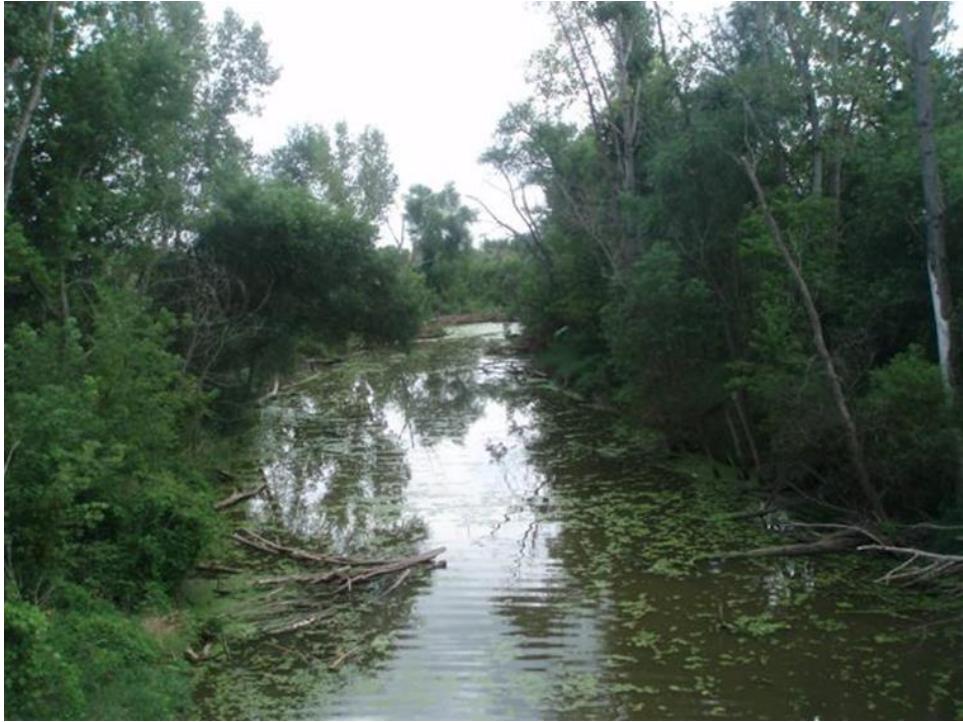
Figure 17. 614-2 Bridge looking downstream #2.

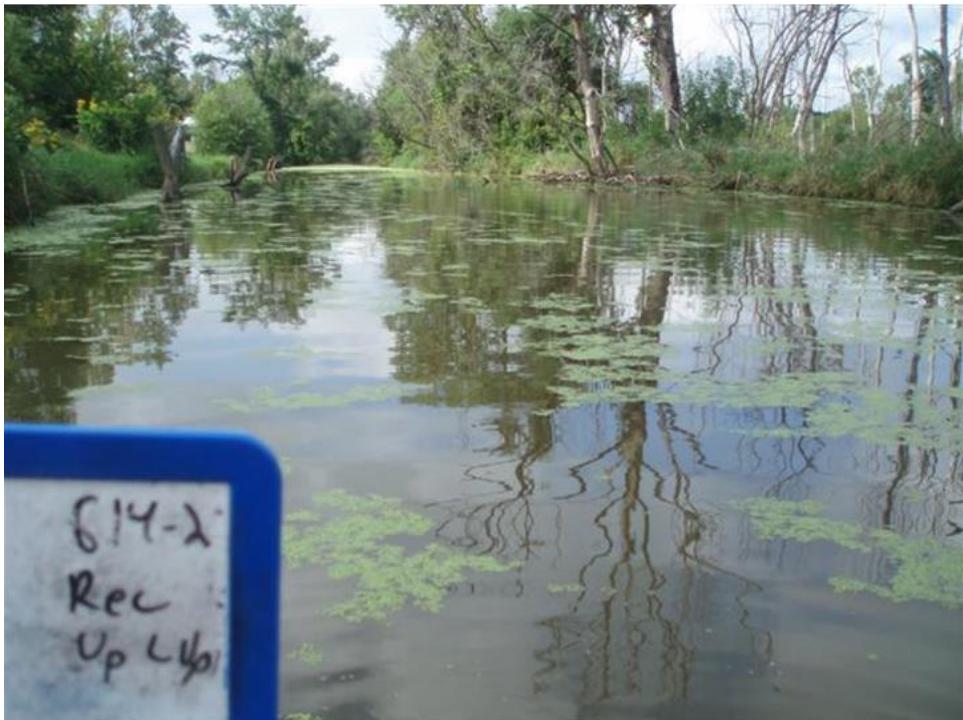
Figure 18. 614-2 Upstream recreation site looking upstream.

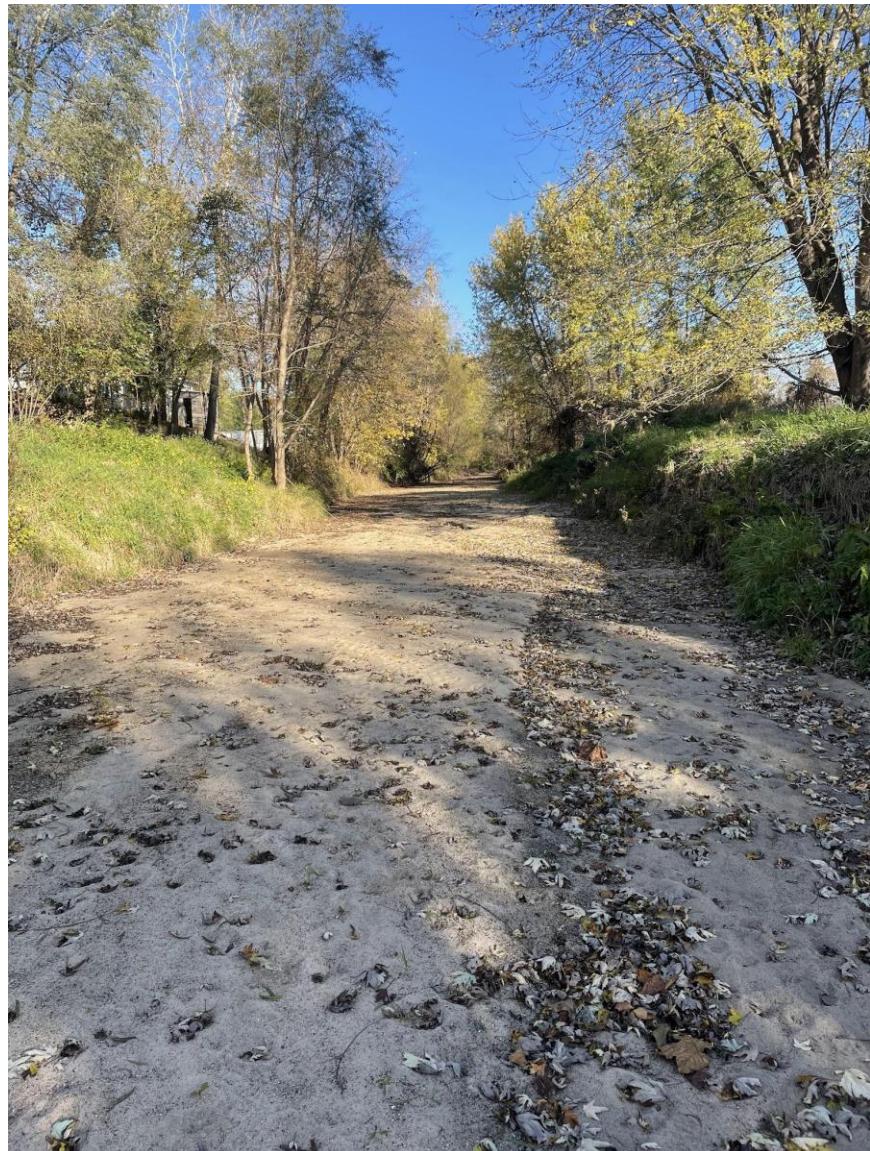
Figure 19. 614-2 Upstream recreation site looking upstream, supplemental visit.

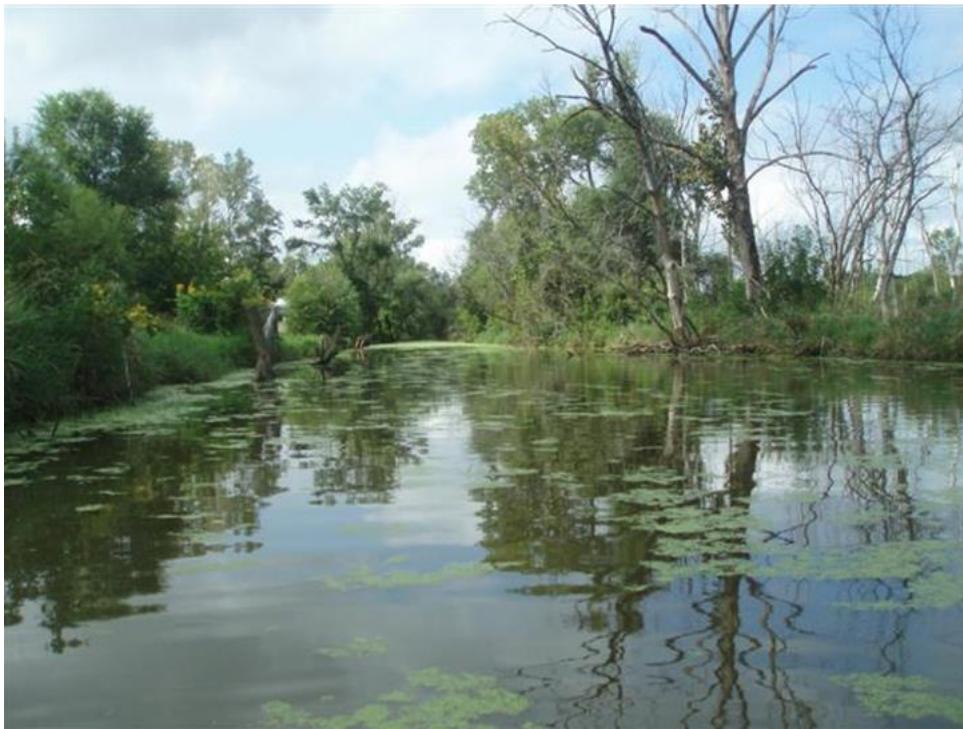
Figure 20. 614-2 Upstream recreation site looking upstream #2.

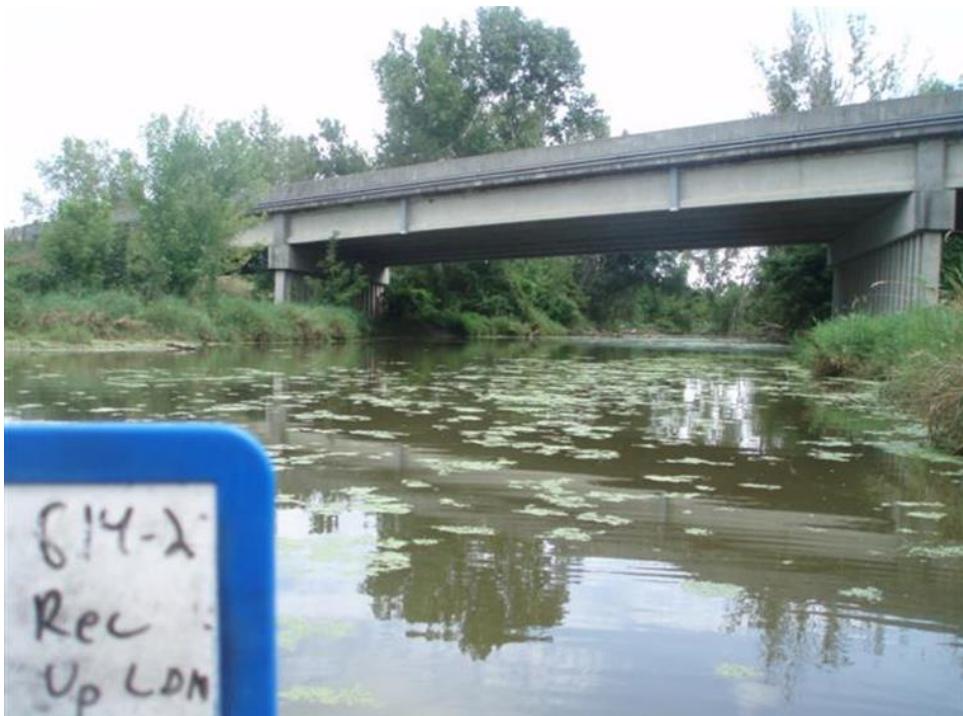
Figure 21. 614-2 Upstream recreation site looking downstream.

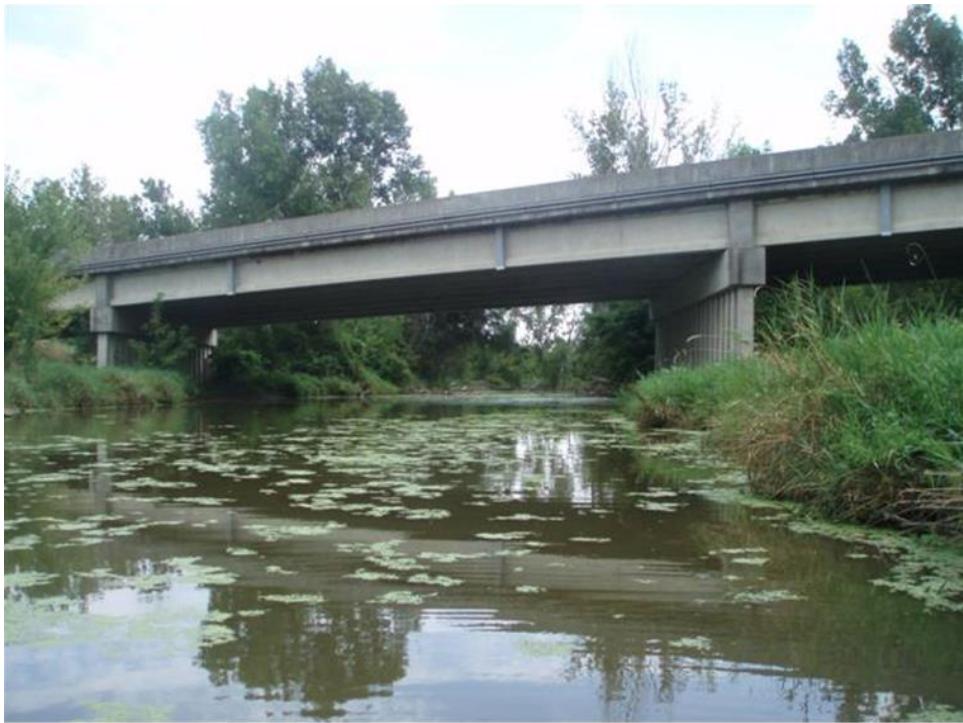
Figure 22. 614-2 Upstream recreation site looking downstream #2.

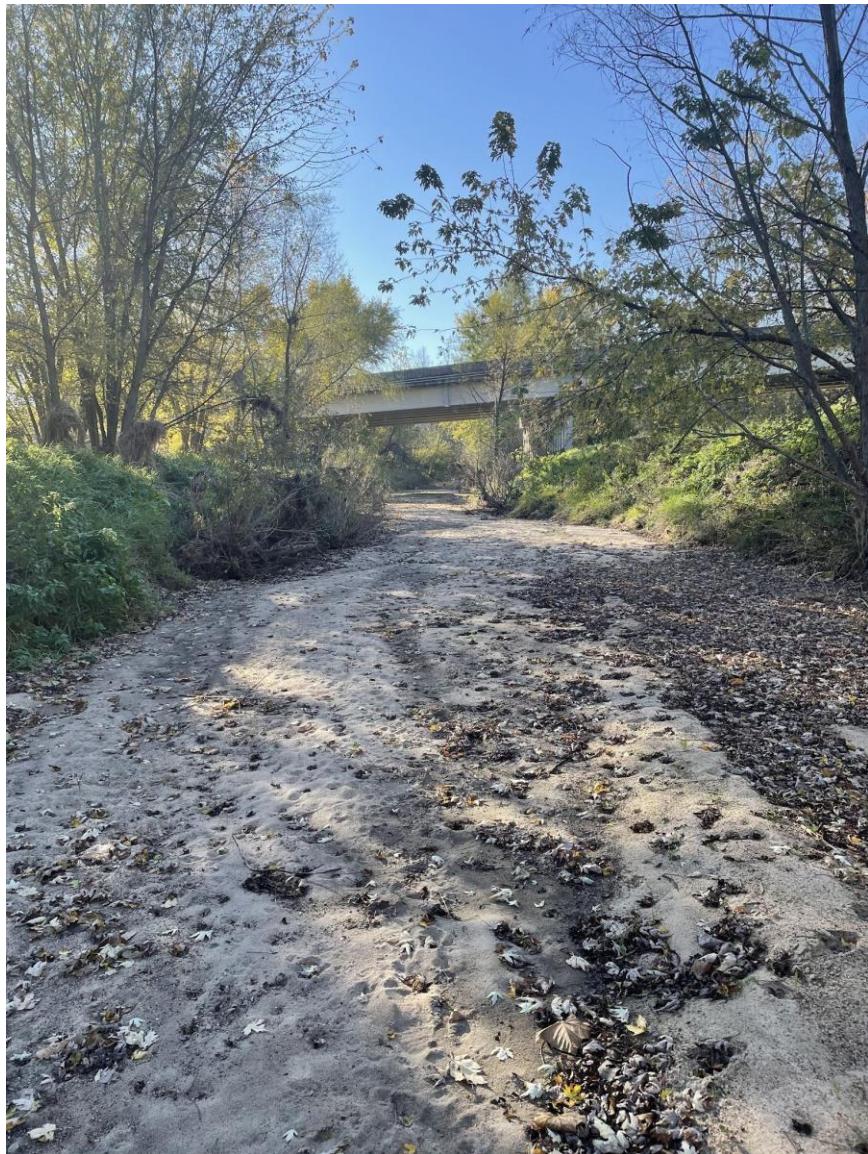
Figure 23. 614-2 Upstream recreation site looking downstream, supplemental visit.

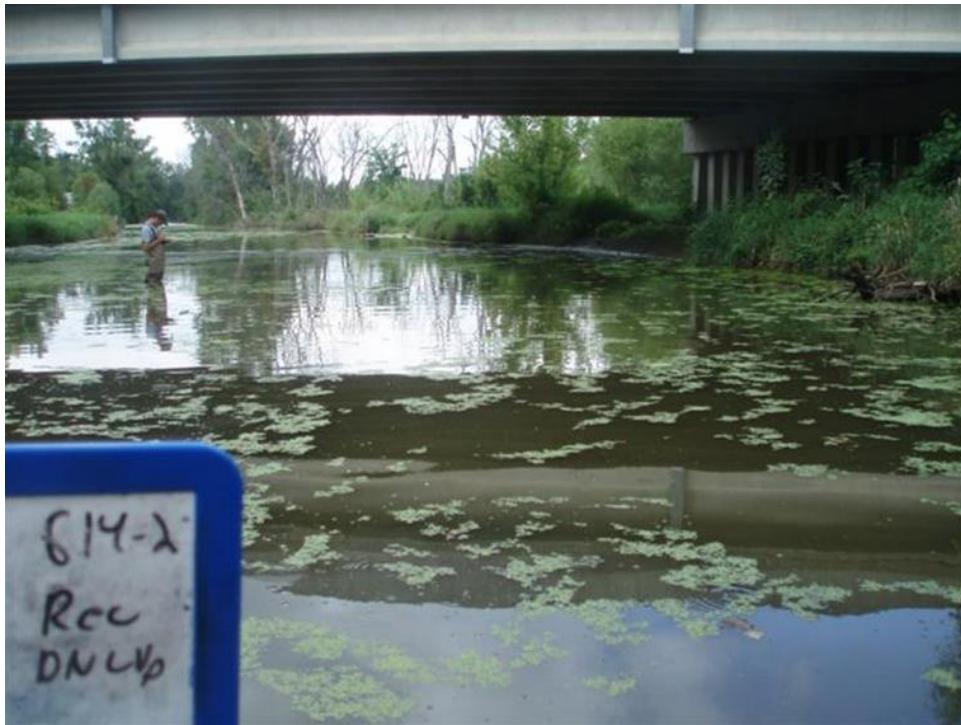
Figure 24. 614-2 Downstream recreation site looking upstream.

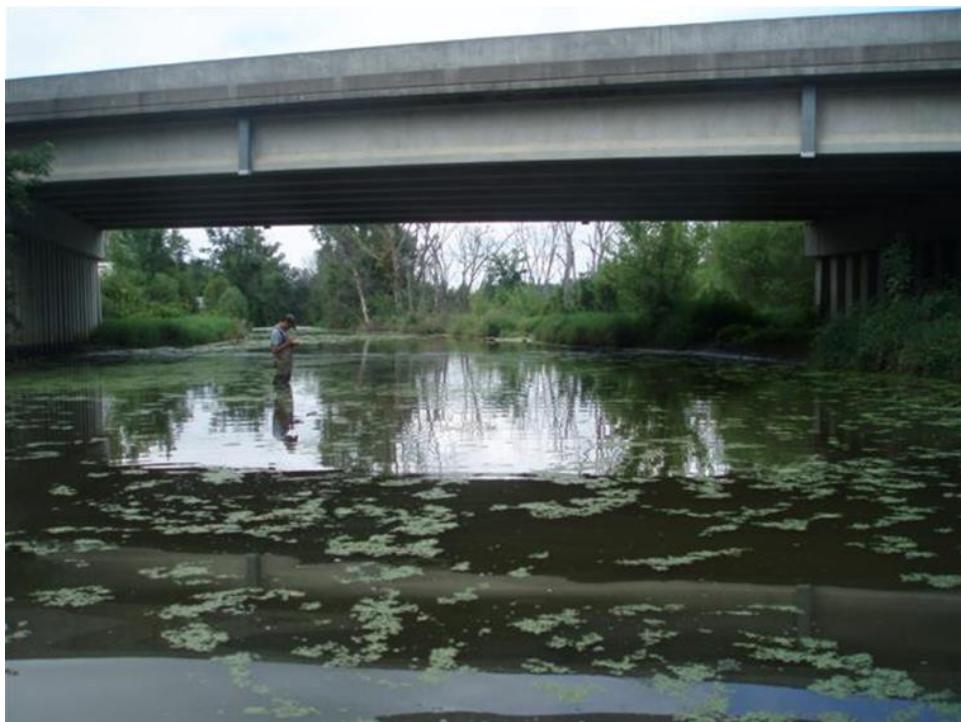
Figure 25. 614-2 Downstream recreation site looking upstream #2.

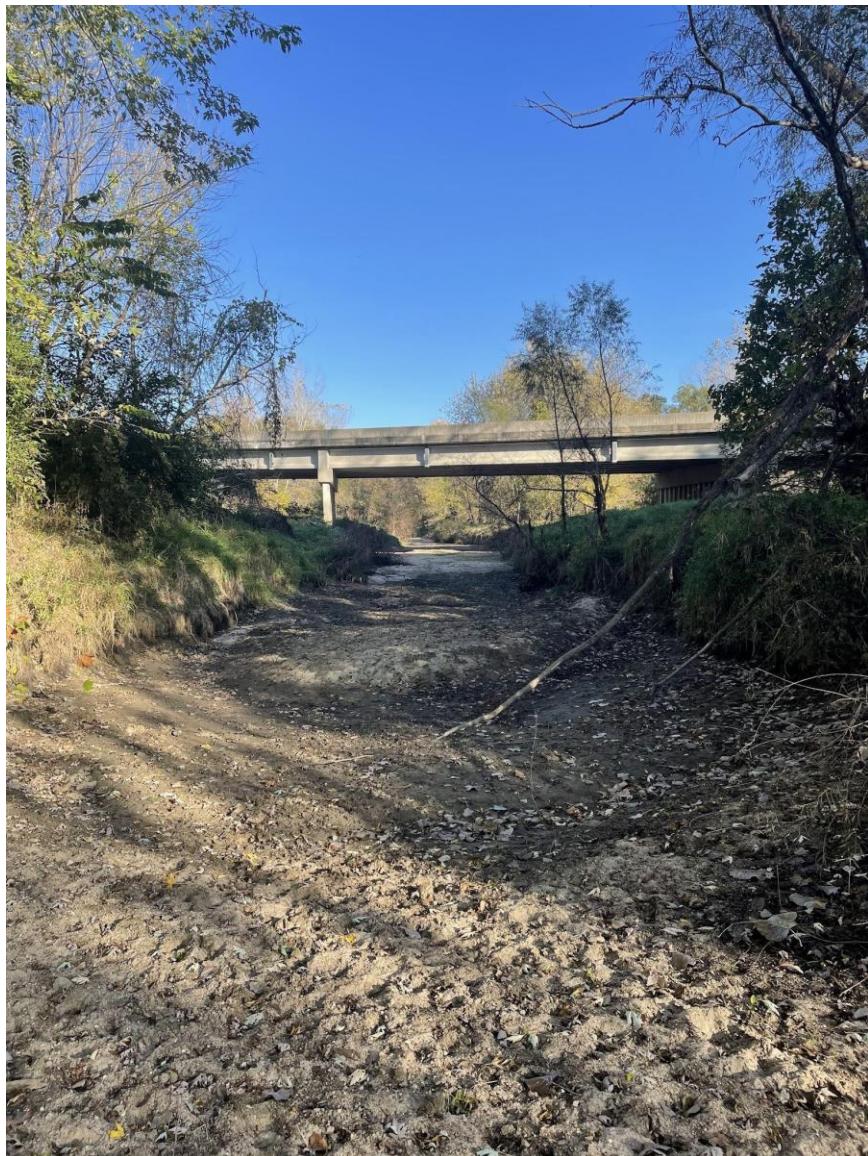
Figure 26. 614-2 Downstream recreation site looking upstream, supplemental visit.

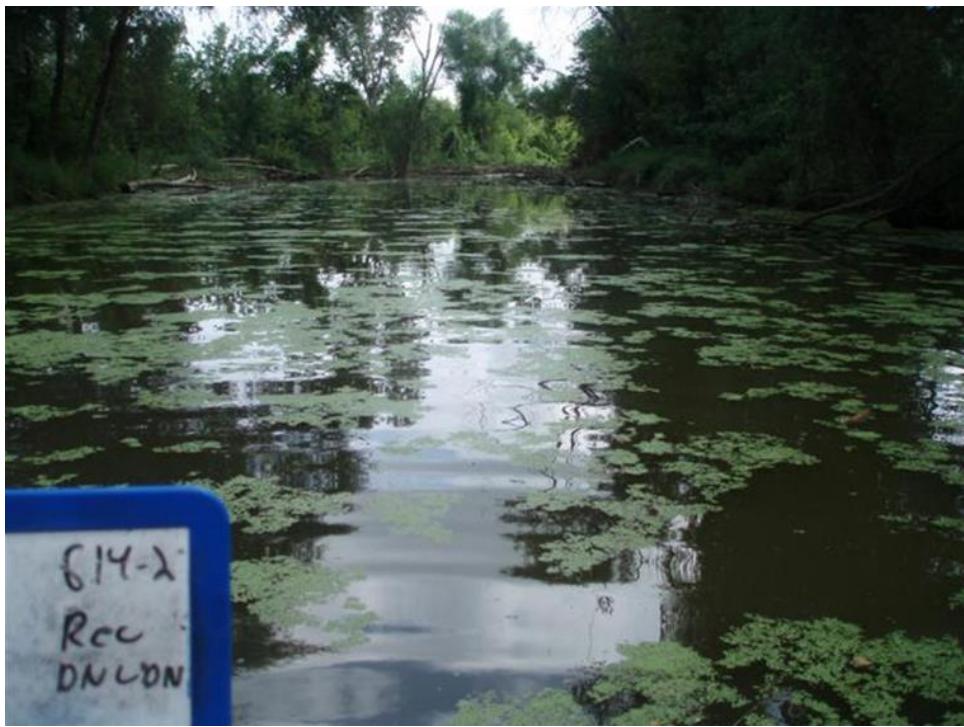
Figure 27. 614-2 Downstream recreation site looking downstream.

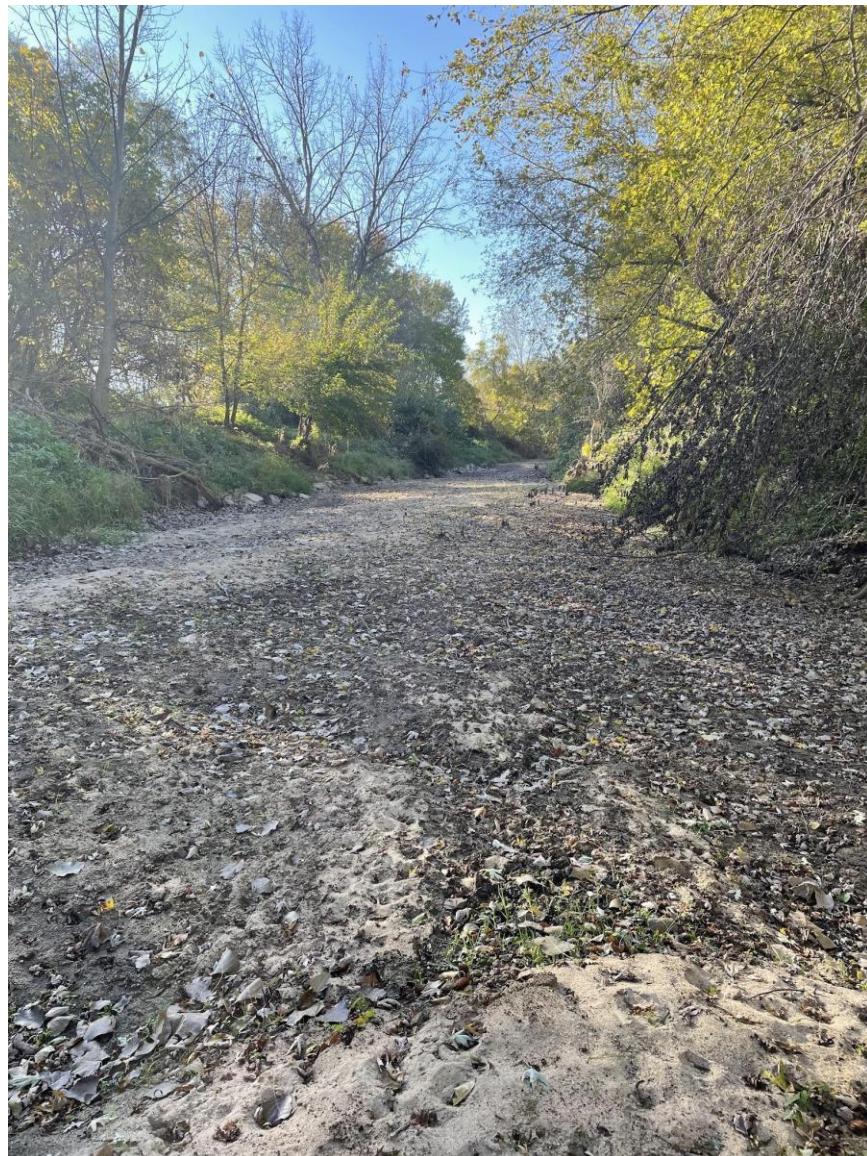
Figure 28. 614-2 Downstream recreation site looking downstream, supplemental visit.
