Use Attainability Analysis

1 Water Body Name	Devils Creek
2 Segment Description	Mouth to confluence with unnamed tributary
3 Segment Length (mi)	4.7
4 Drainage Area (sq. mi.)	21.2
5 Segment Start Latitude, Longitude (DD)	40.59936, -91.42498
6 Segment End Latitude, Longitude (DD)	40.64689, -91.40943
7 Route of Flow (Next Downstream Adopted Designated Use)	Devils Creek (General Use, General Use) to Devils Creek (A1, BWW2)
8 NPDES Facility and Permit Number (If Applicable)	Hidden Oak Estates (5600301)
9 Sample Site ID(s)	614-1, 614-1.5, 614-2
10 Segment County Name(s)	Lee
11 Field Work Date(s)	8/20/2007, supplemental visit 10/31/2025

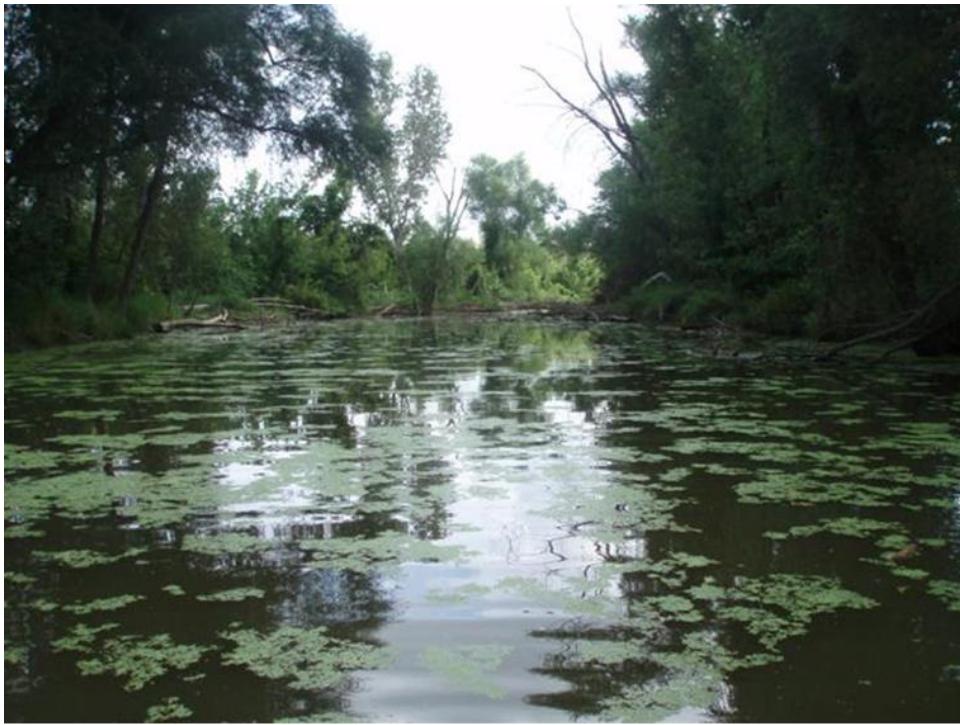
Figure 29. 614-2 Downstream recreation site looking downstream #2.

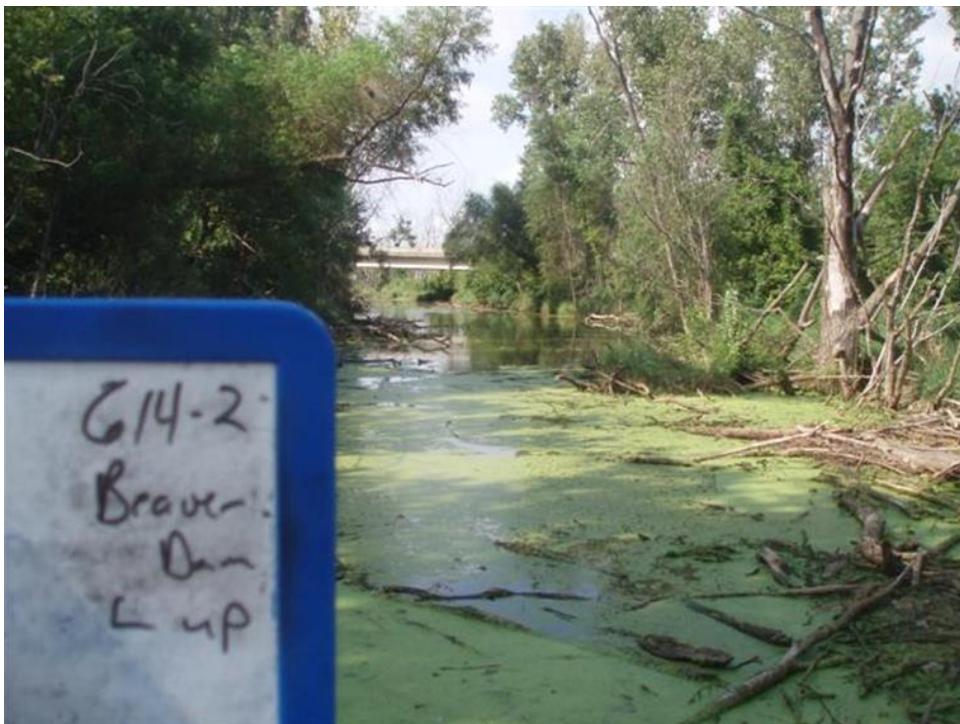
Due to the time that has elapsed since the initial fieldwork was conducted on 8/20/2007 a supplemental site visit was conducted on 10/31/2025. On that visit it was observed that the beaver dam that was creating the large pool no longer existed. The stream bed in that location was completely dry with no pools at all. The furthest upstream site (#614-3) had continuously flowing water.

Figure 30. 614-2 Beaver dam looking upstream.

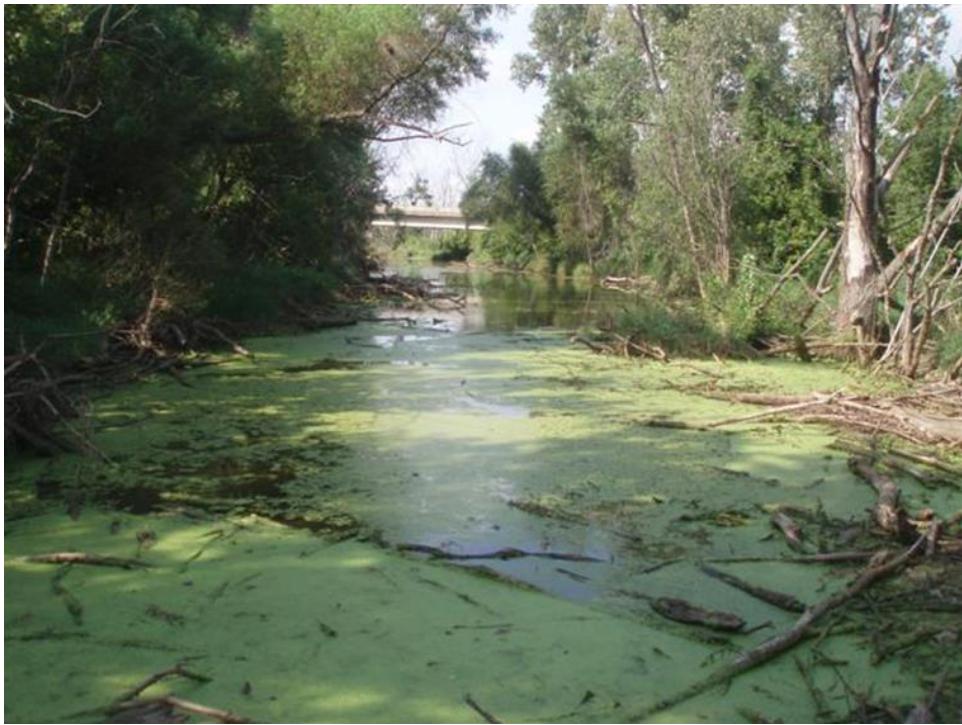
Figure 31. 614-2 Beaver dam looking upstream #2.

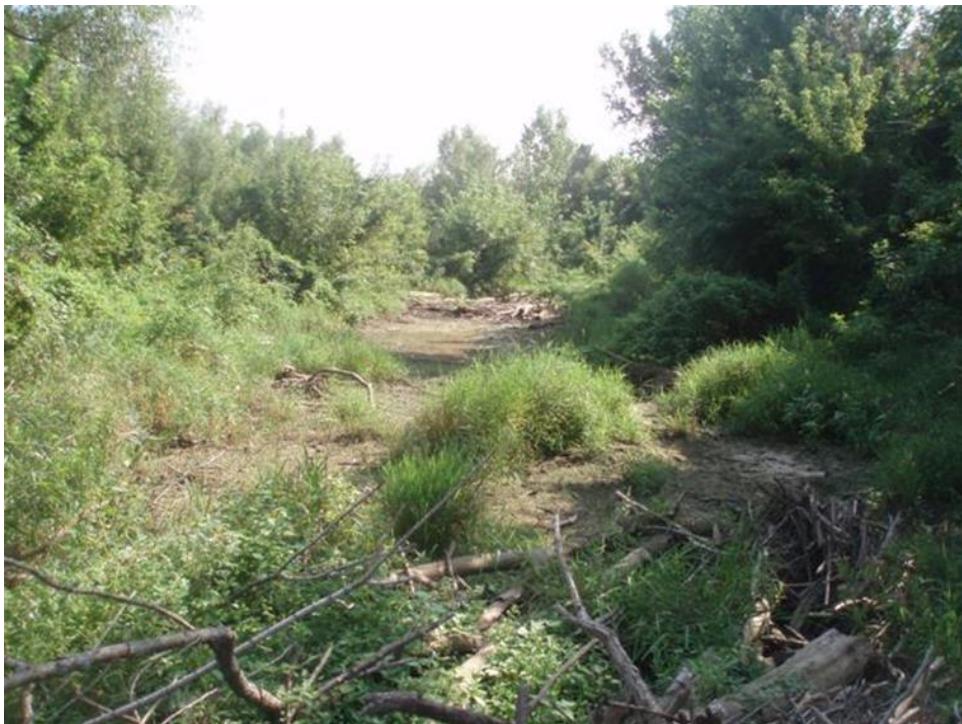
Figure 32. 614-2 Beaver dam looking downstream.

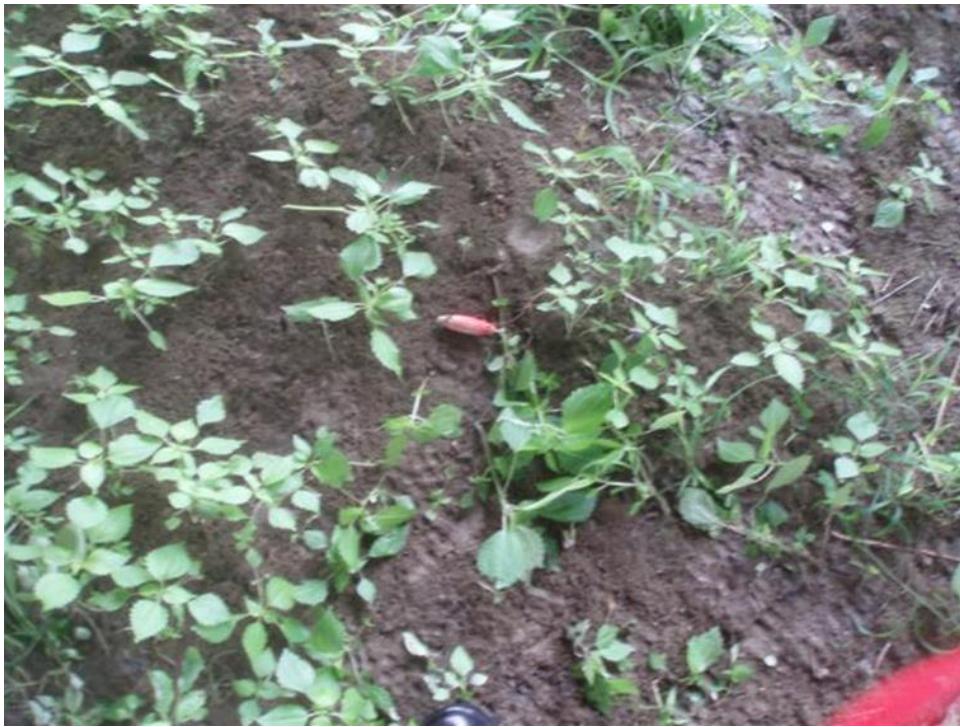
Use	Site parameter	Site ID #614-2
	25 Evidence of Use for Secondary Contact Recreation? (Yes*/No)	Yes. Graffiti and picnic table found under the bridge. There was a boat in the water upstream 600ft. Found hook and bobber and footprints under the bridge.
AL/R	26 Additional Description	No parking, no access. Water was backed up (likely dammed).

Figure 33. 614-2 Bobber present at the assessed location.

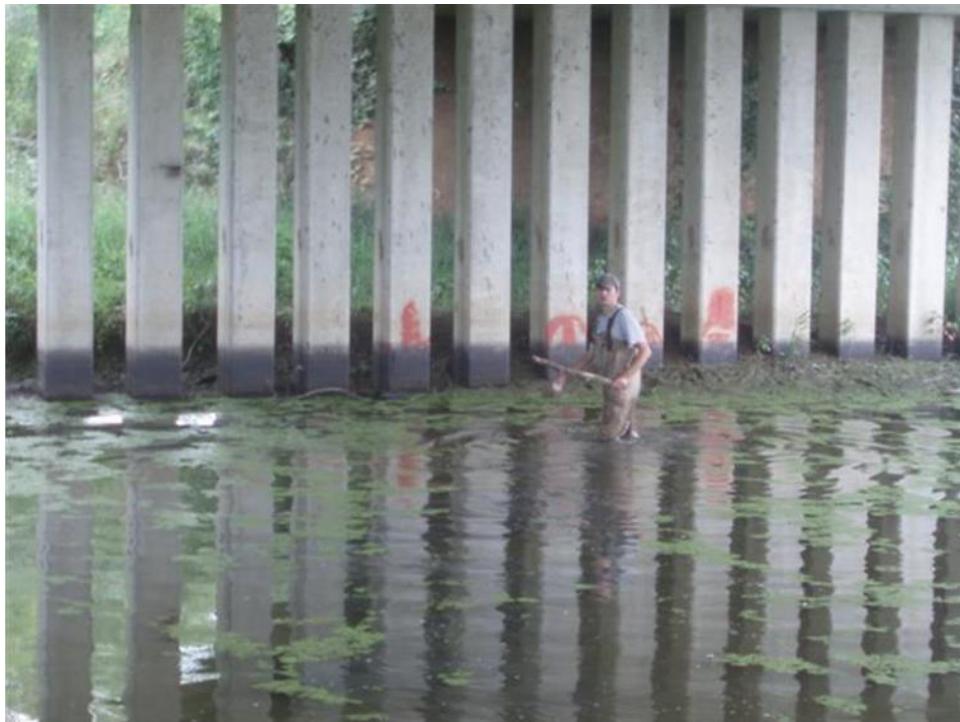
Figure 34. 614-2 Graffiti present under the bridge.

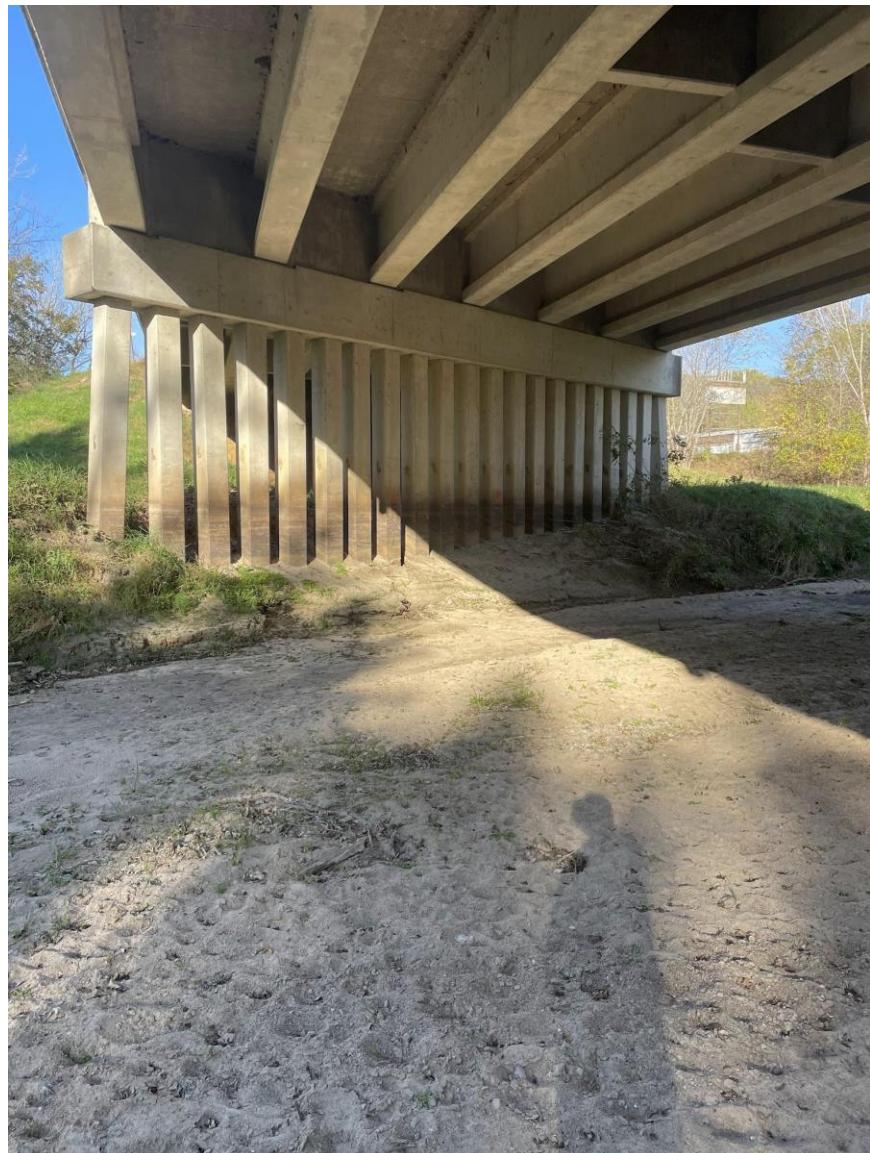
Figure 35. 614-2 Graffiti present under the bridge, supplemental visit.

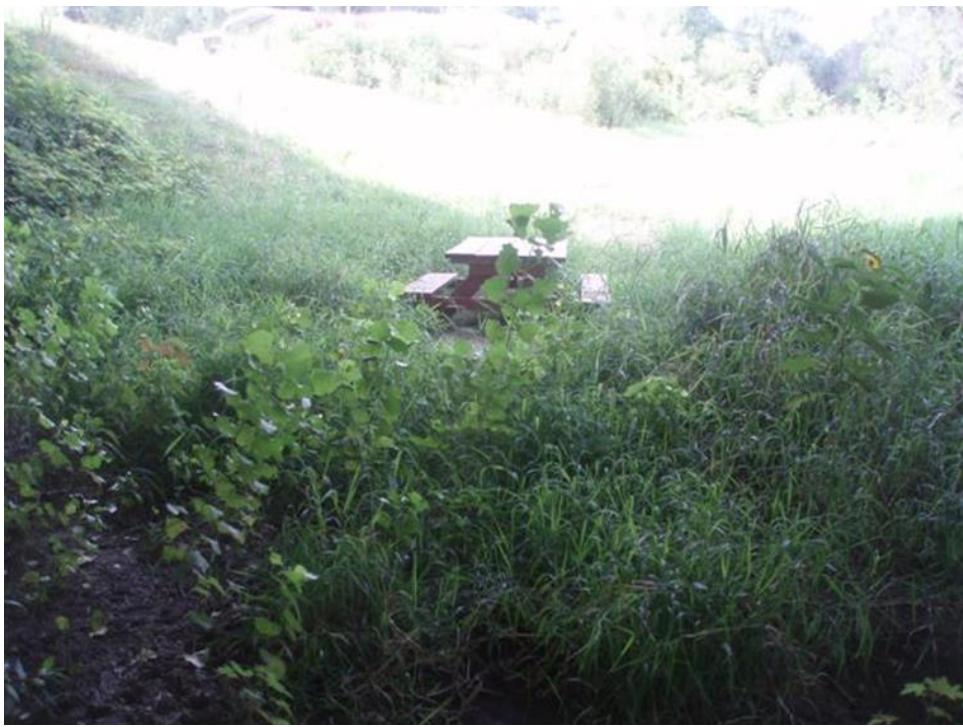
Figure 36. 614-2 Picnic table present at the assessed location.
