General Use Field Evaluation

NPDES Facility and Permit Number	Advanced Heat Treat Corporation - Waterloo (0790123)
NPDES Outfall Latitude, Longitude (Decimal Degrees)	42.53850, -92.35935
Water Body Name	Unnamed Tributary to Brinker Lake
Segment Description	Mouth to Advanced Heat Treat Corporation - Waterloo outfall
Segment Length (ft)	7463
Segment Start (Downstream) Latitude, Longitude (Decimal Degrees)	42.53079, -92.37844
Segment End (Upstream) Latitude, Longitude (Decimal Degrees)	42.53849, -92.35928
Number of Sites	4
County Name(s)	Black Hawk
Field Work Date(s)	9/24/2025

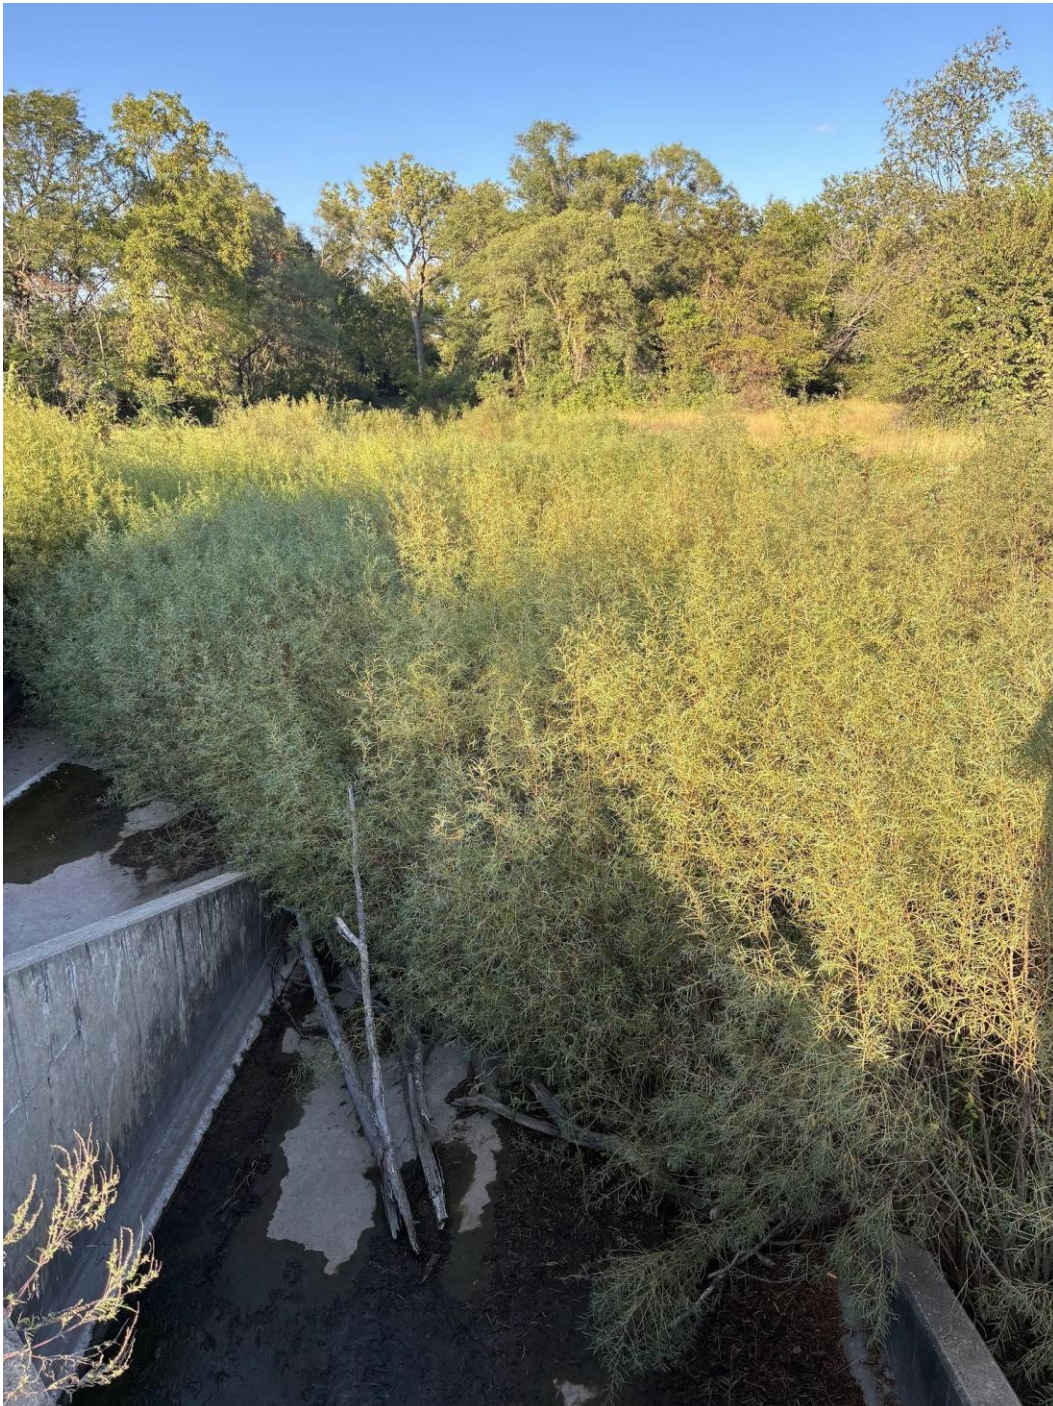
Description/location	42.53273, -92.37700
Water conditions	Some stagnant pools with no flow.
Average/max depths	Not measured
Aquatic life present	None observed
Unusual conditions	None
Channel description	Large drainage ditch.
Physical barriers/objects of significance	None
Human activity/evidence of recreation	None observed

Figure 1. Site #1 looking upstream.

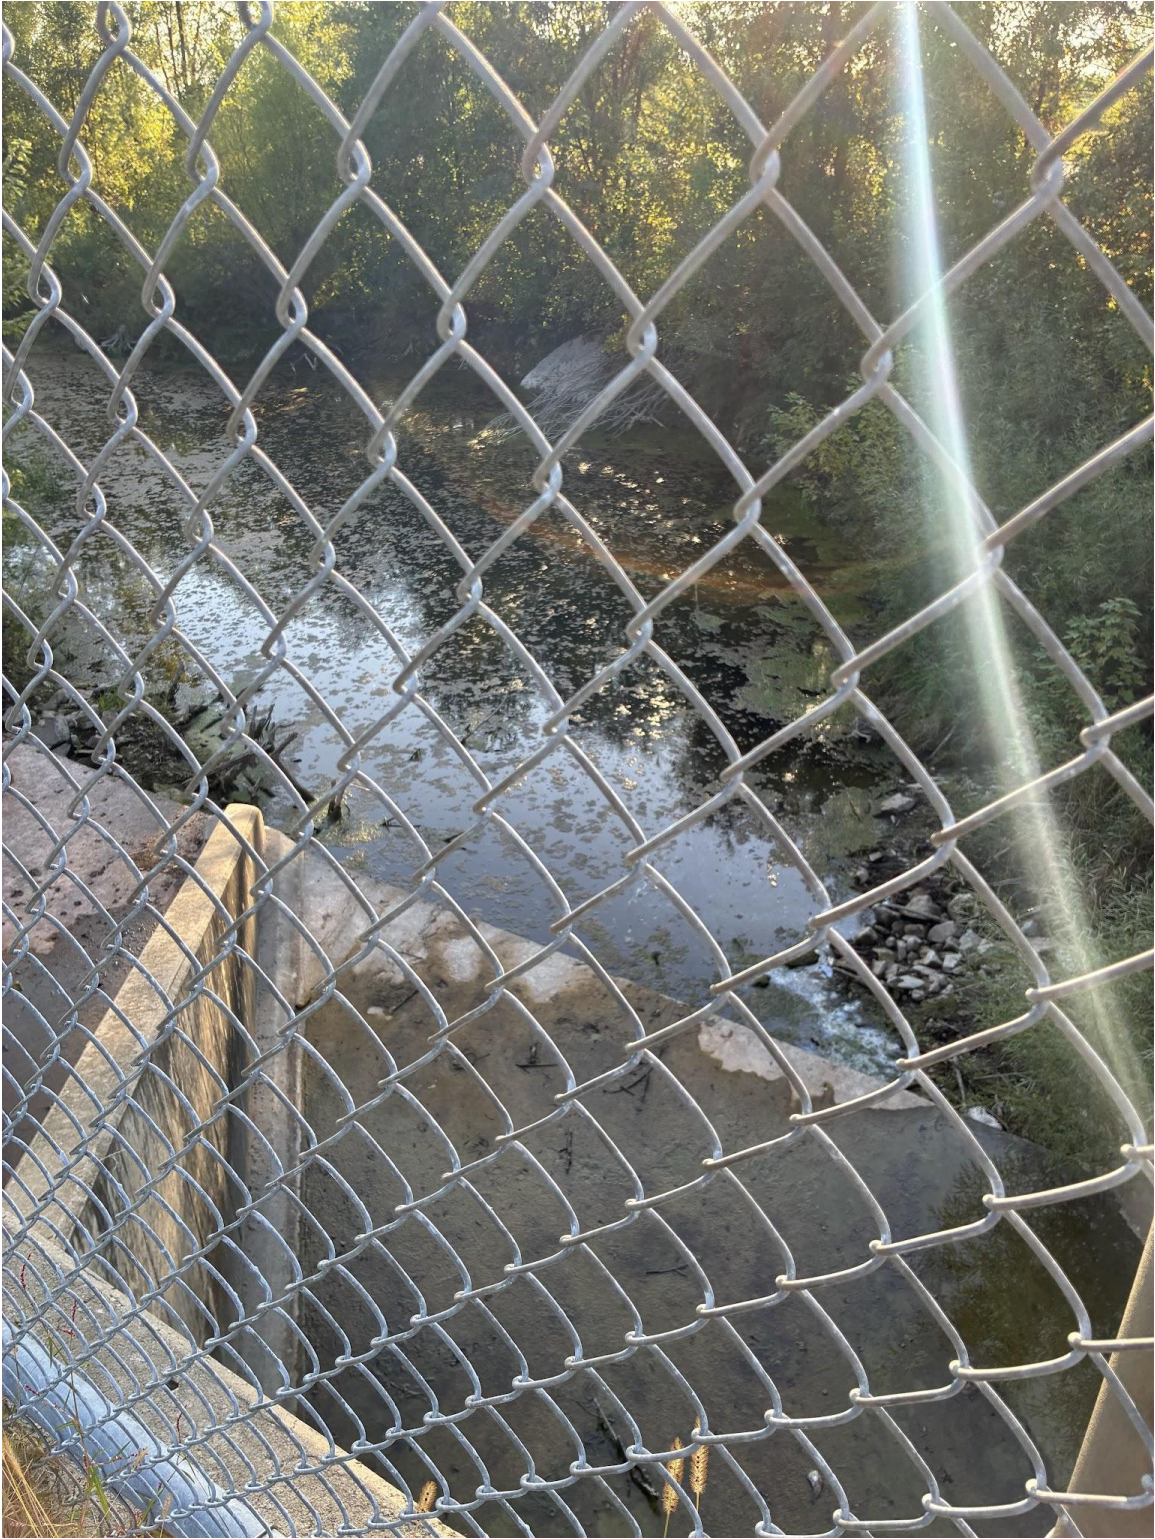
Figure 2. Site #1 looking downstream.

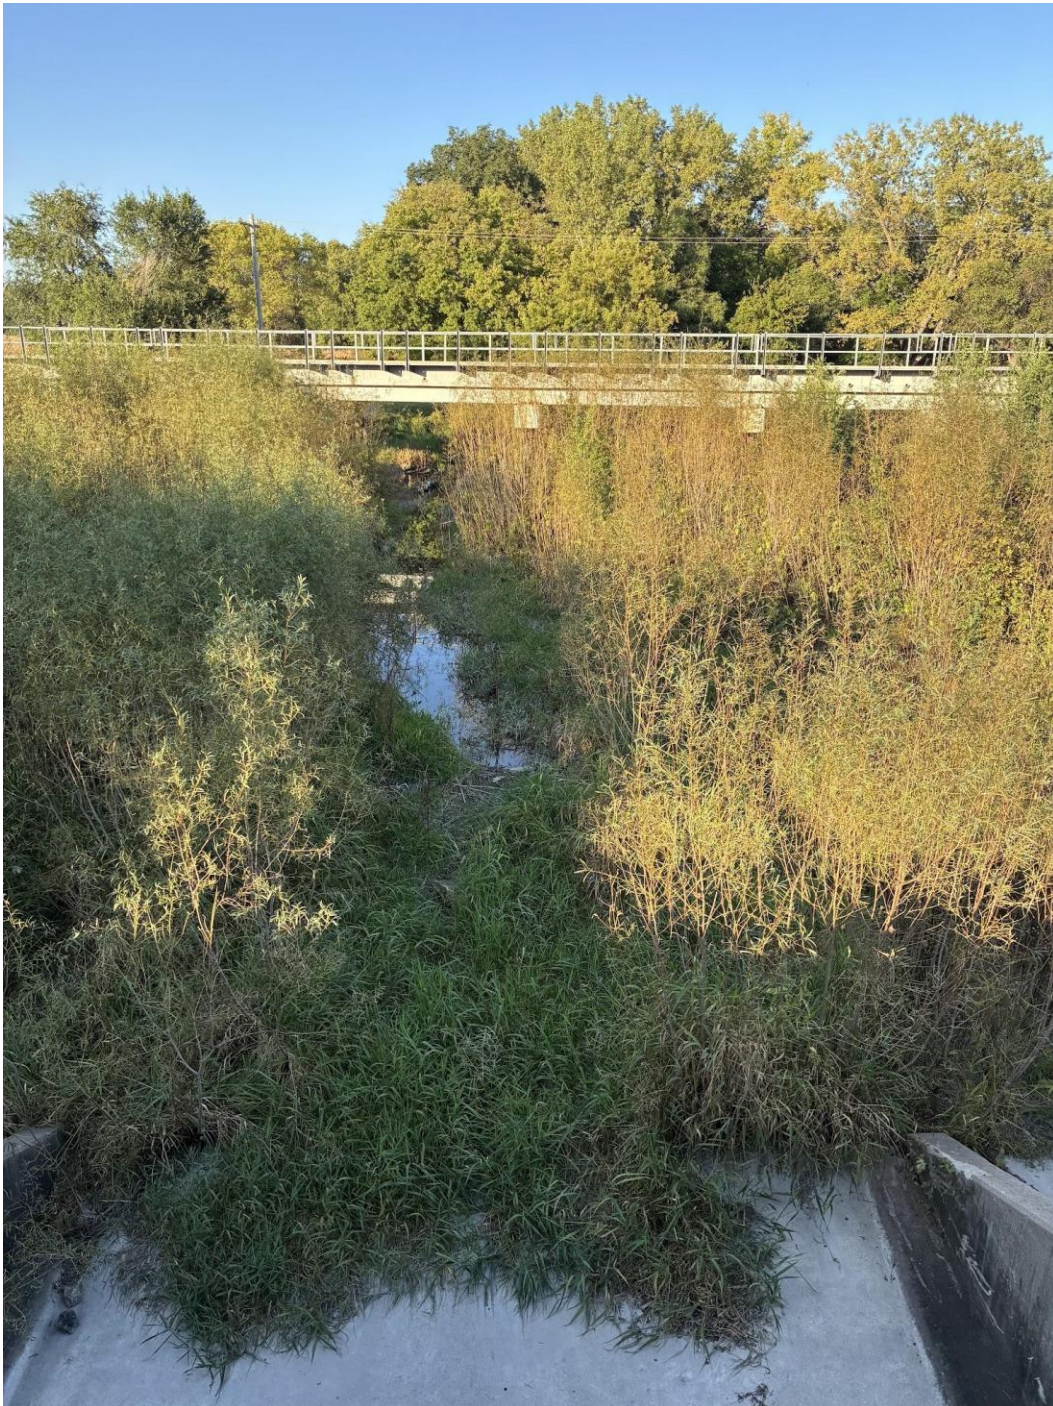
Description/location	42.53478, -92.37473
Water conditions	Some stagnant pools with no flow.
Average/max depths	Not measured
Aquatic life present	None observed
Unusual conditions	None
Channel description	Large drainage ditch.
Physical barriers/objects of significance	None
Human activity/evidence of recreation	None observed

Figure 3. Site #2 looking upstream.

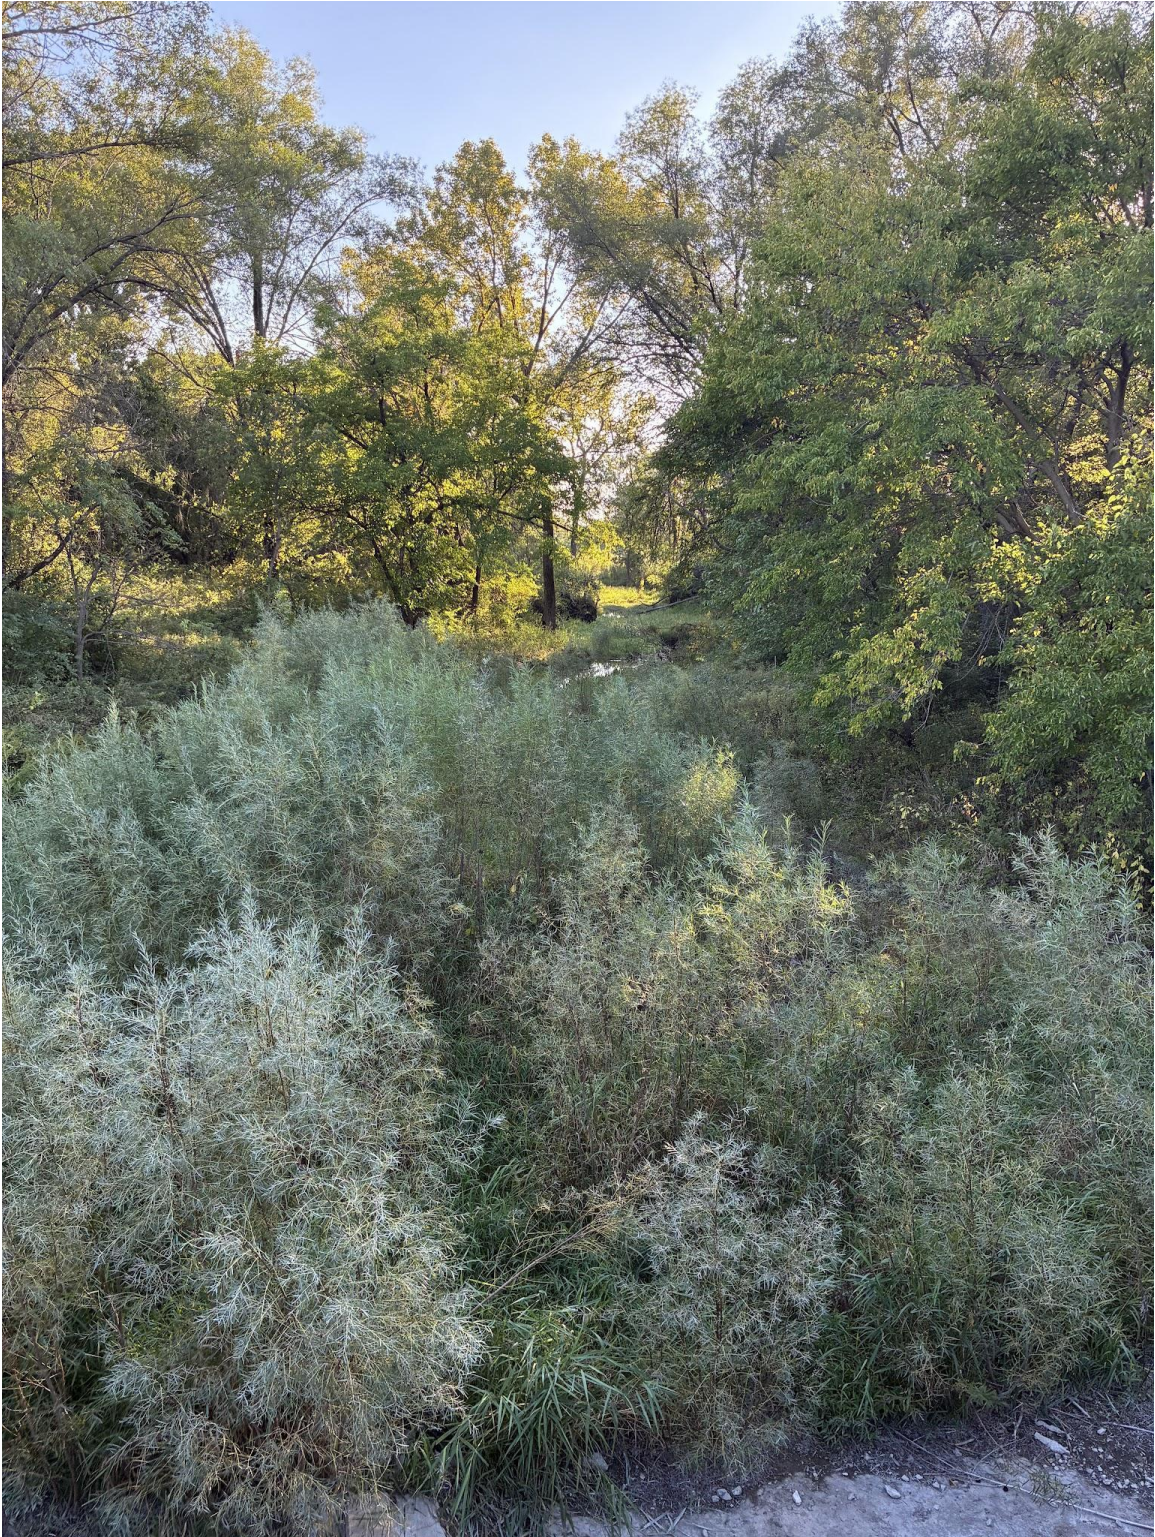
Figure 4. Site #2 looking downstream.

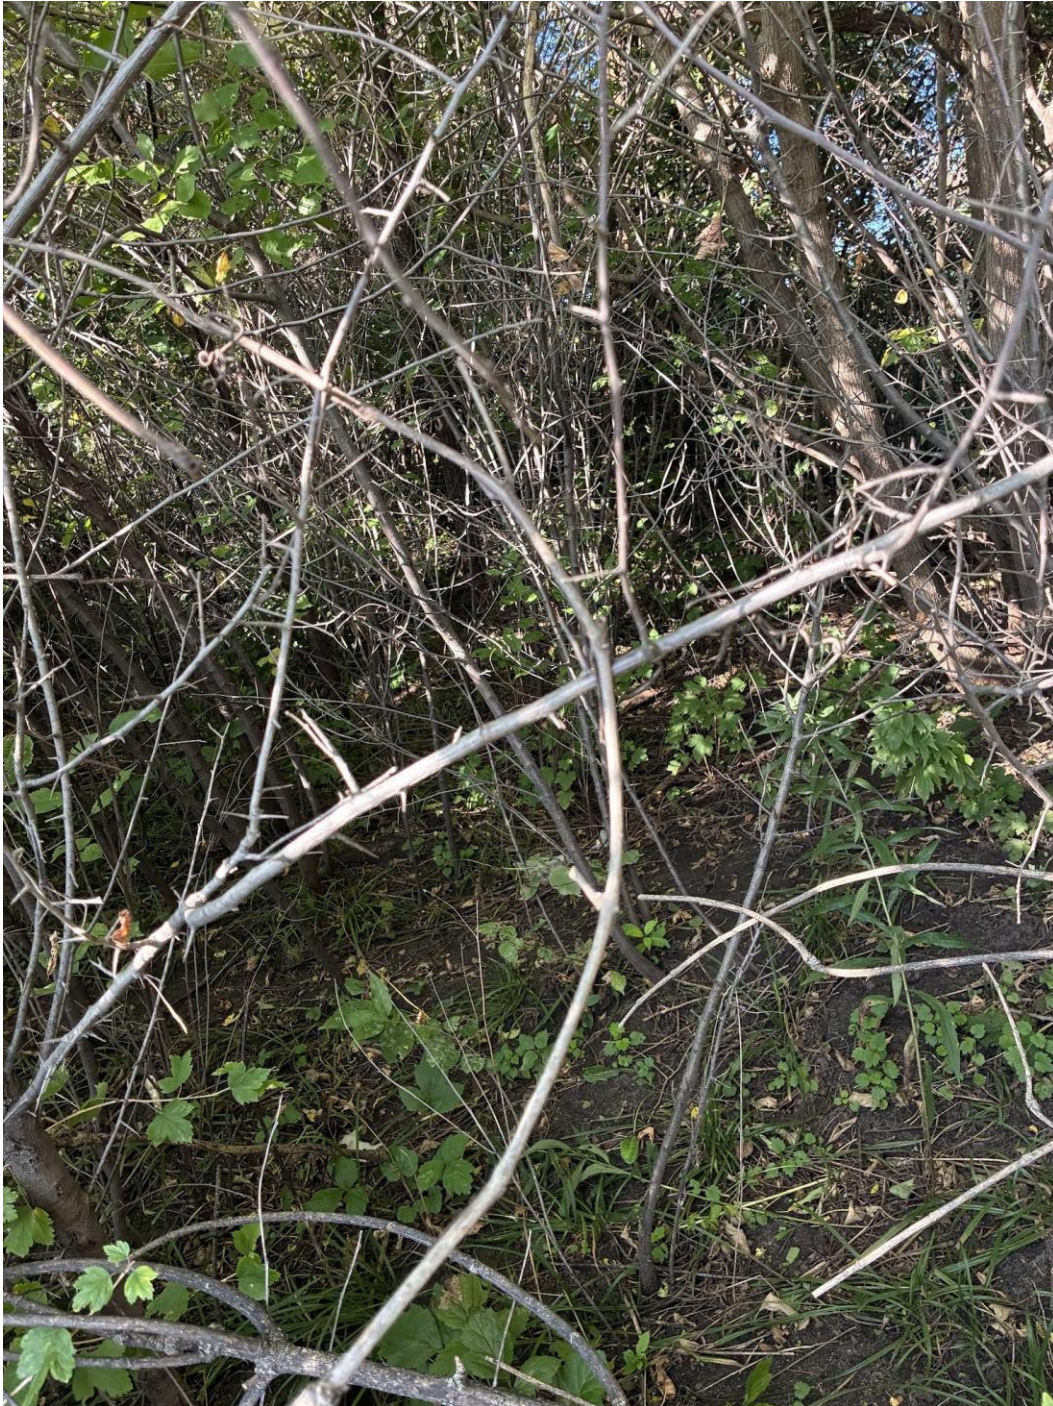
Description/location	42.53491, -92.36732
Water conditions	Dry channel.
Average/max depths	Not measured
Aquatic life present	None observed
Unusual conditions	None
Channel description	Large drainage ditch.
Physical barriers/objects of significance	None
Human activity/evidence of recreation	None observed

Figure 5. Site #3 looking upstream.

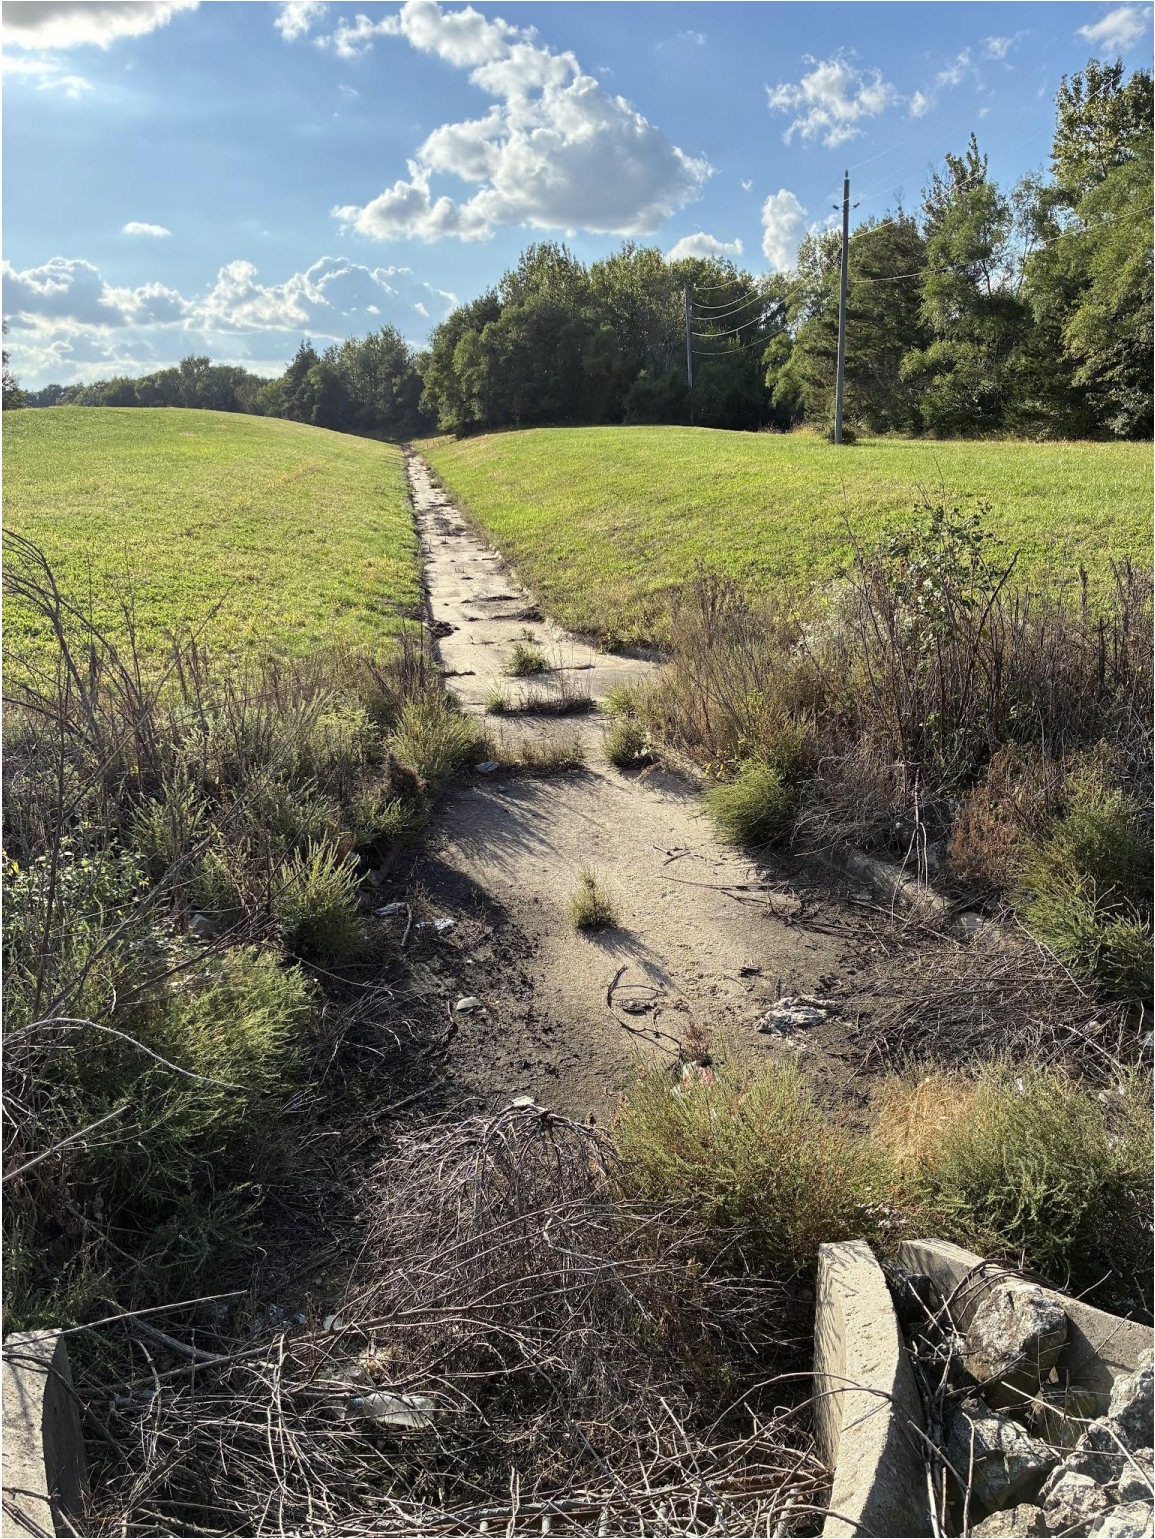
Figure 6. Site #3 looking downstream.

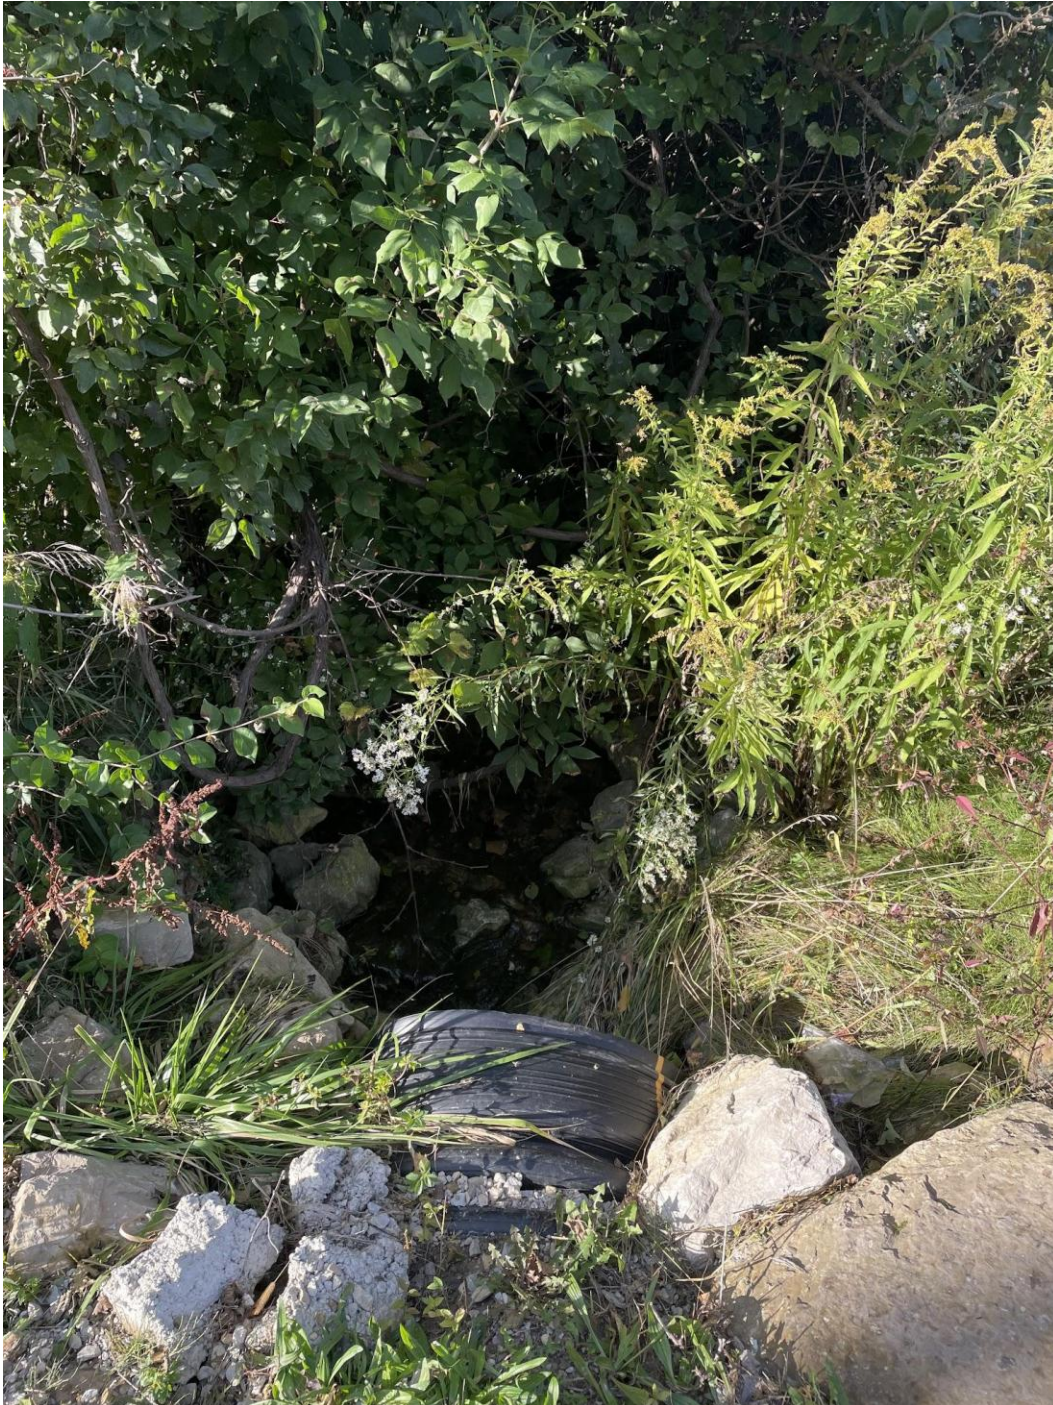
Description/location	42.53850, -92.35935 Outfall
Water conditions	Cooling water was being discharged at the time of the visit.
Average/max depths	Not measured
Aquatic life present	None observed
Unusual conditions	None
Channel description	Large drainage ditch.
Physical barriers/objects of significance	None
Human activity/evidence of recreation	None observed

Figure 7. Site #4 looking upstream at outfall.

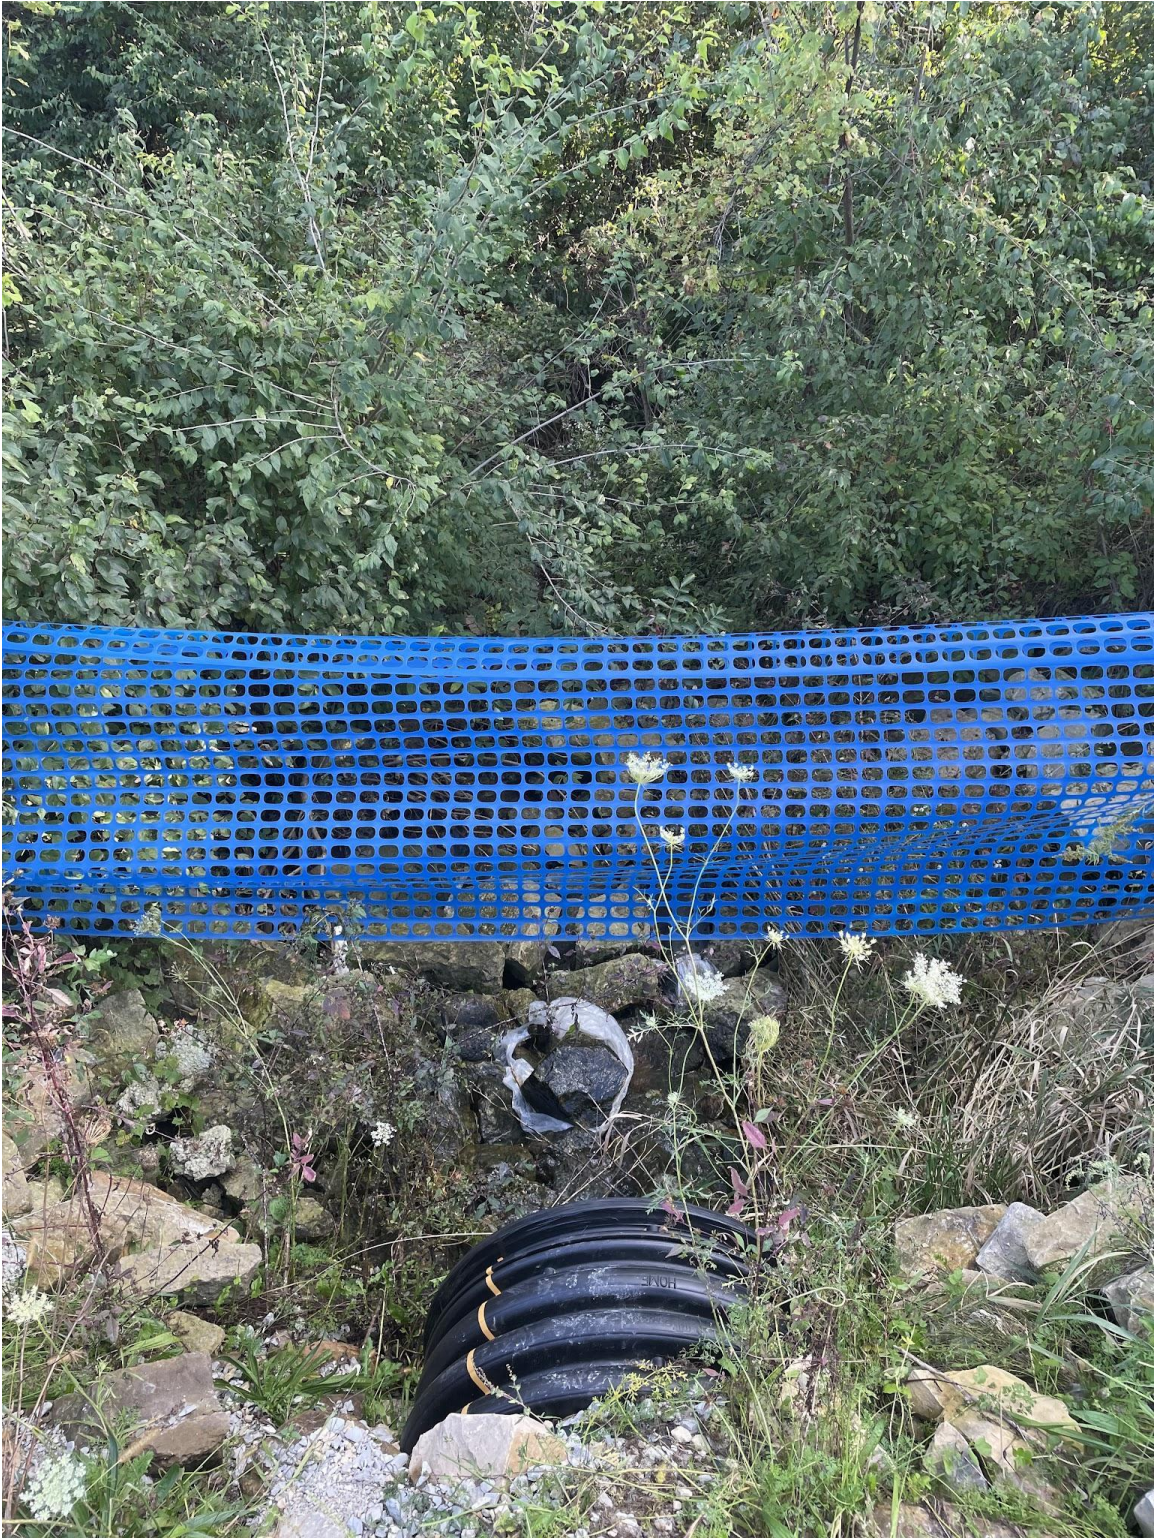
Figure 8. Site #4 looking downstream.
