# Delhi Dam and Head Cut Update

October 14, 2010

## **Stopping the Delhi Head Cut Up the Lake Bed**

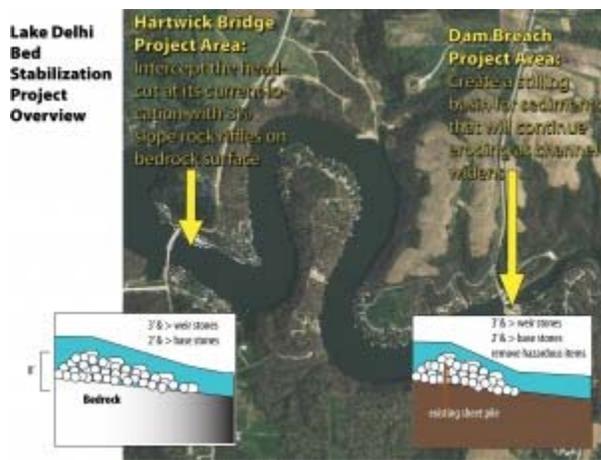
*Delhi Dam breach area for stabilization*

The plan is to create a temporary 6' to 8' rock riffle downstream of Hartwick Bridge. In addition, the streambed will be stabilized in the vicinity of the dam breach.

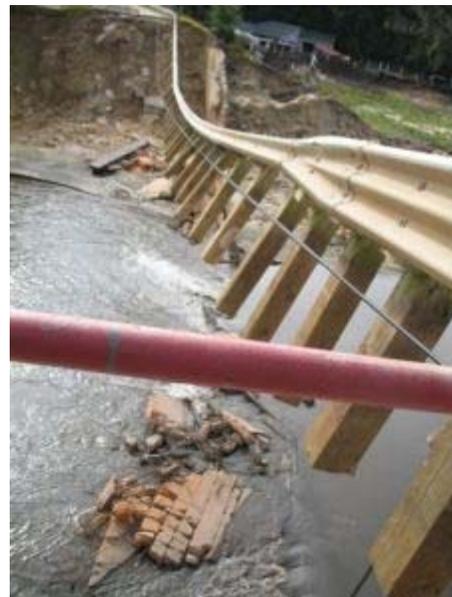
*Breach area for stabilization and clean up*

In-water rock structures are being placed across the river channel at two points to slow down the rate of erosion taking place. Clean up of debris near the dam breach will be done because of safety concerns associated with river navigation. Aerial surveys are being taken of the river channel and former lake bed. This information will assist in helping determine how the channel and lake bed are changing over time

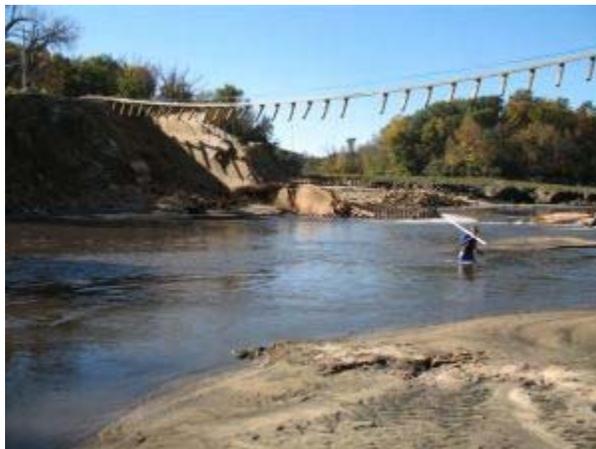
*Head cut on September 17th #1*

The DNR rivers team has been managing the effort, in cooperation with DNR engineering and NRCS, to survey the ongoing head cut through the former lake bed and develop a plan to halt ongoing damage. Nearing the county road X29 bridge, the head cut is now more than 10,000 feet upstream of the dam. The head cut alone has contributed more than 200,000 cubic yards of new sediments to the Maquoketa River downstream, and may threaten road infrastructure upstream. The silt has been reported to fill formerly deep pools — important habitat for aquatic species.

When a river channel bed is abruptly lowered or a dam breaches, the upstream riverbed is perched higher than the lower riverbed. In the case of the head cut at Lake Delhi on the Maquoketa River, the lake bed had accumulated decades of fine silt since 1929 when the dam was constructed. After the dam breached, a pour-over that initially looked like a waterfall formed. The force from this waterfall immediately began to tear up the channel and move farther and farther upstream. Until a head cut makes its way through all sediments and reaches equilibrium, it will not stop. Each day the head cut goes unchecked, it churns up sediment and creates new gullies adding even further to the sediment load and the fix becomes more expensive.

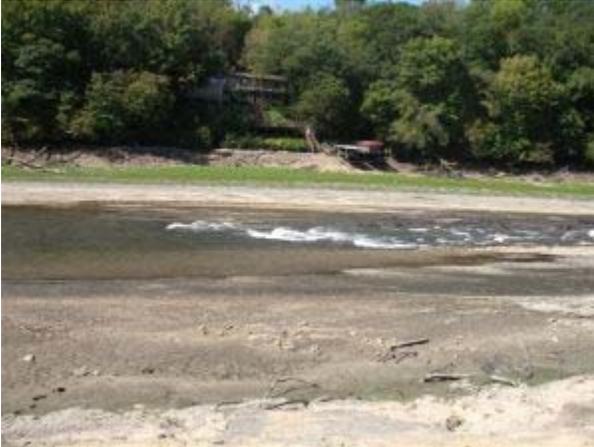
*Head cut on September 17th #2*

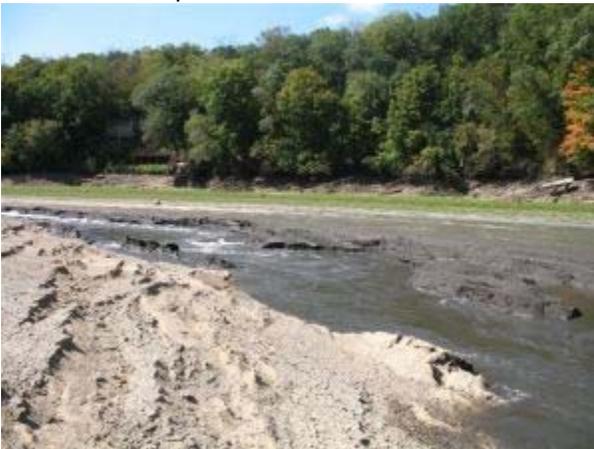
*Riffle at bend, October 5th*

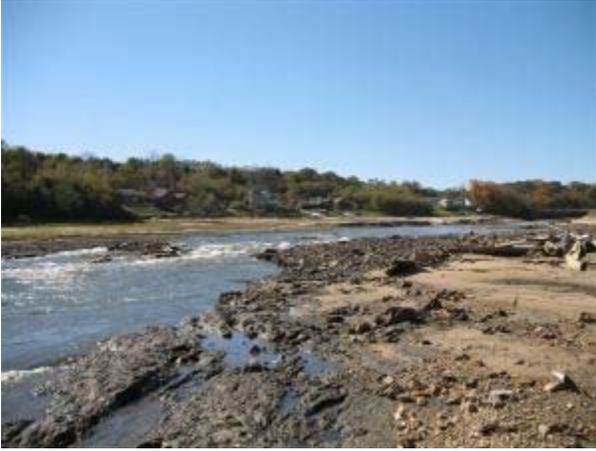
*Riffle near Hartwick Point, September 17th*
