# Muchakinock Creek

*Improving water quality for the future*

# A living history: Creating a new future for Muchakinock Creek

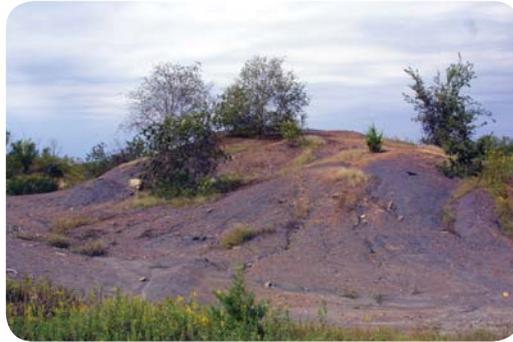
**A former mining site, located south of Oskaloosa in the Muchakinock watershed. Sediment and acid drainage from abandoned mines hurt the creek's water quality.**

Acid drainage and sediment from the mines continue to pollute Muchakinock Creek today. Two former mine sites cover 135 acres and send an estimated 6,300 tons of sediment to the stream every year. Another 90-acre site delivers an estimated 2,800 tons of sediment annually. These three sites are located within two miles of the creek and all have tributaries of the creek running through them.

To reduce sediment delivery and acid mine drainage, the bare pile slopes left after the mining process will be reduced and seeded with vegetation. The new vegetation and shorter slopes will help reduce erosion and neutralize the soil, reducing acid mine drainage.

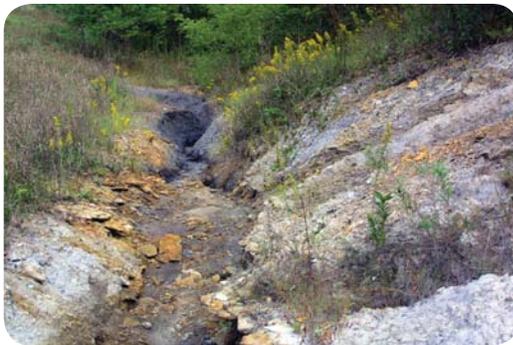
**A former mining site north of Eddyville sends sediment and shale into Muchakinock Creek.**

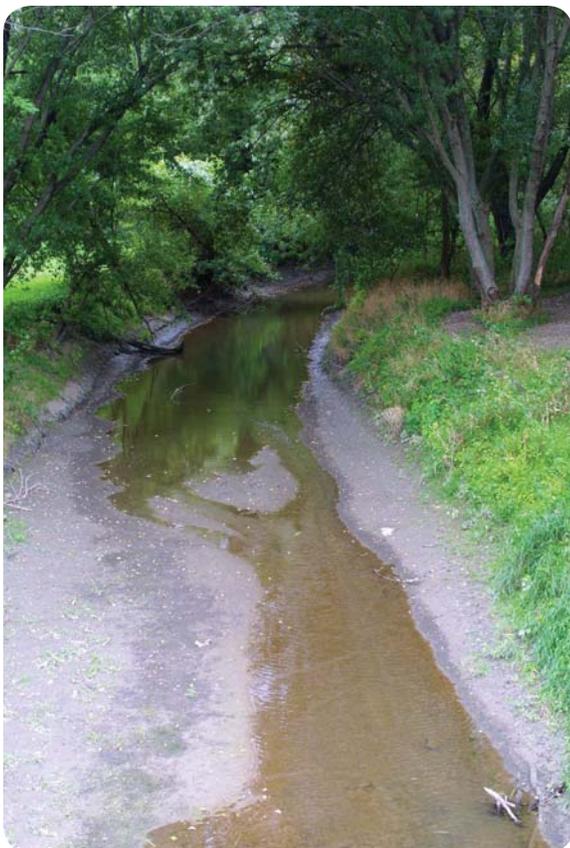
**Sediment fills in the streambed of Muchakinock Creek. Erosion throughout the watershed sends excess sediment to the creek, causing a number of problems.**

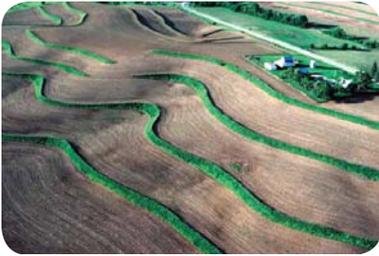
## Terraces

Terraces are embankments built around a hillside, usually on the contour. Terraces either slow runoff and guide it to the bottom of the hill, or collect runoff and store it until the runoff can be absorbed by the ground. Approximately 34,000 feet of terraces are planned for the Muchakinock Creek watershed.

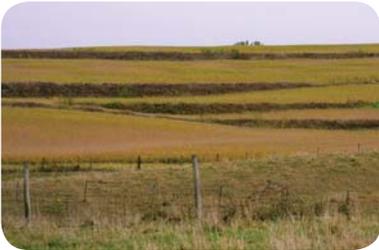
## Water and sediment control basins

While they work in a similar way, these basins work where terraces might not. Water and sediment control basins are embankments, located in areas with concentrated runoff. The basins trap runoff water and sediment before they can reach a stream. There are 189 basins planned for the Muchakinock watershed project.

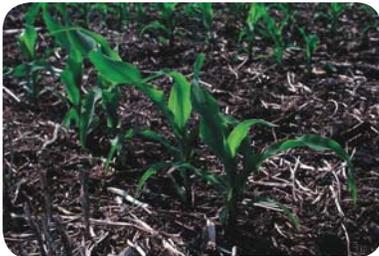
## Conservation tillage

Conservation tillage uses last year's crop residue to provide ground cover, protecting against soil erosion from wind and water. Minimum tillage is already used in the watershed on some corn and soybean fields. No-till methods are used on approximately one-third of cropped fields, and soybeans currently are the preferred crop to use no-till methods on in the watershed. Conservation tillage will be encouraged along with other practices in the watershed.

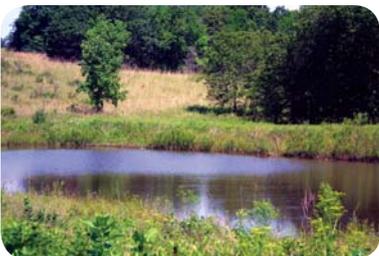
## Grade stabilization structures

A grade stabilization structure is usually a dam, embankment or other structure that reduces water flow. The structures are built across a grass waterway or other gully erosion control to slow water. About 10 structures are planned for the Muchakinock Creek watershed.

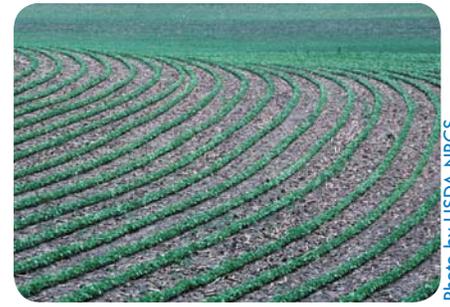
## Contouring

Contour farming, or planting rows around hills rather than up and down hills, reduces erosion from water runoff and conserves soil and water resources.

Farming straight up and down hills can greatly increase soil erosion, while contour farming helps reduce runoff by absorbing more water into the soil rather than allowing it to run off. Contouring prevents gullies from forming and conserves soil.

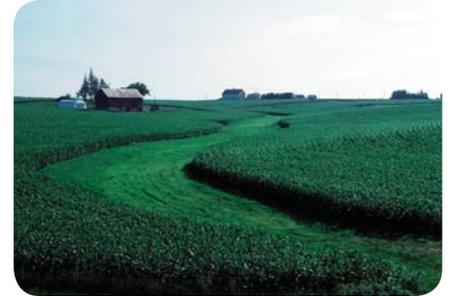
## Grassed waterways

Grassed waterways are shaped and placed in areas with concentrated water flow to slow water, guide it off the field and reduce gully erosion. Grassed waterways help disperse water, preventing small streams from forming. They can also trap nutrients and sediment.

The Muchakinock Creek watershed project plans to install 15 acres of grassed waterways in the watershed.

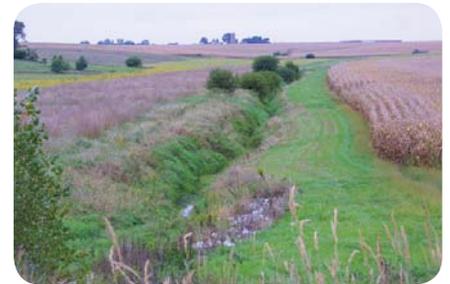
## Conservation buffers

Conservation buffers slow sediment and filter runoff water before it reaches a stream. In addition, buffers reduce erosion from wind and provide habitat for wildlife. The Muchakinock Creek watershed project plans to install 120 acres of conservation buffers.

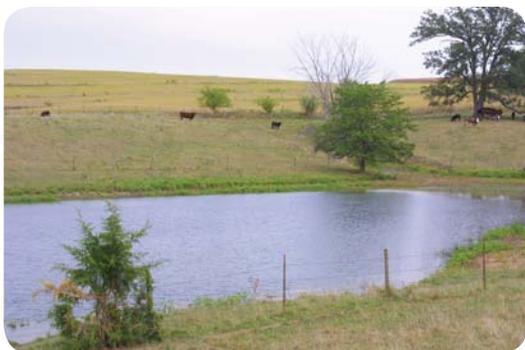
**Jerry Bruxvoort's pond catches excess sediment from nearby farm fields and abandoned mines.**
