CONNOR LIVENGOOD

BURKE MARKETING CORPORATION - HORMEL FOODS

PROJECT BACKGROUND

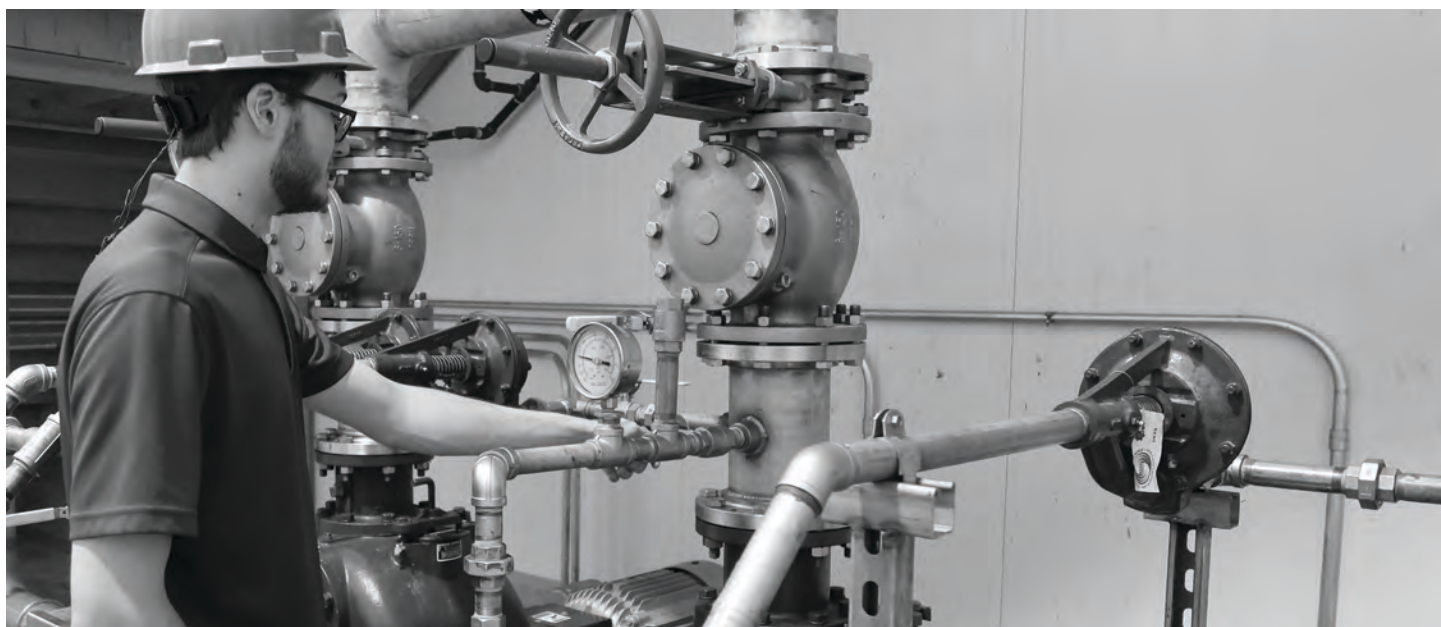
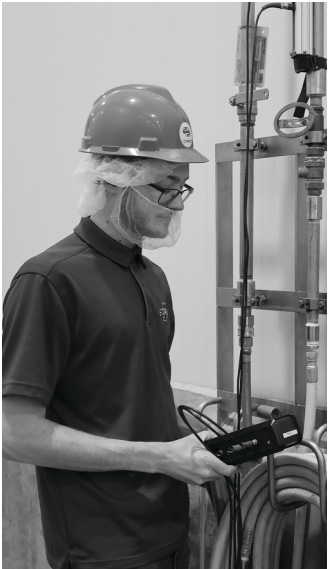
Piping Insulation: A heat exchanger uses steam to reheat a grease water solution to a desired temperature, keeping the grease from solidifying before it is separated from the water and made into a by-product. A long pipe run transports the grease water from the cooking process to the heat exchanger. The ambient air along the uninsulated pipe run causes the grease water to slowly lose temperature so that it requires reheating. Adding insulation to the pipe would help maintain the temperature of the grease water and increase flow efficiency through the pipe. A one-inch insulation thickness was recommended by the vendor based on insulation efficiency ratings and the cost of diminishing returns. This recommendation is also based on the building management system and data from temperature readings on the production floor. By insulating the pipe run, less steam

would need to be produced by the boilers feeding the heat exchanger, reducing both water and natural gas usage. The insulation could be installed with no effect to the production schedule. Once approved for funding, the company could begin installing the piping insulation.
