V. FIELD INVESTIGATIONS

A. PHASE I RECONNAISSANCE

On September 28-30, 2011, LBG conducted Phase I reconnaissance surveys for selected portions of the study area (Figures 9a-9c). The field survey was performed by the author with assistance from Field Archaeologist Sam Williams and was designed to inspect landforms considered to have high potential for unreported archaeological sites. The survey also gathered information on the nature of valley landforms and local geology, patterns of land use and landscape/shoreline modification, and the nature and extent of damage to valley landforms and archaeological resources caused by catastrophic flooding. LBG was given access to the entire study area but was instructed to respect private property beyond the lake shoreline. Public roads and boat ramps provided preferred access points to the lakebed although LBG also gained access to portions of the study area via private property with the consent of local landowners. Public road access was limited to the valley crossings at 220th Avenue, the Turtle Creek Recreation Area along 267th Street, and County Road X31 (which of course remained closed at the Delhi Dam). Boat ramp access was utilized a

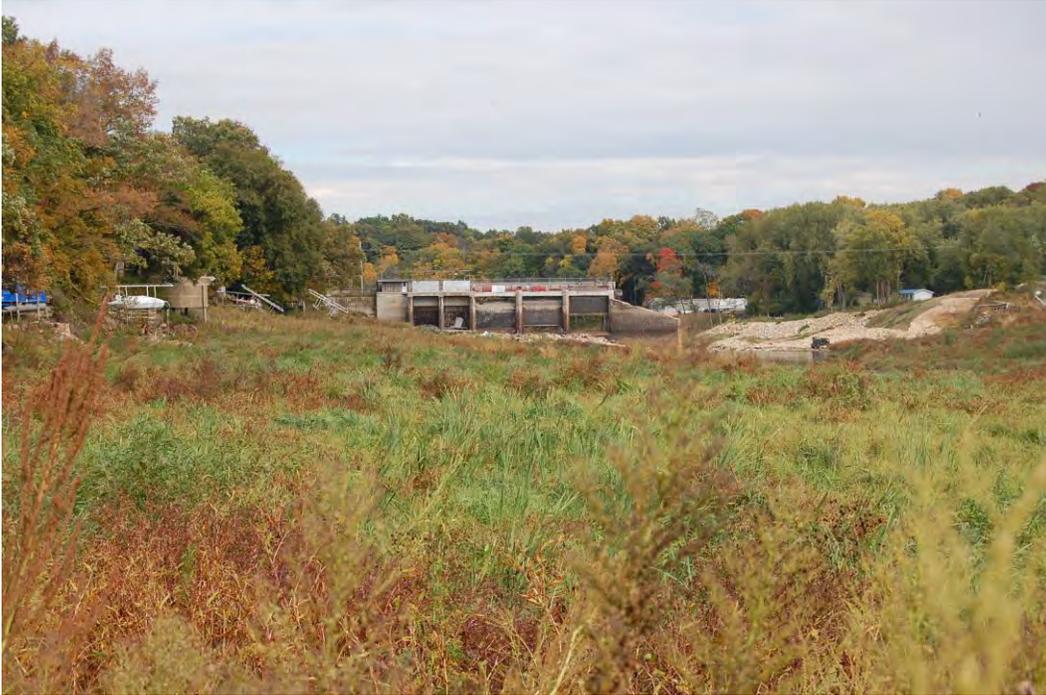
Plate 8. Vegetation Obscures the Lakebed Above Delhi Dam. View downstream.

Photos taken shortly after the July 24, 2010 breach event at Lake Delhi show a largely barren landscape of sand and mud littered with boat cradles, boat docks and other debris. The survey described here was performed about 14 months after the event and during the interim nature did its best to reclaim the exposed lakebed. Most low-lying areas within the drained valley were blanketed with a thick layer of silt that represented fertile ground for pioneering weedy plants. At the time of our survey, these locations were completely covered with a thick tangled growth of weedy vegetation about three to four feet tall. Higher terraces tended to have less vegetation, partly because they were covered by less fertile sand deposits but also because some landowners were making efforts to cut it back where possible. Even so, all but the most sandy land surfaces were also becoming overgrown by vegetation (Plates 8-13).

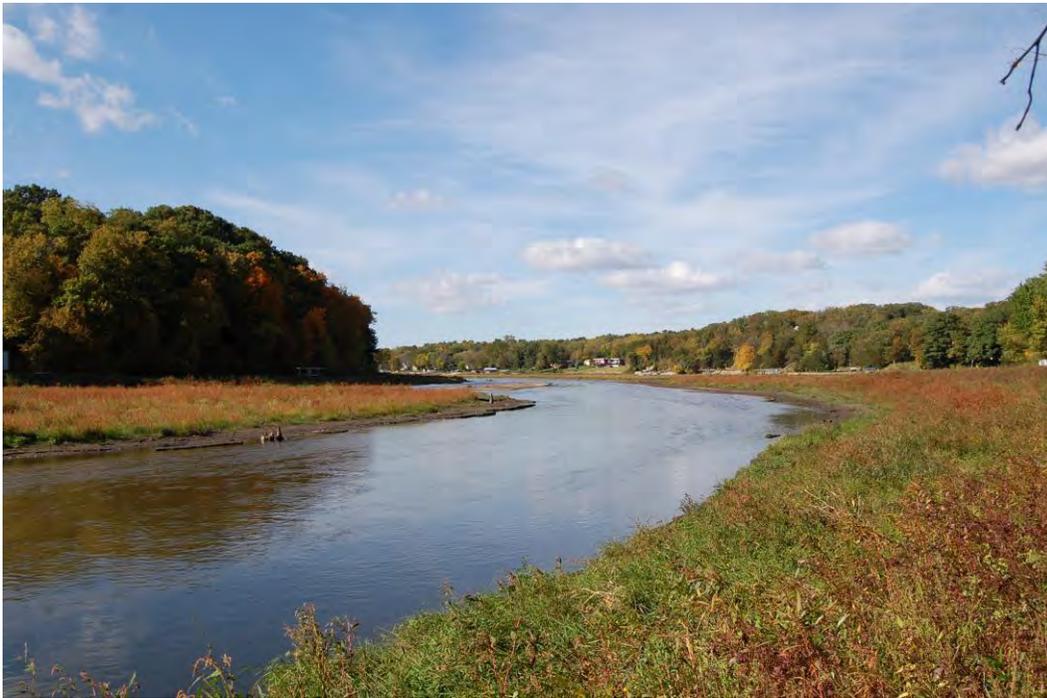
Plate 13. View looking upstream toward the Cedars.

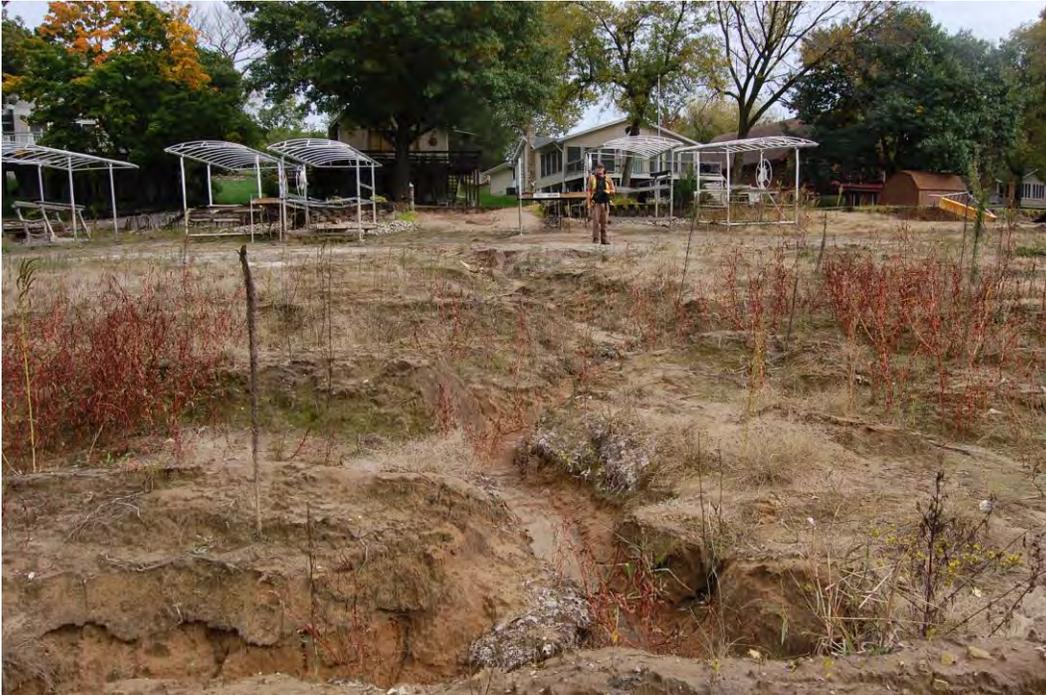
Plate 14. Gullies formed by storm water runoff near Hickory Hollow

Sheet erosion along with rill and gully erosion is also developing on many of the high terrace slopes from a point beginning about one-half mile above the Hartwick bridge downstream to the Delhi Dam (Plates 14, 15). The damage is caused by normal rainfall and sheet erosion on unprotected surfaces, but the problem is also exacerbated or amplified in many places by stormwater runoff from nearby homes and other developments above the shoreline. In many places, stormwater that was once diverted by drain tile or landscaping directly into the lake is now being drained onto the surface of the exposed terrace landforms. In places where this surface is unprotected, we observed many rills and large gullies developing along the terrace edge. In several places we found gullies like these cutting through what appear to be potentially significant archaeological deposits (e.g., Site 13DW133).

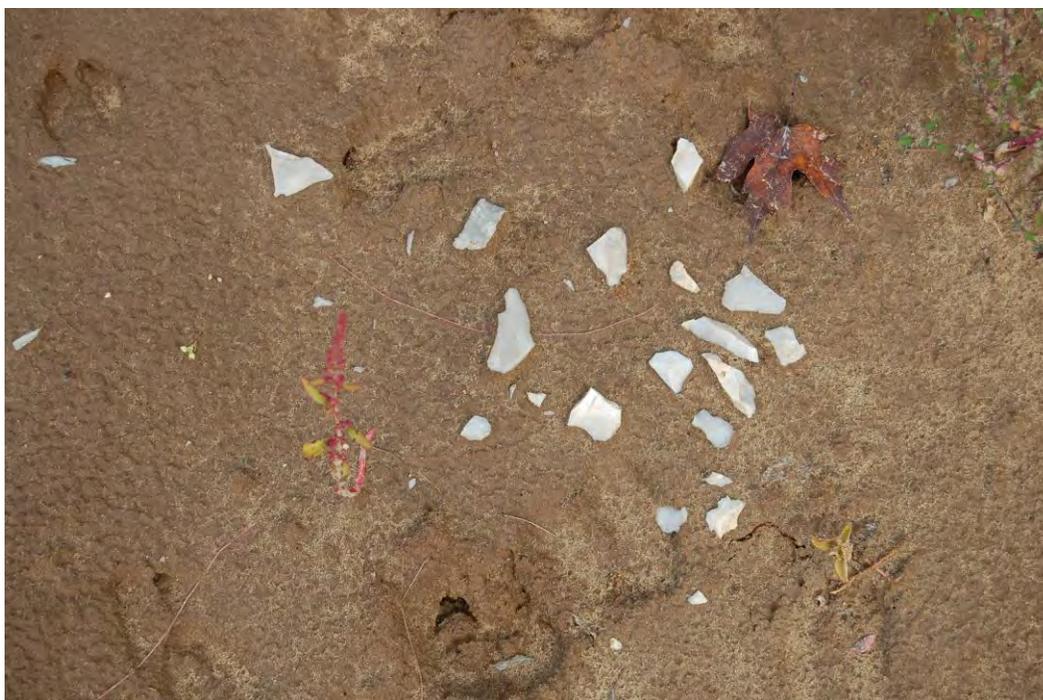
Plate 16. Chipped-Stone Artifacts Exposed on the Eroded Surface of Site 13DW124.

LBG did not collect any additional material from the surface of the site but observed several concentrations of chipped-stone artifacts exposed on the ground surface extending as much as 50 meters north of the site boundary reported by WVA. In each instance, the artifacts appeared to be in-situ and were pedestaled on otherwise eroded subsoil (B horizon) deposits (Plate 16). No modified specimens, tools, or other temporally diagnostic artifacts were observed at the site. Other downstream portions of the site appeared to have experienced less sheet erosion and still retained what appeared to be an intact A horizon; however, surface erosion has progressed to the point where rills and gullies have developed through these deposits, in some places well into subsoil.

No subsurface tests have been excavated at the site which is believed likely to extend above the shoreline onto the adjacent terrace. The site remains unevaluated for listing in the NRHP. Based on the field observations summarized above, LBG recommends that additional archaeological investigations be

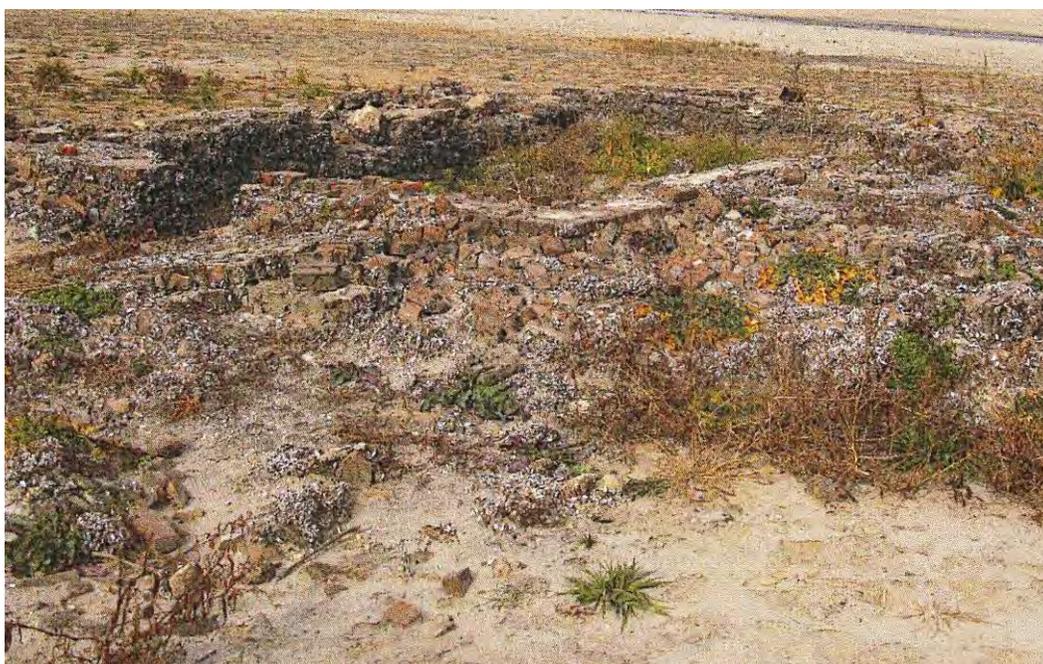
Plate 17. Exposed Building Foundation at 13DW125. (Reproduced from Finn and Morrow 2010).

Site 13DW125 was identified by WVA in the fall of 2010 based on the discovery of a square stone-foundation with brick-wall superstructure. The foundation appeared to have been exposed by floodwaters that scoured overlying sediments from the area. The stone foundation was constructed with cut blocks of

local dolomite and measured approximately six meters by six meters in size. A substantial number of bricks interpreted to be collapsed walls were observed on all sides of the foundation. A small cast-iron stove was observed inside the structure, but no other associated artifacts were observed around the building. WVA speculated that archaeological deposits outside the building foundation were likely removed by floodwaters but that some deposits may still exist within the interior.

LBG did not reinvestigate this site and the site remains unevaluated for listing in the NRHP. Based on the observations recorded by WVA, LBG recommends that additional archaeological investigations be conducted to more fully define the nature and extent of the archaeological deposits present at 13DW125.

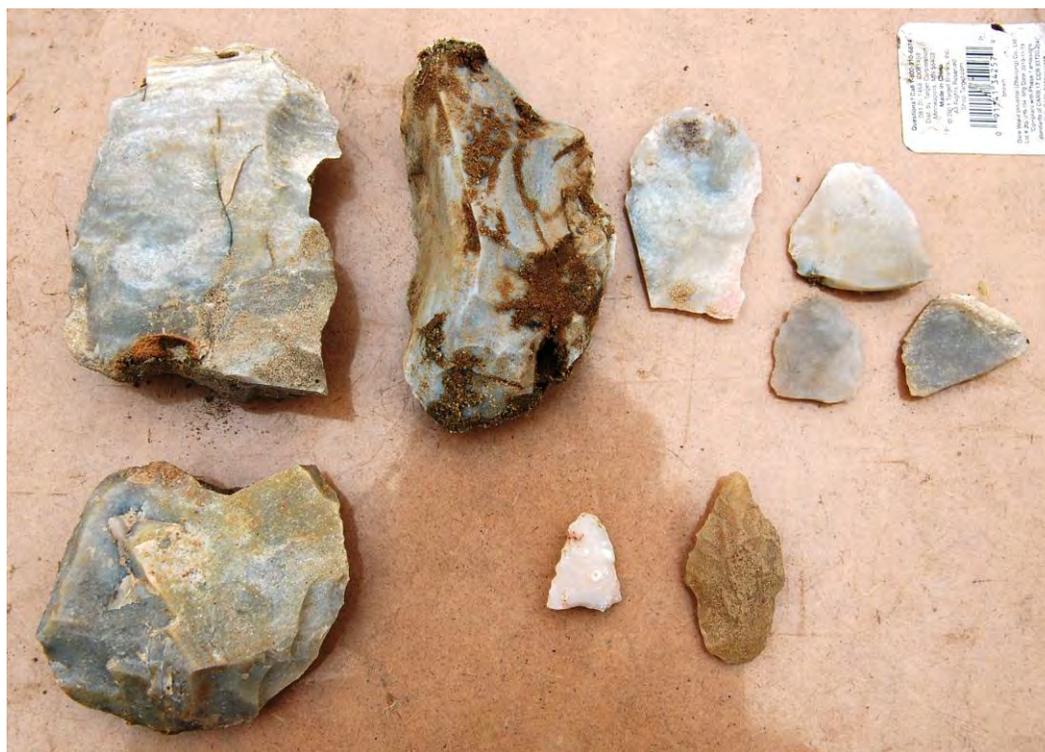
Site 13DW133 was identified by LBG based on field investigations performed on September 28, 2011. The site is represented by a moderate scatter of prehistoric chipped-stone tools, bifaces and other by-products of stone-tool manufacture on the exposed surface of a high terrace overlooking the Maquoketa River. Chipped-stone artifacts were observed on the exposed surface of the terrace and in erosional gullies that had developed along the outer margins of the terrace slope. One of these, a small contracting stem projectile point (cf., Waubesa Contracting Stem) is diagnostic of Early to Middle Woodland period (2800-1500 years BP) assemblages in eastern Iowa. The specimen from 13DW133 is unusual in that it was manufactured from a tan or brownish variety of Cambrian-age Hixton silicified sandstone which is derived from bedrock sources in Jackson County, Wisconsin near Black River Falls. A small fragment of another finished biface was also observed at the site. This appeared to be manufactured from a light-colored Mississippian-age (Burlington Formation) chert most likely derived from sources in southeast Iowa. The overwhelming majority of specimens were otherwise made from a translucent gray variety of Hopkinton chert which is locally abundant in both bedrock sources and secondary outwash deposits. The latter included a wide range of early reduction bifaces, primary shaping flakes and biface thinning flakes. A concentration of unmodified limestone/dolomite cobbles was observed near the center of the site. The rock concentration must have a cultural origin because stones of this size would not occur naturally in this geologic context, but its purpose or function was not obvious or apparent. No bone or artifacts were observed in direct association with the feature and there was no visible indication of any soil staining or

Plate 18. Chipped-Stone Artifacts from Site 13DW133.

No subsurface tests have been excavated at the site. Artifacts were observed near the outer margin of the terrace and were also observed close to the former shoreline and there is a very high likelihood that they are more extensive than reported here, i.e., there is high potential for the site deposits to extend onto the adjacent terrace landform above the shoreline. Portions of the site, particularly areas near the outside terrace margin are being severely eroded by stormwater runoff that is creating deep rills and gullies through the site deposits including areas immediately adjacent to the cultural feature described above.

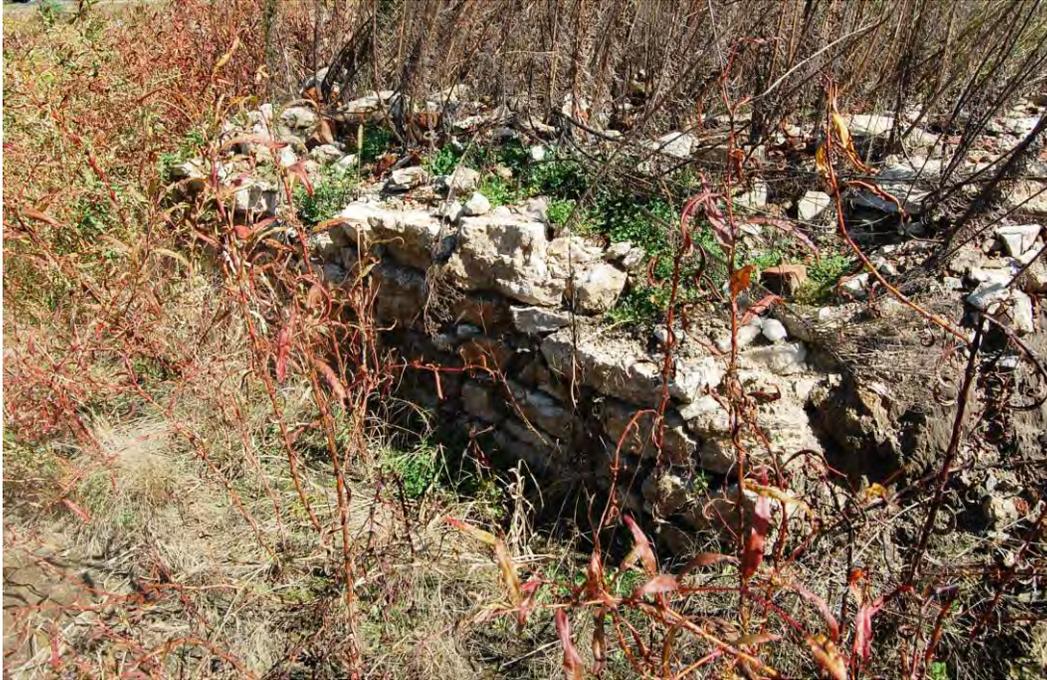
Plate 20. Stone Foundation at Site 13DW136. View of the west wall.

Site 13DW136 consists of a stacked limestone or dolomite foundation situated about 40 feet from the outer margin of an early Holocene terrace. The foundation appears to be rectangular in outline and is oriented with its shorter wall parallel to the terrace edge and the present Maquoketa River channel a short distance beyond. The full extent of the foundation is not exposed but the visible portion measures 24 feet wide and at least 30 feet long. The short wall on the west side is fully exposed and both it and the south wall are mostly visible and appear to be largely intact; however, the north west corner of the foundation has been washed out by the river and a 15-foot section is mostly absent. The short wall facing the river is exposed to a height of three feet and includes seven courses of tabular stone. Close inspection of the foundation along the south wall shows that it measures 24 inches thick. The ruins also include a large quantity of brick and many of the individual bricks are still attached to one another with mortar. Comparatively few historic artifacts were observed, although a number of machine-cut nails could be seen along the walls.

No test excavations have been performed at this location and the site remains unevaluated for listing in the NRHP. Based on the historic background research completed for this report and the information gathered about the building's foundation, LBG recommends that additional archaeological investigations be conducted to determine if the structure has potential to be identified as the saw mill built by John Clark and later operated by the Furman family. These investigations should begin with more comprehensive archival research and interviews with local residents who may be knowledgeable about the early history of the Hartwick area. There may be historic photographs of the original mill complex that could be useful in making this determination without additional archaeological testing. If no conclusive evidence is found, then subsurface investigations both within and outside the foundation should be performed to

determine if any undisturbed archaeological materials exist that may help establish the building's historic identity and evaluate its potential eligibility for listing in the NRHP.

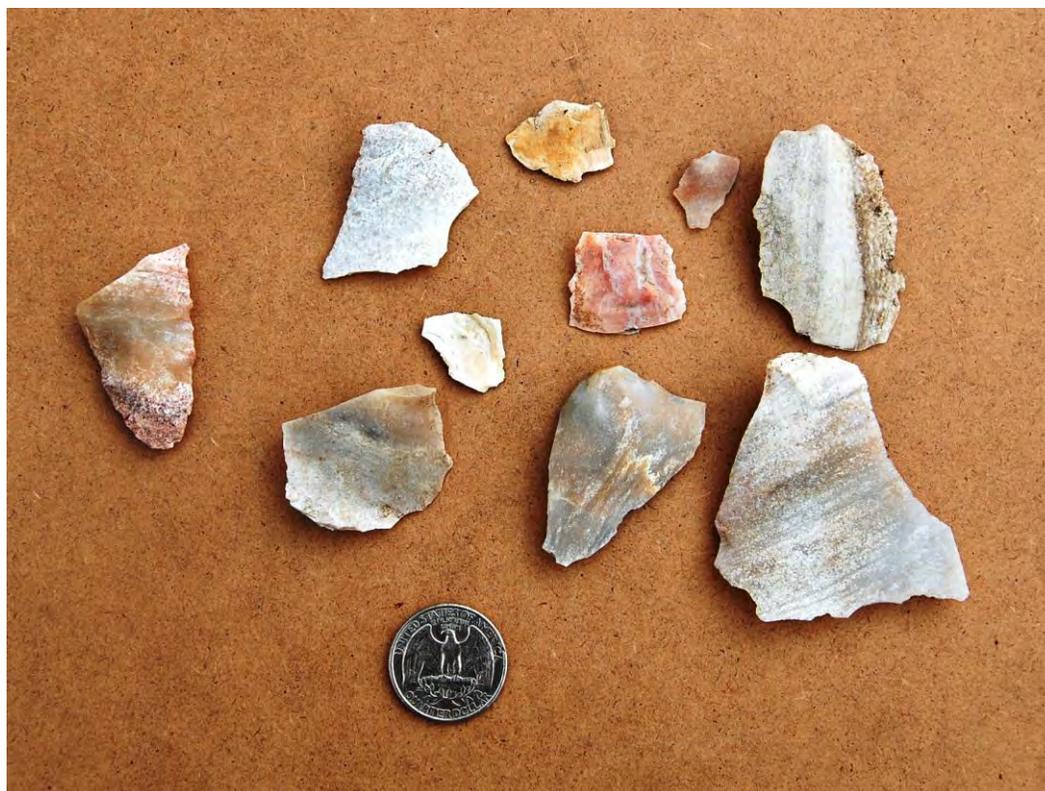
Site 13DW137 was identified by LBG based on field investigations performed on September 29, 2011. The site is represented by a moderate scatter of prehistoric chipped-stone artifacts including a finished knife-like biface and other by-products of middle to late-stage stone-tool manufacture that were observed eroding from the top of a high terrace slope overlooking the Maquoketa River (Plate 22). Chipped-stone artifacts were observed on the exposed surface of the terrace at and below the former lake shoreline. No temporally diagnostic artifacts were observed, but numerous pieces of chert debitage are present on the eroded slope below the former lake shoreline. Most of these items appear to be middle to late-stage biface thinning flakes manufactured from local variations of Hopkinton chert. The majority of the chipped stone artifacts observed at the site appear to be unaltered with regard to heat treatment, but some heat-treated specimens are present including the finished biface. Heat may have been used to improve the fracture qualities of the local stone and is often applied during the later stages of stone tool manufacture.

Plate 22. Chipped-Stone Artifacts from Site 13DW137.

Site 13DW137 remains unevaluated for listing in the NRHP but the high terrace adjacent to the site is not heavily developed; therefore, there is potential for well preserved archaeological deposits to be present in the residential yard areas adjacent to the site. Based on these observations LBG recommends that additional archaeological investigations be conducted to more fully define the nature and vertical and horizontal extent of the archaeological deposits present at 13DW137, including site deposits that are likely to extend above the anticipated shoreline elevation of 897 feet amsl.

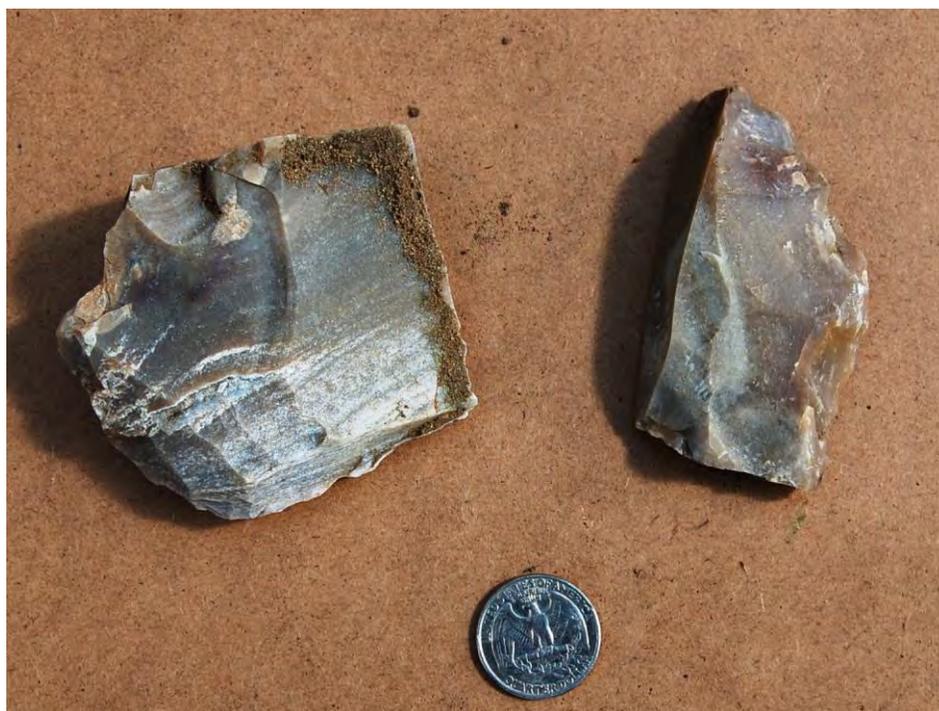
Site 13DW138 was identified by LBG based on field investigations performed on September 30, 2011. The site is represented by a light scatter of prehistoric chipped-stone artifacts that include early to middle-stage bifaces, flakes, and other by-products of stone-tool manufacture (Plate 23). Artifacts were observed on the eroded terrace slope below the surface of a high terrace. No temporally diagnostic artifacts were observed, but pieces of chert debitage are present on the eroded slope below the former lake shoreline. Most of these items appear to be associated with early-stage biface shaping and reduction and all of the items observed appeared to be manufactured from local variations of untreated or un-heat-altered Hopkinton chert.

Plate 23. Chipped-Stone Artifacts from Site 13DW138.

No subsurface tests were excavated at the site. Artifacts were observed below the outer edge of the high terrace below the former shoreline in disturbed contexts; however, it is reasonable to assume that more extensive site deposits extend onto the adjacent high terrace above the shoreline. The potential for undisturbed or intact archaeological deposits along the shoreline exists at the 895 to 897 elevation level and above; however, since most of the shoreline adjacent to this site is already stabilized by two to three-foot tall concrete retaining walls; the potential for continued erosion of in-situ archaeological site deposits at this location appears to be minimal. Subsurface testing on the adjacent terrace surface above the shoreline would be needed to determine the nature and extent of the site deposits at 13DW138.

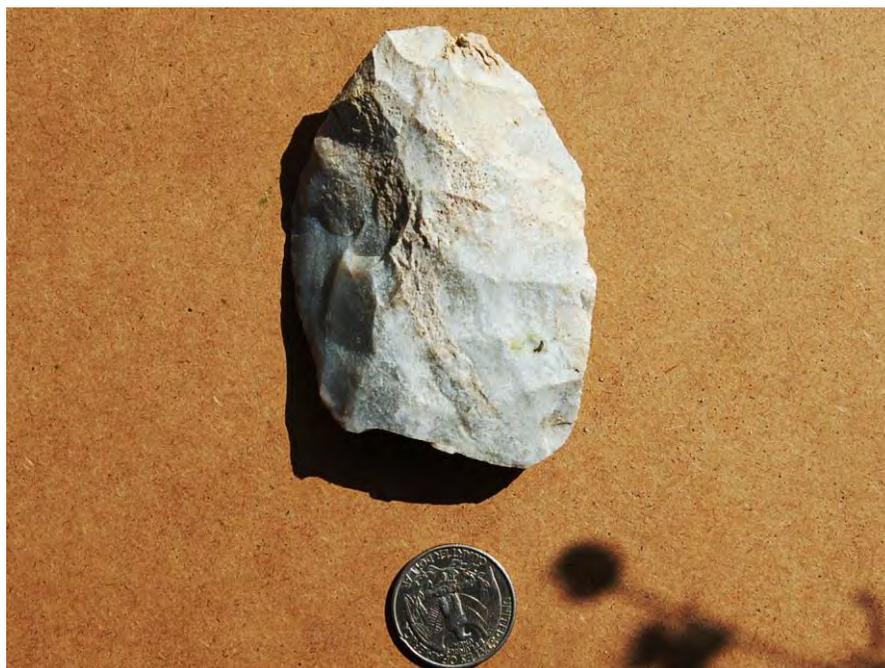
Site 13DW139 was identified by LBG based on field investigations performed on September 30, 2011. This site is located on the same high terrace point bar landform as 13DW138, but is situated almost 200 meters downstream. Site 13DW139 is represented by a moderate scatter of prehistoric chipped-stone artifacts that included a middle-stage biface, thinning flakes, and other probable by-products of stone-tool manufacture. Artifacts were observed on the eroded portion of the high terrace below the former shoreline. No temporally diagnostic artifacts were observed, but at least one shaped and thinned biface blank (Plate 24) and numerous pieces of chert debitage were noted on the sandy terrace surface. Most of these items appear to be manufactured from local variations of untreated Hopkinton chert.

Plate 24. Middle-Stage Biface from Site 13DW139.

the shoreline that have potential to be largely undisturbed; therefore, there is potential for preserved archaeological deposits to be present in the residential yard areas adjacent to the site. Based on these observations LBG recommends that additional archaeological investigations be conducted to define the nature and vertical and horizontal extent of the archaeological deposits present at 13DW139, including site deposits that are likely to extend above the anticipated shoreline elevation of 897 feet amsl. Even though the shoreline adjacent to the present site materials has already been stabilized, it is possible that undisturbed site deposits may extend to other portions of this terrace landform that are unprotected.

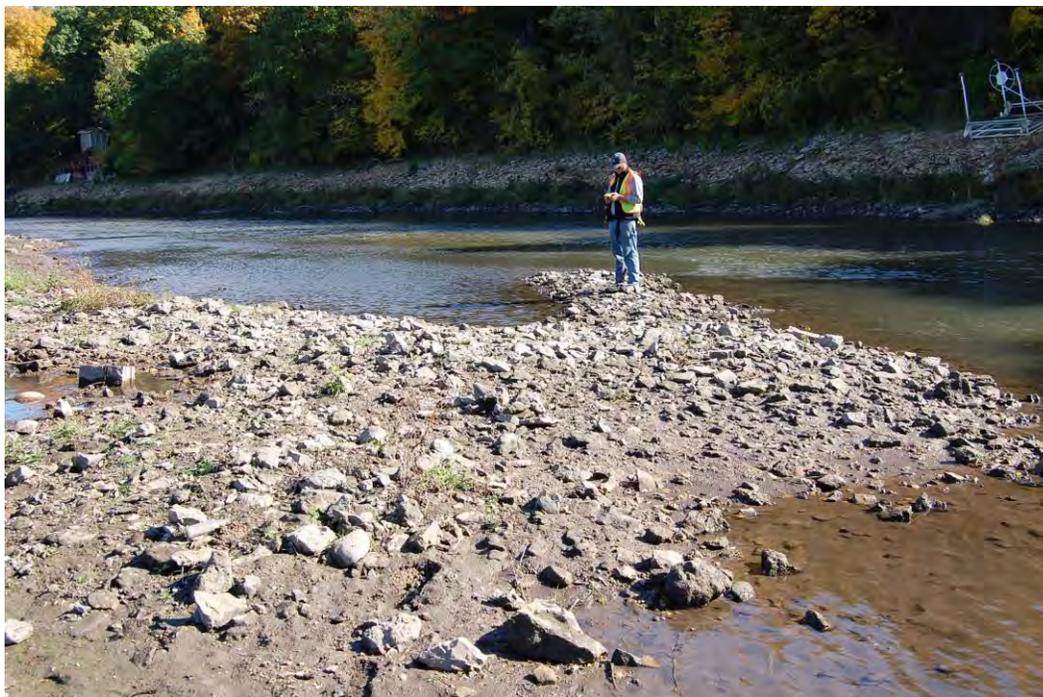
Plate 25. Photograph of Site 13DW140. View looking downstream.

The rock alignment observed within the study area appears to include only rock. No wood poles or other evidence of an associated structure was observed at the site and no artifacts of any type, prehistoric or historic, appeared to be present or associated. The setting for this structure strongly suggests that it may be part of a prehistoric fish weir. It is situated in a portion of the valley that has a bedrock wall on the outside meander to create a stable shoreline and the talus materials that have accumulated along the base of that slope would have provided a close and convenient supply of building materials. The structure has been submerged for the past 80 years so it is not of recent construction, and there are no records of historic activity in this part of the valley that might indicate 19th century construction of a small overflow dam in this area. The overall dimensions of the alignment are comparable with other barrier structures located on the Wapsipinicon River (e.g., Slide Rock Fish Weir – 13JN313) and the size of rocks used to assemble the Lake Delhi structure are comparable to those used to construct other prehistoric fish weirs, i.e., small enough to be carried by hand.

Site 13DW140 remains unevaluated for listing in the NRHP; however, it appears to be a strong candidate to be the first prehistoric fish weir reported on the Maquoketa River. The structure appears to be incomplete, but it is possible that a companion alignment extending from the right bank, if it existed, may have been removed during the 2004-2005 dredging operations that took place within the river channel. Based on the observations described above, LBG recommends that additional archaeological investigations be conducted to carefully map and document the rock alignment that remains. These investigations may include exploration to determine if any evidence exists for wood pole inclusions that might help confirm its design and purpose.

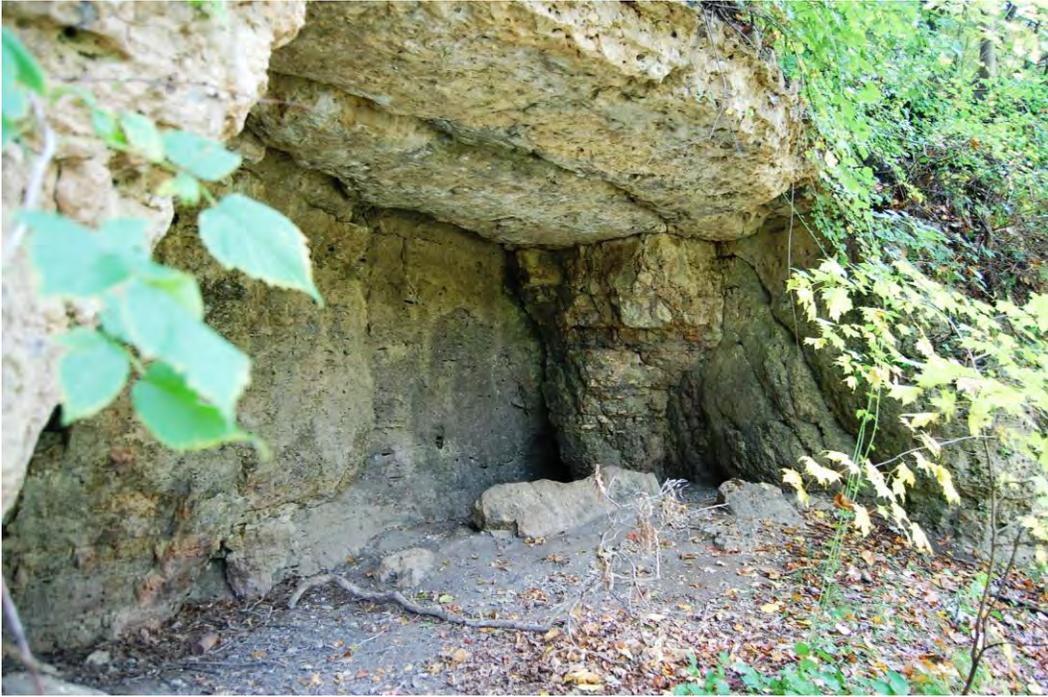
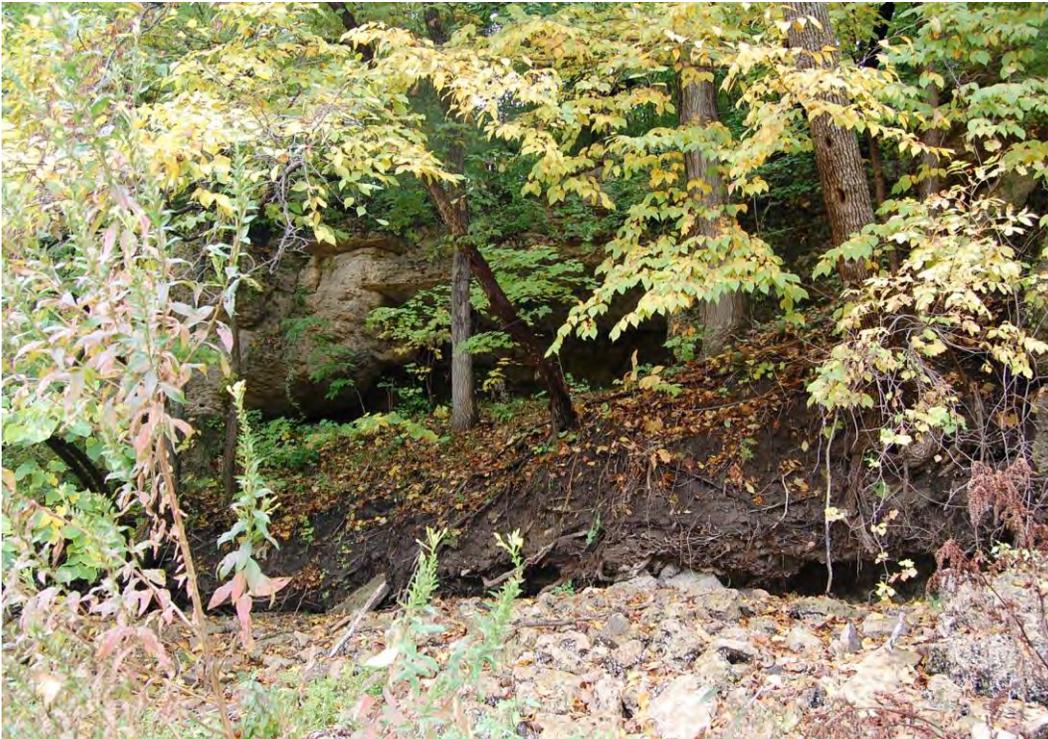
Plate 26. Overview of Rockshelter Interior at 13DW141.

Plate 27. Photograph of Eroded Shoreline at 13DW141.

The shelter is small but has an estimated floor space of about 40 square meters (Plates 26, 27). The ceiling is approximately 7 to 8 feet above the current floor elevation providing ample space for use as a habitation site. No subsurface tests have been excavated at the site and the floor deposits within the protected portion of the shelter do not appear to have been disturbed. No carvings, petroglyphs, or mineral stains were observed on the walls of the shelter and no features were observed on the floor. Some reddish discoloration was noted on the back wall of the shelter which suggests oxidation from fire and heat. No artifacts were observed on the floor of the shelter, but several pieces of chipped stone debitage and small fragments of burned rock were observed eroding from deposits in front of the shelter within approximately two to three feet of the former high water mark for Lake Delhi.

Site 13DW141 remains unevaluated for listing in the NRHP. Site 13DW141 is located above the 897 foot elevation contour which has been identified as the upper limit for consideration of the proposed project's potential for adverse effects. However, it appears that the potential for below-ground archaeological deposits associated with Site 13DW141 may extend into or very near this zone of effect. Based on the field observations described above including the presence of associated archaeological materials at or near the previous high water mark for Lake Delhi (see Plate 27), LBG recommends that this site be included in the assessment of the project's potential effects on archaeological resources. LBG further recommends that additional archaeological investigations be conducted to define the nature and extent of the archaeological deposits present at 13DW141 including those located outside the dripline in front of the shelter.
