# Welch Lake Complex Wetland Prioritization

# CENTER LAKE WATERSHED

## BIG SPIRIT LAKE WATERSHED

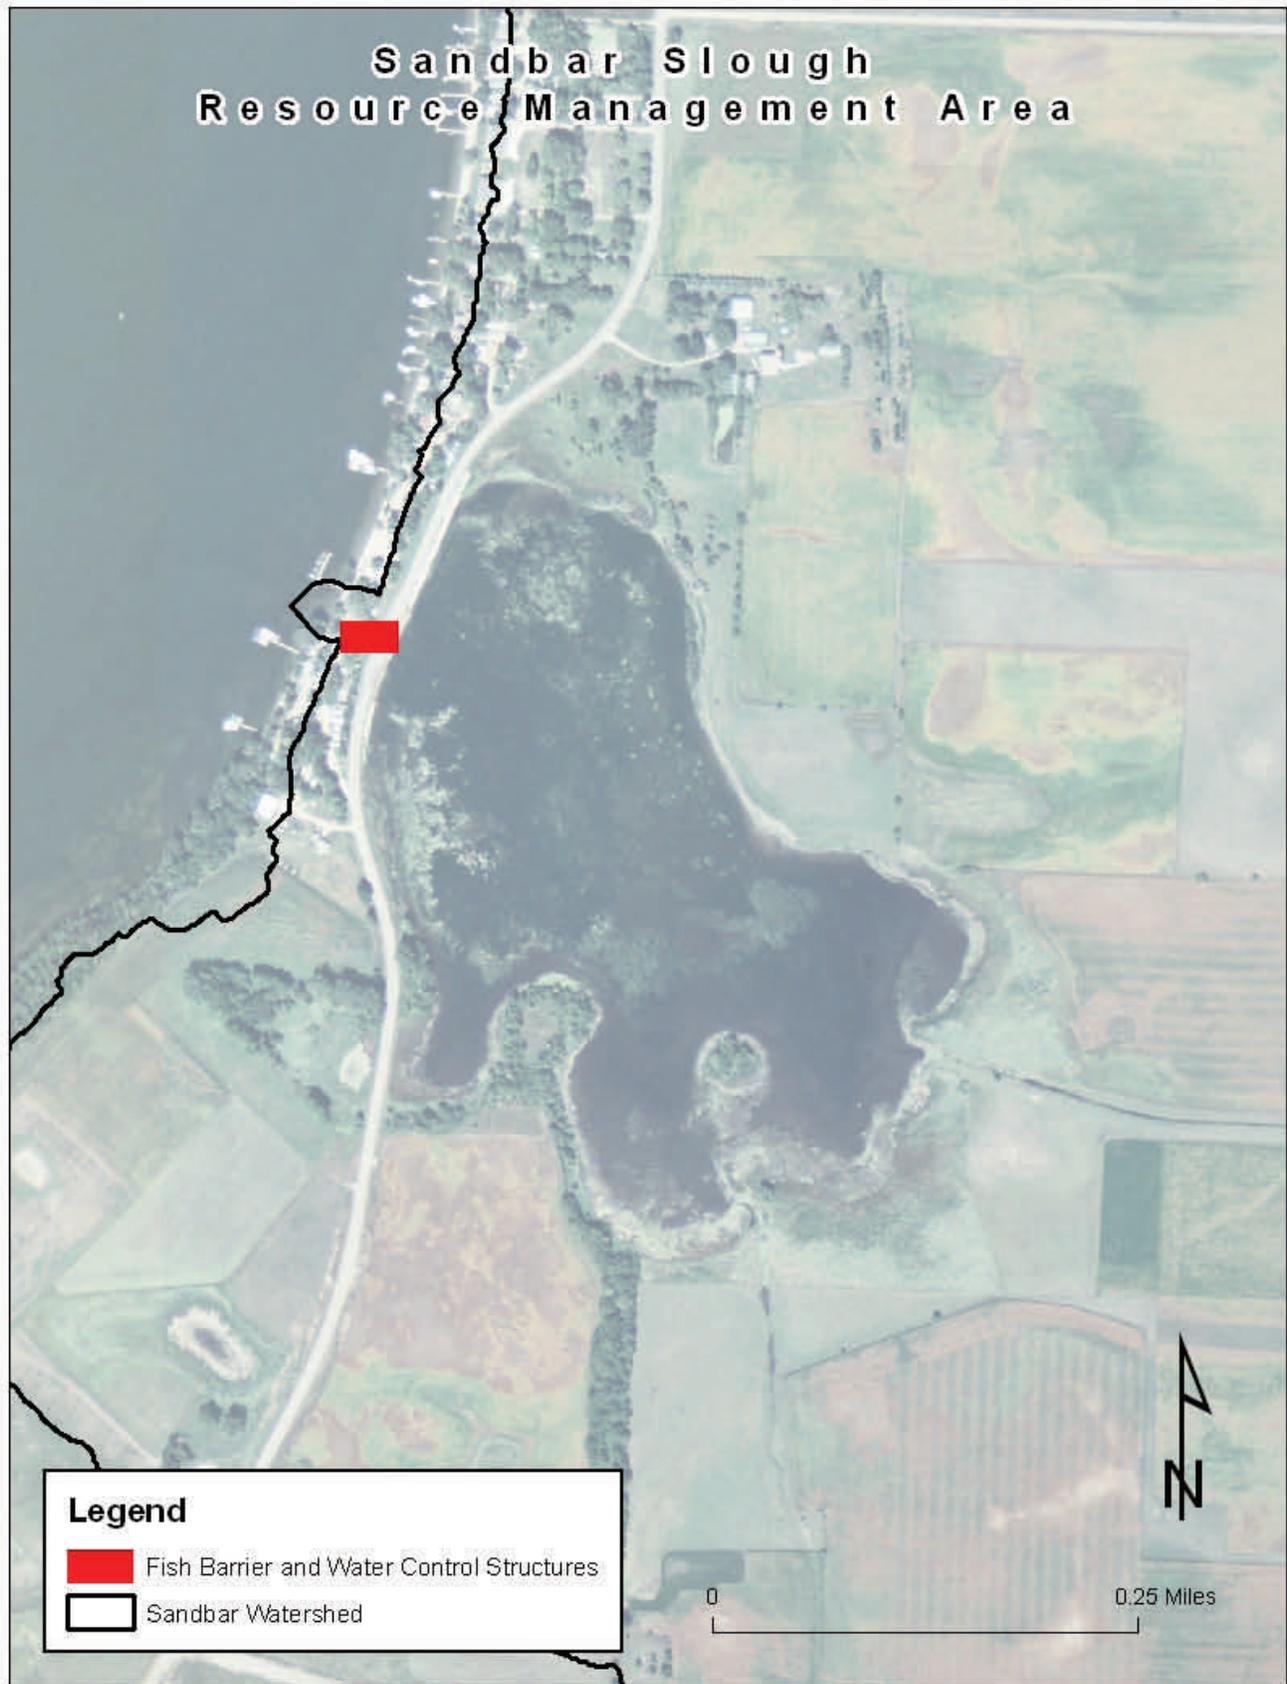
**Figure 1.53 Sandbar Slough Fish Barrier Location**

Proper in lake management begins by controlling the movement of water and fish in/out of Sandbar Slough. A new fish barrier (Figure 1.53) and water control structure should be constructed between Sandbar Slough and Big Spirit Lake to help control the movement of common carp into the slough. An electric water control structure and drain pipe should be placed at the outlet of the slough to allow for periodic draw downs that mimic historic drought conditions that are no longer occurring due to watershed changes. These water level fluctuations will allow managers to control fisheries populations and promote natural and diverse vegetation communities that benefit both fisheries and wildlife interests.

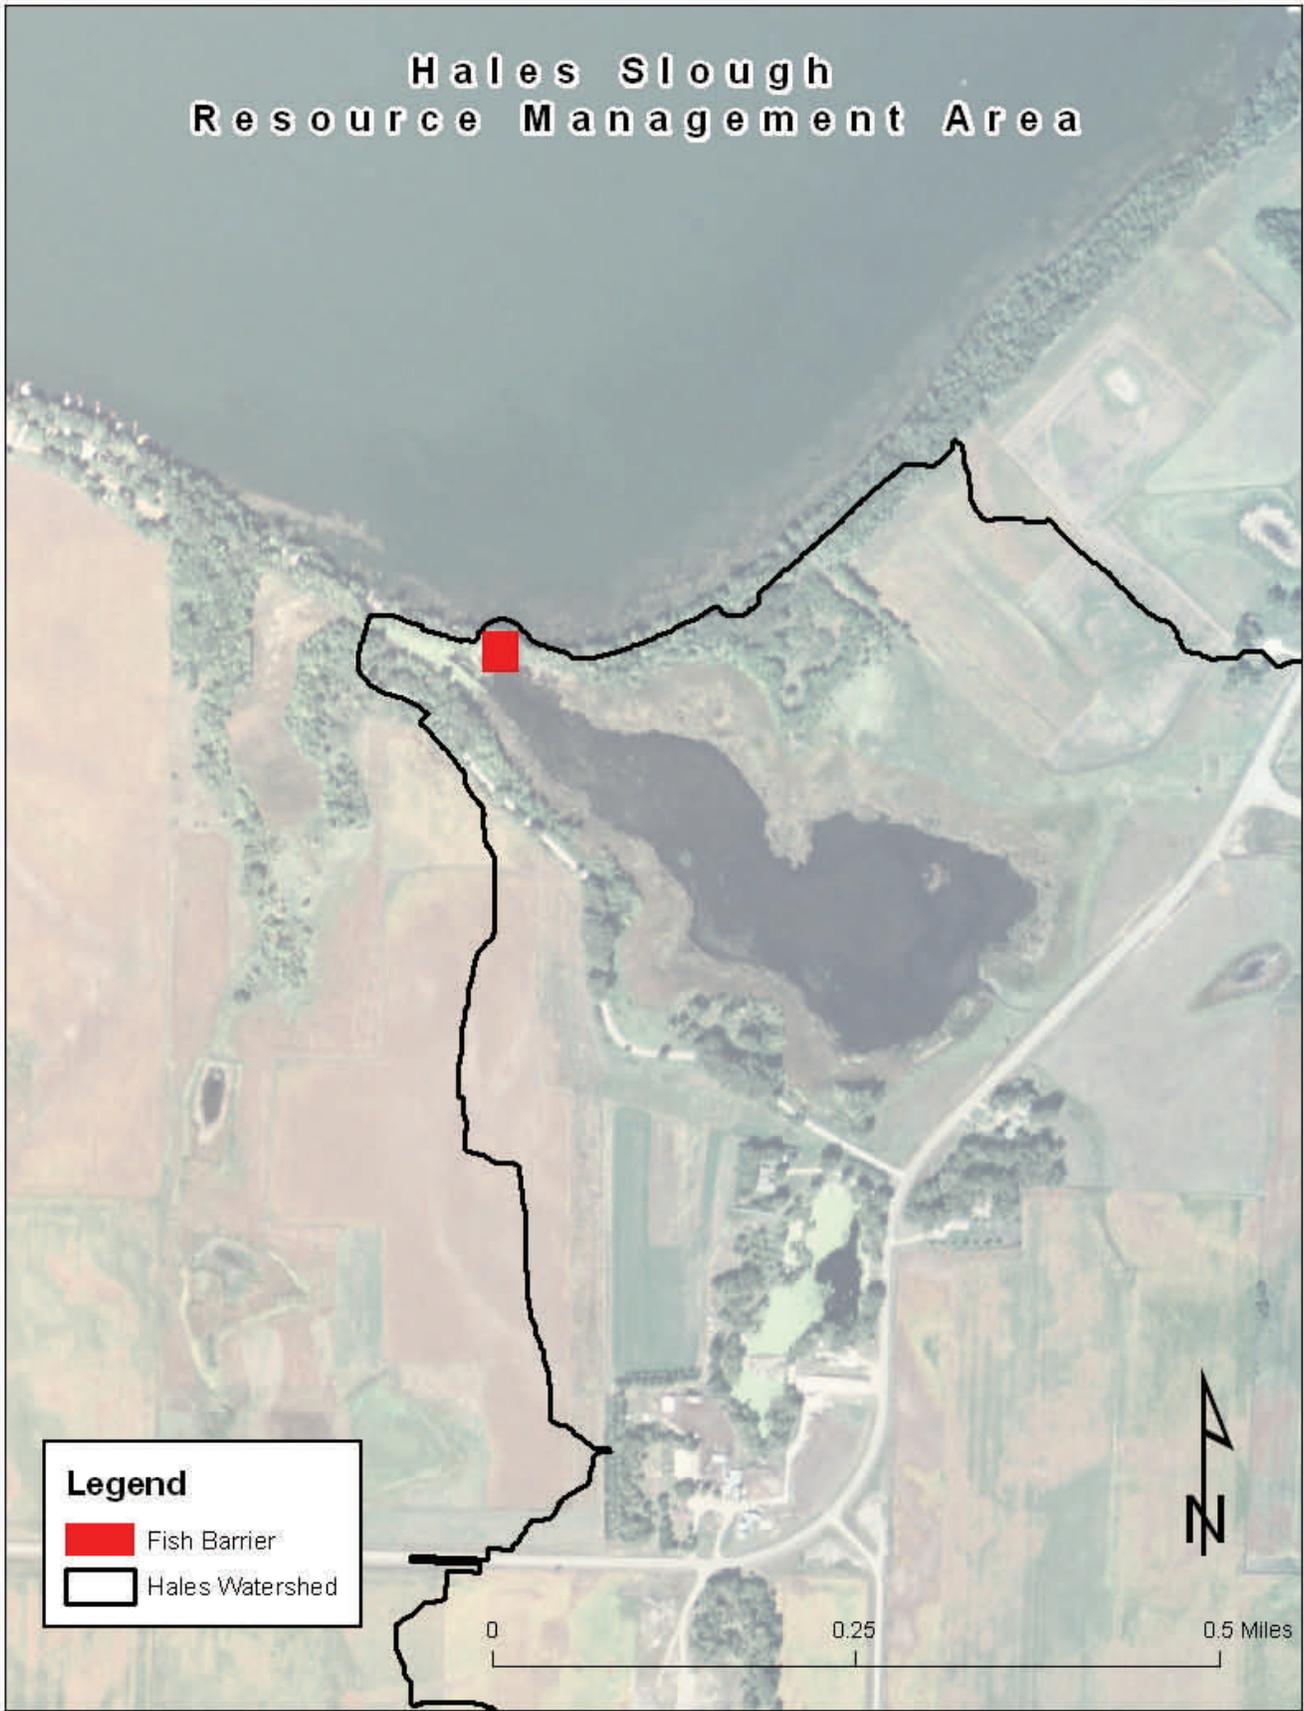
Figure 1.62 Hales Slough Fish Barrier Location

Proper in lake management begins by controlling the movement of water and fish in/out of Hales Slough. A new fish barrier should be constructed at the outlet of Hales Slough in order to prevent the movement of common carp into the slough (Figure 1.62).
