Union Grove Lake Watershed

Watershed
Management Plan
2012-2026
June 2012

Tama Soil & Water
Conservation District, Iowa

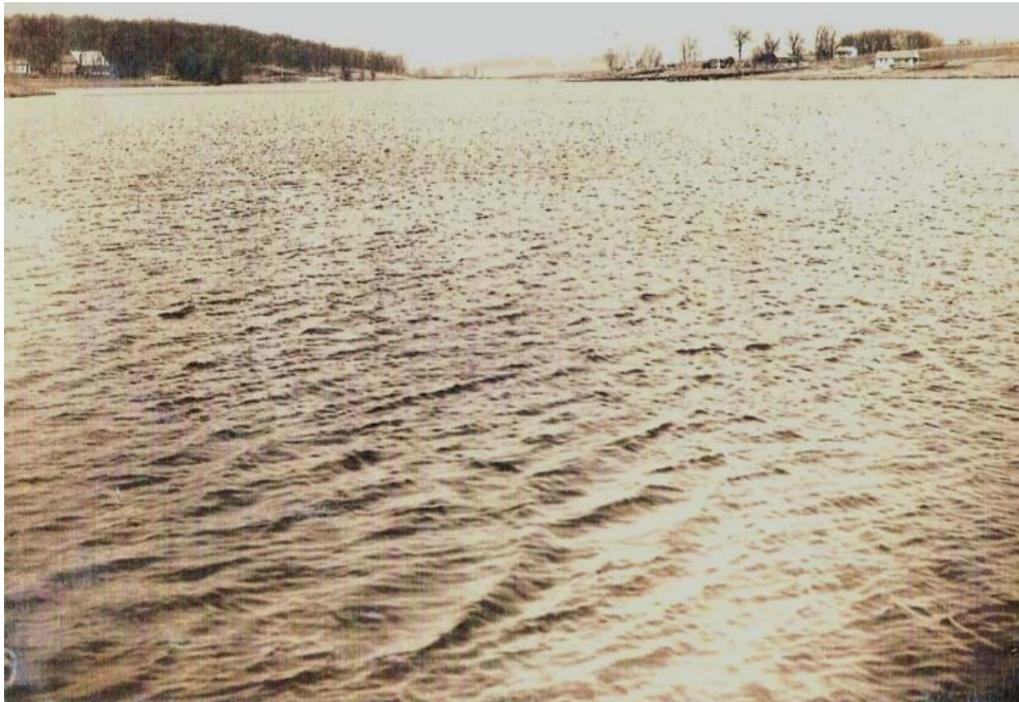
Figure 2

1936 photo, looking northwest from dam

Membership provided the \$35,000+ needed to purchase 230 acres of land. 171 acres were deeded for the lake bed, shoreline, and public park required to meet WPA requirements. By August 1937 the lake was constructed and filled (Figure 2), and the corporation held a celebratory water carnival, complete with boat regatta and airplane rides. The lake was operated privately by the corporation for the next few years and proved a popular public recreation area. Amenities included boat and canoe rental, a bath house, and a small restaurant.

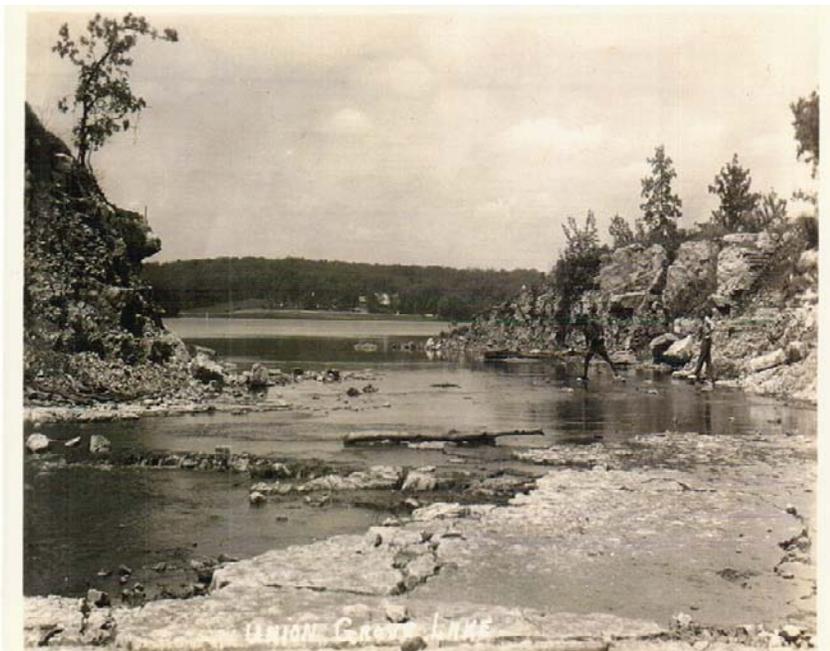
Figure 3

Union Grove Lake's primary outlet, Chapin Limestone Formation

An original dam crest elevation of 937.6 feet provided for a 118-acre lake. The lake's outlet was created by removing limestone from near the east end of the 1320-foot dam, which still acts as Union Grove Lake's primary spillway (Figure 3). This stone was crushed and used for road construction within the park. In July 1940, the lake, shoreline, and park were sold to the State of Iowa for \$10,000, creating Union Grove State Park. Lake & Park Holding Corporation remains a very active watershed group making financial, material, and labor donations to the lake and state park each year.

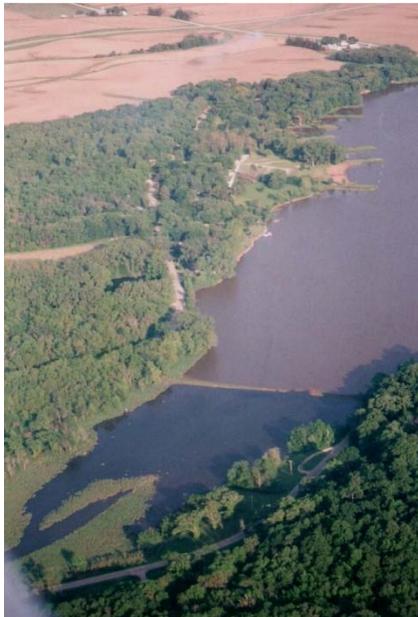
Figure 11

Sediment retention dike at northwest end of lake, looking southeast

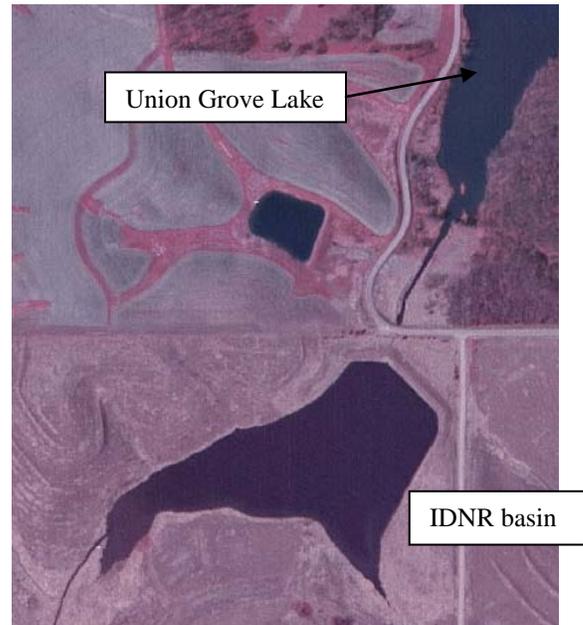
Figure 12

Sediment retention basin near southwest corner of lake

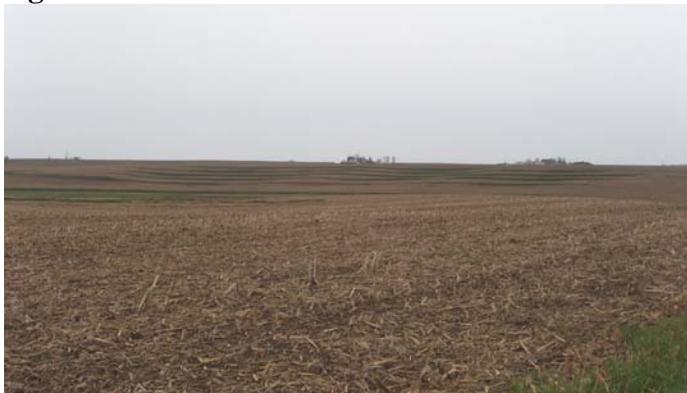
Figure 13

2008 photo of terraces built in 1991. Note no-till in foreground. Section 20, Spring Creek Township, Tama County

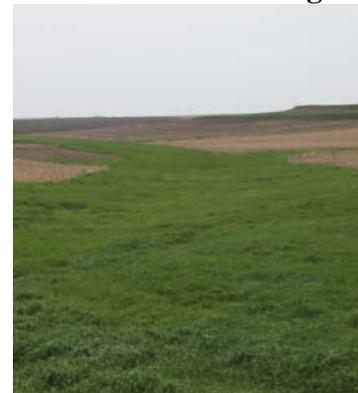
Figure 14

2008 photo of waterway built in 1985. Section 21, Spring Creek Township, Tama County

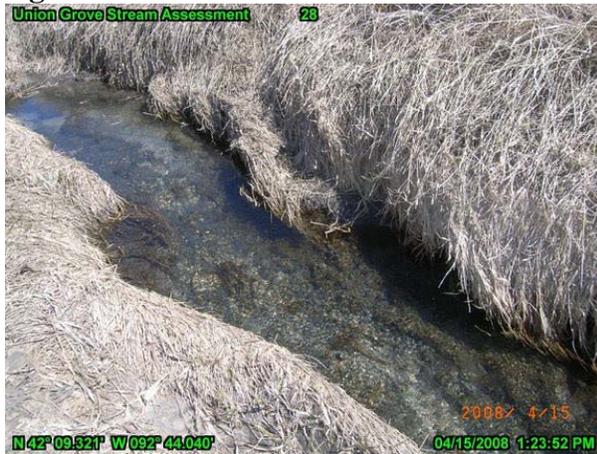
Figure 17

A Rapid Assessment of Stream Condition Along Length (RASCAL, Figure 17) began on 4.3 miles of watershed stream corridor in the fall of 2007 and completed in the spring of 2008. This assessment recorded data on 24 parameters and helped the project to target priority areas in which to focus conservation efforts. During personal contacts with stakeholders, RASCAL data also helped farm owners and operators to visualize problem areas on their farms.

RASCAL assessment, tributary of Deer Creek, 2008 section 20, Spring Creek Township, Tama County

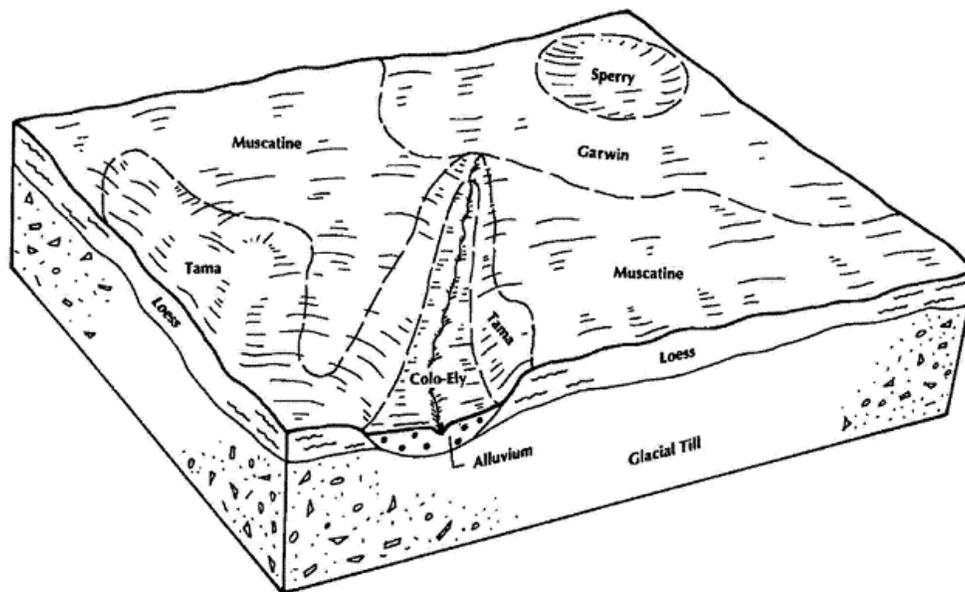
Figure 19

Soil associations in the headwaters of the watershed are of the Tama Association and the Muscatine-Tama-Garwin Associations. Soils in the Tama group are gently sloping to moderately steep, well drained, silty upland soils that formed in loess. This association's soils lie on broad, convex ridgetops and long, convex side slopes ranging from undulating to hilly. They are well suited or moderately well suited to producing row crops, small grains, and hay. The main management concerns in this association are controlling erosion and maintaining tilth and fertility. Soils in the Muscatine-Tama-Garwin Association are nearly level to moderately sloping, silty upland soils that formed in loess. Their drainage, however, ranges from well drained to poorly drained. These soils lie on broad, convex ridgetops and side slopes creating a nearly level to gently rolling land surface. They are well suited to the production of row crops, small grains, and hay. Their main management concerns are erosion in the moderately sloping areas and seasonal high water table in the poorly drained soils.

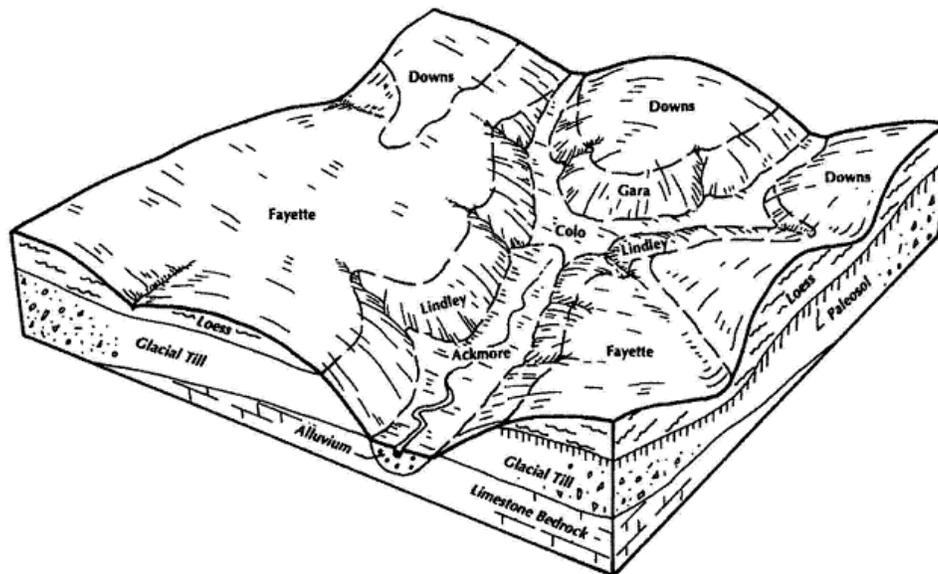
Figure 20

Closer to the lake, soil types are typically Fayette-Downs Association. Soils in this group are gently sloping to very steep, well drained, silty upland soils formed in loess. They are typically found on broad to narrow, convex ridgetops and long, convex side slopes which are dissected by numerous waterways. The landscape varies from undulating to very steep. These soils are generally well suited or moderately well suited to row crop, small grain, and hay production. The association's steeper slopes are unsuitable for crops but well suited for pasture and trees. Main management concerns in this association are controlling erosion, preventing gully formation, maintaining fertility, and managing pasture and timber.

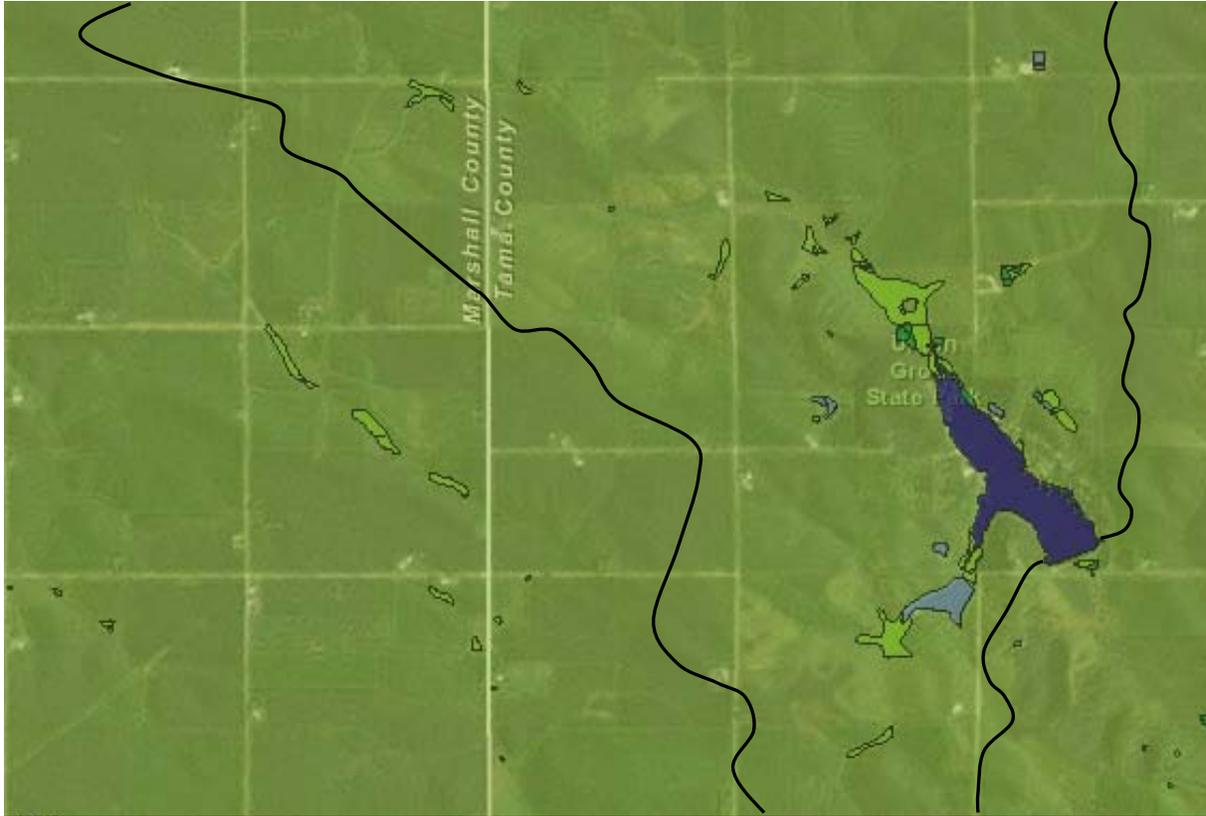
Wetlands

Union Grove Lake has one major surface tributary. Deer Creek enters the northwest end of the lake and discharges over a 70-foot wide weir at the southeast corner of the lake. Union Grove Lake is in the headwaters of Deer Creek, which then flows into the Iowa River in the City of Tama. A secondary, unnamed tributary drains into an IDNR sediment detention basin before discharging into the southwest corner of the lake. Figure 22 shows wetlands designated in the National Wetlands Inventory. Uncrossable intermittent flow, perennial flow, and Deer Creek are shown in Figure 23.

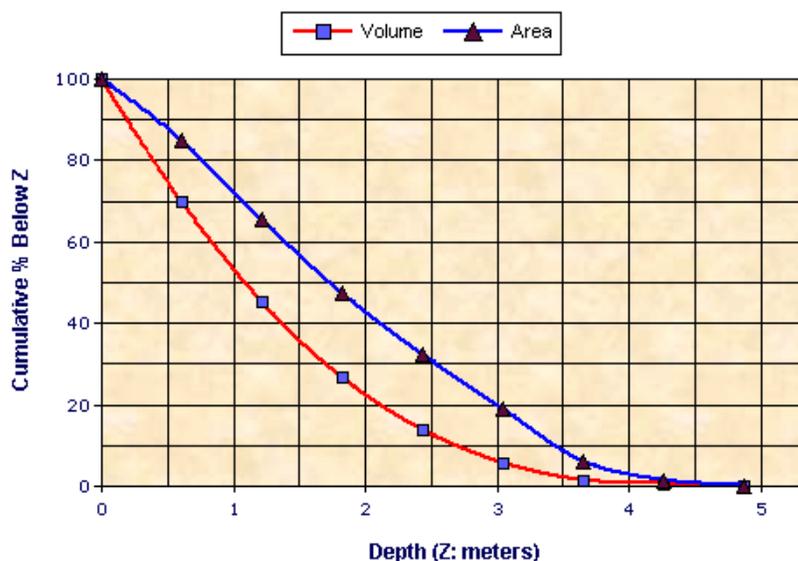
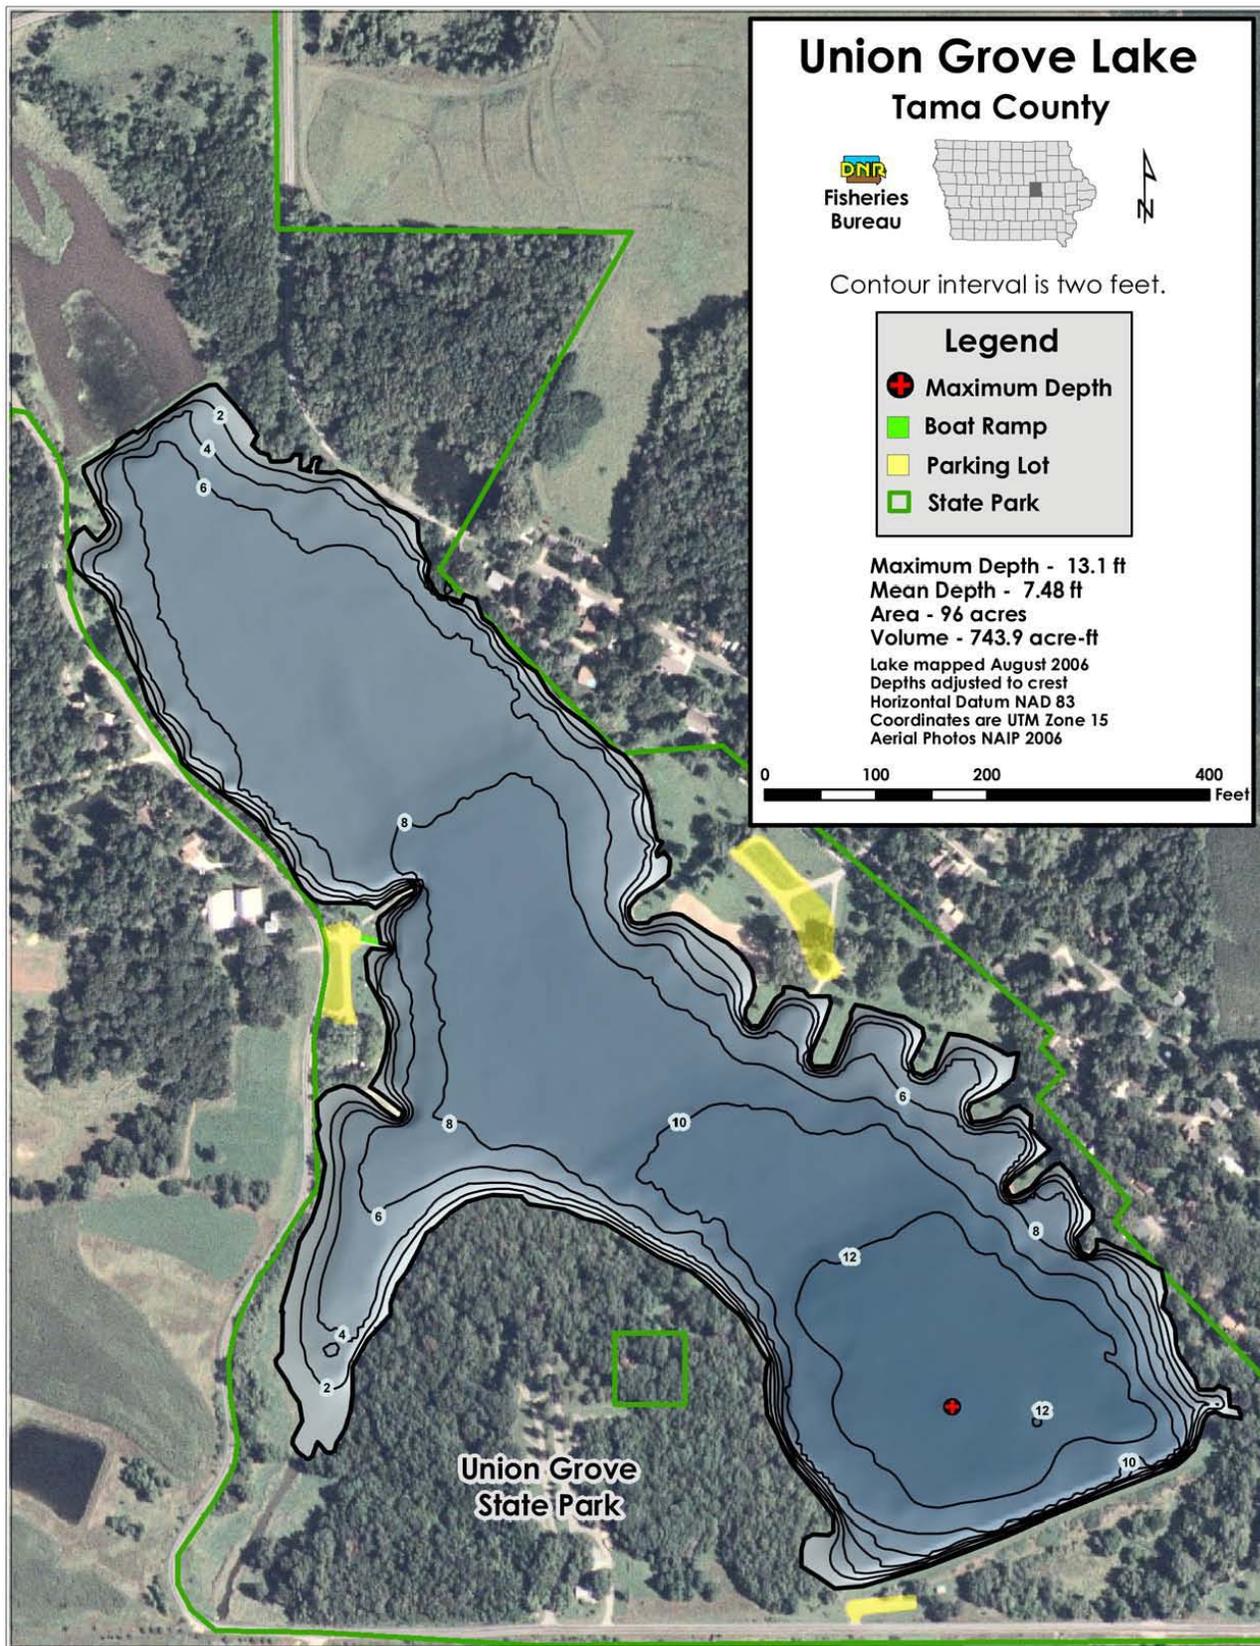
The most recent bathymetry of Union Grove Lake was completed in 2006 by the IDNR (Figures 25 and 26) excluding the area upstream of the sediment detention dike. Union Grove Lake has a mean depth of 7.48 feet and a maximum depth of 13.1 feet. The lake surface area is 96 acres and storage volume is 744 acre-feet. Its detention time is 44 days based on estimated outflow.

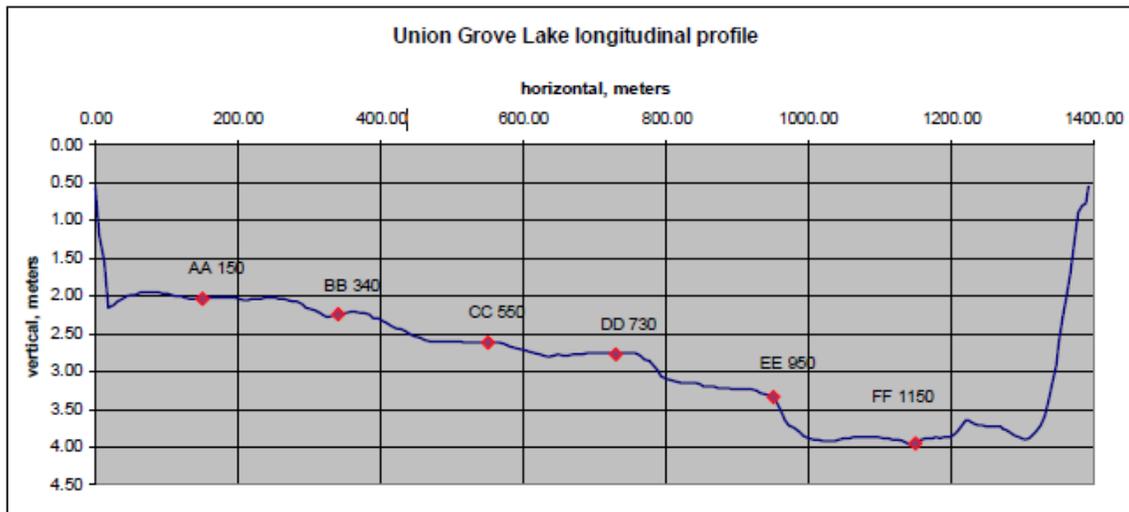
Figure 28

Bathymetry of the lake segments downstream of the sediment basin and the locations of the longitudinal profile and cross-sections used to approximate the lake morphology for the Water Quality Improvement Plan model are shown in Figure 27. Slopes and depths for the segments were calculated from the profile illustrated in Figure 28.

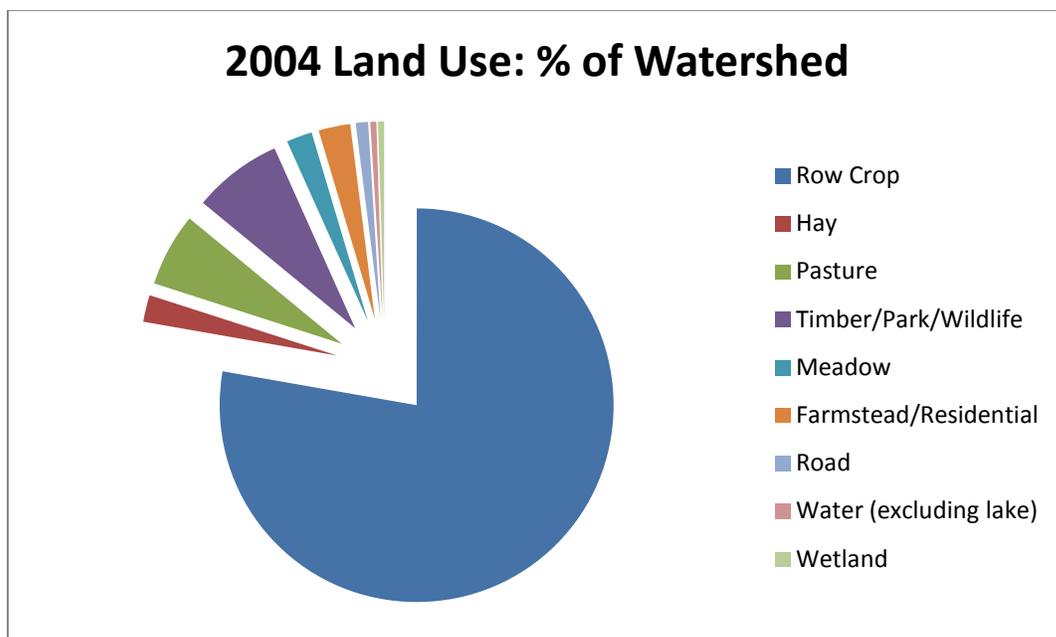
Figure 31

IDNR utilized land use data from its 2004 land use assessment in Union Grove Lake’s Water Quality Improvement Plan, completed in 2009. **Figure 31** demonstrates this data with the lake’s surface area removed to make the figures more compatible with the 1982 diagnostic study data. As in 1982, row crop agriculture is the predominant land use in the watershed.

From 1982 to 1994, the acreage in hay remained relatively unchanged. The amount of pasture decreased somewhat, most likely due to changes in the number of watershed cooperators involved in livestock production. The percentage of watershed in row crop decreased slightly while the percentage in meadow increased, most likely due to acres that became enrolled in the Conservation Reserve Program.

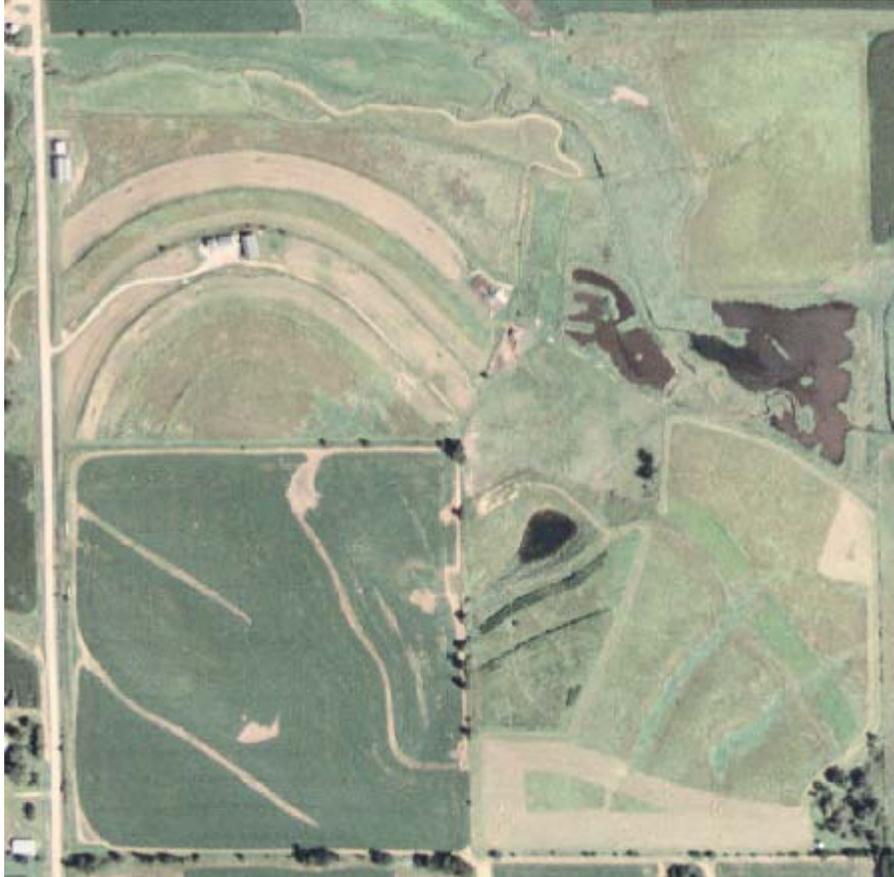
Figure 32

Southwest quarter section, Section 29 Spring Creek Township

One significant land use change since the 2004 assessment is the completion of a constructed wetland complex (aka Umphrey property) on Deer Creek in the southwest quarter section of Section 29 Spring Creek Township (T85N R16W). This complex (Figure 32) in the northwest portion of Union Grove Lake Watershed has very likely dramatically affected the subwatershed's contribution of sediment delivered to the lake. After this document was first drafted, the current project's coordinator was contacted by the landowners regarding storm damage. They have since completed necessary repairs to the main structure and are considering further improvements. Discussion regarding the overall effectiveness of this site will be addressed in Section 4.3.

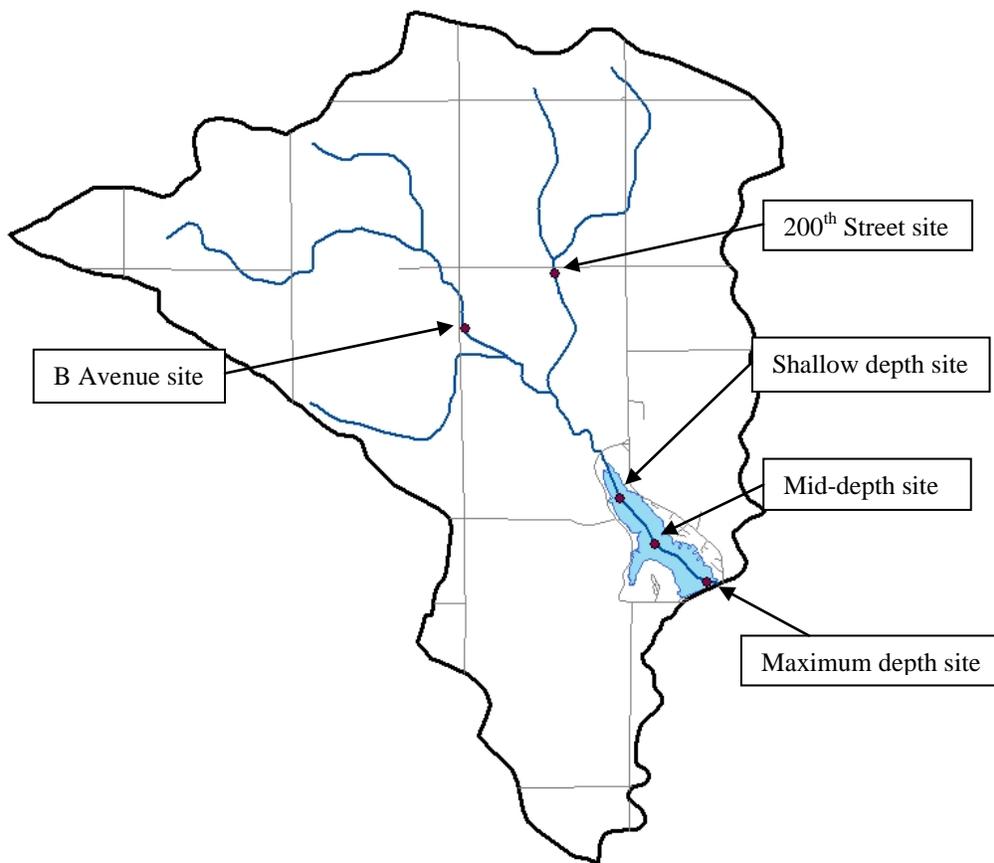
Figure 33

Water quality testing was conducted by personnel from the current project or the State Hygienic Laboratory (University of Iowa) at the 200th Street and B Avenue (Deer Creek) tributary sites and the maximum depth in-lake site July through October 2008, May through October 2009, and May through October 2010. Shallow and mid-depth in-lake sites were sampled only during the 2008 sampling season. A storm event sampler was utilized at the B Avenue tributary sampling site during the 2009 and 2010 sampling seasons. Sampling sites may be found in Figure 33.

Total Phosphate base flow concentrations at the two tributary sites (Figure 33) were typically low compared to good quality streams in the same region of Iowa. However, large amounts of phosphorus moved through the tributary system during storm events. The lake’s maximum depth site showed Total Phosphate concentrations similar to those collected by Iowa’s ambient lake monitoring program. The project’s lowest median concentration occurred in 2010. Total Phosphate was generally higher in Union Grove Lake than in its tributaries with the exception of the B Avenue site during storm event conditions.

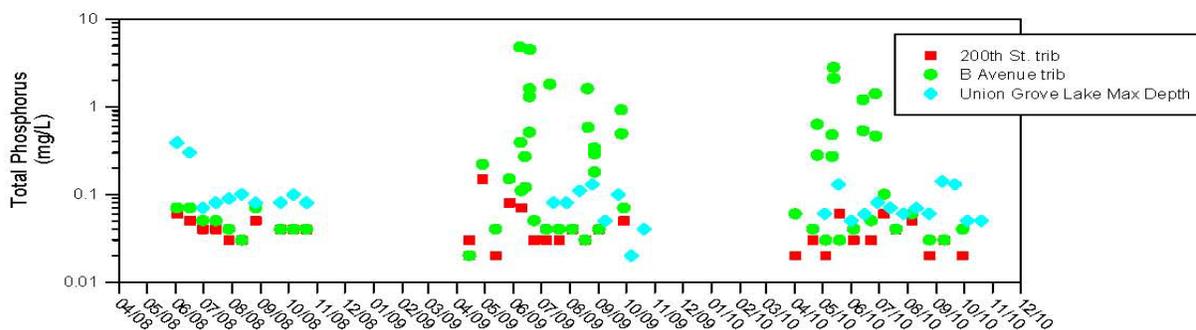
Figure 34 shows results for Total Phosphorus from all three sampling sites used throughout the life of the project. Data for orthophosphate, the soluble and reactive form of phosphorus utilized by plants, may be found in Figure 35.

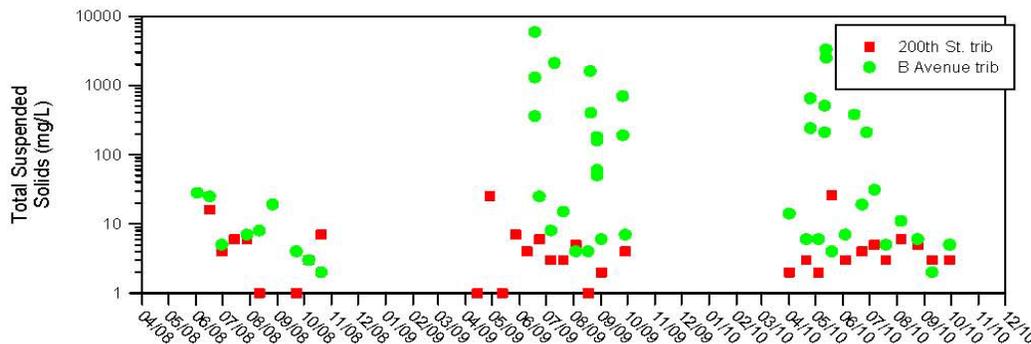
Figure 36

Total Suspended Solids (TSS) data from the current project’s tributary sampling sites are found in Figure 36. TSS was not sampled in-lake. TSS measures the total filterable material in the water, including sediment and algae. Total Volatile Suspended Solids (TVSS) is a measure of solids lost on ignition, providing a good estimate of the amount of organic matter in the water. Total Fixed Suspended Solids (TFSS), which measures inorganic suspended solids in the water, and TVSS data were collected only at the tributary sampling sites during 2008. Both TVSS and TFSS results were very low and neither were graphed for this plan.

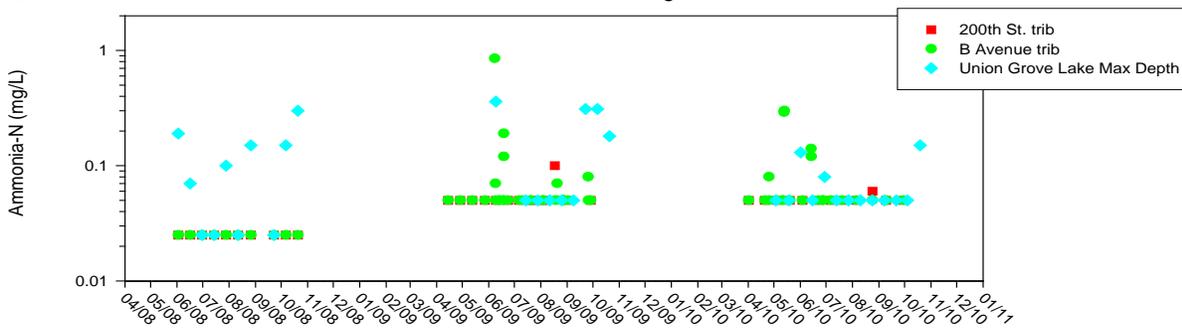
Figure 37 shows test results for ammonia nitrogen, the least stable form of nitrogen in water. It is readily converted to nitrate in well-oxygenated water and can be toxic to fish and aquatic macroinvertebrates. Its toxicity is dependent upon pH and temperature conditions.

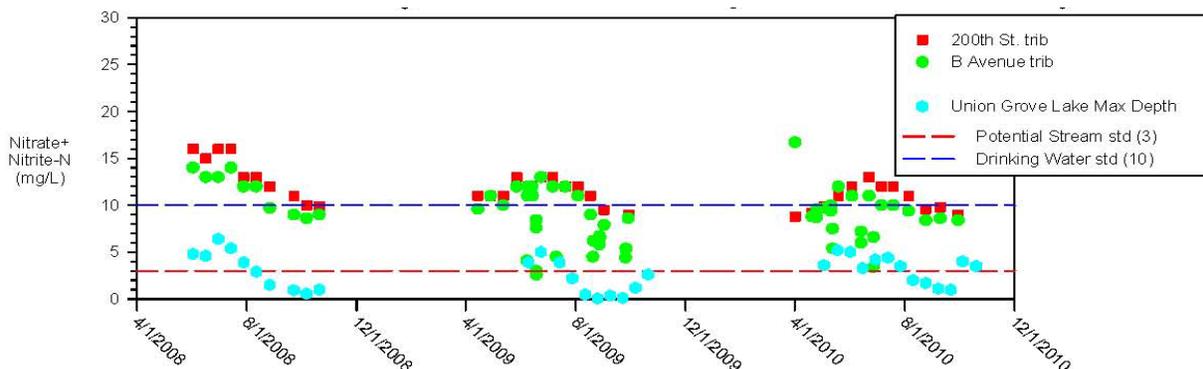
Figure 38

In Figure 38, project results may be found for Nitrate + Nitrite Nitrogen, an inorganic form of nitrogen which is very water soluble and therefore is easily transported off the landscape by precipitation.

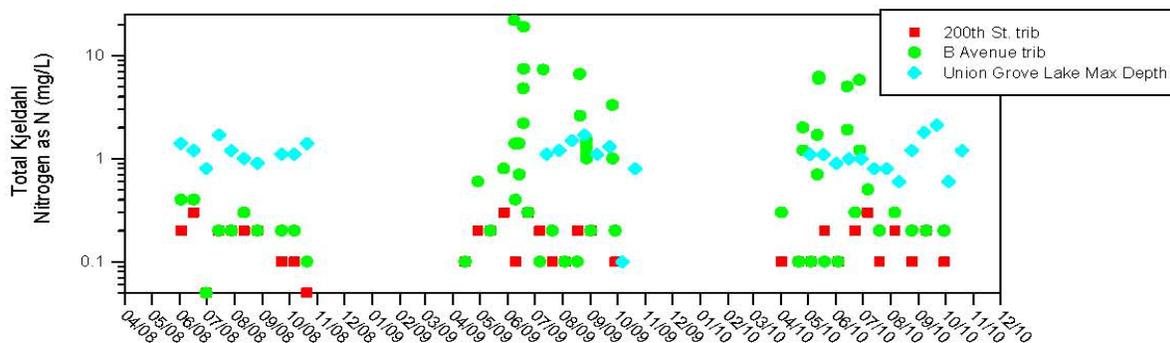
Figure 39

Total Kjeldahl Nitrogen (TKN) measures water’s organic nitrogen, such as the nitrogen found in amino acids, proteins, and peptides. These forms are released into water by living organisms and through decomposition. TKN data may be found in Figure 39.

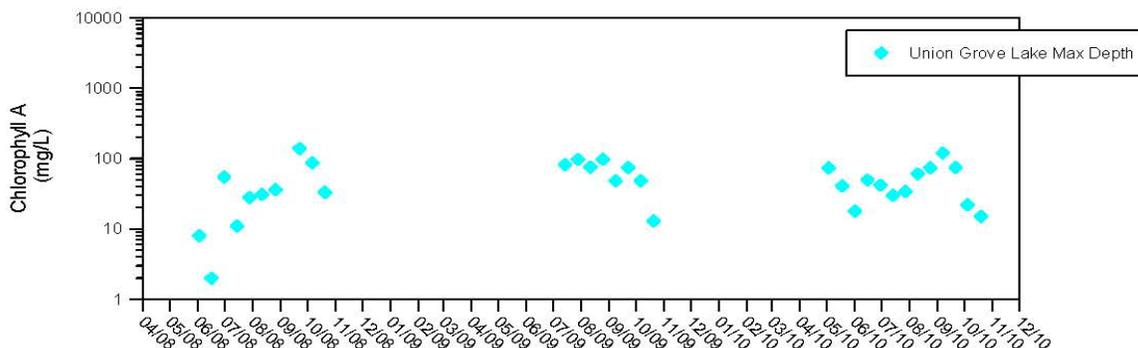
Figure 40 shows project results for chlorophyll sampling at Union Grove Lake’s maximum depth site. Chlorophyll *a* concentration is often used to approximate algal biomass and can indicate the relative productivity and condition of a lake. Potential problems with high chlorophyll *a* concentrations include unsightly surface blooms, itching upon skin contact, foul odor, and toxicity from certain cyanobacteria, or blue-green algae.

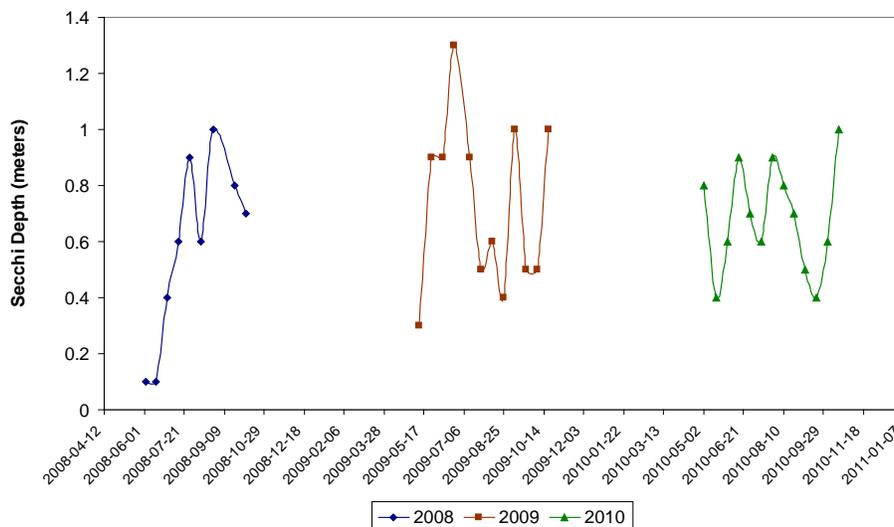
Secchi depth is used to determine the clarity of a lake by lowering a special disc into the water and recording the depth at which it is no longer visible. Water clarity is affected by the color of the water and by organic and inorganic materials suspended in the water column. Secchi depth is often used as an indicator of overall algal abundance and an estimator of general lake productivity. Figure 41 shows Secchi data from all three sampling seasons of the project. A smaller Secchi value indicates poorer clarity conditions.

Union Grove Lake's mean Secchi depth of 0.6 meter (Figure 51) compares to an average of 1.2 meters for all Iowa lakes surveyed, suggesting that during normal summer conditions, Union Grove Lake may have higher abundance of algae and lake productivity.

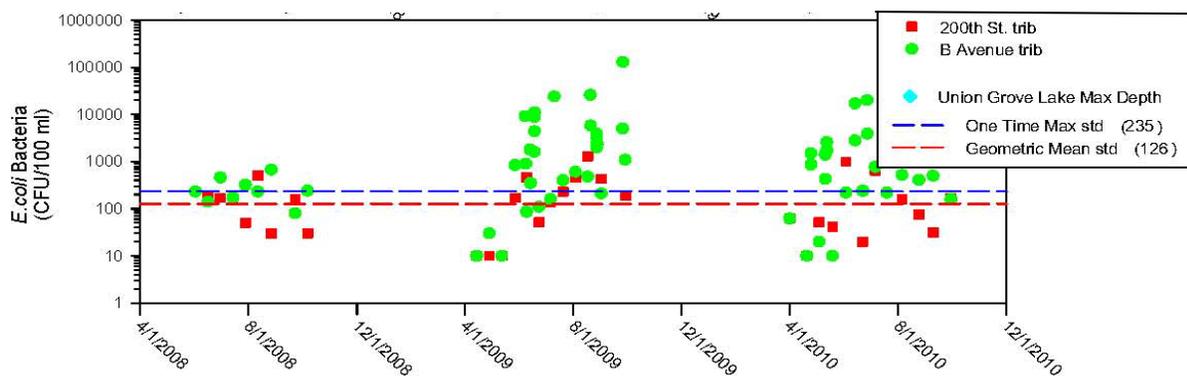
Figure 42

The U.S. Environmental Protection Agency has recommended that *E. coli* bacteria be used to assess the likelihood of risks to human health from exposure to water containing *E. coli*. The presence of this indicator merely suggests that as *E. coli* bacteria levels increase in water, there is an increased likelihood that disease-causing pathogens may be present. *E. coli* concentrations at the two tributary sampling sites may be found in Figure 42. Figure 43 depicts *E. coli* sampling results from Union Grove Lake’s beach with the Single Sample Maximum Standard of 235 MPN/100ml indicated in red. Figure 44 shows data from the same timeframe with the Geometric Mean Standard of 126 MPN/100 ml indicated in red.

Sampling at the tributary sites showed *E. coli* levels slightly higher at B Avenue than 200th Street (Figure 42). During three seasons of scheduled sampling, 14 of 33 B Avenue samples exceeded the state water quality standard. Storm event samples from this site revealed concentrations even more pronounced. *E. coli* tended to increase rapidly after rainfall events and levels were always higher in samples collected as the stream rose compared to samples collected as the stream fell back to normal. During base flow conditions, *E. coli* levels were generally below Iowa's single-sample maximum water quality standard, which is uncommon for streams of their size.

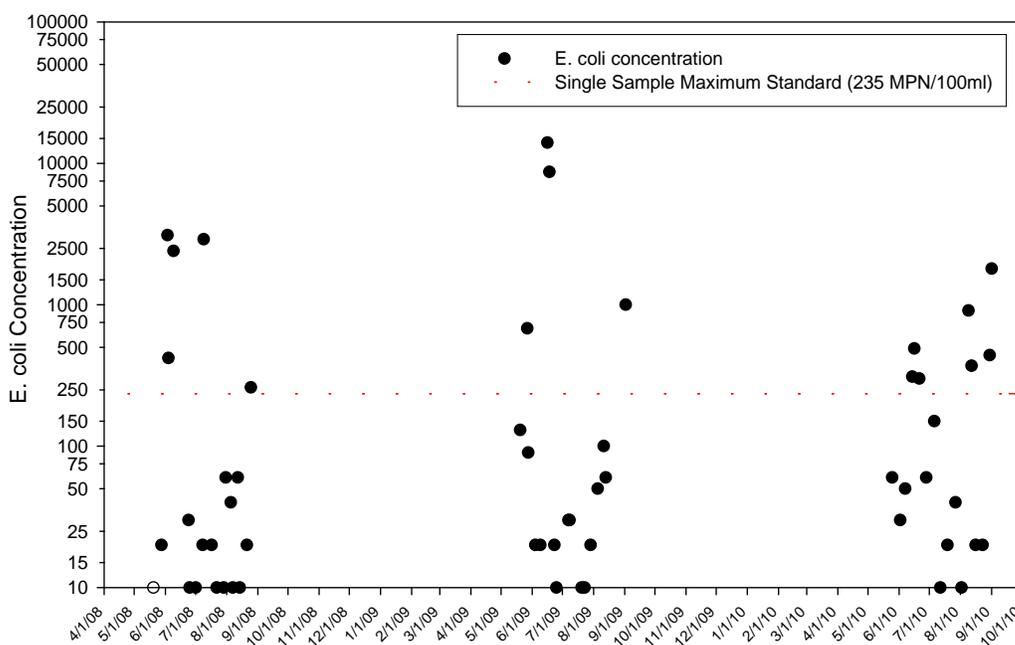
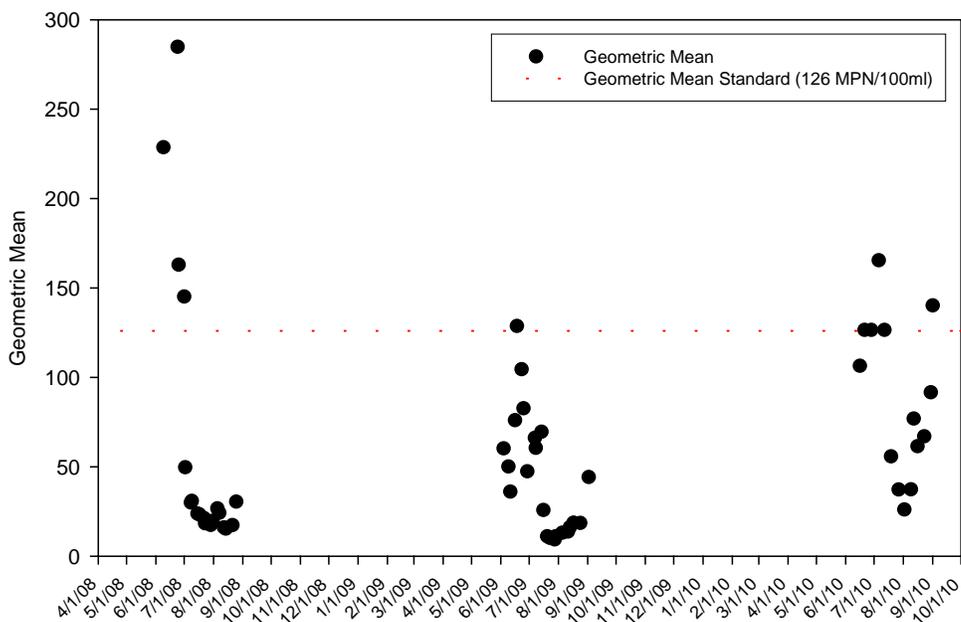
Union Grove Lake beach bacteria levels (Figures 43 and 44) appeared highest in the spring during 2008 and 2009 and were more widespread during 2010. The beach had bacteria warnings posted four times each in 2008, 2009, and 2010. High levels of bacteria in 2008 (Figure 45) paralleled very closely with rainfall events. 2009 (Figure 46) and 2010 (Figure 47) bacteria counts did not correspond as well with the rainfall data. 2009 showed the highest bacteria levels in spring, with relatively low levels present until September. In 2010, late summer and fall rains may have caused increases in *E. coli* levels, but for the remainder of the sampling season, bacteria levels stayed very consistent.

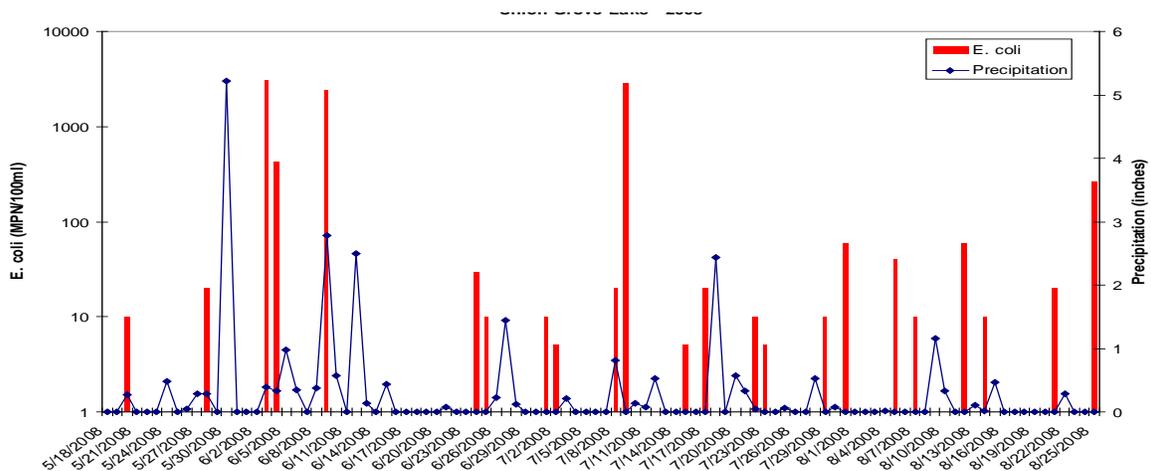
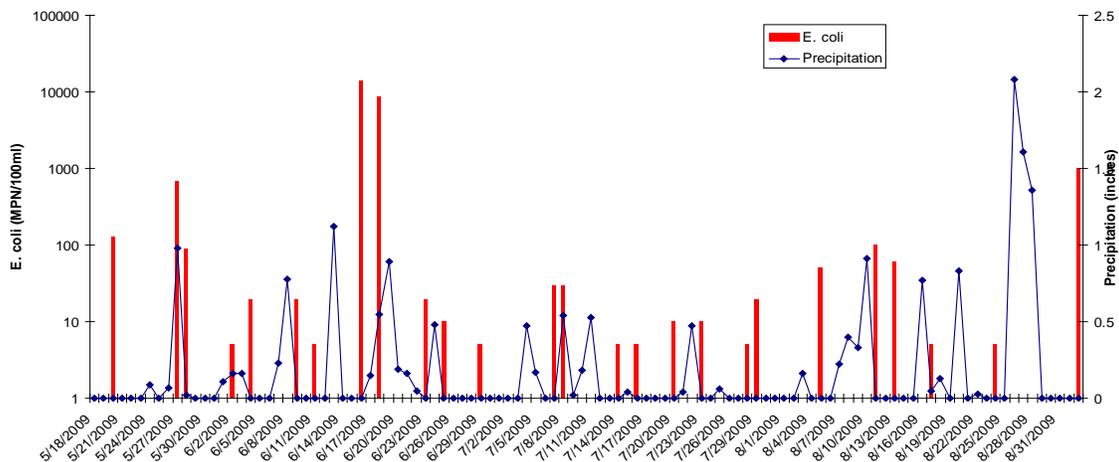
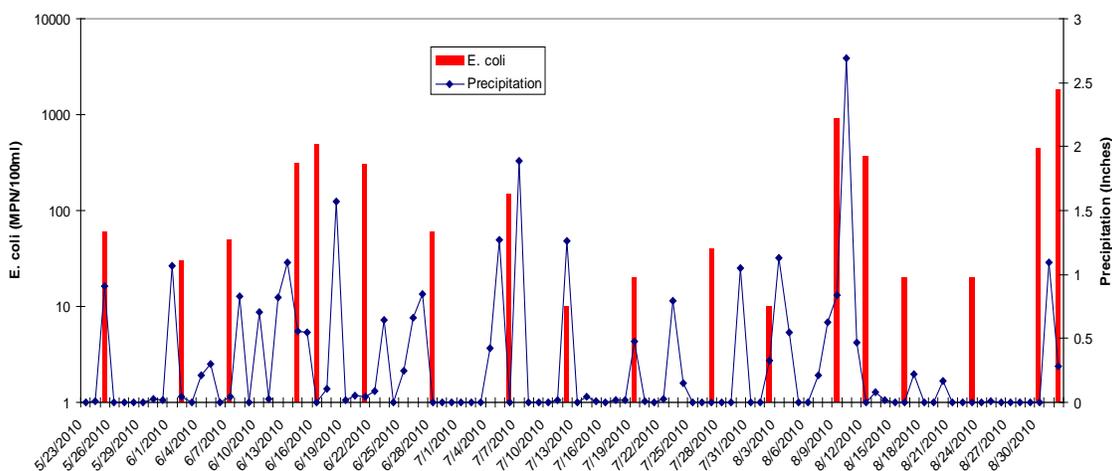
Figures 45 through 47 (2008 through 2010) show the correlation between local rainfall (Toledo, Iowa weather station) and Union Grove Lake beach *E. coli* levels during Project 086-3.08.

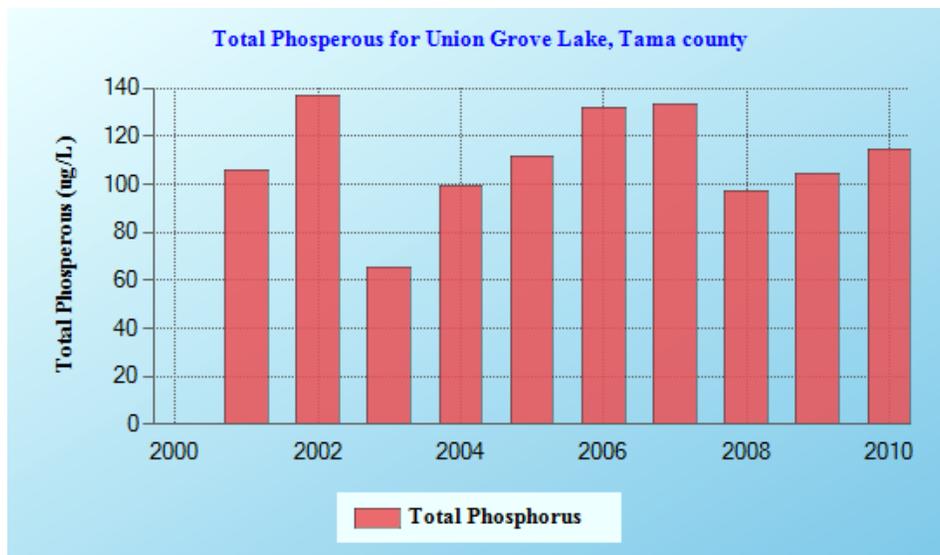
Figure 48

Total Phosphorus results for Union Grove Lake may be found in Figure 48. Phosphorus is often the limiting nutrient for algal growth, and at values above 30 parts per billion (ppb), lakes generally begin to exhibit conditions indicative of eutrophic, or highly productive, systems.

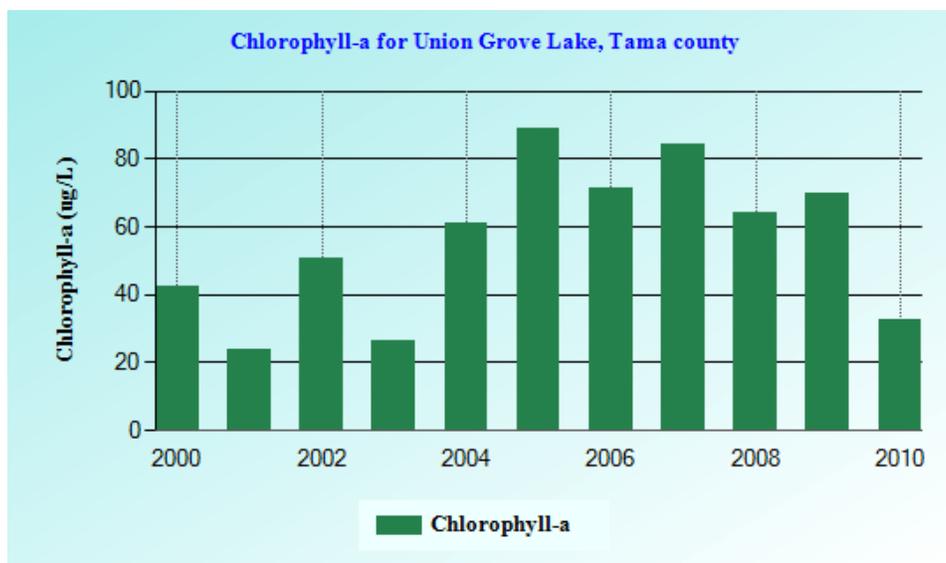
Figure 49 shows data regarding Union Grove Lake’s chlorophyll *a* concentrations.

Union Grove Lake's chlorophyll *a* concentrations (Figure 49) ranged from 5 ppb to 231 ppb during this 10-year period with a summer mean of 64 ppb from 38 observations. The average for all Iowa lakes is 44 ppb. These data indicate that Union Grove Lake may have higher chlorophyll *a* concentrations and lake productivity compared to other Iowa lakes during normal summer conditions.

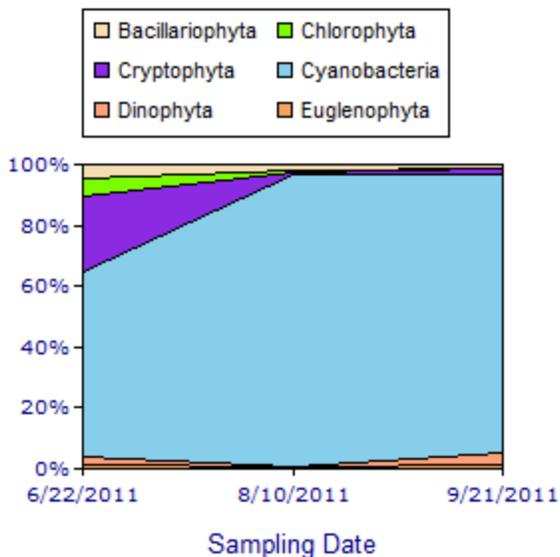
Figure 50

The Limnology Laboratory also sampled phytoplankton from 2000 to 2011. Its 2011 composition results presented as percentages of total wet mass are found in Figure 50. It shows the phytoplankton genera for three 2011 sampling dates, June 22, August 10, and September 21.

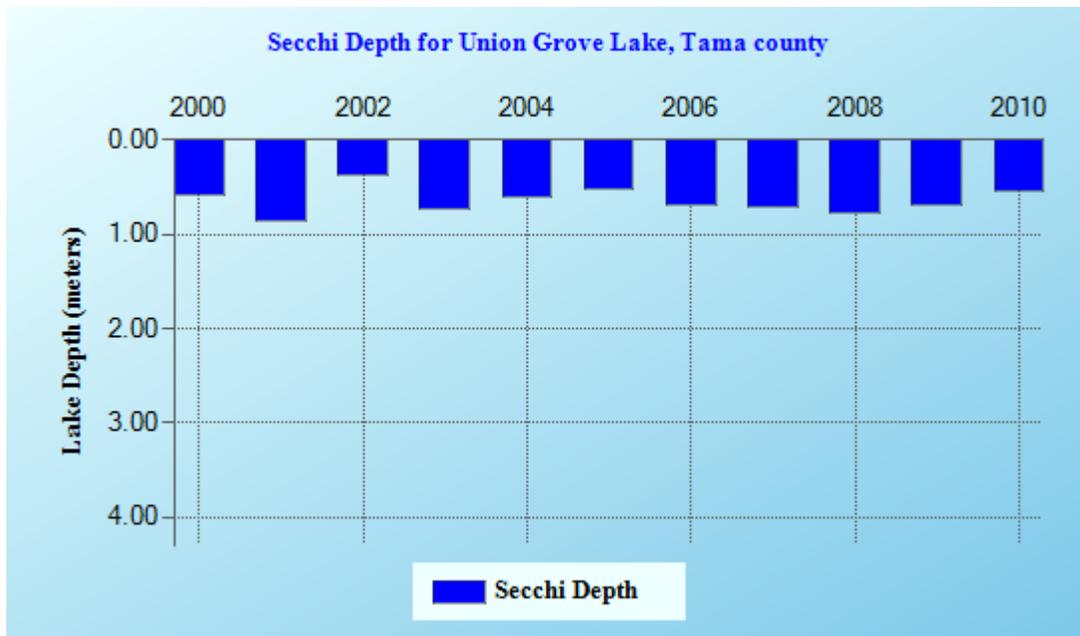
Union Grove Lake’s water clarity values ranged from 1.4 to 0.3 meters (4.6 to 1.0 feet) during this 11-year period with a summer mean Secchi depth of 0.6 meters (2.1 feet) from 40 data observations. Figure 51 shows each year’s mean as depth from the lake surface.
