Union Grove Lake Watershed

Watershed
Management Plan
2012-2026
June 2012

Tama Soil & Water
Conservation District, Iowa

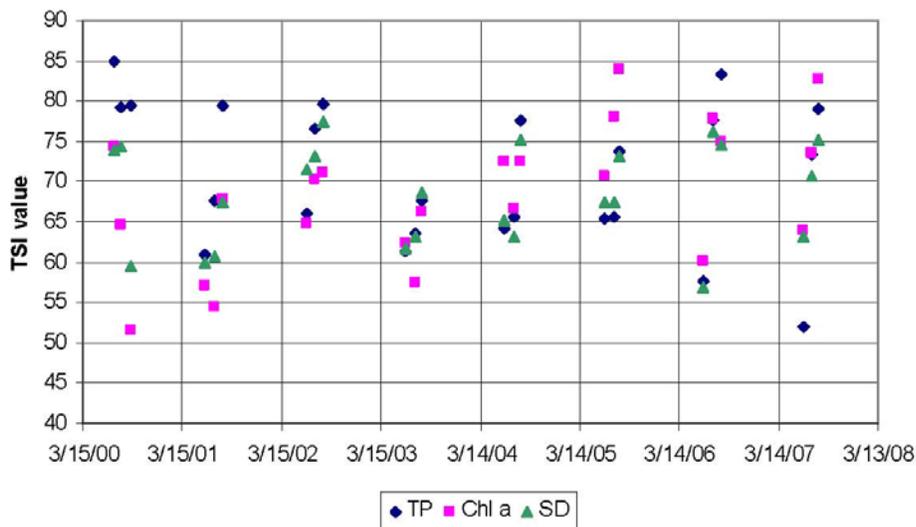
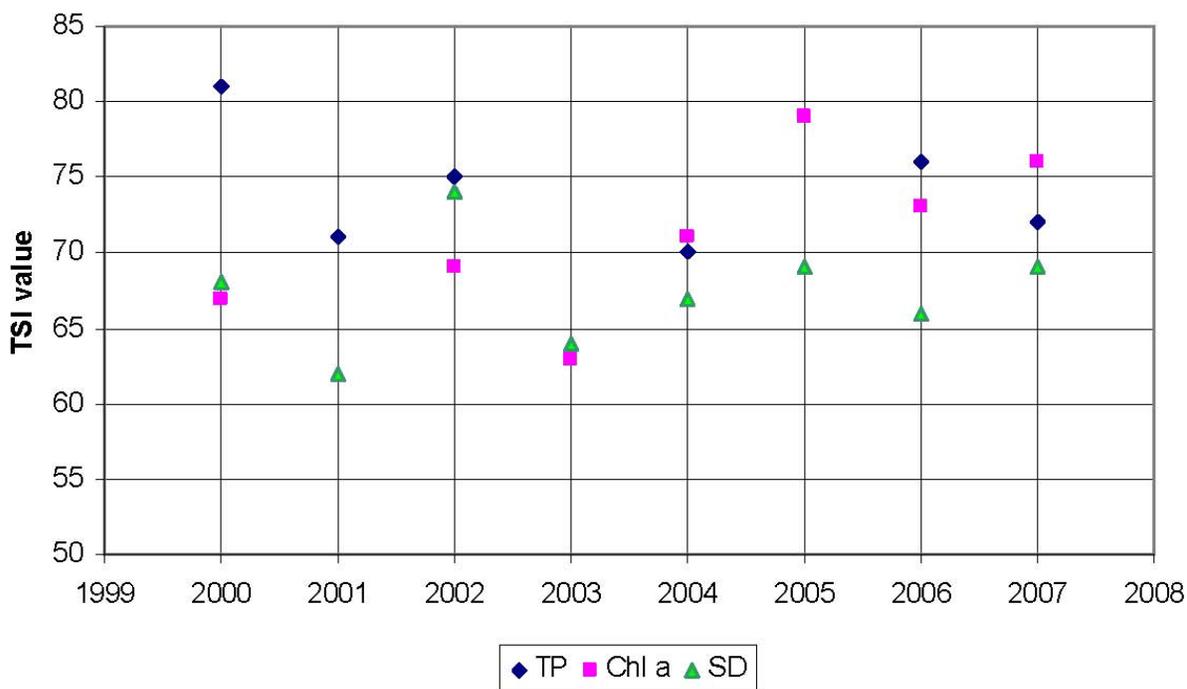
Carlson’s Trophic State Index (TSI) is used to relate algae, as measured by chlorophyll; transparency, as measured by Secchi depth; and total phosphorus to one another and to set water quality improvement targets. TSI from ISU Lake Study data may be found in Figure 57 with the seasonal averages in Figure 58.

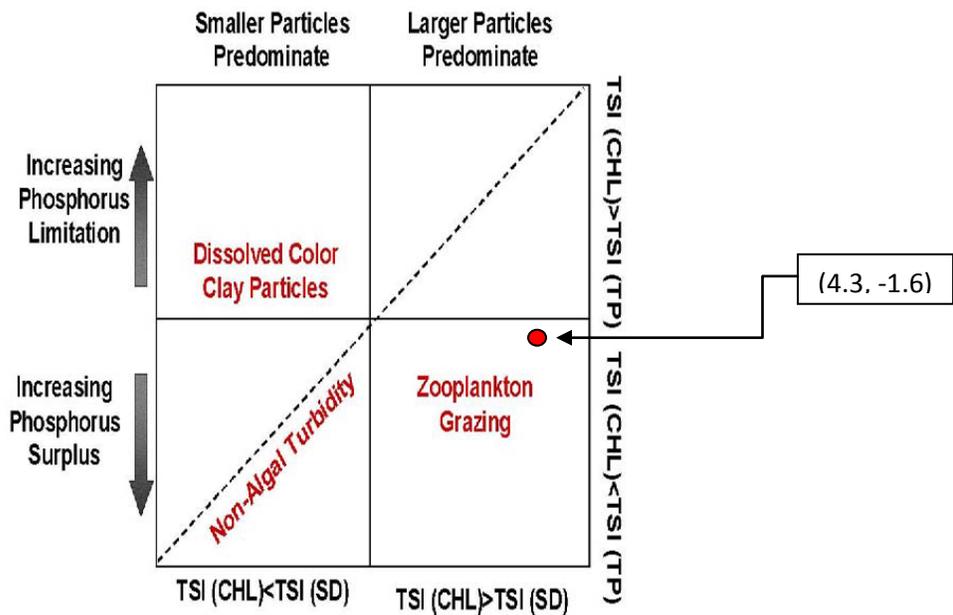
Figure 60

Evaluation of the Union Grove Lake monitoring data indicates the lake's limiting nutrient for algae growth is phosphorus. A plot that compares the three TSI variables and interprets the differences between them is shown in Figure 60. Union Grove Lake's variables show this lake system plots in the lower right quadrant. A point in this location (4.3, -1.6) indicates that there is a slight surplus of phosphorus, meaning that not all available TP is expressed as algae. This plot also indicates non-algal turbidity is a factor and that zooplankton is grazing on the algae.

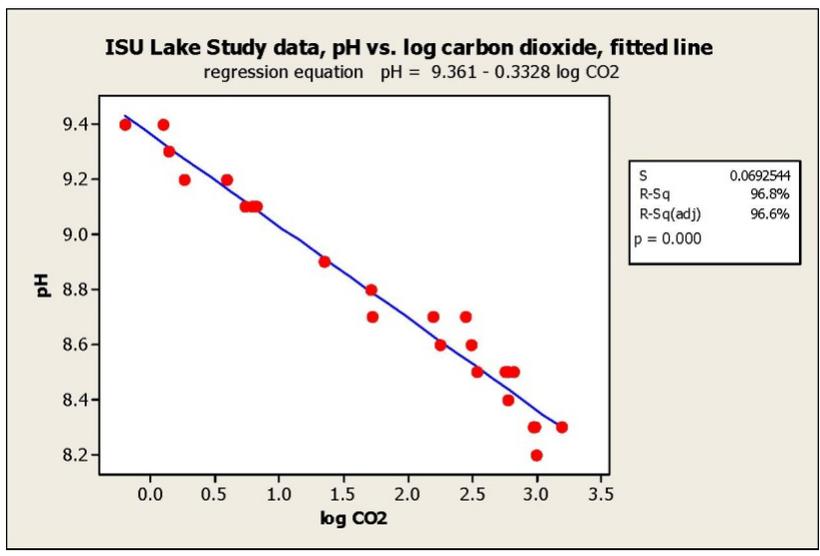
The USGS continuous data set from Summer 2008 does not include measurements of dissolved carbon dioxide, but ISU Lake Study 2000-2007 data do. The regression shown in Figure 61 shows a strong inverse correlation between pH and carbon dioxide. This is predicted in a natural water system where pH is driven by carbonate equilibrium. As shown in the WASP modeling section of the TMDL’s Appendix D, the dissolved oxygen-dissolved carbon dioxide dynamics are the consequence of algal photosynthesis and respiration. Therefore, decreasing the mass and duration of algal blooms in Union Grove Lake will control the diurnal rises in pH that exceed the water quality standard criteria.

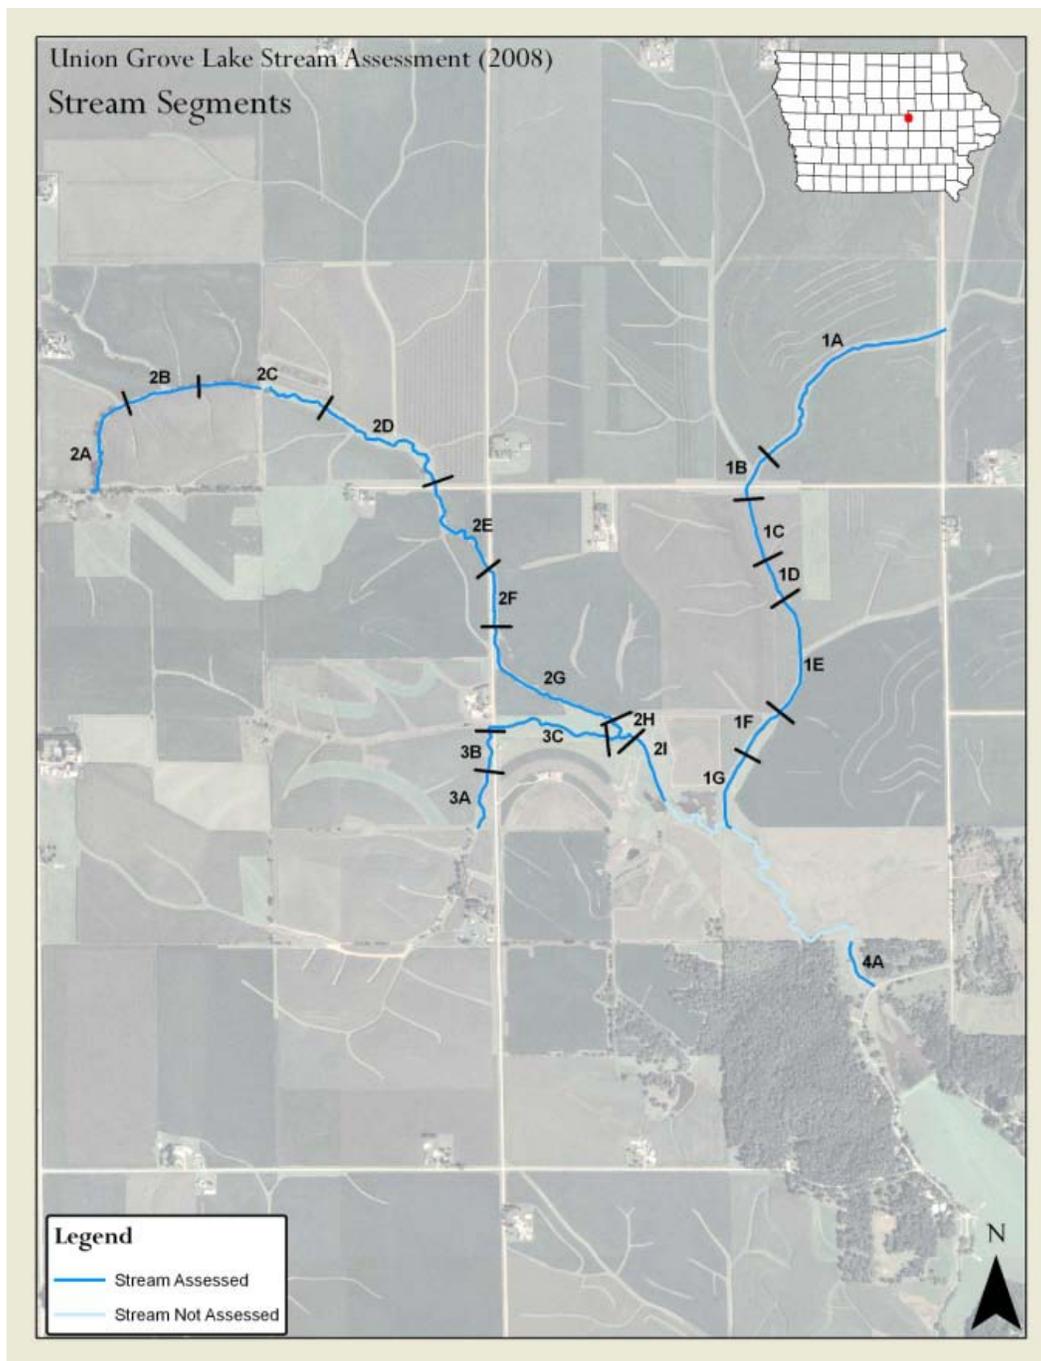
Of the 24 stream and buffer parameters examined during the watershed’s RASCAL, five key parameters--stream substrate, streambank stability, riparian buffers, adjacent land cover, and knickpoints--were determined illustrative of existing conditions and were used for evaluating potential water quality threats in the watershed. For RASCAL purposes, Figure 62 illustrates how the surveyed steams are divided into segments according to common conditions.

For the most part, the streambanks in Stream Segments 1,3, and 4 are relatively stable. However, according to the RASCAL data and LiDAR imagery, several problems exist along Segments 2B through 2E. There are numerous knickpoints within these segments along with areas of channel degradation and streambank erosion. These issues result from significant hydrologic changes in a watershed. Of the potential causes, the most probable is stream straightening. Straightening a stream may make the adjacent farmland more farmable, but it also shortens the overall length of the stream, increasing the streambed slope and the rate of flow within the channel. It is likely this increased rate of flow generated the numerous knickpoints found in Segments 2C through 2E. As knickpoints cut further down into the streambed, the toes of adjoining streambanks typically erode, causing the bank themselves to become unstable and slough into the stream. The RASCAL found this in Segments 2B through 2E and is further supported by the channel gradient chart found in Figure 64. The streambed elevation data indicates major grade changes are occurring within Segments 2B and 2C.

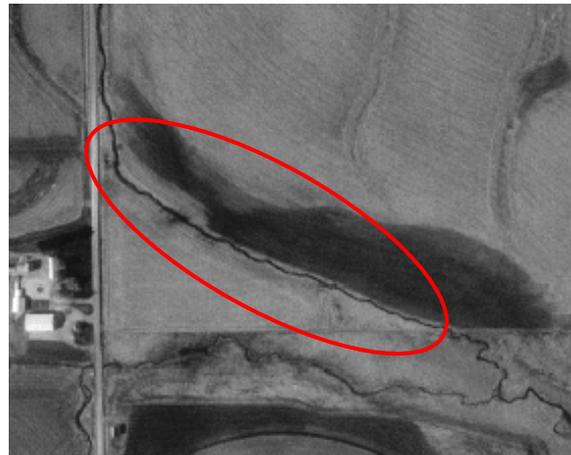
Figure 66

same site, 1990

According to historical aerial photographs, an attempt to straighten Deer Creek occurred in Section 29 of Spring Creek Township (T85N R16W) on Segment 2G sometime between 1930 and 1990 (Figures 65 and 66). Another occurred around 2005 in Spring Creek Township’s Section 30 on Segment 2E (Figures 67 and 68).

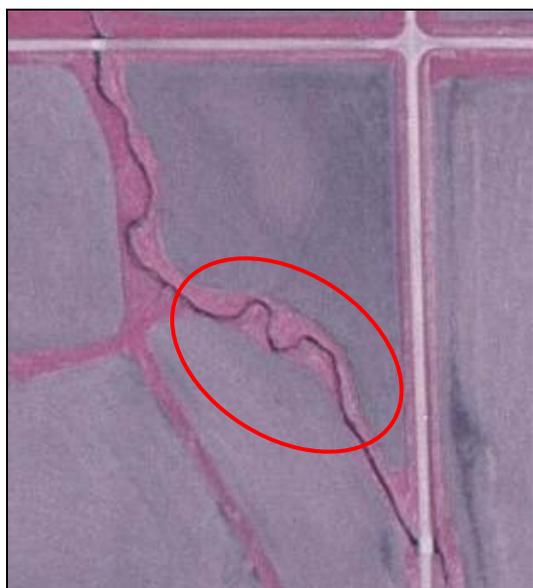
Figure 67

Deer Creek 2002, NE ¼ Section 30, Spring Creek Twp same site, 2006

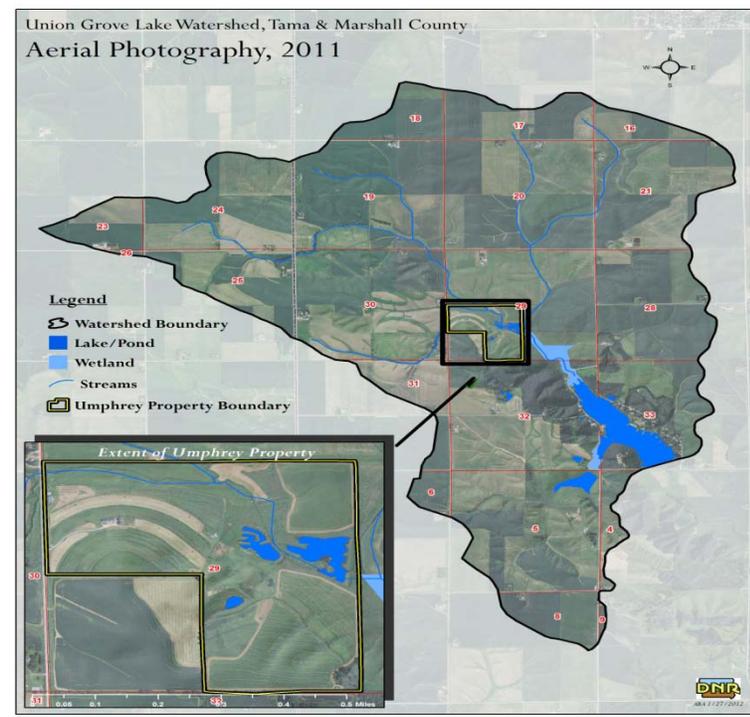
Deer Creek Wetland Catchment (83 acres) – Also known as Umphrey Property

Over the past few years rumors of potential change in ownership has caused some interest in pursuing a conservation easement or land acquisition for the property. To justify this potentially high expense, IA DNR GIS staff calculated 9 different land use scienarios. Each scienario shows the potential change in sediment and phosphorus delivery to Union Grove Lake.

Scenario	Change Area	Acres Changed	Sed. Delivery	Change
#1 (Baseline condntions)	None	None	438	0
#2 (CRP to CB)	Terraced Fields	32	452	+15
#3 (CRP to CB)	Entire Property	83	479	+40
#4 (CRP to CB, Wetland Removed)		83	1910	+1472

Please note the existing wetland, in its existing condition, is preventing approximately 1472 tons of sediment from reaching Union Grove Lake each year, and thus 1767 pounds of TP annually.

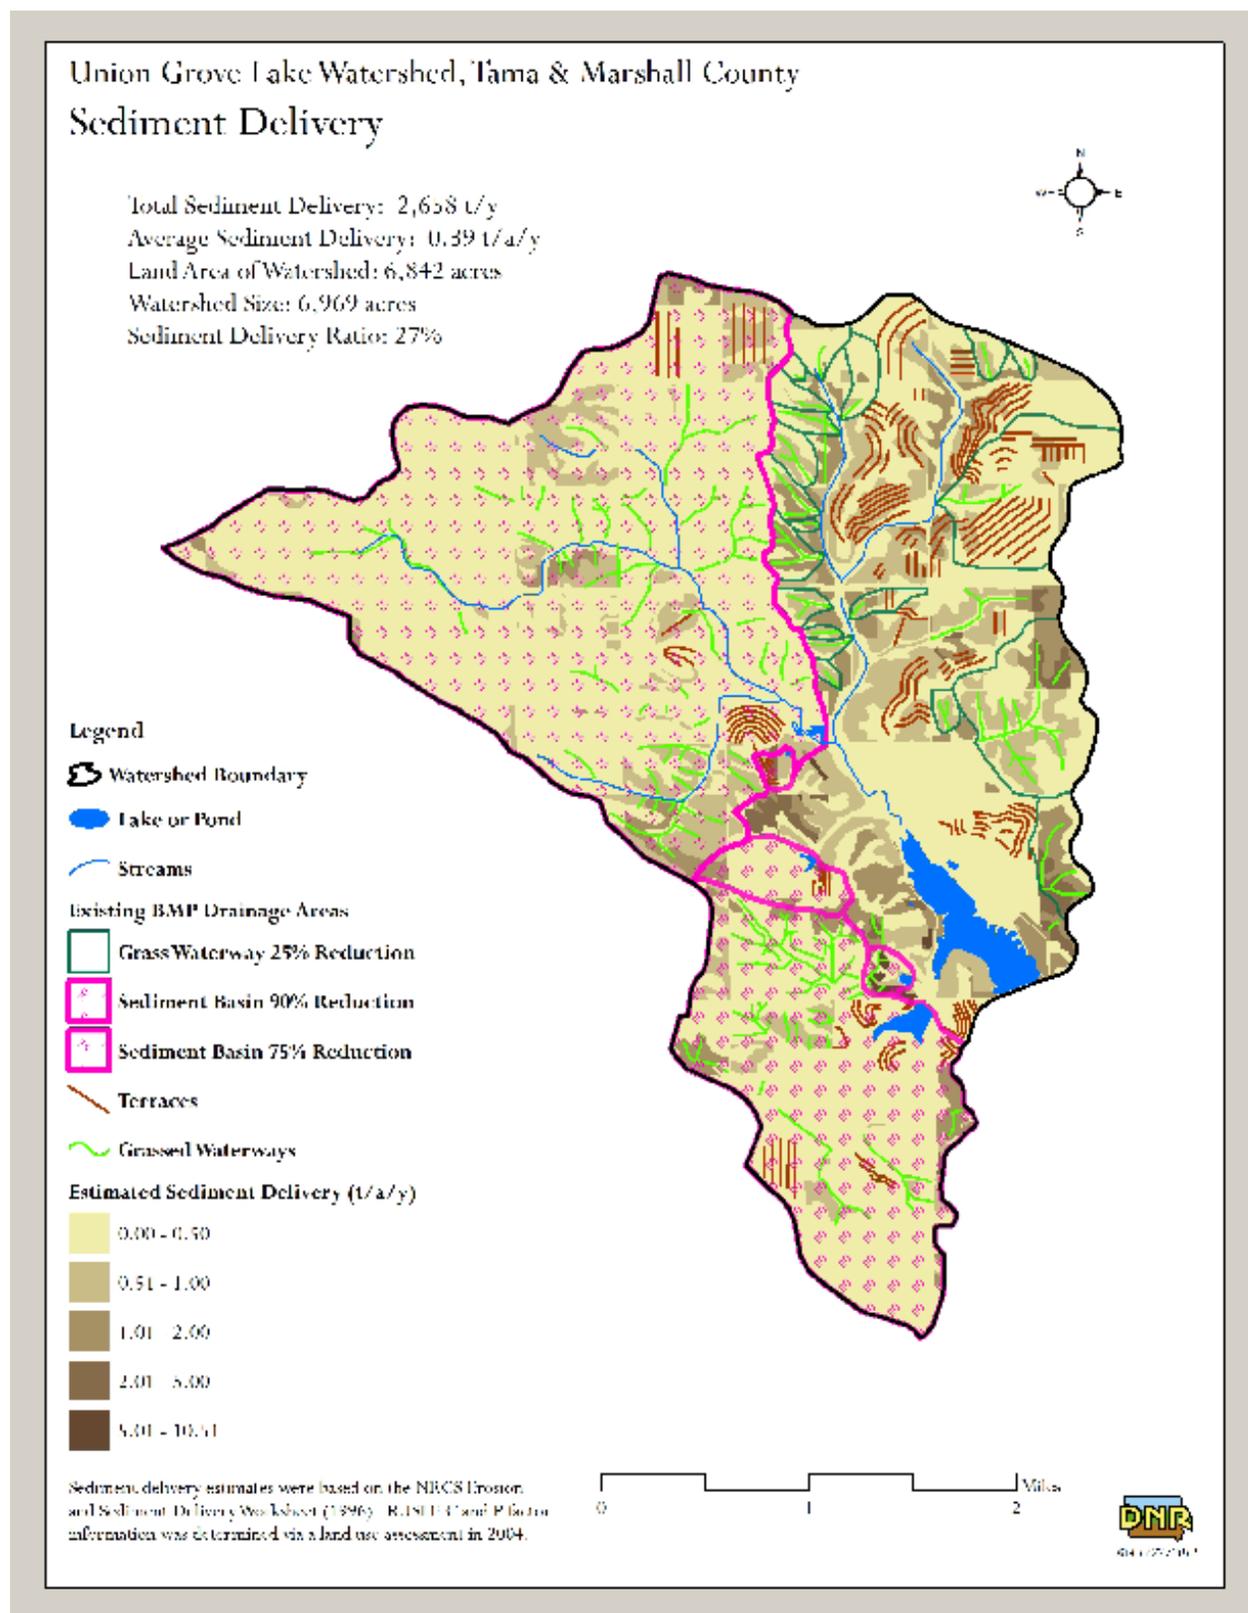
Figure 73

Considering this data and the constructed wetland complex discussed in Section 4.4, IDNR updated the watershed’s estimated total sediment delivery in January 2012 (Figure 73). The data indicates the watershed’s total sediment delivery is approximately 2,658 tons/year, or about 0.4 ton/acre/year. Areas contributing sediment, and therefore phosphorus, to Union Grove Lake are found in darker shades of brown.

This total sediment delivery corresponds with an estimated Total Phosphorus load from the watershed of 3,788 lb/year. Substituting this updated data for the watershed’s contribution to the lake’s TP load found in the TMDL’s Section 3, the estimated TP loads to Union Grove Lake are as found in Figures 74 and 75. According to these estimated figures, while the watershed still contributes to the lake’s TP load, internal recycling within the lake itself appears to be contributing almost half of the system’s Total Phosphorus, as significant a contributor as the entire watershed.

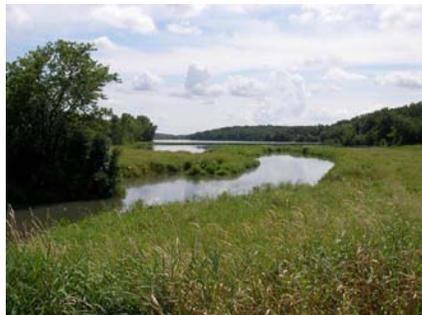
Figure 78

- Remove 50,000 yd³ of sediment upstream from retention dike at Deer Creek influx (Figure 78) and replace shallow open-throat ingress with a constructed wetland complex capable of water level fluctuation.
