Use Attainability Analysis

| 1 Water Body Name | Unnamed Tributary to Linn Creek |
| 2 Segment Description | Mouth to headwaters |

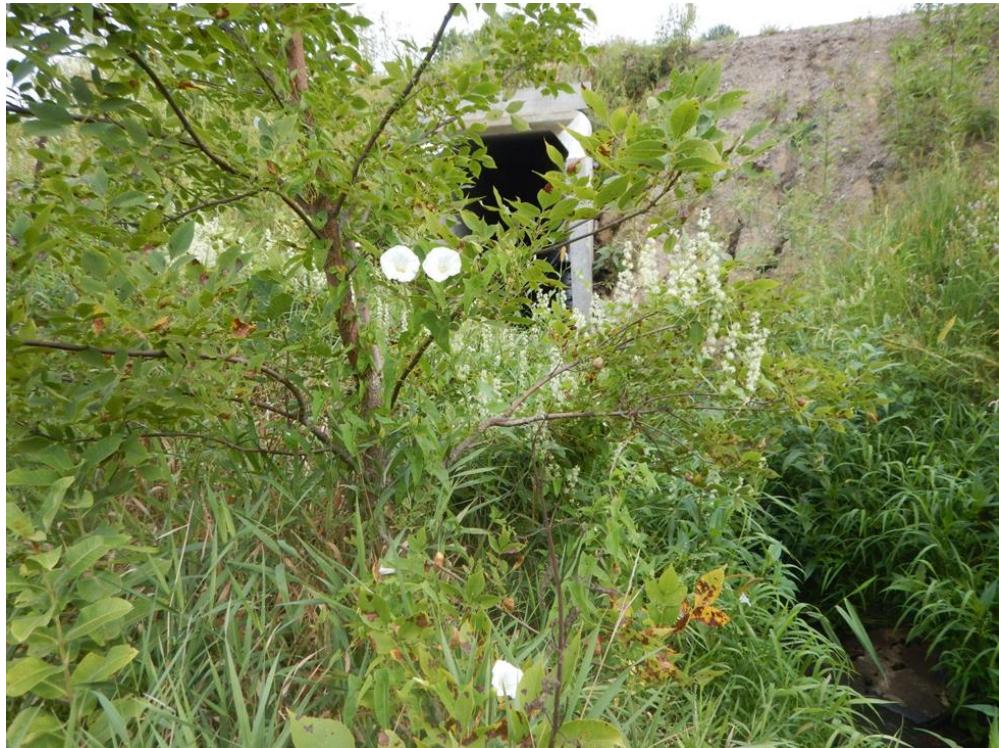
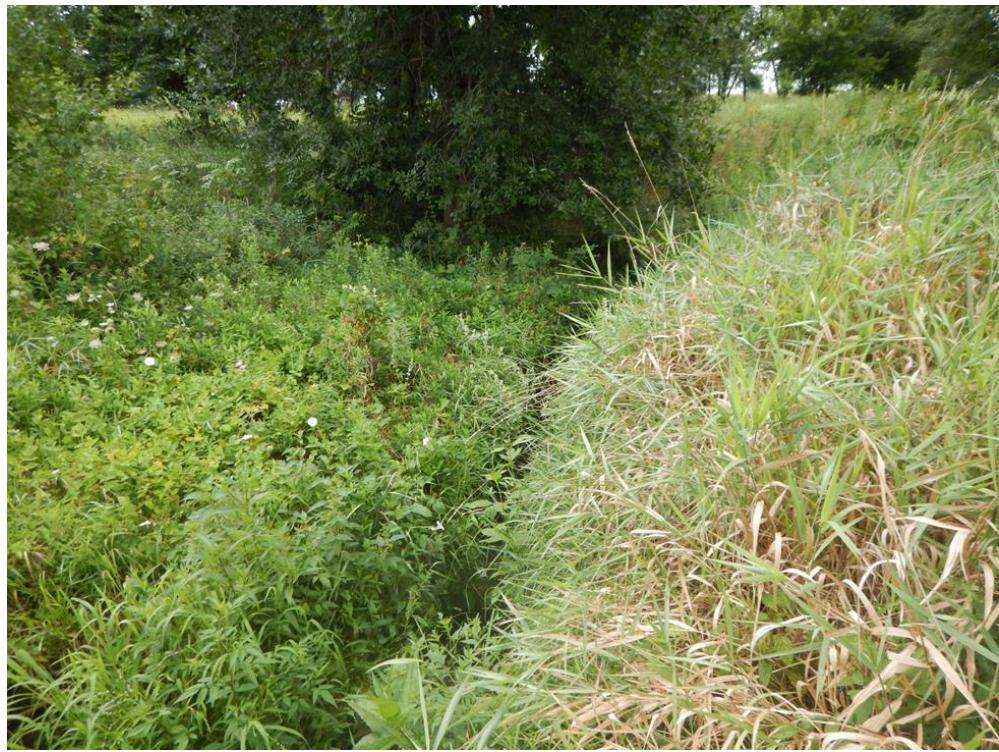
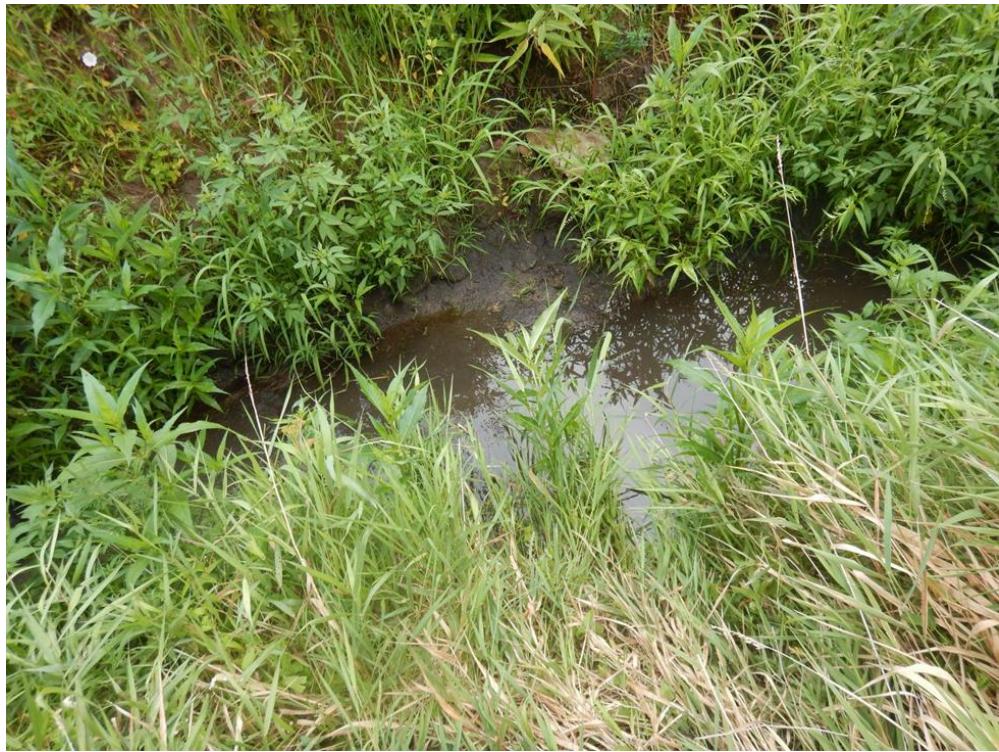
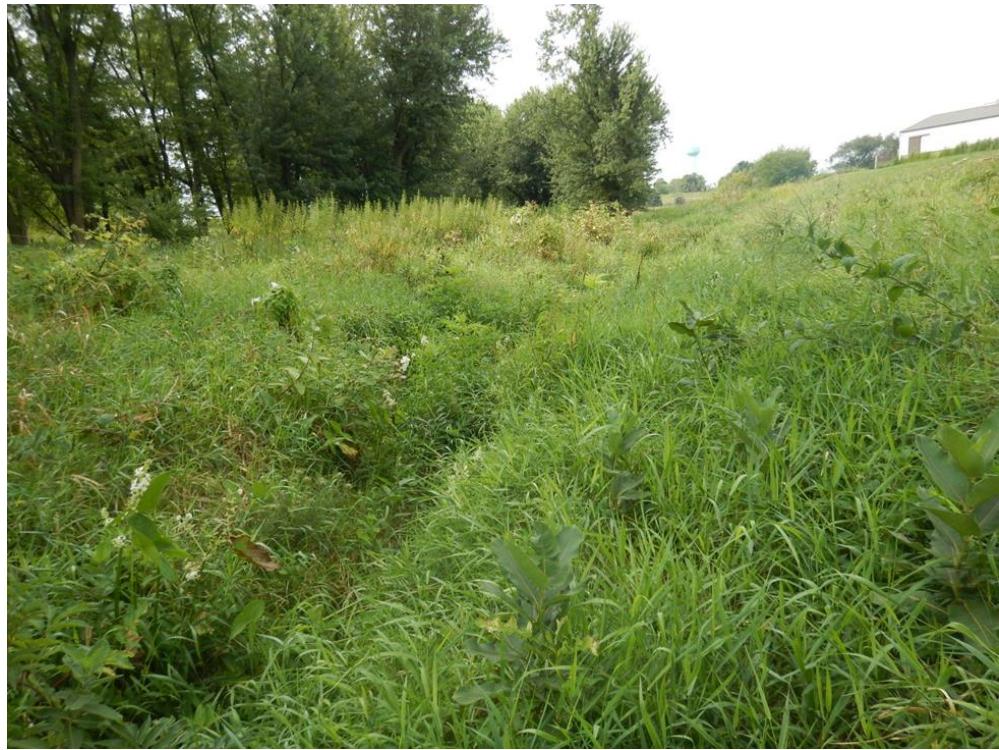
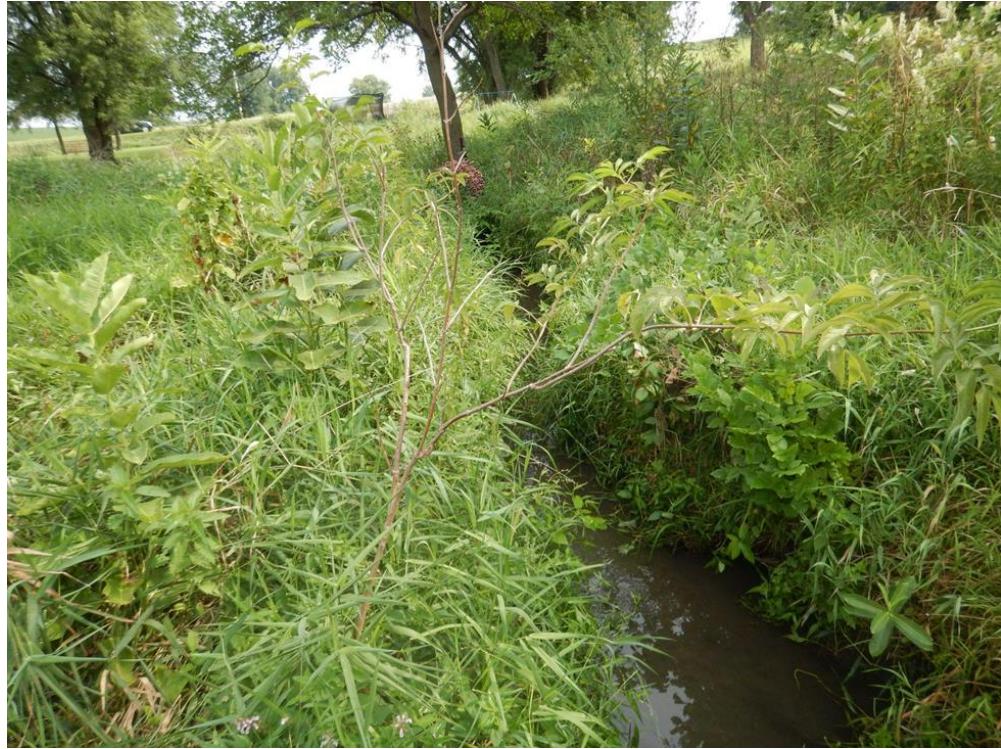
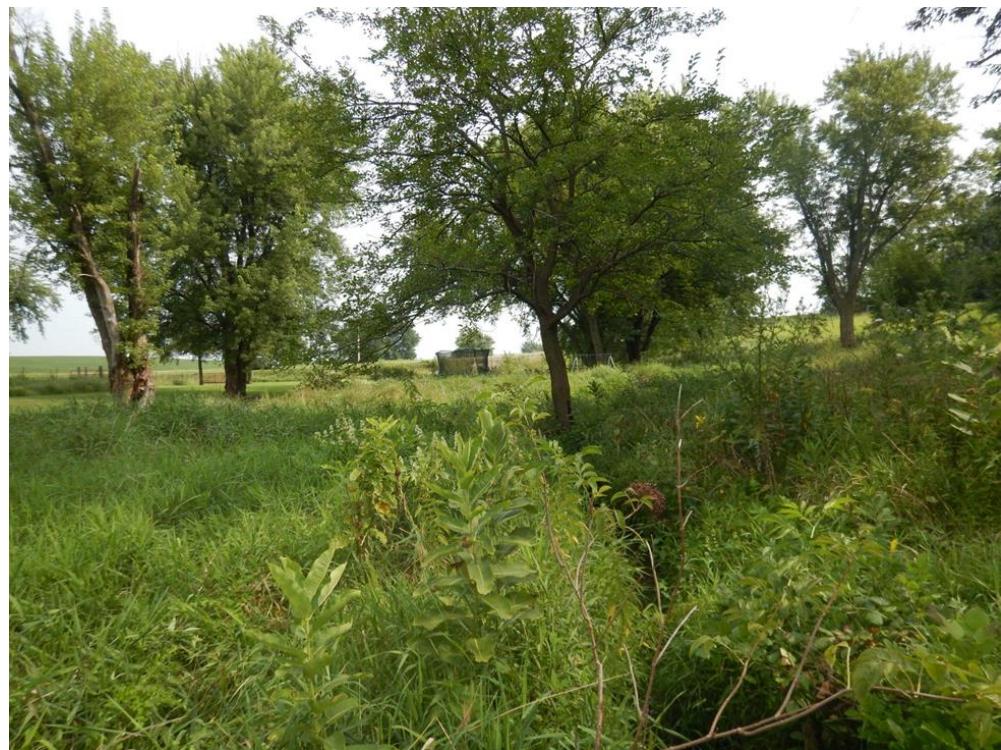
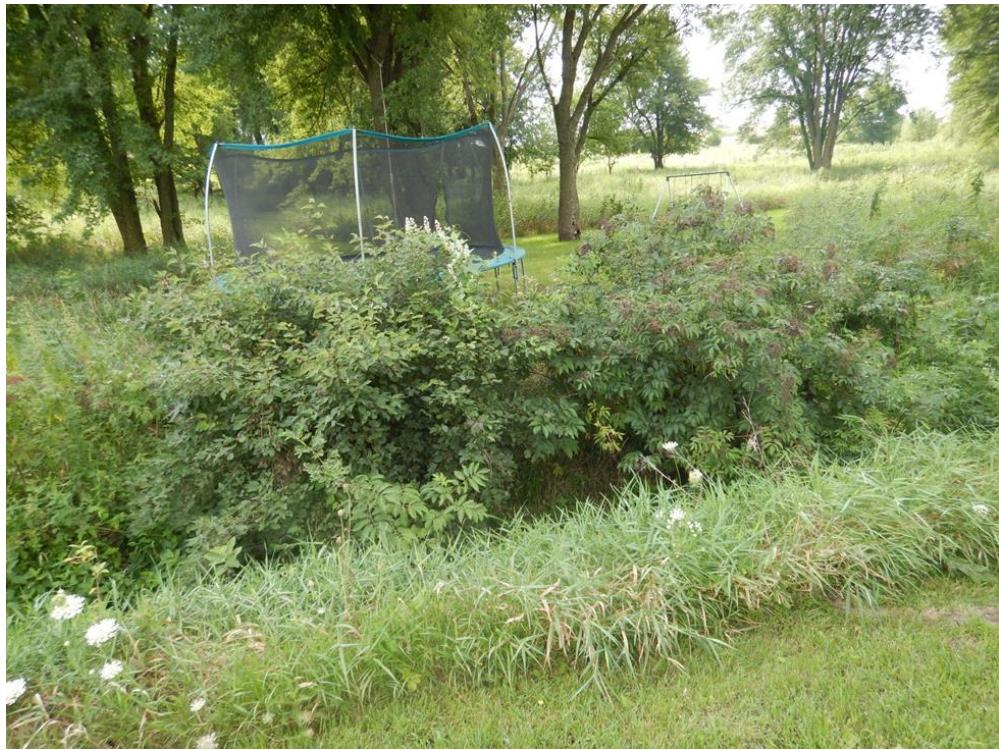
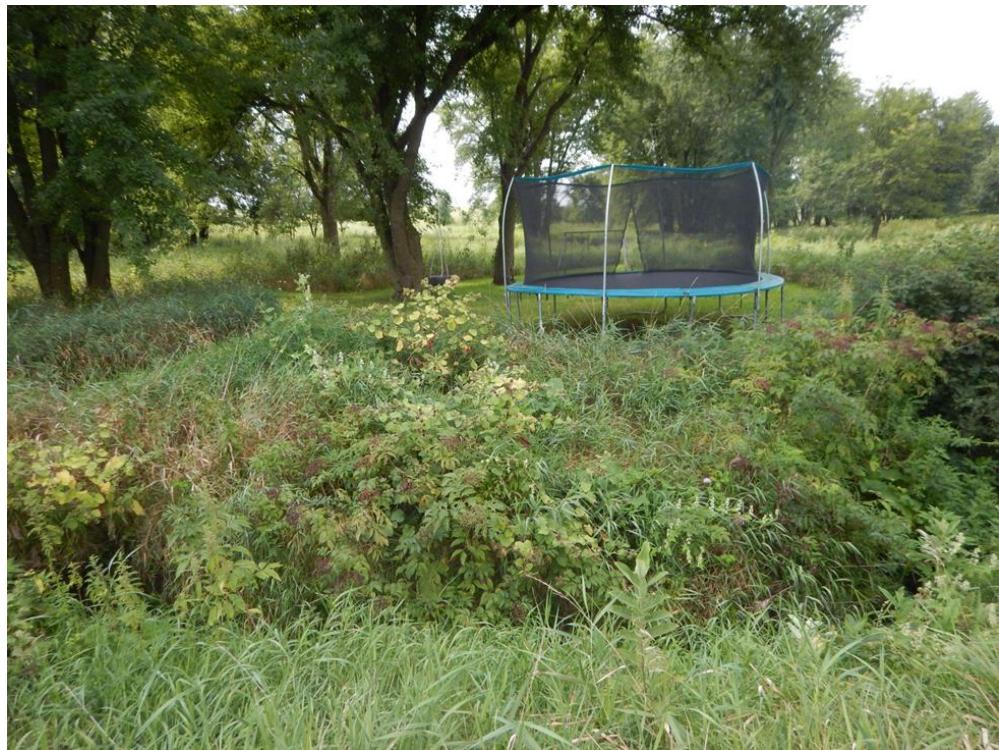
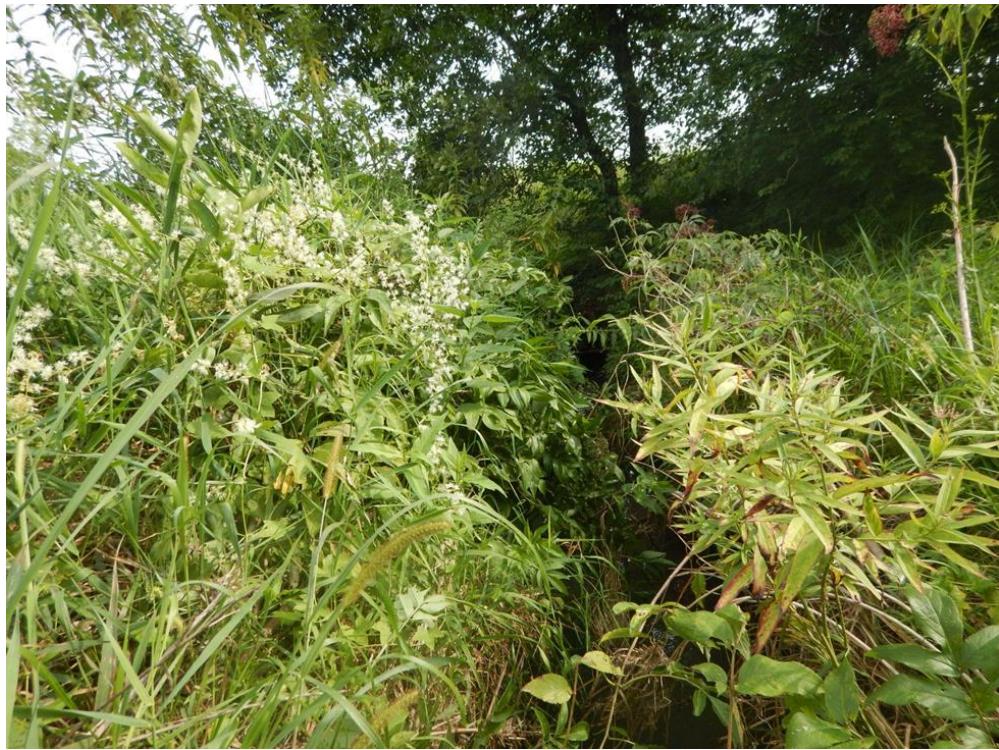
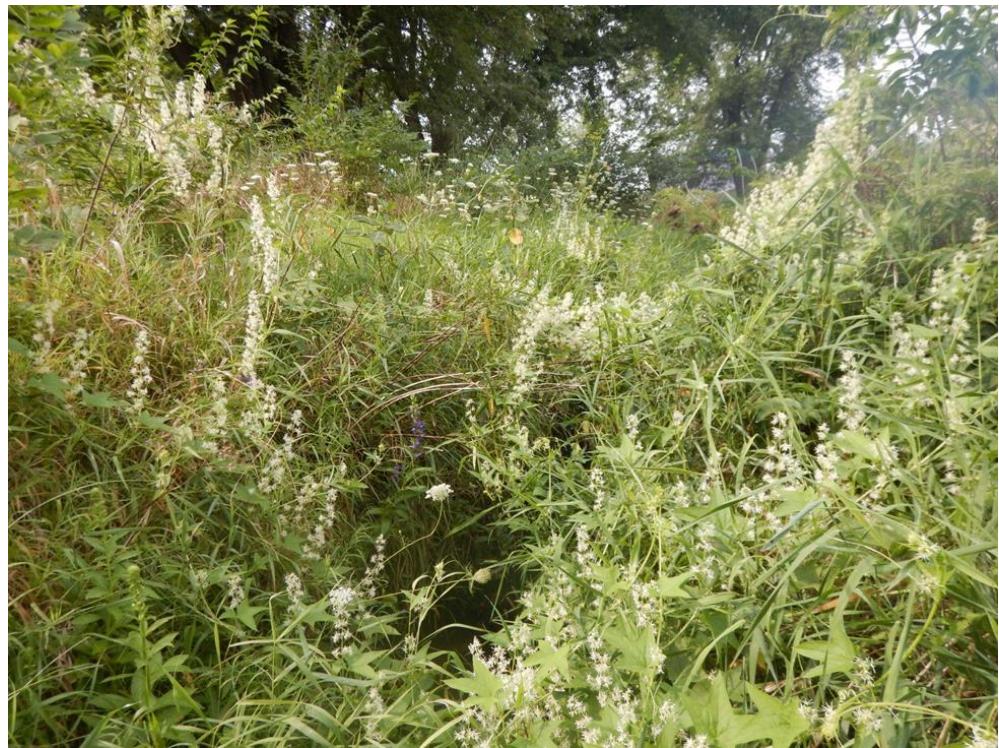
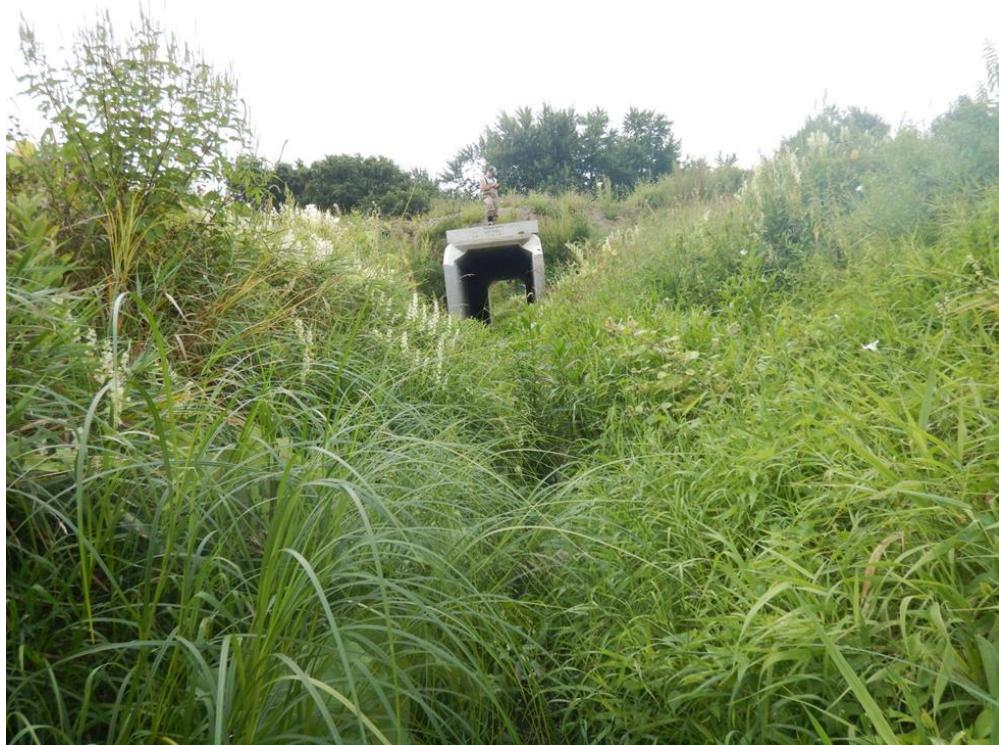
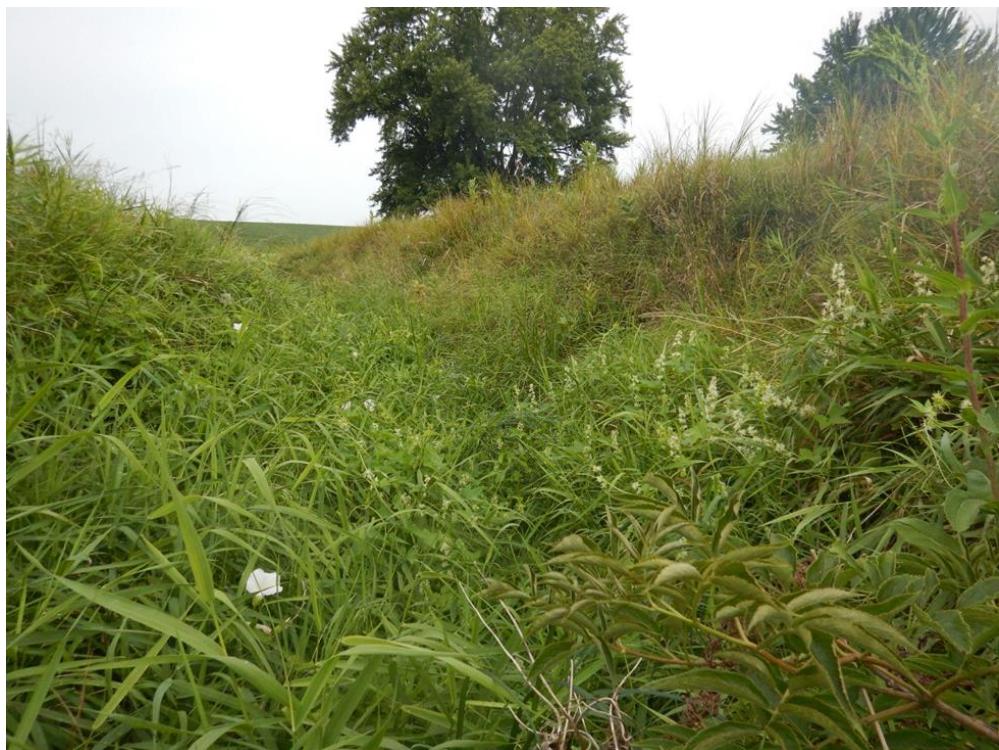
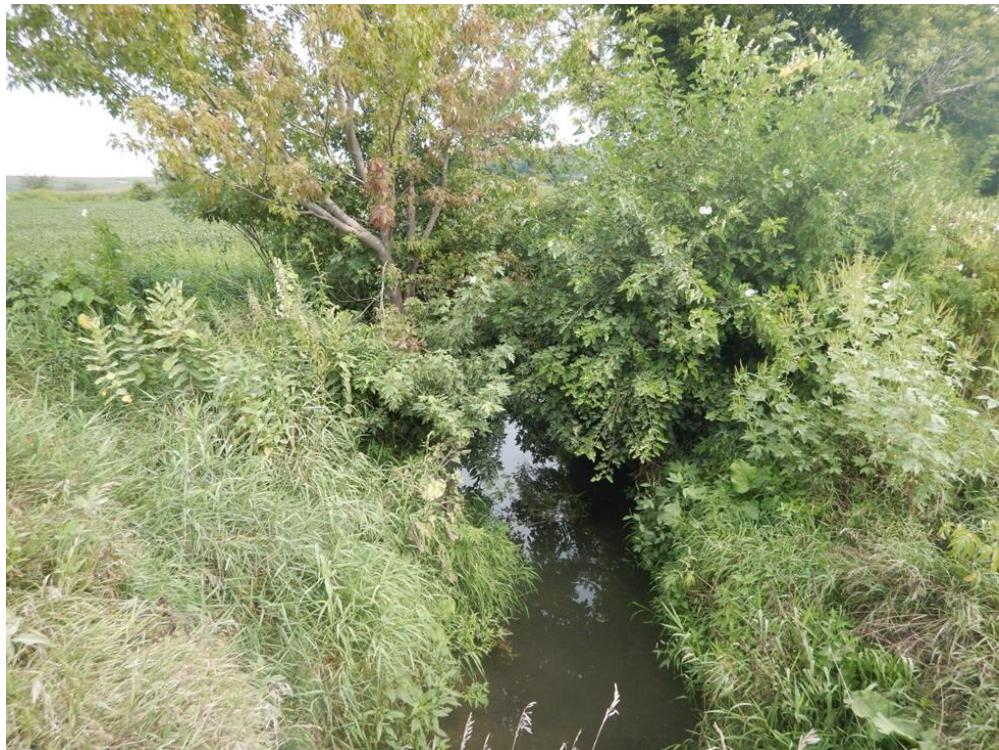
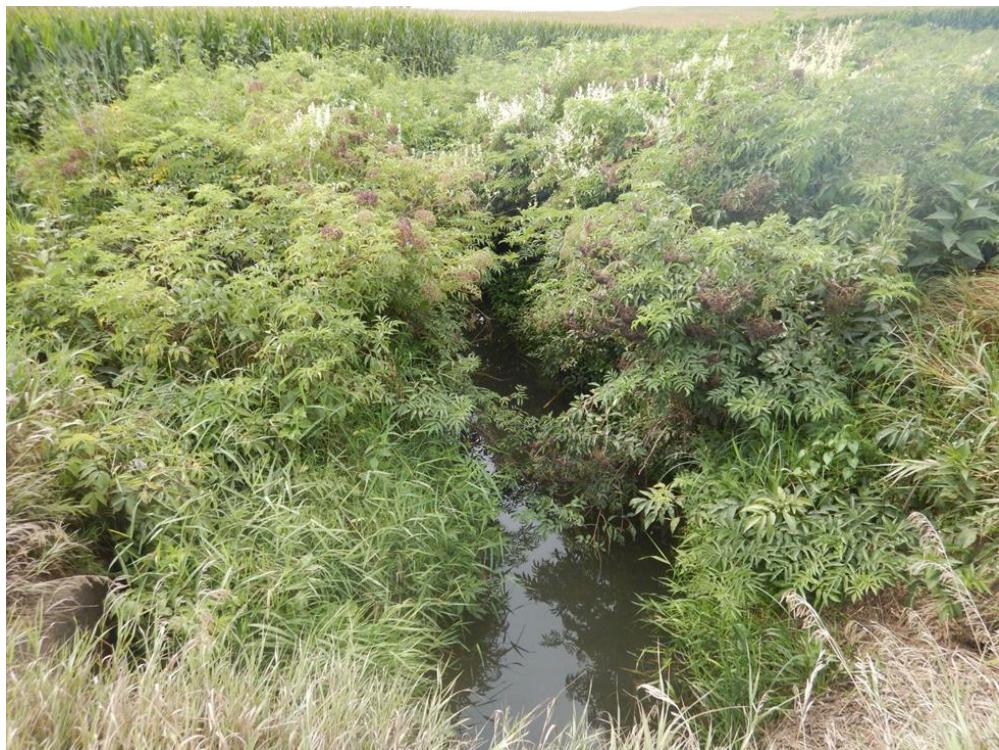
29 Site Photos

| Use | Site parameter | Site ID #1389-1 |
|---|---|---|
| | 22 Stream Habitat (See also: #29 Site Photos) | Stream substrate was a mix of silt sand and gravel upstream and sand and gravel downstream. Lots of overhanging vegetation. Meandering, decent habitat diversity, no really deep pools. |

| Use | Site parameter | Site ID #1389-2 |
|---|---|--|
| | 22 Stream Habitat (See also: #29 Site Photos) | Water too deep to assess. Signs of beaver use. |
