## Use Attainability Analysis

| <b>1 Water Body Name</b> | Unnamed Tributary to Unnamed Tributary to Little Wapsipinicon River |
| <b>2 Segment Description</b> | Mouth to Oran Community Sanitation District outfall |
| <b>8 NPDES Facility and Permit Number (If Applicable)</b> | Oran Community Sanitation District (0900902) |

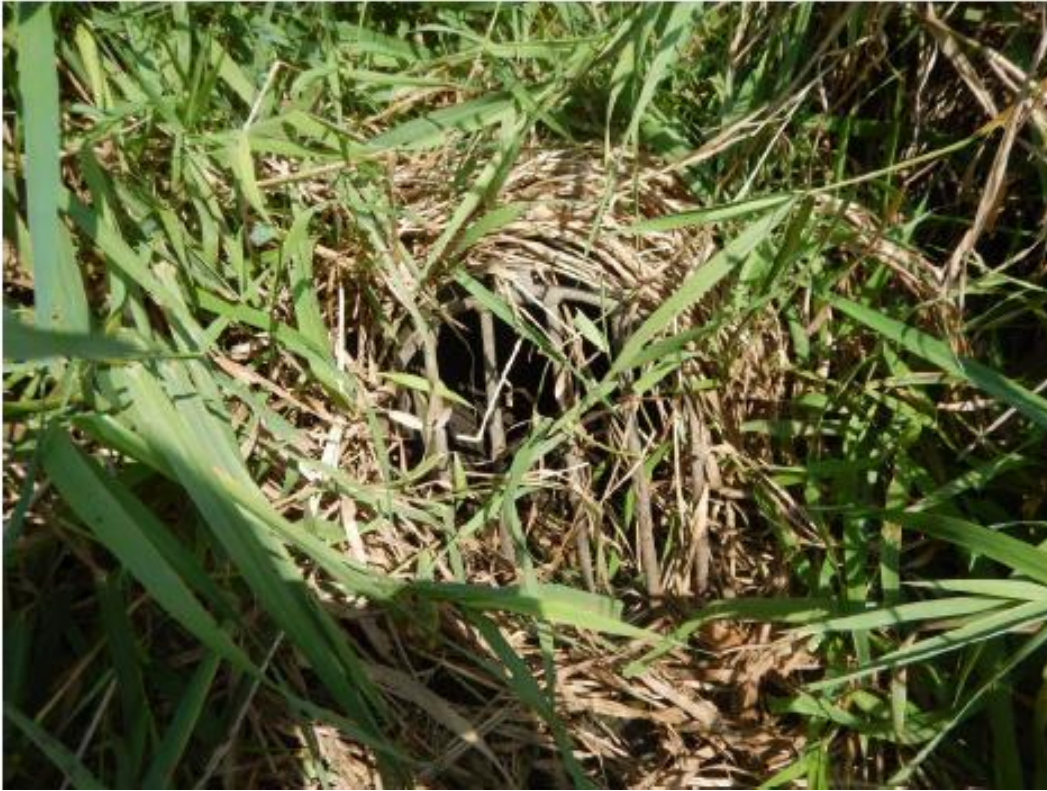
Figure 1. 1343-1 Outfall.

| Use | Site parameter | Site ID # 1343-1 |
|---|---|---|
| AL/R | 26 Additional Description | Dry creek bed. No water or fish were observed. |
