Use Attainability Analysis

1 Water Body Name	Unnamed Tributary to North Skunk River
2 Segment Description	Mouth to Lynnville STP outfall
3 Segment Length (mi)	0.17
4 Drainage Area (sq. mi.)	0.08
5 Segment Start Latitude, Longitude (DD)	41.57694, -92.77234
6 Segment End Latitude, Longitude (DD)	41.57558, -92.77498
7 Route of Flow (Next Downstream Adopted Designated Use)	Unnamed Tributary (general use, proposed) to North Skunk River (A1, BWW2)
8 NPDES Facility and Permit Number (If Applicable)	Lynnville, City of STP (5047001)
9 Sample Site ID(s)	1387-1
10 Segment County Name(s)	Jasper
11 Field Work Date(s)	8/1/2018

12 Aquatic Life Use Attainability Analysis - Conclusion

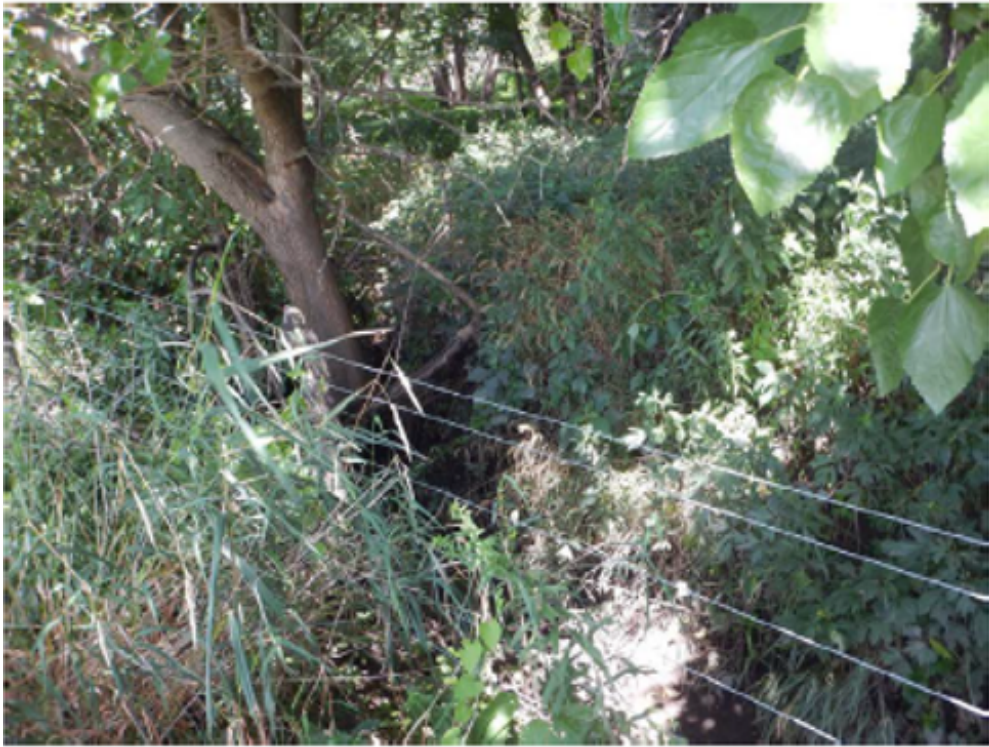
Use	Site parameter	Site ID #1387-1
AL/R	15 Latitude, Longitude (DD)	41.57558, -92.77502
AL/R	16 Average Depth (in)	Not measured (dry)
AL/R	17 Maximum Depth (in)	Not measured (dry)
AL/R	18 Stream Width (ft)	Not measured (dry)
AL/R	19 Pools Observed?	No
AL only	20 Non-Game Fish Present and Counts (Species: Number)	None
	21 Game Fish Present and Counts (Species (Size Range): Number)	None
	22 Stream Habitat (See also: #29 Site Photos)	Small puddle at outfall. Well shaded area, very close to the North Skunk River.
R only	23 Evidence of Use for Primary Contact Recreation? (Yes*/No)	No
	24 Evidence of Use by Children? (Yes*/No)	No
	25 Evidence of Use for Secondary Contact Recreation? (Yes*/No)	No
AL/R	26 Additional Description	No flow at time of assessment. Outfall to dry creek.

Figure 1. 1387-1 Recreational use assessment looking upstream.

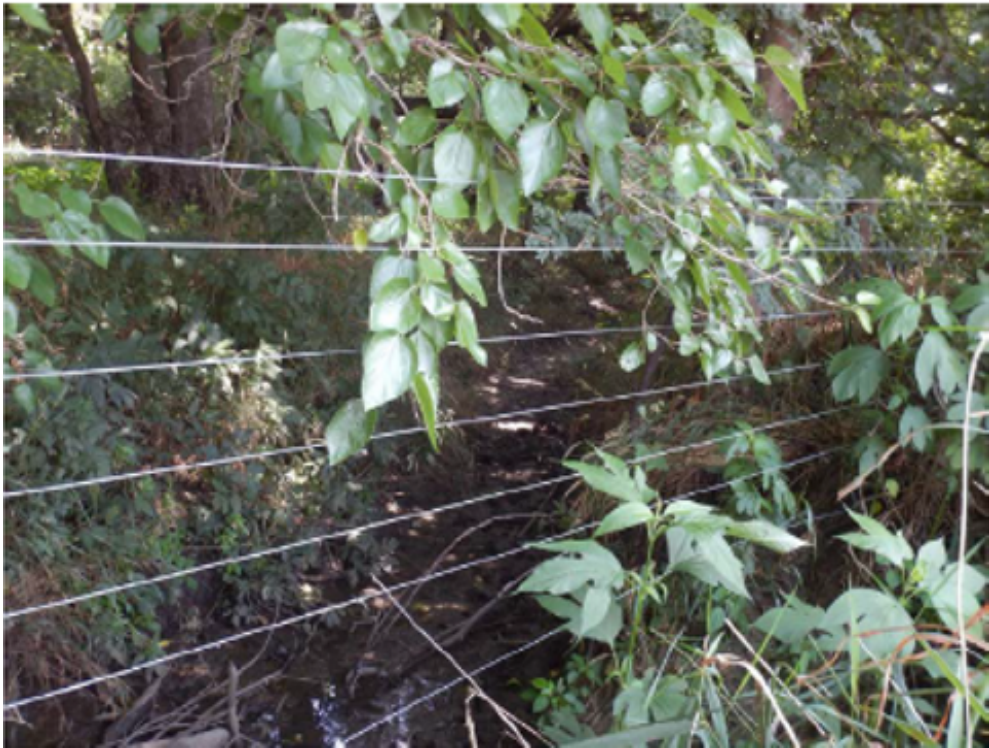
Figure 2. 1387-1 Recreational use assessment looking downstream.

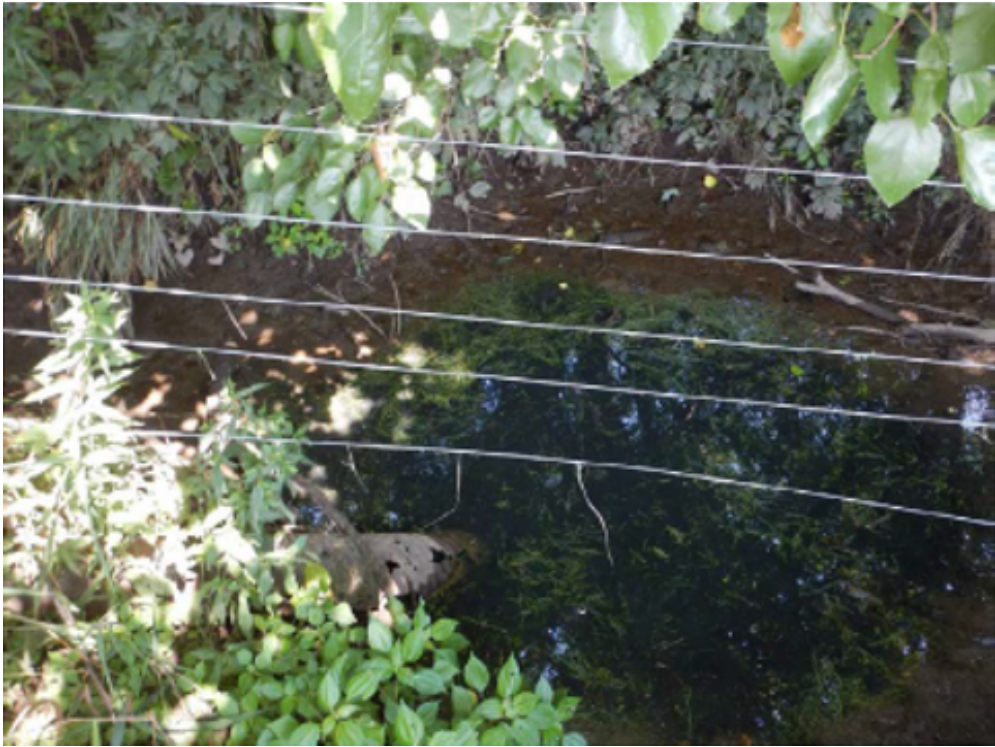
This specific stream segment is not identified on the perennial coverage of the USGS 1993 map. Therefore, to trigger a designated aquatic life or recreational use, the intermittent segment must contain sufficient perennial pools. While field observations at Site 1387-1 noted a small puddle at the outfall, there are no perennial pools meeting the criteria established in the warm water protocol.

Applying these protocol factors to Site 1387-1 further justifies a General Use classification. This puddle lacks substantial size, lacks prevalent depth, and is overwhelmingly predominated by natural dry or low-flow conditions throughout the rest of the 0.17-mile channel. There is also no evidence of existing recreational use at this location.

Figure 3. 1387-1 Recreational use assessment puddle under outfall.
