## Use Attainability Analysis

| <b>1 Water Body Name</b> | Unnamed Tributary to Unnamed Tributary to Honey Creek |
| <b>2 Segment Description</b> | Mouth to New Providence STP outfall |

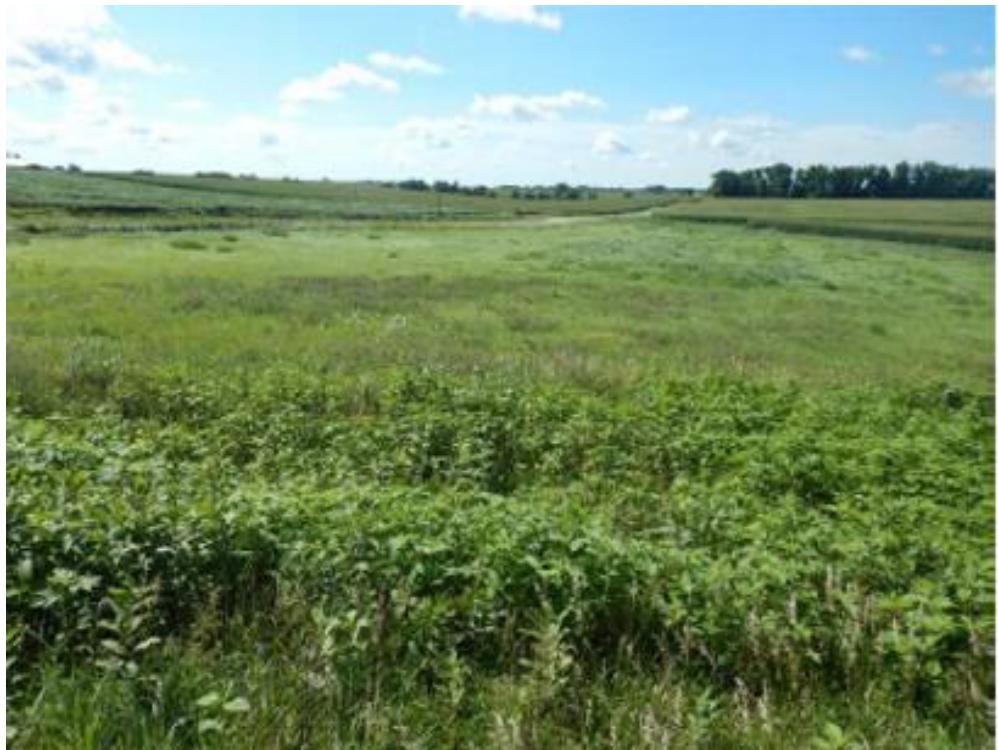
| Use | Site parameter | Site ID #1371-1 |
|---|--|---|
| R only | 22 Stream Habitat (See also: #29 Site Photos) | The stream was a small, dry, grassy drainage ditch through a pasture. |

**Figure 2. 1371-1 Recreational use assessment looking downstream.**
