Use Attainability Analysis

1 Water Body Name	West Branch Iowa River
2 Segment Description	Mouth to Crystal Lake city limits
3 Segment Length (mi)	39.4
4 Drainage Area (sq. mi.)	150
5 Segment Start Latitude, Longitude (DD)	42.86060, -93.61407
6 Segment End Latitude, Longitude (DD)	43.22513, -93.78759
7 Route of Flow (Next Downstream Adopted Designated Use)	West Branch Iowa River (A2, BWW2, proposed to A2, BWW1, HH, proposed) to Iowa River (A1, BWW1, HH)
8 NPDES Facility and Permit Number (If Applicable)	Crystal Lake, City of STP (4115001)
9 Sample Site ID(s)	1334-1, 1334-2, 813-4, 813-5, 813-6, 813-7, 813-8
10 Segment County Name(s)	Hancock, Wright
11 Field Work Date(s)	8/4/2015 (813-4, 813-5, 813-6, 813-7, 813-8), 9/13/2017 (1334-1, 1334-2), 8/8/2019 (BioNet 1207)

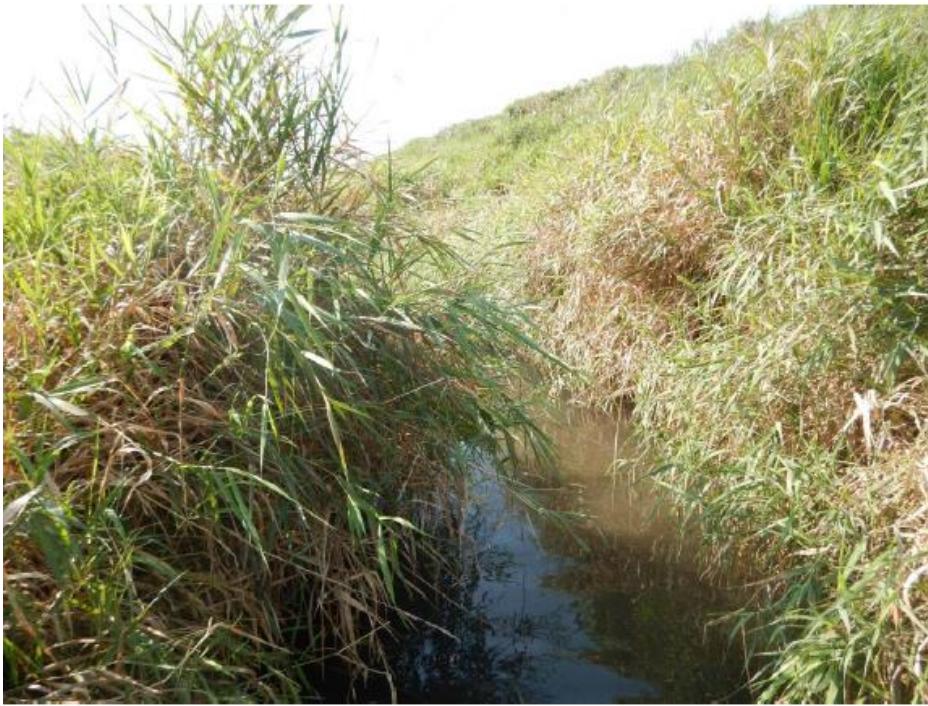
Use	Site parameter	Site ID # 1334-1
AL/R	15 Latitude, Longitude (DD)	43.22698, -93.77297
AL/R	16 Average Depth (in)	4
AL/R	17 Maximum Depth (in)	14.4
AL/R	18 Stream Width (ft)	5
AL/R	19 Pools Observed?	Yes
AL only	20 Non-Game Fish Present and Counts (Species: Number)	Blackside darter: 4 Creek chub: 12 Fathead minnow: 6 Green sunfish: 4 Johnny darter: 3 White sucker: 6
	21 Game Fish Present and Counts (Species (Size Range): Number)	Black bullhead (unknown): 10 Bluegill (unknown): 2 Common carp (unknown): 1
R only	22 Stream Habitat (See also: #29 Site Photos)	Abundant grass overhanging stream. Few deeper pockets up to one foot depth. Aquatic vegetation present. Drainage ditch. Shallow depths, clear water.
	23 Evidence of Use for Primary Contact Recreation? (Yes*/No)	No
	24 Evidence of Use by Children? (Yes*/No)	No
AL/R	25 Evidence of Use for Secondary Contact Recreation? (Yes*/No)	No
	26 Additional Description	No trespassing sign was present.

Figure 1. 1334-1 Recreational use assessment midpoint looking upstream.

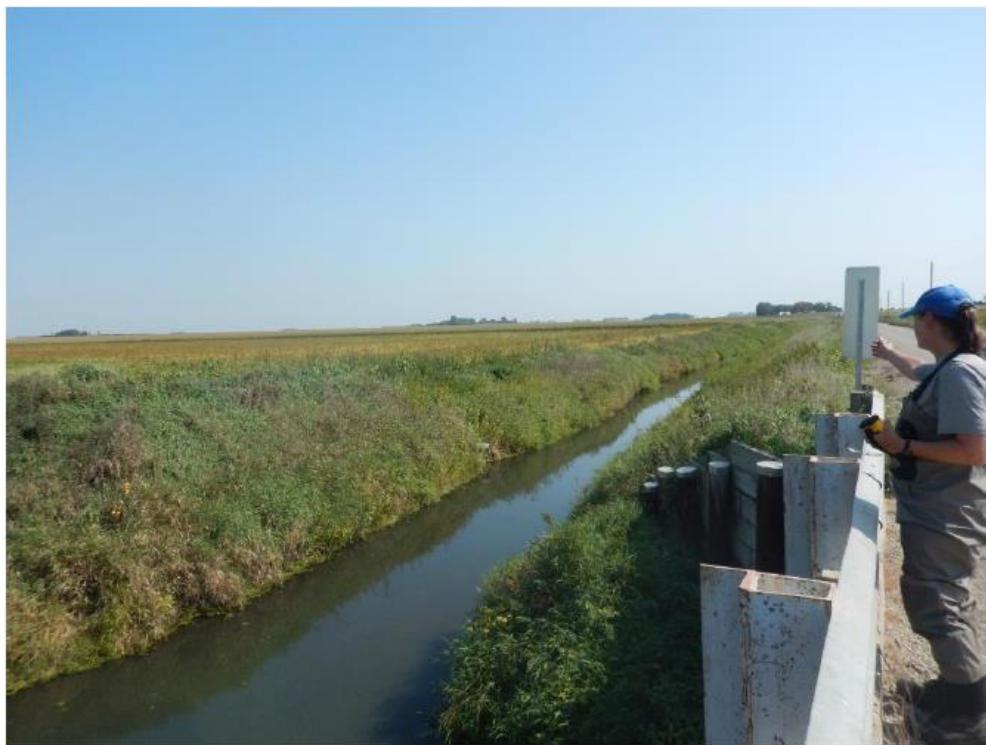
Use	Site parameter	Site ID # 1334-2
AL/R	15 Latitude, Longitude (DD)	43.19833, -93.71741
AL/R	16 Average Depth (in)	8
AL/R	17 Maximum Depth (in)	27.6
AL/R	18 Stream Width (ft)	16
AL/R	19 Pools Observed?	Yes
AL only	20 Non-Game Fish Present and Counts (Species: Number)	Not sampled
	21 Game Fish Present and Counts (Species (Size Range): Number)	Not sampled
	22 Stream Habitat (See also: #29 Site Photos)	N/A
R only	23 Evidence of Use for Primary Contact Recreation? (Yes*/No)	No
	24 Evidence of Use by Children? (Yes*/No)	No
	25 Evidence of Use for Secondary Contact Recreation? (Yes*/No)	No
AL/R	26 Additional Description	N/A

Figure 12. 1334-2 Recreational use assessment midpoint looking upstream.

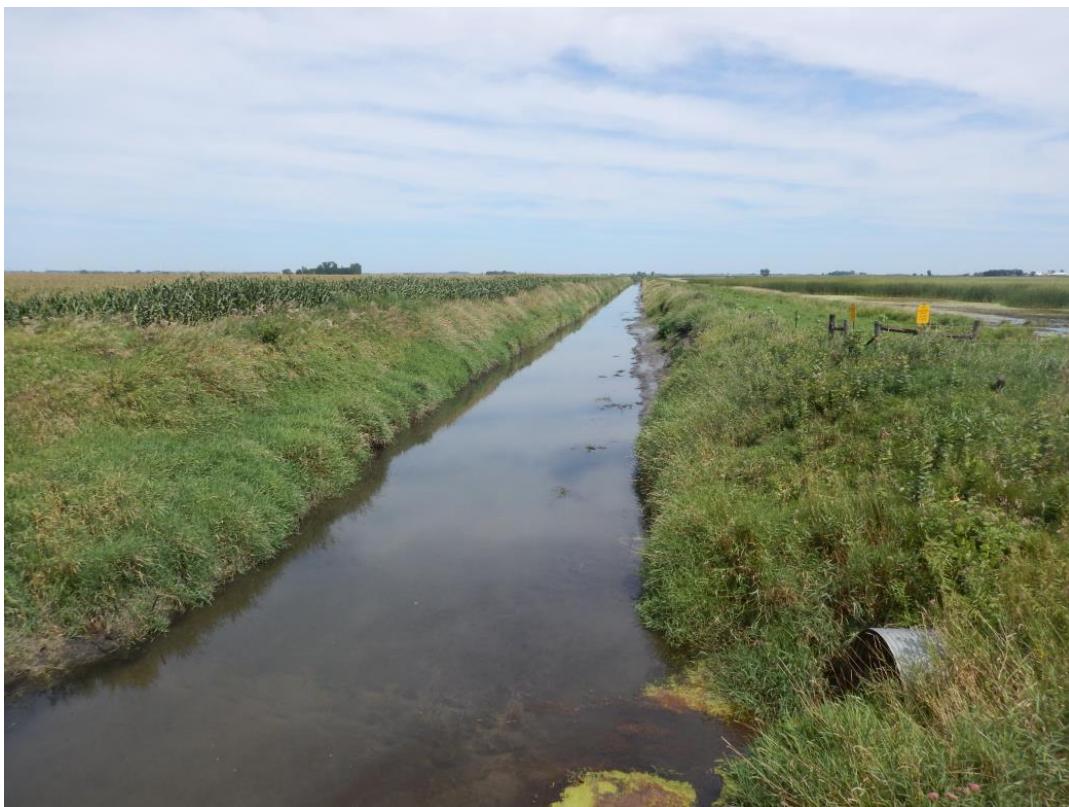
Use	Site parameter	Site ID #813-4
AL/R	15 Latitude, Longitude (DD)	43.15552, -93.74919
AL/R	16 Average Depth (in)	11
AL/R	17 Maximum Depth (in)	24
AL/R	18 Stream Width (ft)	17
AL/R	19 Pools Observed?	No
AL only	20 Non-Game Fish Present and Counts (Species: Number)	Green sunfish: 2 Johnny darter: 1
	21 Game Fish Present and Counts (Species (Size Range): Number)	Black bullhead (unknown): 3 Bluegill (unknown): 2 Northern Pike: 1
	22 Stream Habitat (See also: #29 Site Photos)	Channelized drainageway. Sheen on water.
R only	23 Evidence of Use for Primary Contact Recreation? (Yes*/No)	No
	24 Evidence of Use by Children? (Yes*/No)	No
	25 Evidence of Use for Secondary Contact Recreation? (Yes*/No)	No
AL/R	26 Additional Description	N/A

Figure 18. 813-4 Recreational use assessment midpoint looking upstream.

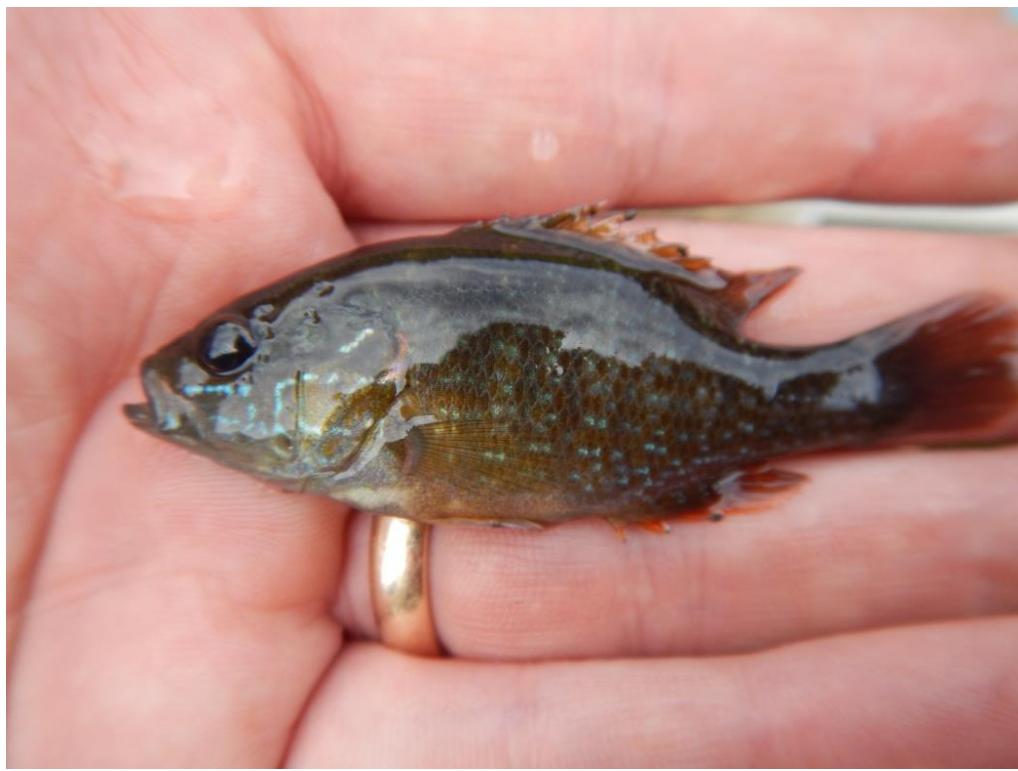
Figure 26. 813-4 Green sunfish.

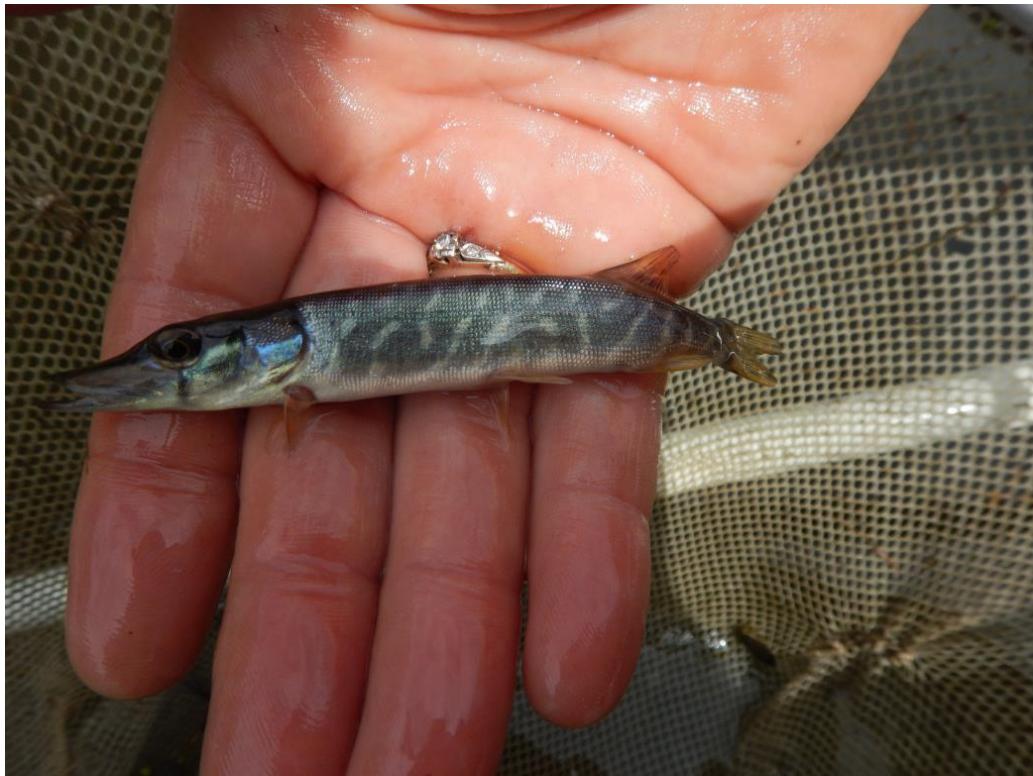
Figure 27. 813-4 Small northern.

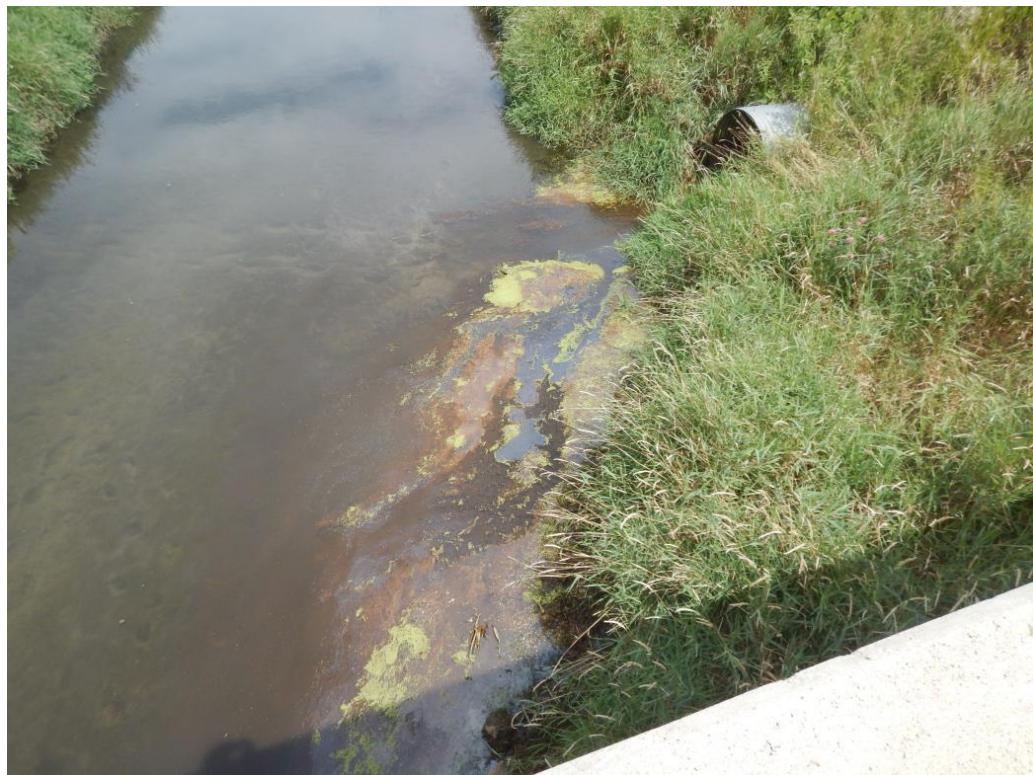
Figure 28. 813-4 Sheen on water.

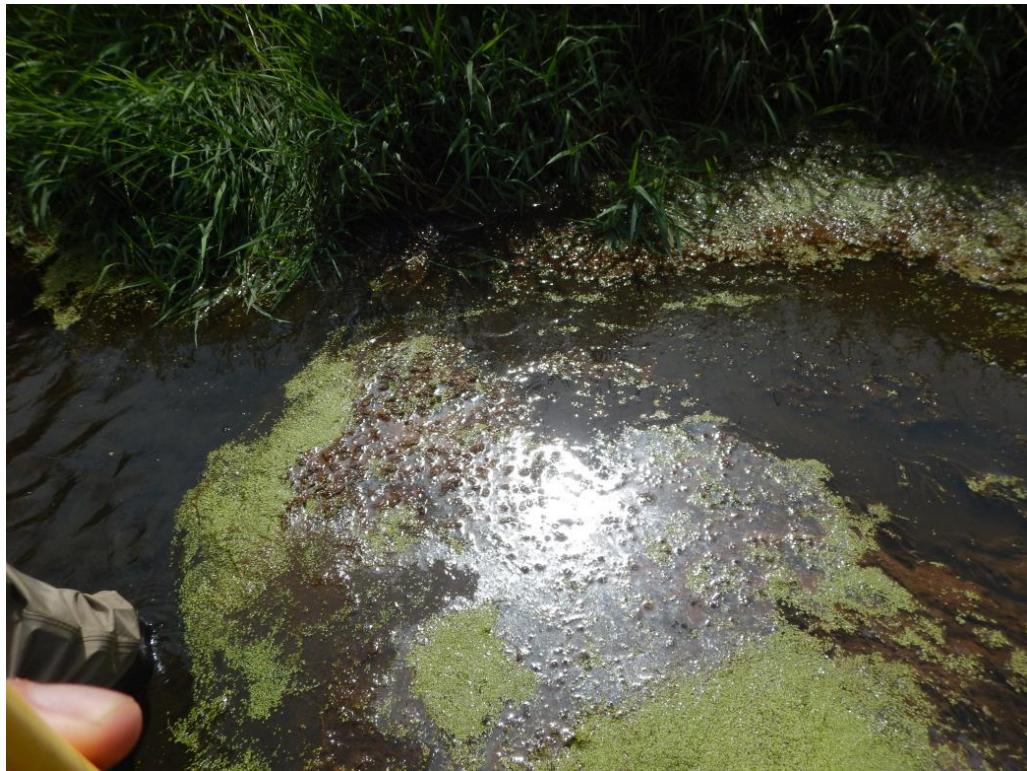
Figure 29. 813-4 Additional sheen on water.

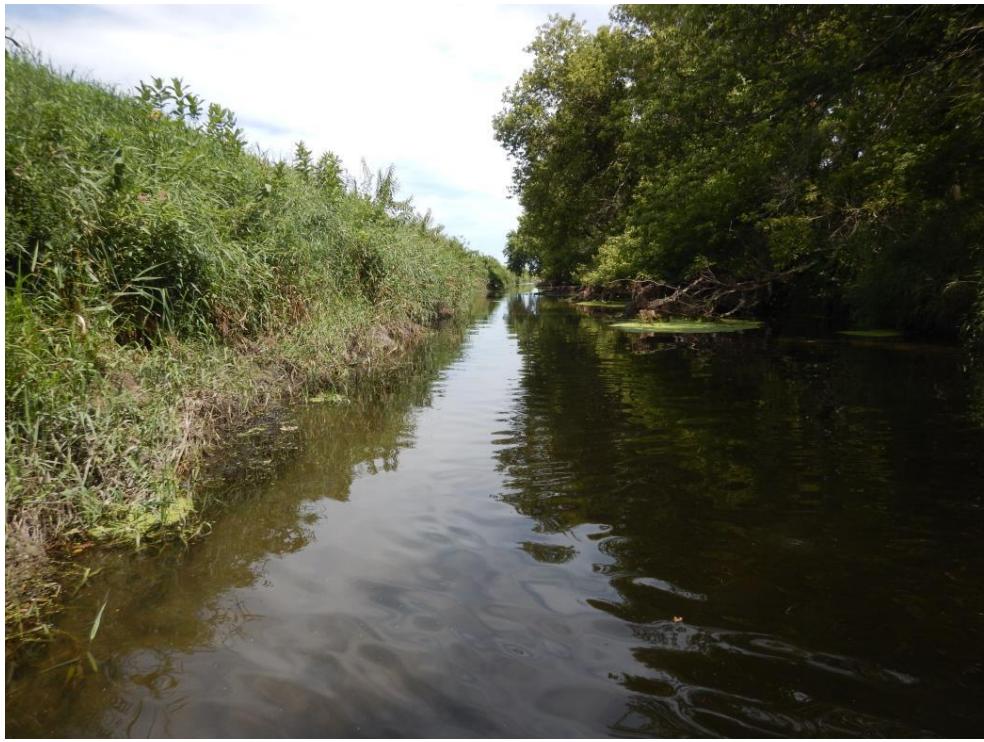
Use	Site parameter	Site ID #813-5
AL/R	15 Latitude, Longitude (DD)	43.08329, -93.75514
AL/R	16 Average Depth (in)	14
AL/R	17 Maximum Depth (in)	31
AL/R	18 Stream Width (ft)	25
AL/R	19 Pools Observed?	No
AL only	20 Non-Game Fish Present and Counts (Species: Number)	Not sampled
	21 Game Fish Present and Counts (Species (Size Range): Number)	Not sampled
	22 Stream Habitat (See also: #29 Site Photos)	N/A
R only	23 Evidence of Use for Primary Contact Recreation? (Yes*/No)	No
	24 Evidence of Use by Children? (Yes*/No)	No
	25 Evidence of Use for Secondary Contact Recreation? (Yes*/No)	No
AL/R	26 Additional Description	N/A

Figure 31. 813-5 Recreational use assessment upstream looking upstream.

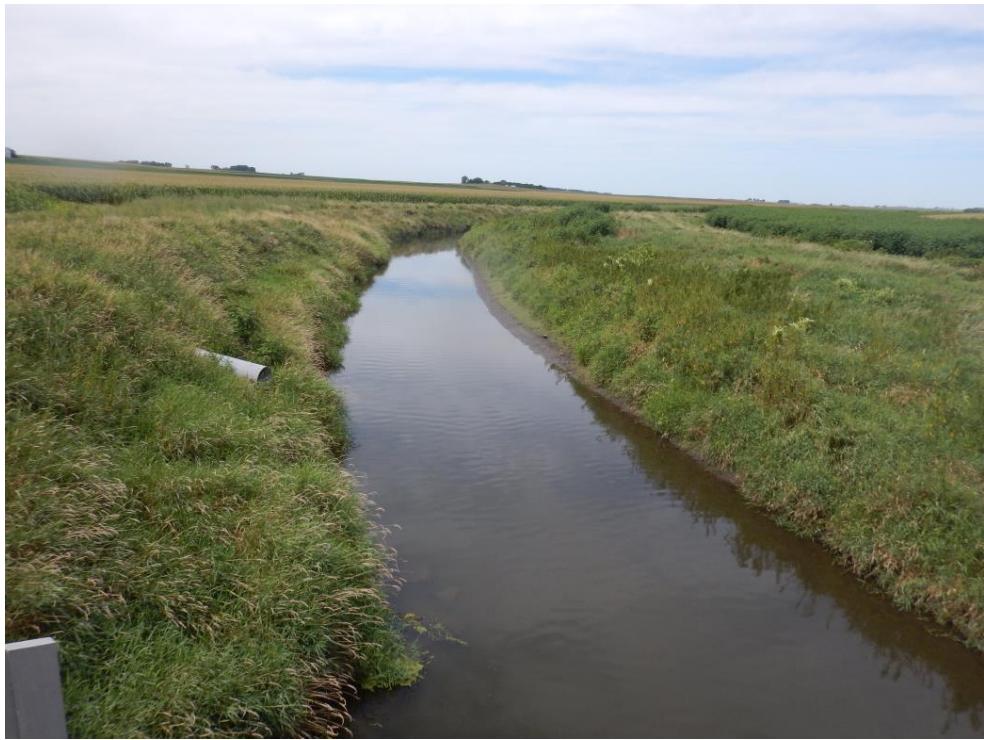
Use	Site parameter	Site ID #813-6
AL/R	15 Latitude, Longitude (DD)	42.99522, -93.72367
AL/R	16 Average Depth (in)	15.5
AL/R	17 Maximum Depth (in)	36
AL/R	18 Stream Width (ft)	24
AL/R	19 Pools Observed?	No
AL only	20 Non-Game Fish Present and Counts (Species: Number)	Not sampled
	21 Game Fish Present and Counts (Species (Size Range): Number)	Not sampled
	22 Stream Habitat (See also: #29 Site Photos)	Channelized stream.
R only	23 Evidence of Use for Primary Contact Recreation? (Yes*/No)	No
	24 Evidence of Use by Children? (Yes*/No)	No
	25 Evidence of Use for Secondary Contact Recreation? (Yes*/No)	No
AL/R	26 Additional Description	In a rural setting.

Figure 35. 813-6 Recreational use assessment midpoint looking upstream.

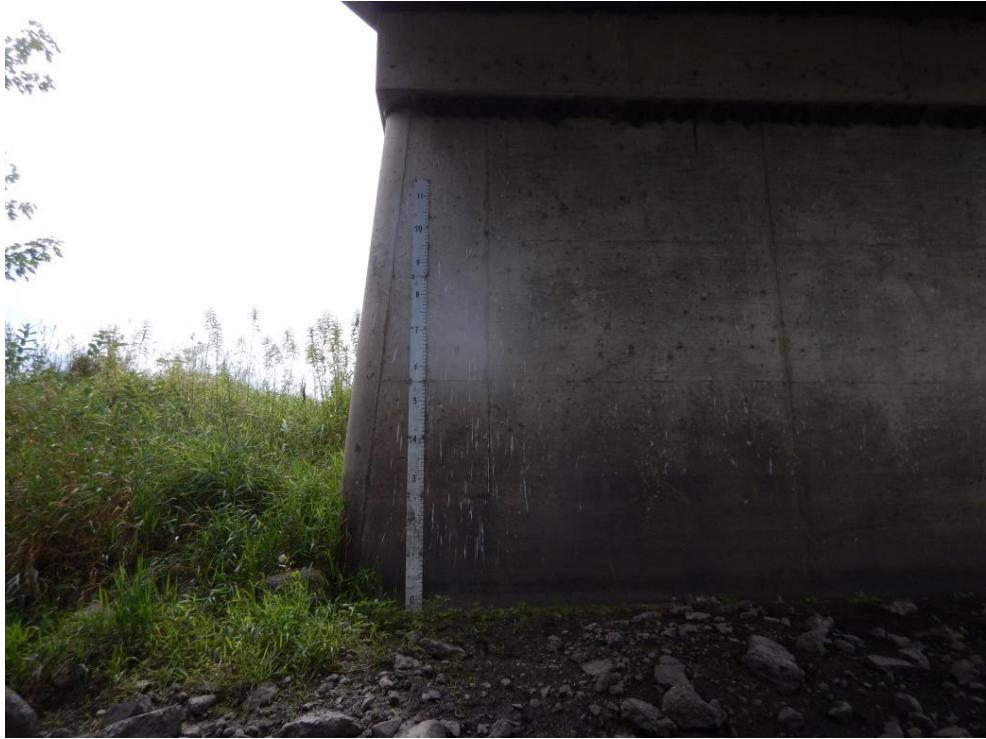
Use	Site parameter	Site ID #813-7
AL/R	15 Latitude, Longitude (DD)	42.92307, -93.68699
AL/R	16 Average Depth (in)	10.5
AL/R	17 Maximum Depth (in)	30
AL/R	18 Stream Width (ft)	37
AL/R	19 Pools Observed?	No
AL only	20 Non-Game Fish Present and Counts (Species: Number)	Not sampled
	21 Game Fish Present and Counts (Species (Size Range): Number)	Not sampled
	22 Stream Habitat (See also: #29 Site Photos)	N/A
R only	23 Evidence of Use for Primary Contact Recreation? (Yes*/No)	No
	24 Evidence of Use by Children? (Yes*/No)	No
	25 Evidence of Use for Secondary Contact Recreation? (Yes*/No)	No
AL/R	26 Additional Description	Near a busy highway with a gage ruler on the downstream side of the bridge.

Figure 47. 813-7 Stream gage.

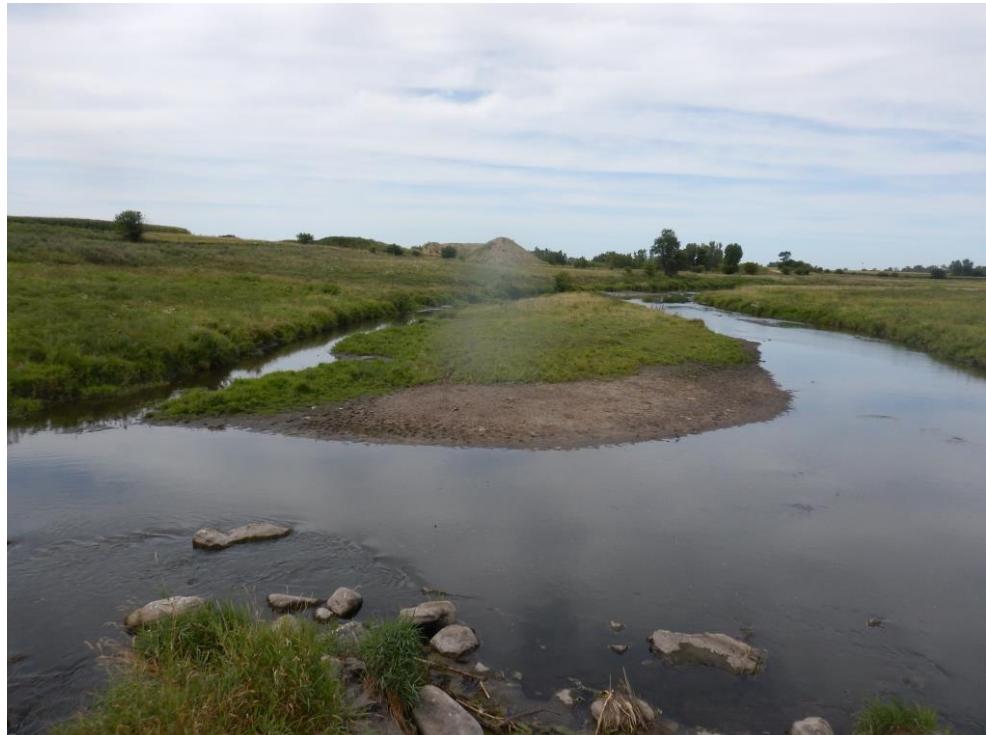
Use	Site parameter	Site ID #813-8
AL/R	15 Latitude, Longitude (DD)	42.87765, -93.63217
AL/R	16 Average Depth (in)	9
AL/R	17 Maximum Depth (in)	33
AL/R	18 Stream Width (ft)	44
AL/R	19 Pools Observed?	No
AL only	20 Non-Game Fish Present and Counts (Species: Number)	Not sampled
	21 Game Fish Present and Counts (Species (Size Range): Number)	Not sampled
	22 Stream Habitat (See also: #29 Site Photos)	N/A
R only	23 Evidence of Use for Primary Contact Recreation? (Yes*/No)	No
	24 Evidence of Use by Children? (Yes*/No)	No
	25 Evidence of Use for Secondary Contact Recreation? (Yes*/No)	No

Use	Site parameter	Site ID #813-8
AL/R	26 Additional Description	Sand and gravel pit upstream along the west side. Barbed wire line across river upstream.

Figure 48. 813-8 Recreational use assessment midpoint looking upstream.
