Use Attainability Analysis

| 1 Water Body Name | Unnamed Tributary to Unnamed Tributary to South Skunk River |
| 2 Segment Description | Mouth to headwaters |

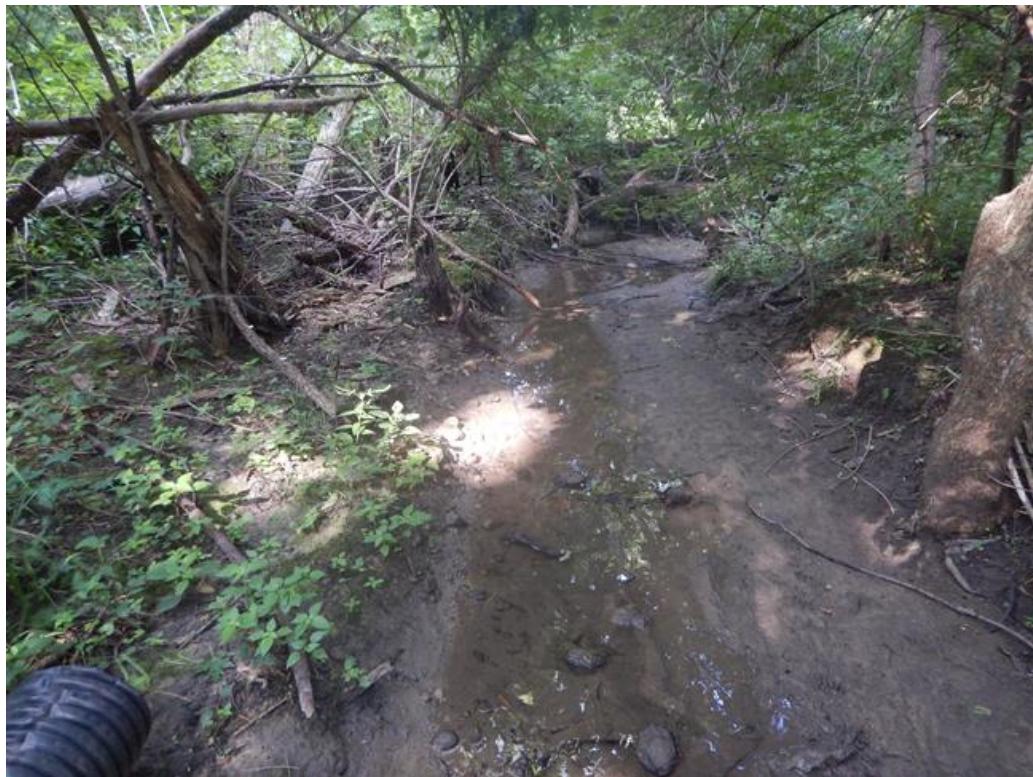
Figure 1. 1258-1 Looking upstream.

| Use | Site parameter | Site ID #1258-1 |
|---|---|--|
| | 22 Stream Habitat (See also: #29 Site Photos) | Stream small and shallow with isolated pools. No fish observed. Wooded stream cover. |
