Use Attainability Analysis

1 Water Body Name	Middle Branch Blue Earth River
2 Segment Description	Iowa-Minnesota state line to confluence with Drainage Ditch Number 7
3 Segment Length (mi)	10.4
4 Drainage Area (sq. mi.)	88.2
5 Segment Start Latitude, Longitude (DD)	43.50011, -94.10688
6 Segment End Latitude, Longitude (DD)	43.40961, -94.04223
7 Route of Flow (Next Downstream Adopted Designated Use)	Middle Branch Blue Earth River (A2, proposed, BWW2, existing)
8 NPDES Facility and Permit Number (If Applicable)	Buffalo Center, City of STP (9506001)
9 Sample Site ID(s)	1287-2, 1287-3
10 Segment County Name(s)	Kossuth
11 Field Work Date(s)	9/14/2017

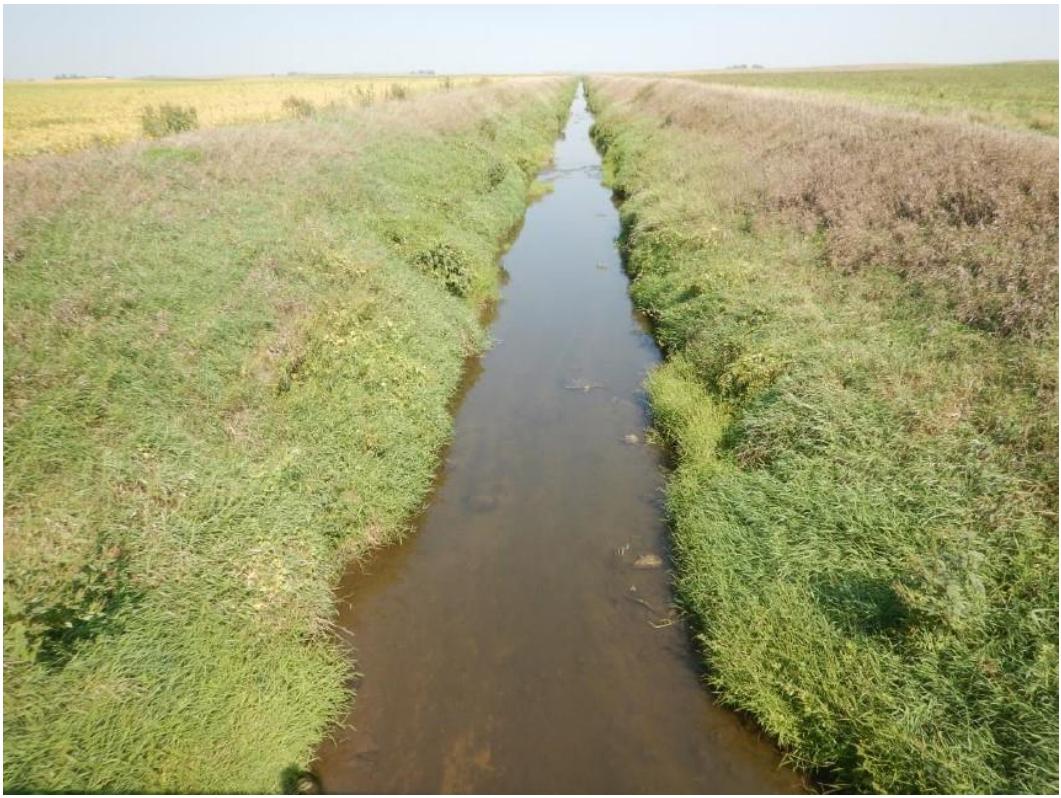
Figure 2. 1287-2 Recreational use assessment midpoint looking downstream.

Use	Site parameter	Site ID # 1287-2
AL/R	26 Additional Description	Few tires immediately downstream of the bridge.
