Use Attainability Analysis

1 Water Body Name	Walnut Creek
2 Segment Description	Mouth to confluence with unnamed tributary
3 Segment Length (mi)	63.7
4 Drainage Area (sq. mi.)	224
5 Segment Start Latitude, Longitude (DD)	40.78695, -95.58993
6 Segment End Latitude, Longitude (DD)	41.49348, -95.21235
7 Route of Flow (Next Downstream Adopted Designated Use)	Walnut Creek (A2, BWW2, proposed, to A2, proposed, BWW2, existing, to A1, proposed, BWW1, HH, existing) to West Branch Nishnabotna River (A1, BWW1, HH)
8 NPDES Facility and Permit Number (If Applicable)	Walnut, City of STP (7872001)
9 Sample Site ID(s)	501-1, 501-2, 501-3, 501-4, 501-5, 501-6, 501-8, 501-9, 501-10, 501-11, 501-12
10 Segment County Name(s)	Fremont, Page, Montgomery, Pottawattamie
11 Field Work Date(s)	4/13/2006 (501-1, 501-2, 501-3), 4/12/2006 (501-4), 7/25/2007 (501-5, 501-6, 501-8), 10/4/2011 (501-9, 501-10, 501-11, 501-12)

12 Aquatic Life Use Attainability Analysis - Conclusion

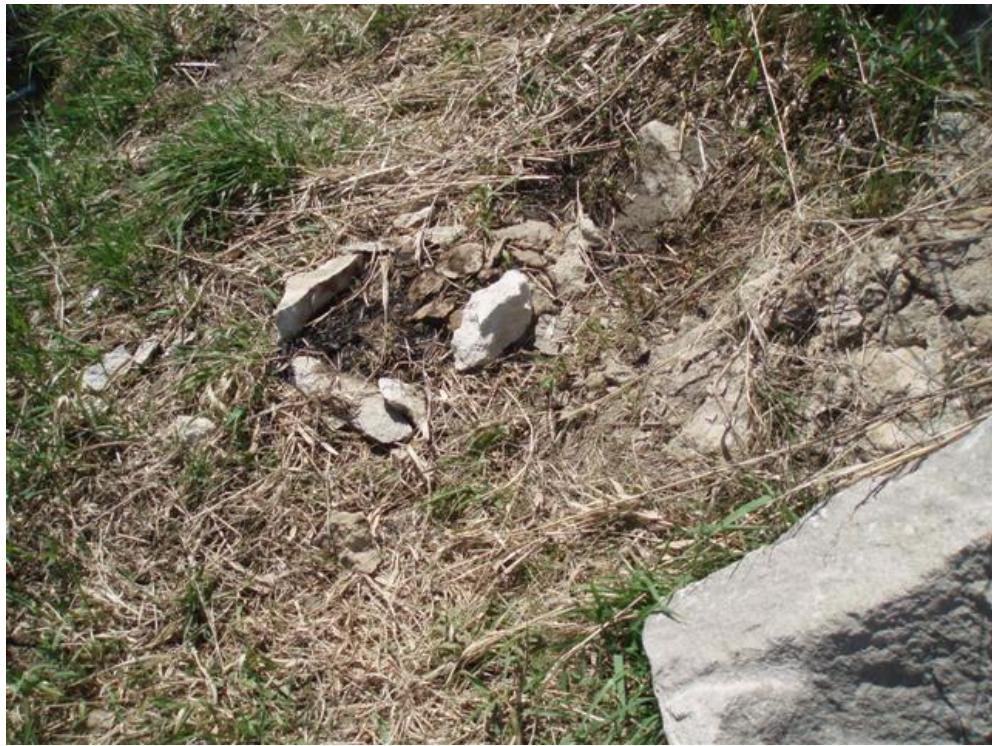
Use	Site parameter	Site ID #501-2
AL/R	15 Latitude, Longitude (DD)	41.08755, -95.26852
AL/R	16 Average Depth (in)	19.5
AL/R	17 Maximum Depth (in)	>36
AL/R	18 Stream Width (ft)	45
AL/R	19 Pools Observed?	Yes
AL only	20 Non-Game Fish Present and Counts (Species: Number)	N/A
	21 Game Fish Present and Counts (Species (Size Range): Number)	N/A
	22 Stream Habitat (See also: #29 Site Photos)	Sill dam 8 ft below bridge.
R only	23 Evidence of Use for Primary Contact Recreation? (Yes*/No)	No
	24 Evidence of Use by Children? (Yes*/No)	No
	25 Evidence of Use for Secondary Contact Recreation? (Yes*/No)	No
AL/R	26 Additional Description	Fishing area. Path to creek along bridge slope. Fire pit present.

Figure 15. 501-2 Fire pit present at the assessed location

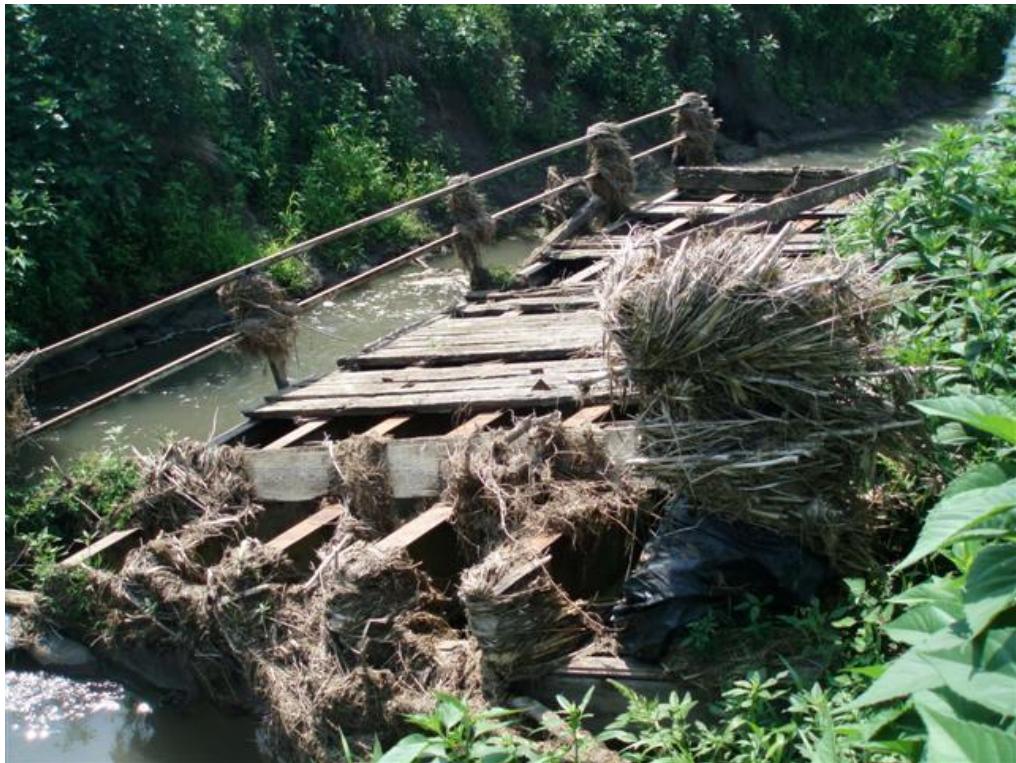
Use	Site parameter	Site ID #501-5
AL/R	15 Latitude, Longitude (DD)	41.41828, -95.19438
AL/R	16 Average Depth (in)	10.5
AL/R	17 Maximum Depth (in)	15
AL/R	18 Stream Width (ft)	Not measured
AL/R	19 Pools Observed?	Yes
AL only	20 Non-Game Fish Present and Counts (Species: Number)	Not measured
	21 Game Fish Present and Counts (Species (Size Range): Number)	Not measured
	22 Stream Habitat (See also: #29 Site Photos)	Not measured
R only	23 Evidence of Use for Primary Contact Recreation? (Yes*/No)	No
	24 Evidence of Use by Children? (Yes*/No)	No
	25 Evidence of Use for Secondary Contact Recreation? (Yes*/No)	No
AL/R	26 Additional Description	Old washed out bridge present. Scour hole at old bridge piling.

Figure 36. 501-5 Bridge platform laying in the creek

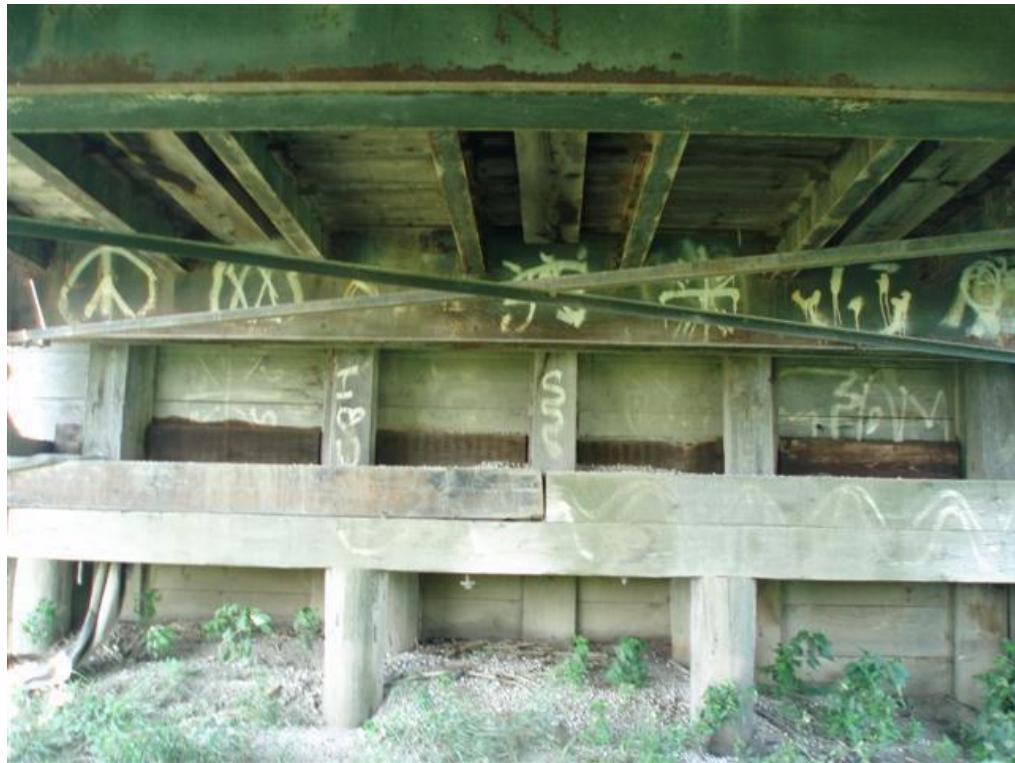
Figure 53. 501-6 Graffiti present under the bridge

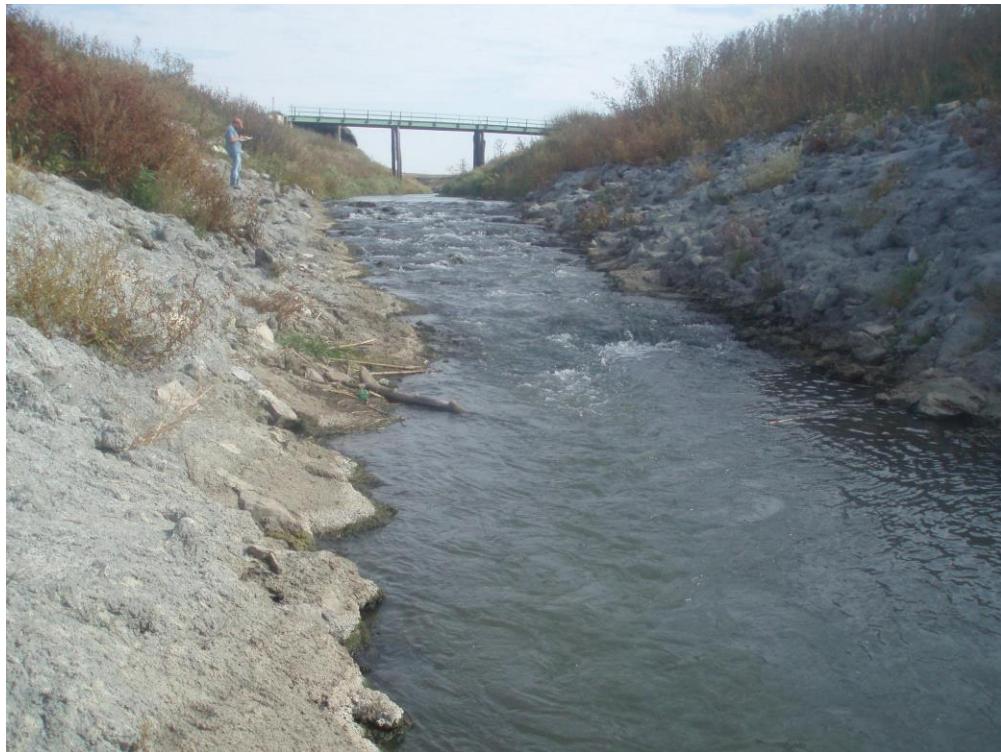
Figure 69. 501-9 Weir downstream of bridge

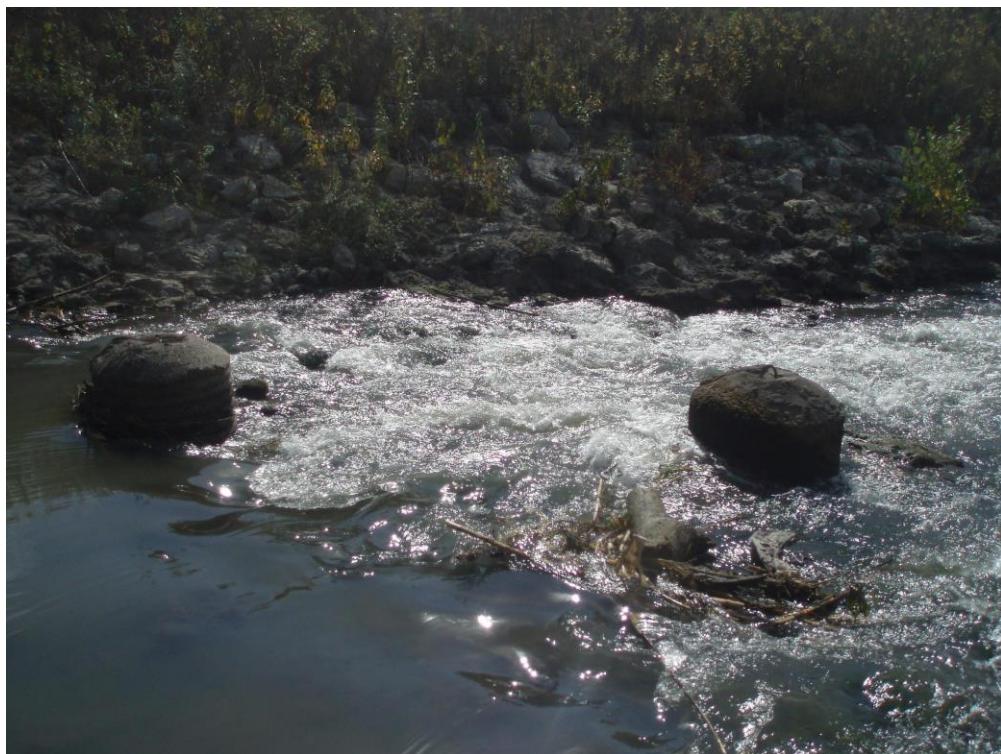
Use	Site parameter	Site ID #501-11
AL/R	15 Latitude, Longitude (DD)	41.00185, -95.33076
AL/R	16 Average Depth (in)	27.5
AL/R	17 Maximum Depth (in)	39
AL/R	18 Stream Width (ft)	36
AL/R	19 Pools Observed?	Yes
AL only	20 Non-Game Fish Present and Counts (Species: Number)	N/A
	21 Game Fish Present and Counts (Species (Size Range): Number)	N/A
	22 Stream Habitat (See also: #29 Site Photos)	Steep slopes and riprapped banks.
R only	23 Evidence of Use for Primary Contact Recreation? (Yes*/No)	No
	24 Evidence of Use by Children? (Yes*/No)	No
	25 Evidence of Use for Secondary Contact Recreation? (Yes*/No)	No
AL/R	26 Additional Description	Two riprap flow control dams downstream back up the flow.

Figure 82. 501-11 Weir downstream
