Use Attainability Analysis

| 1 Water Body Name | Bee Branch |
| 2 Segment Description | Mouth to flood control structure |

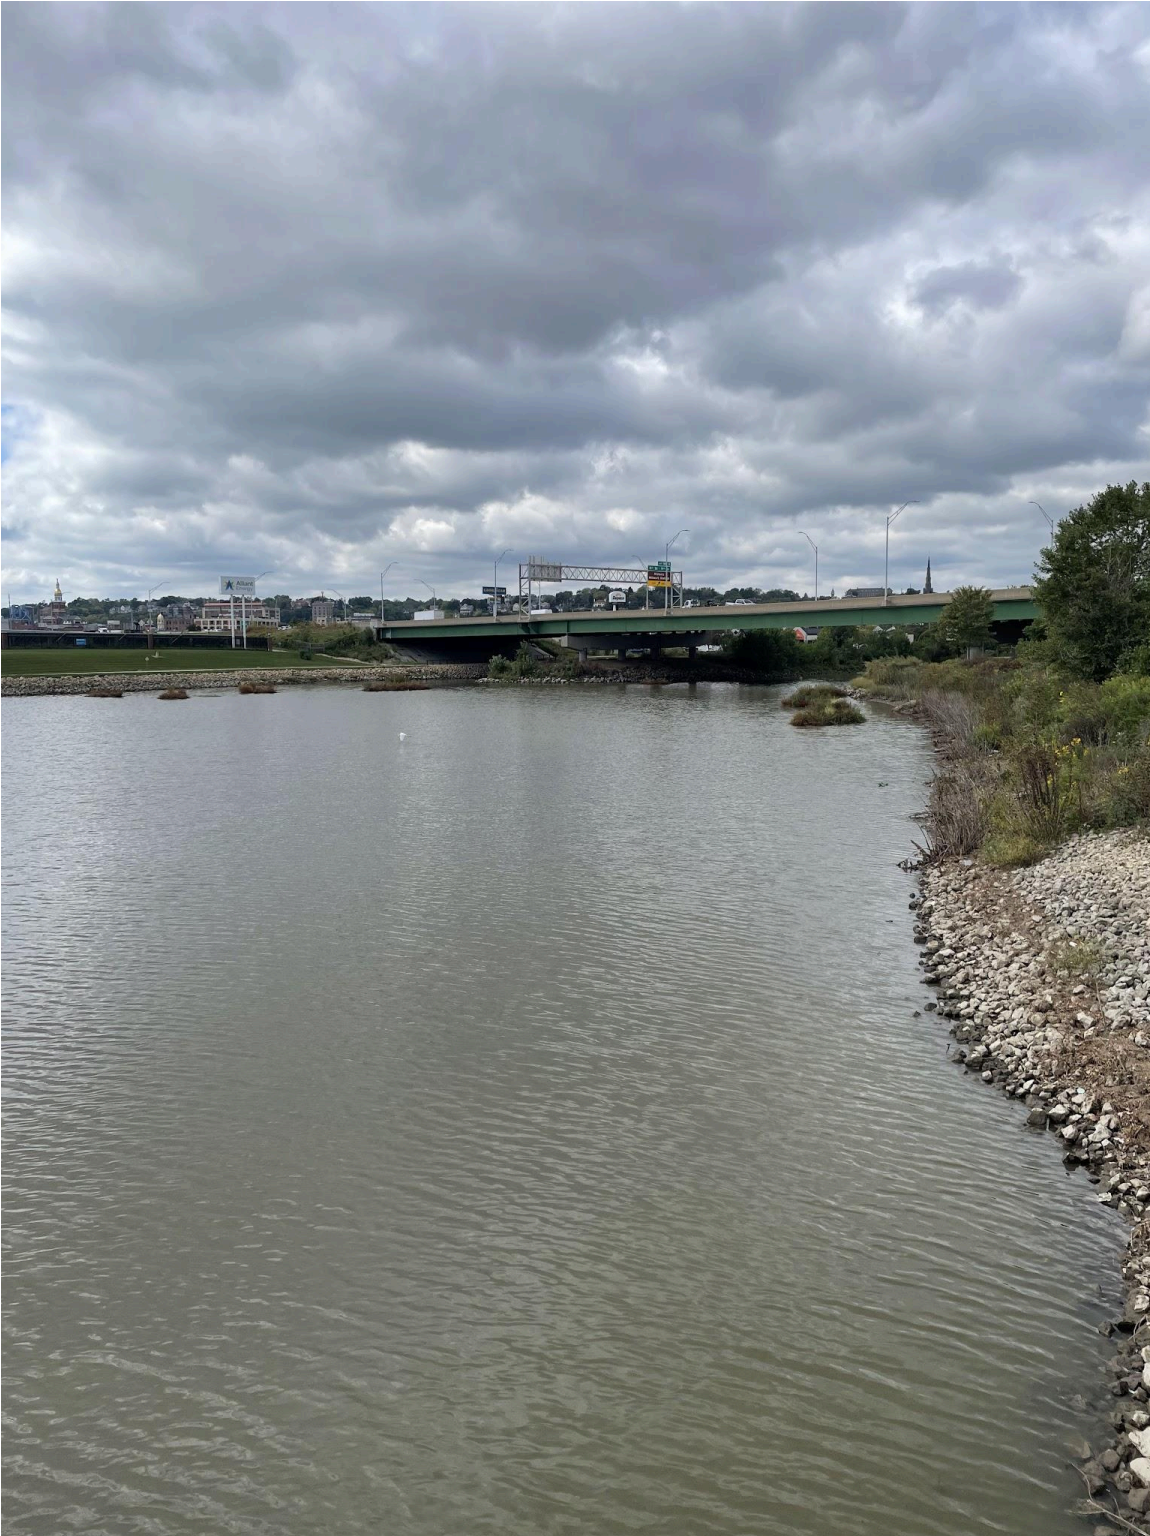
Figure 1. Site #1 looking upstream.

| Use | Site parameter | Site ID #1 |
|---|--|---|
| | 22 Stream Habitat (See also: #29 Site Photos) | Large pool |
| AL/R | 26 Additional Description | Fishing pier |

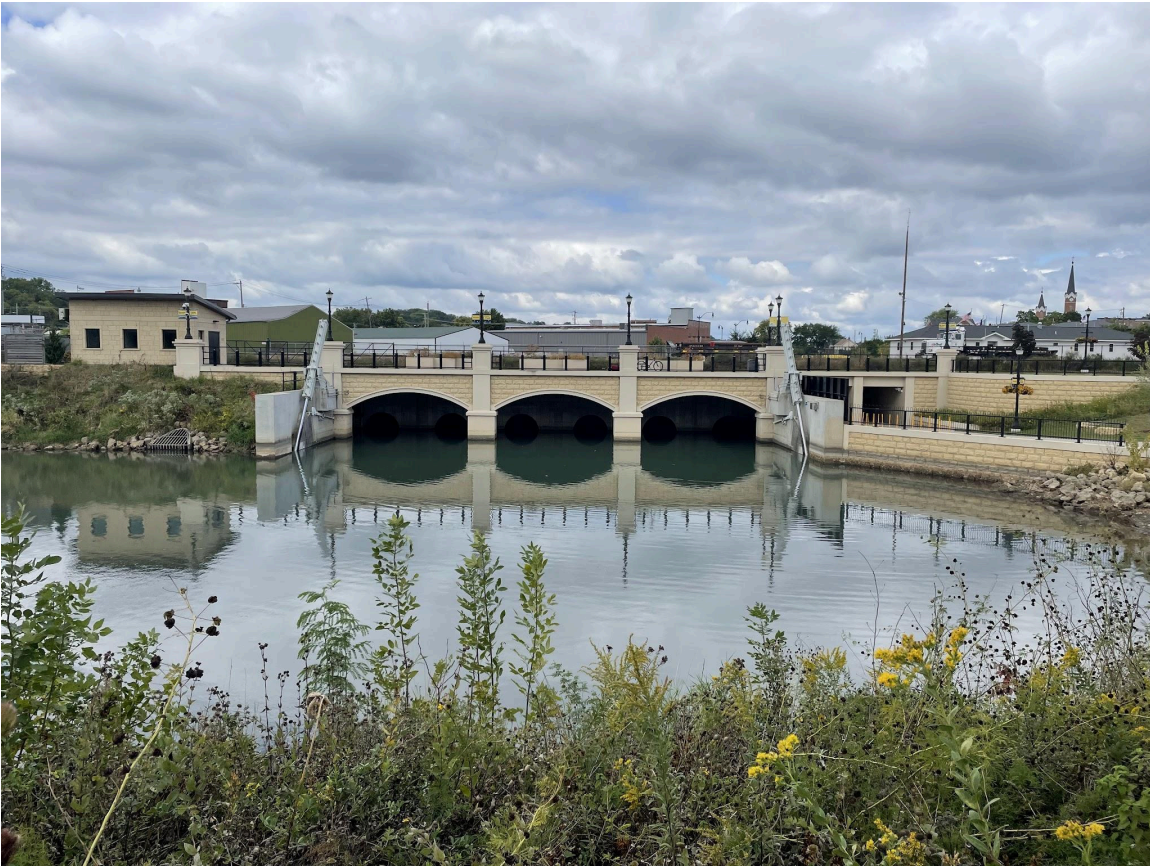
Figure 3. Site #2 looking upstream at the flood control structure.

| Use | Site parameter | Site ID #2 |
|---|---|--|
| | 22 Stream Habitat (See also: #29 Site Photos) | Large pool |
| AL/R | 26 Additional Description | Flood control structure |

The pool is approximately 28 acres. The furthest downstream point of the segment is a flood control structure that was inaccessible at the time due to construction.

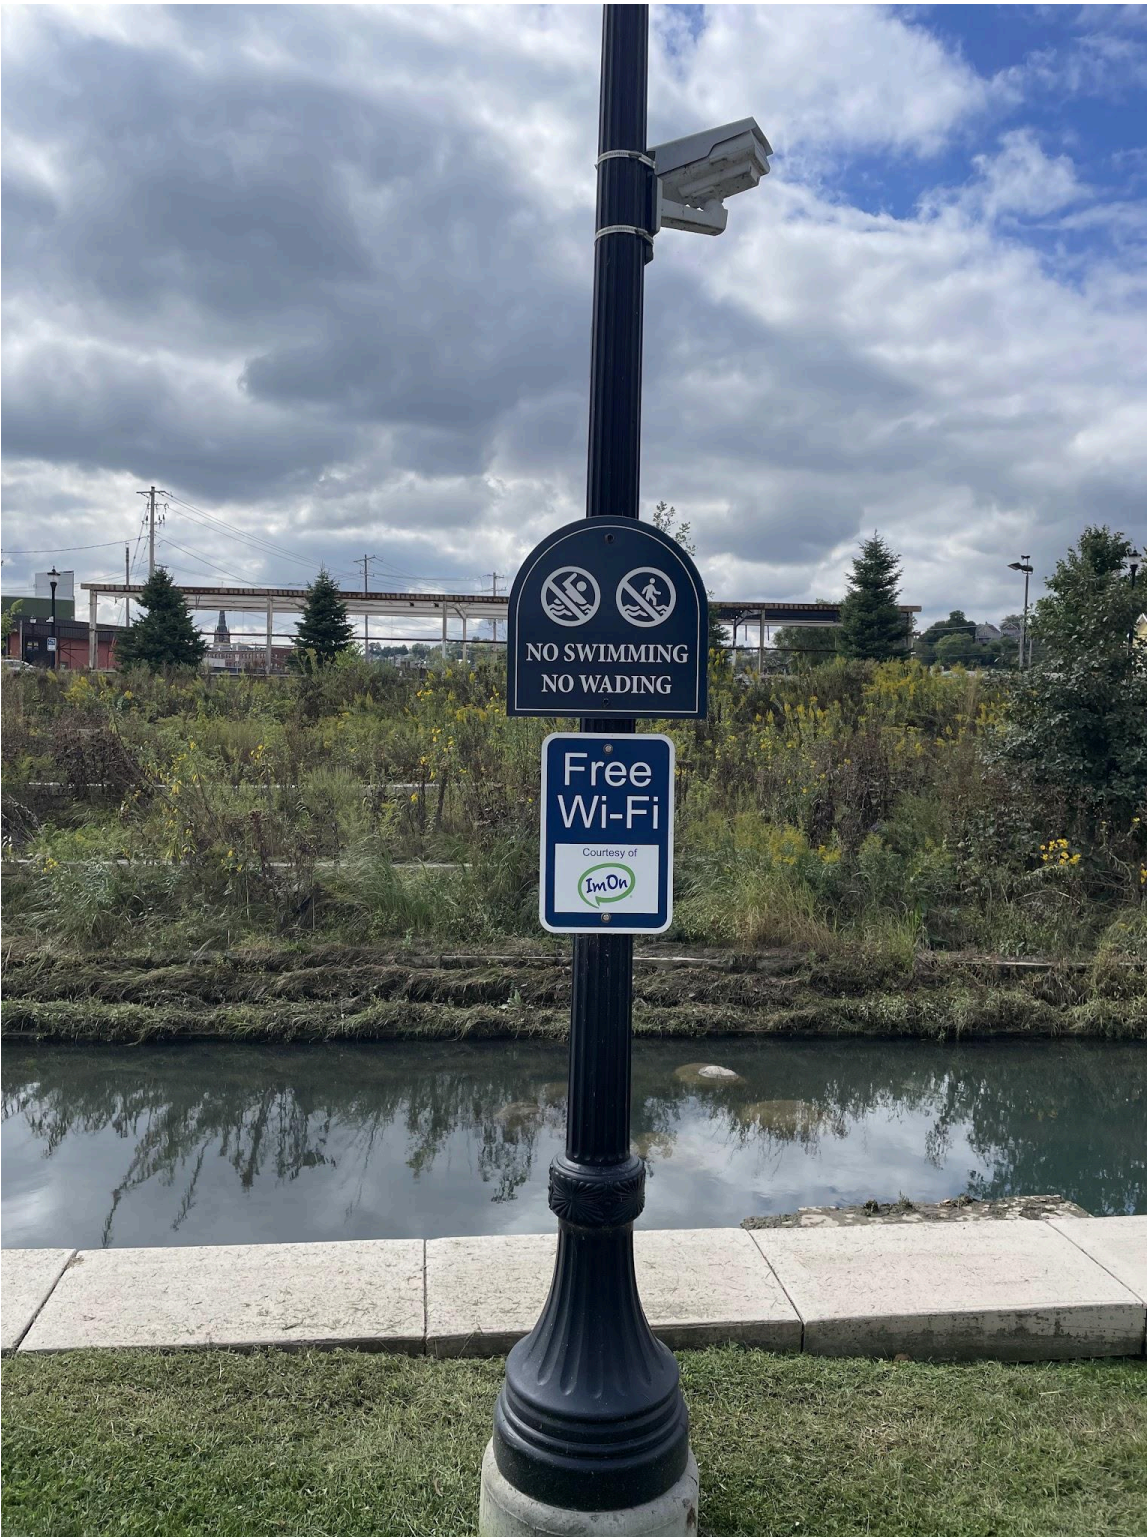
Figure 4. No swimming or wading sign located upstream of the pool being designated.

| Use | Site parameter | Site ID #1 |
|---|--|---|
| R only | 23 Evidence of Use for Primary Contact Recreation? (Yes*/No) | Yes (signs indicate where you can and cannot swim/wade) |
