UNITED HYDRAULICS

(Hampton, Iowa)

GENERAL DESCRIPTION

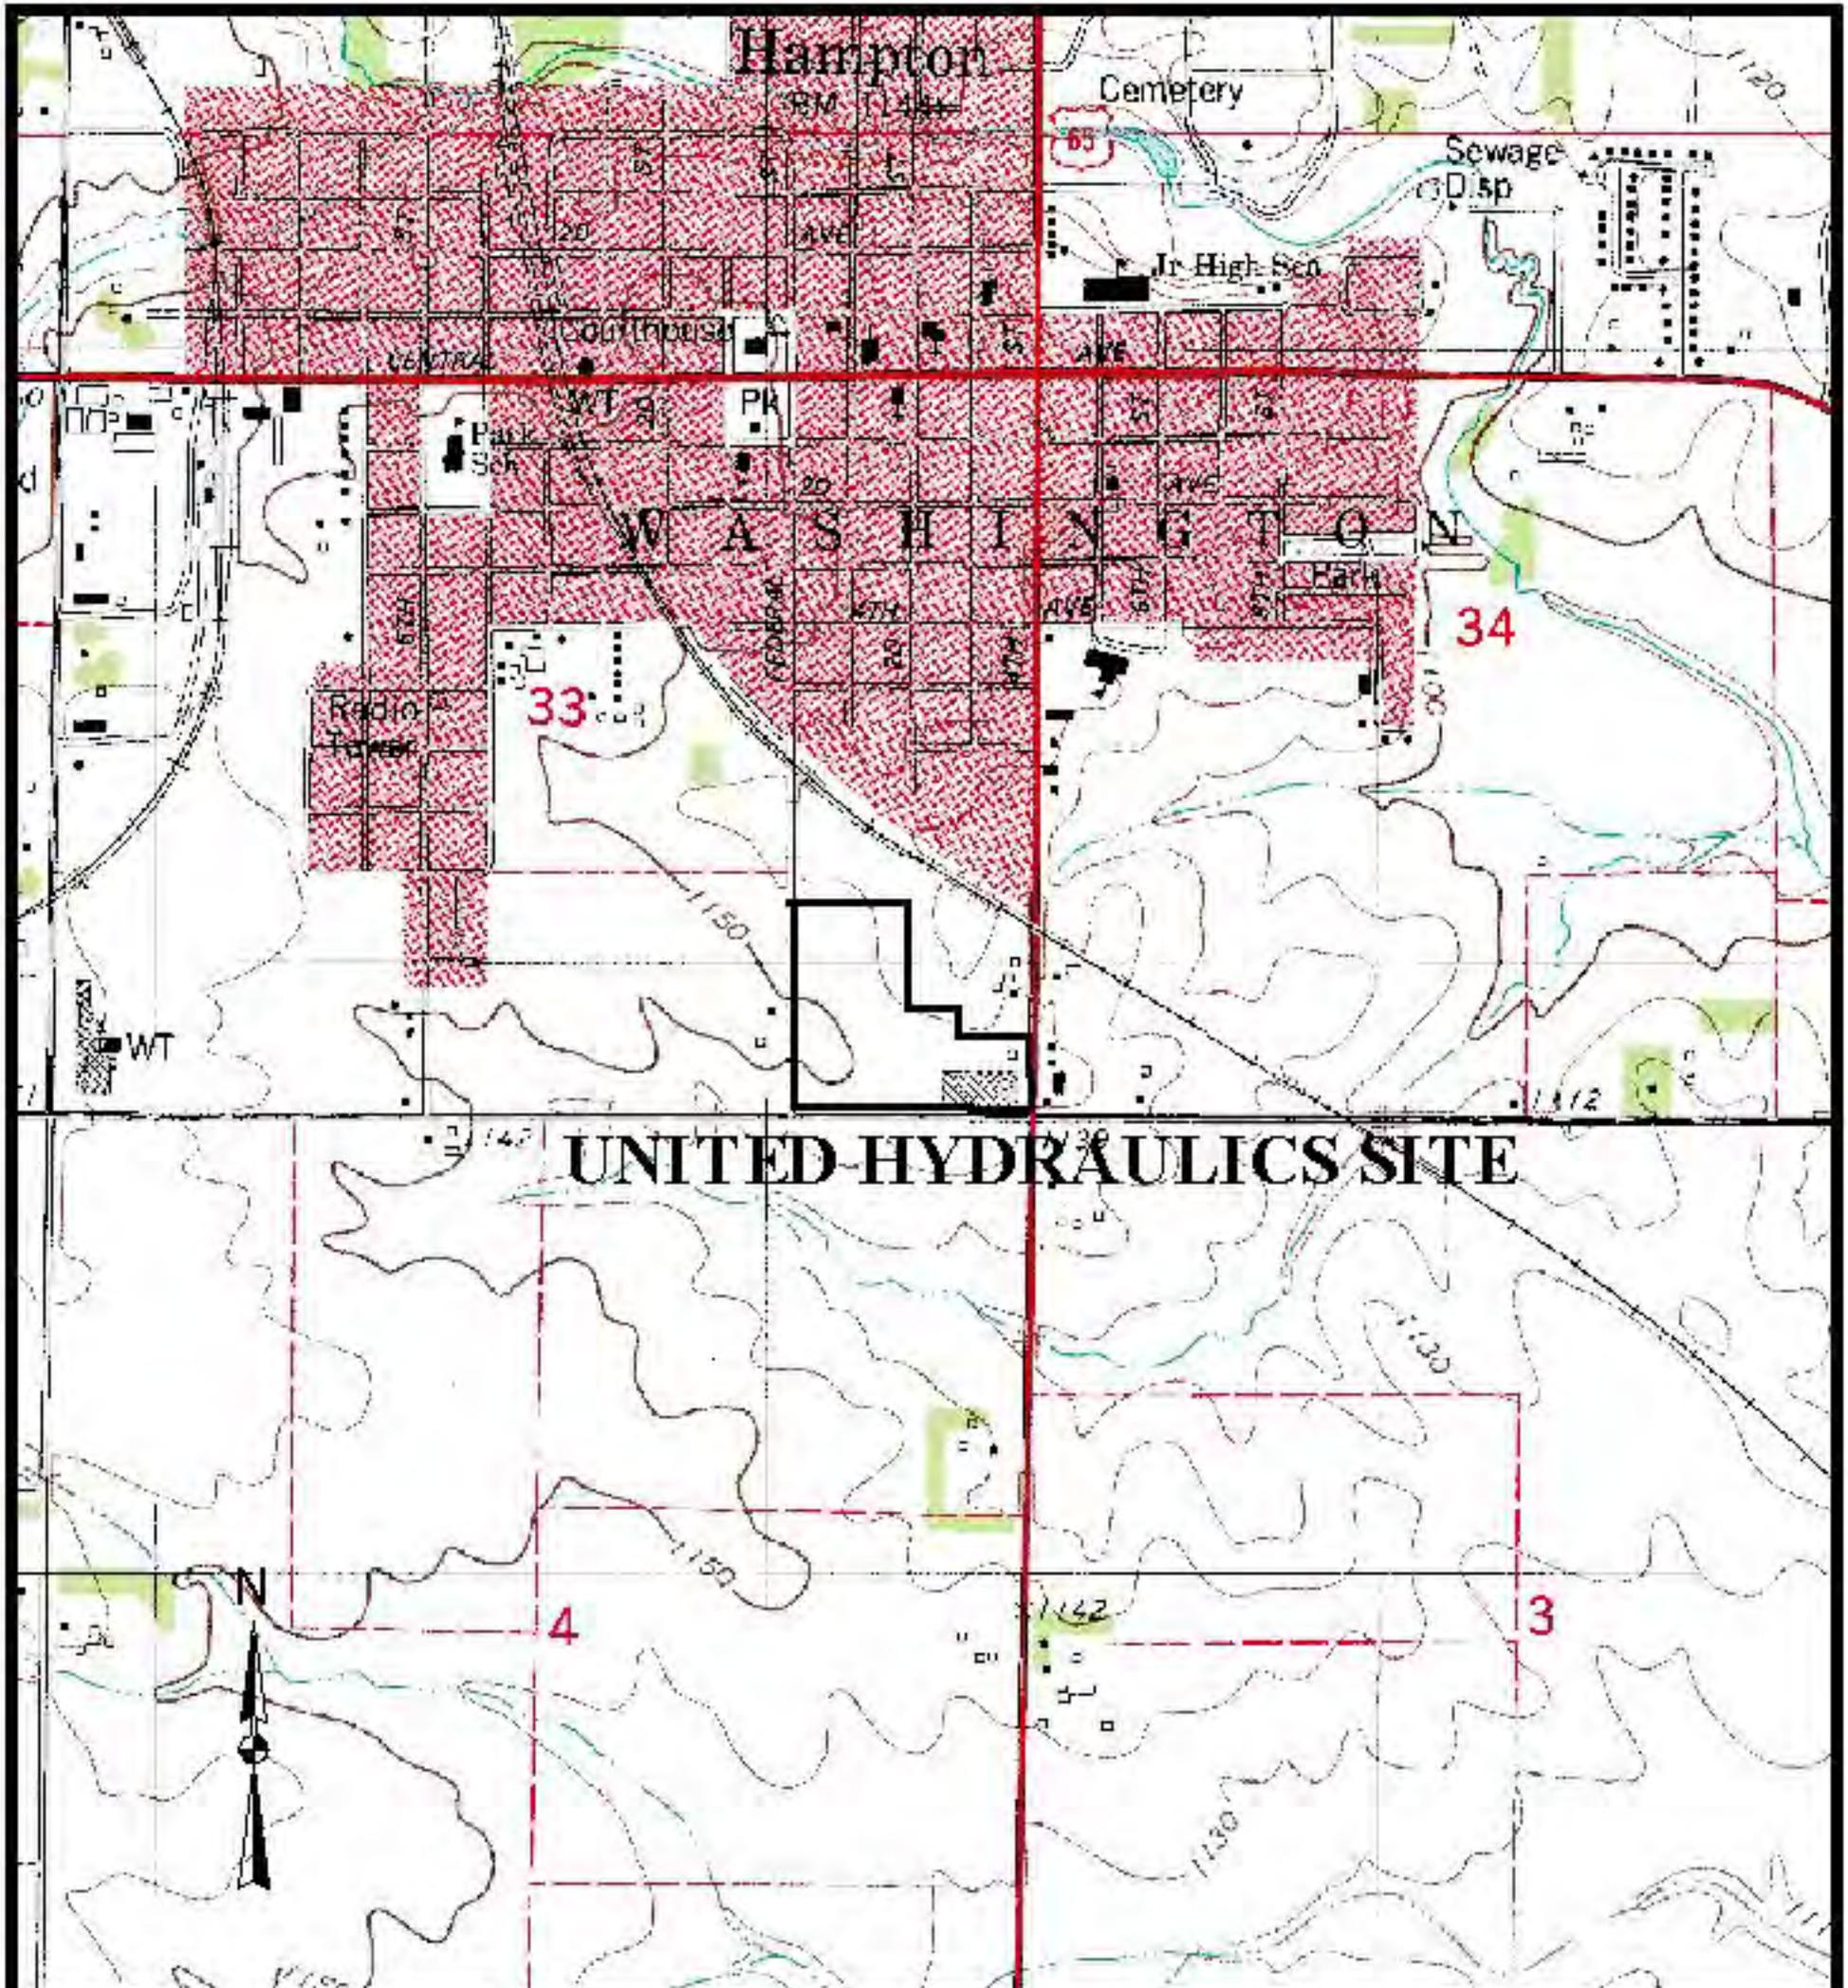
Figure 2-3
 ESTIMATED EXTENT OF
 TVOC AND CHROMIUM
 ZONE A
 JUNE 2006

Further investigations in 1988 and 1989 found the chromium contamination in the shallow groundwater extends at least 1300 feet east-southeast of the site. Another investigation was conducted in 1991 in conjunction with the development of a remedial action plan. A total of 34 monitoring wells have been installed and sampled during these investigations. The maximum groundwater contamination levels for chromium and volatile organic compounds (VOCs) appear in Table 1.
