APPENDIX G

Hydraulic and Hydrology Analysis

Report on Mechanical Equipment

Lake Delhi Dam Mechanical and Electrical Observations and Report

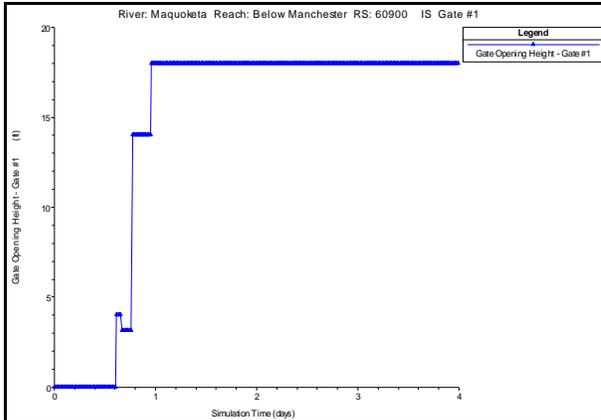
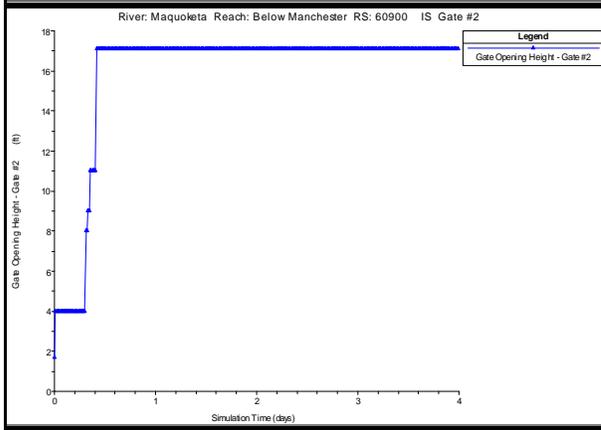
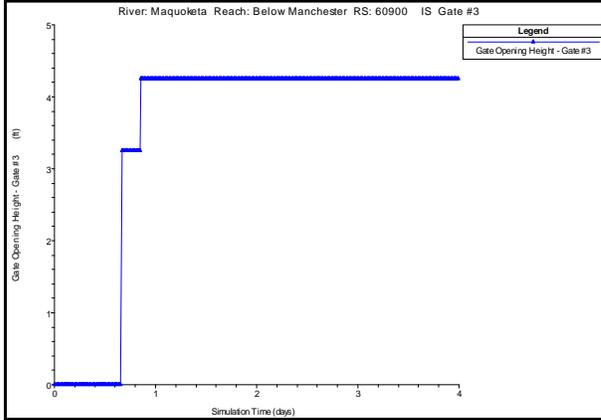
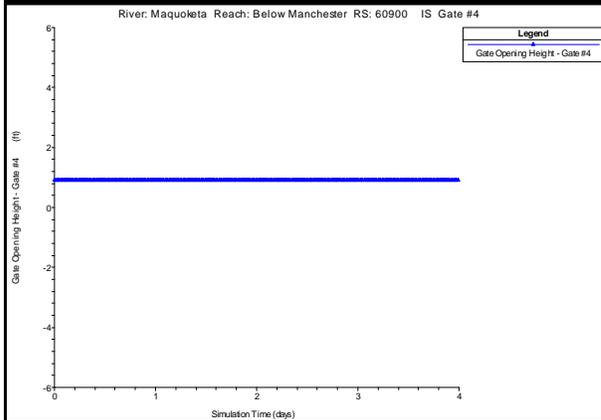
Figure 9: Spillway gate and wicket operations using operator's logbook with field-measured final openings

According to the operator's logbook, Gate # 2 would have been fully out of the water briefly on July 23 (about 8 am until about 10 am) and thus, these weir flow assumptions were used those hrs.

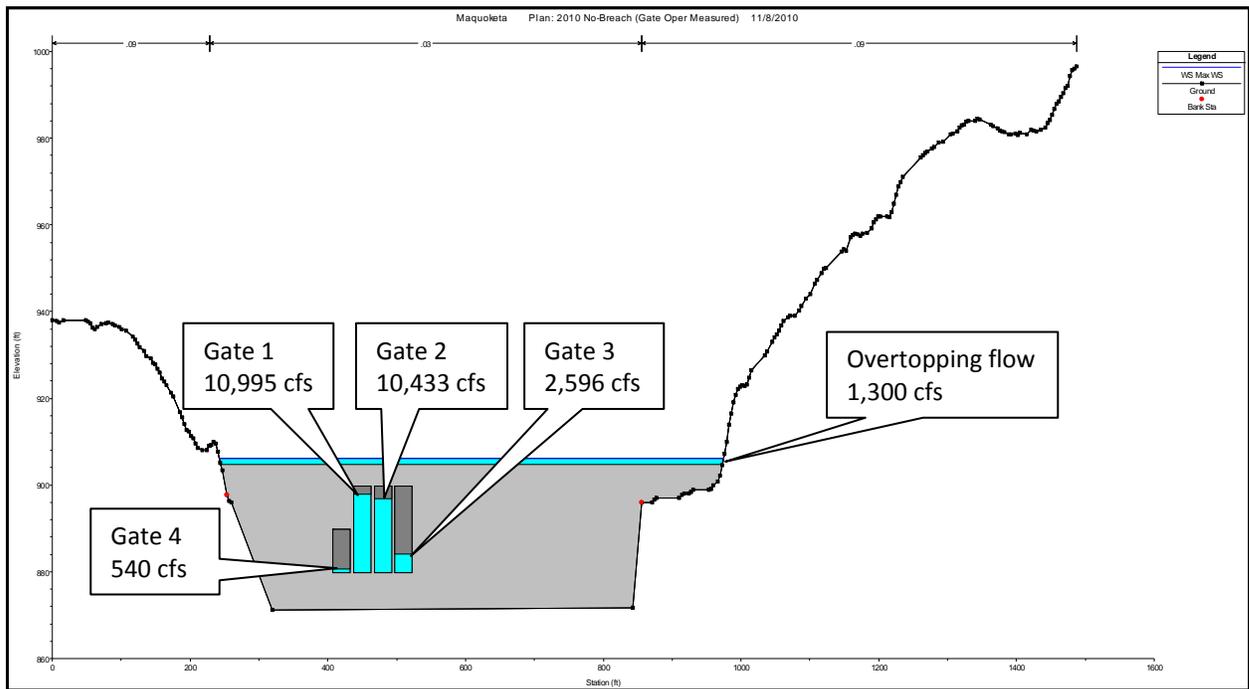
Figure 10: Maximum Discharge Computed at Peak Observed WSEL (905.55 ft NGVD29)

The spillway rating curve is computed directly in the HEC-RAS software based on the geometry and gate operation settings. The maximum discharges for the measured gate operations based on field measurements are shown in Figure 10. Aside from the brief period (≈ 8 am – 10 am) on July 23, 2010 when the logbook indicates that Gate # 2 would have fully been out of the water (weir flow regime), the entire flood event would have been passed under orifice flow conditions. The spillway rating table per gate shown in Figure 11 was computed using the orifice equations listed in the HEC-RAS Hydraulic Reference Manual.

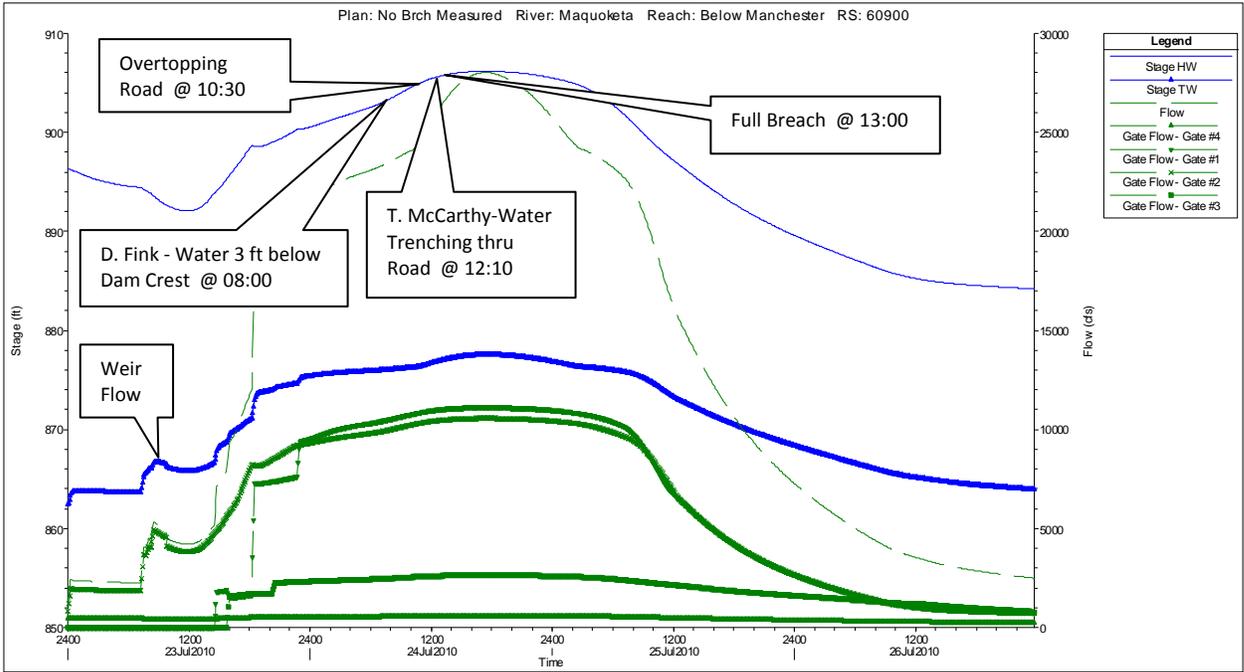
Figure 12: Revised HEC-RAS Stage and Flow Hydrograph

Based the input assumptions as described above, the revised Iowa DNR model was able to provide a good replication of the observed events (see Figure 12). A comparison of the model's and observed high water marks at other cross-sections is shown in Table 1. Another example of model accuracy comes from eyewitness reports which stated that the upstream bridge at County Road X21/240th St had "4 to 5 feet" of water flowing over the top of it at 9:40 am on July 24, 2010. Figure 13 below shows a picture of that bridge during the event as compared to the HEC-RAS model.

Although there are no eyewitness accounts of the reservoir lowering as far as shown on July 23, the weir flow conditions that produce it are a result of replicating the operator’s logbook.

The revised model based on the operator’s logbook and measured final gate openings matches the observed timing and water surface elevations well up to the point where breach progression is underway. As such, the revised model peaks after the actual time of failure.

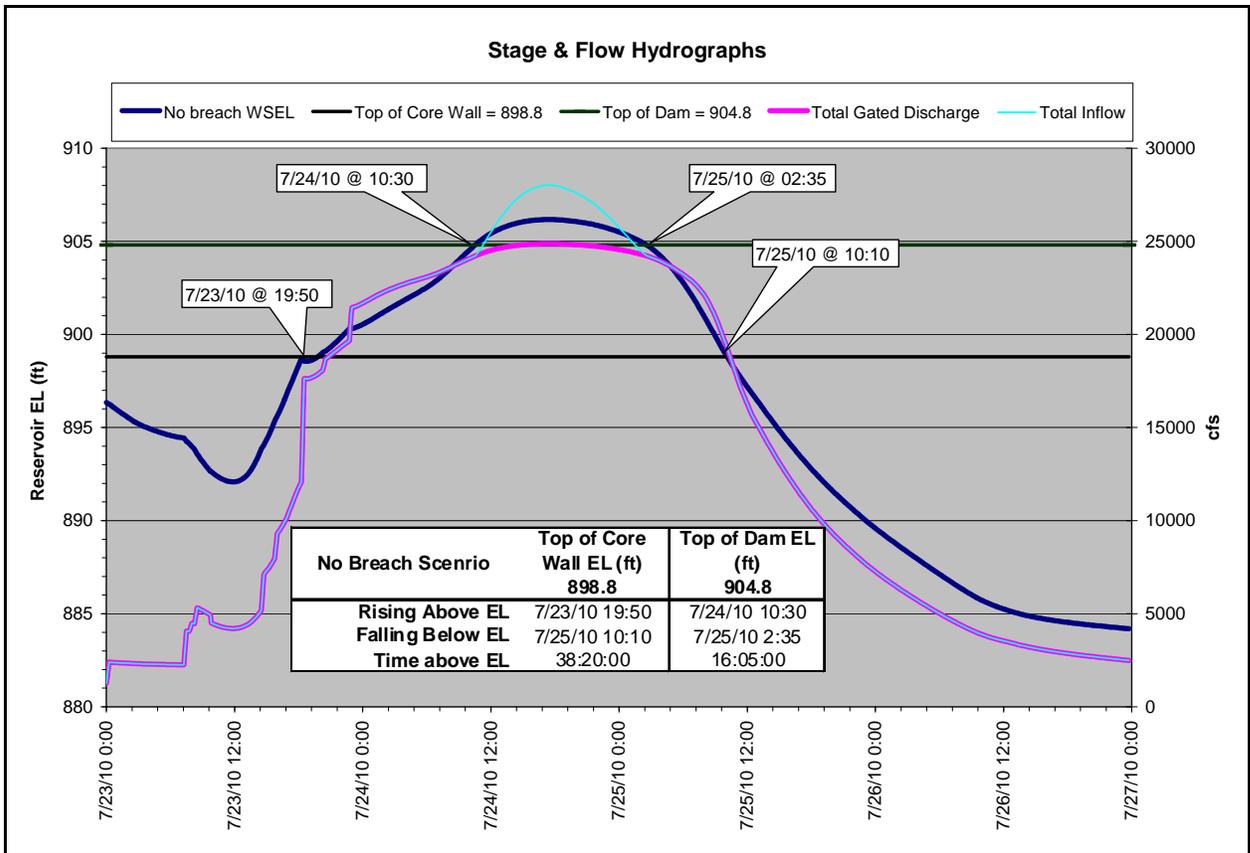
Figure 14: Reservoir Duration above Top of Core Wall (EL 898.8 NGVD29)

- The revised no-breach model was used to determine the potential total overtopping duration for when the reservoir elevation was above the top of core wall, 898.8 ft. This along with the stage hydrograph for the breach scenario is shown in Figure 14.

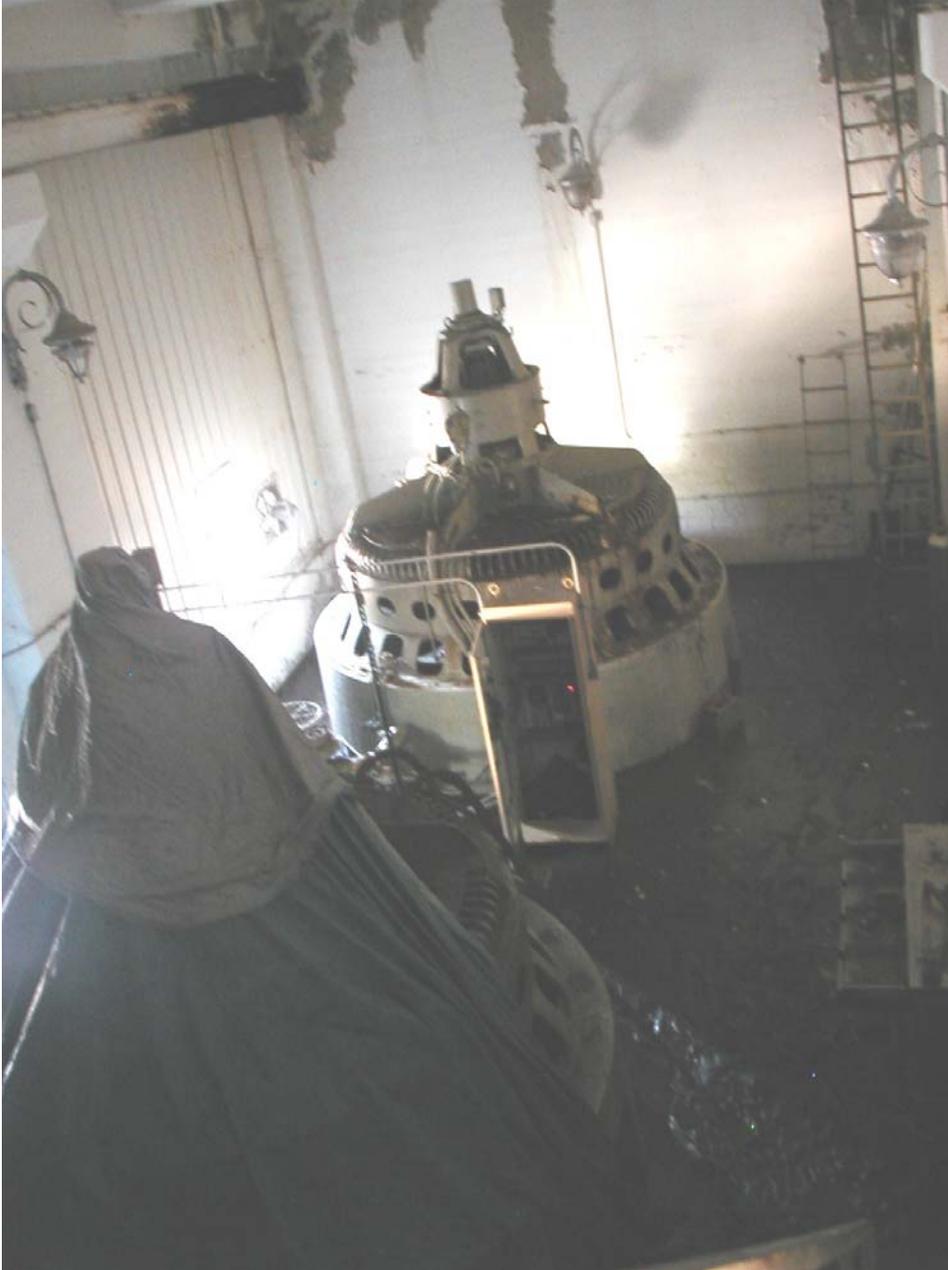
This picture shows the inside of the hydropower facility and the two turbines. Both of the turbines are currently deactivated. The new hydropower work being

proposed would add new draft tubes for the turbines and provide up to 60% increase in flow (above the existing flow through the dam) according to Mr. Fink.

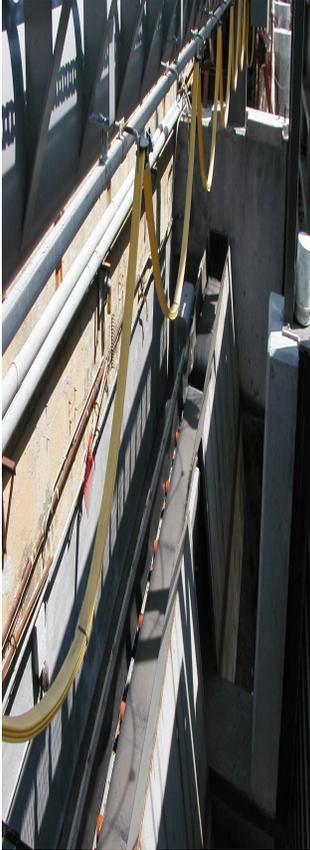
This picture shows the hydropower area of the dam on the upstream side (or the pool side). The hydropower area of the dam has a trash screen in front of it. This overhead trash screen system was added in 2009.

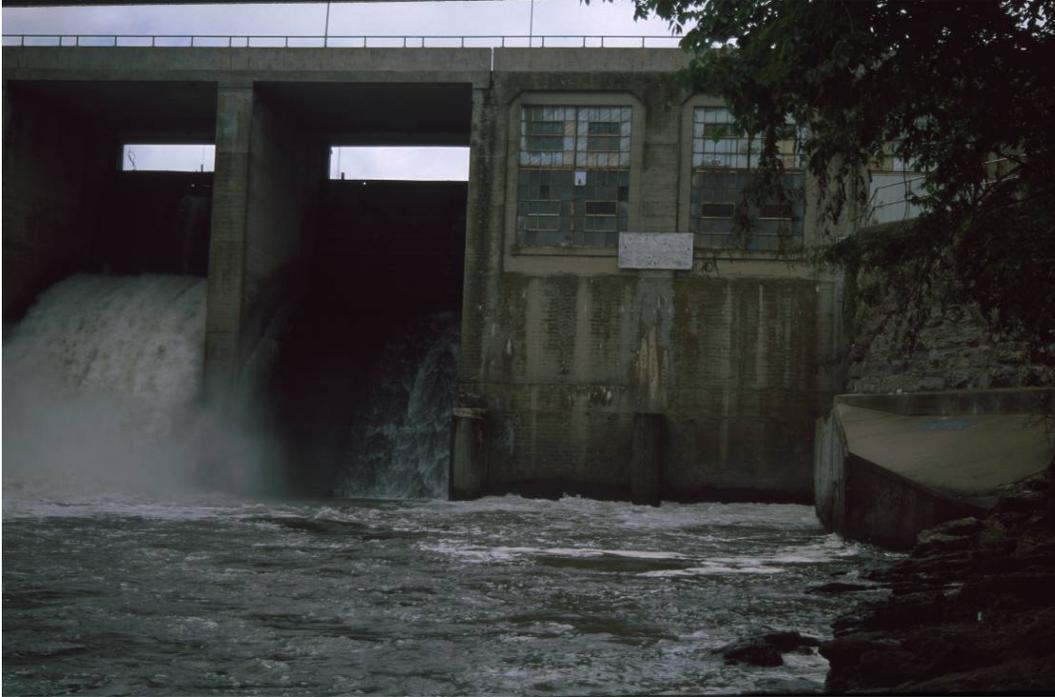
This is a previous inspection photo taken 2009 on the downstream end or tailwater side of the dam. The spillway gates are to the left. The hydropower facility is to the right in the photo.

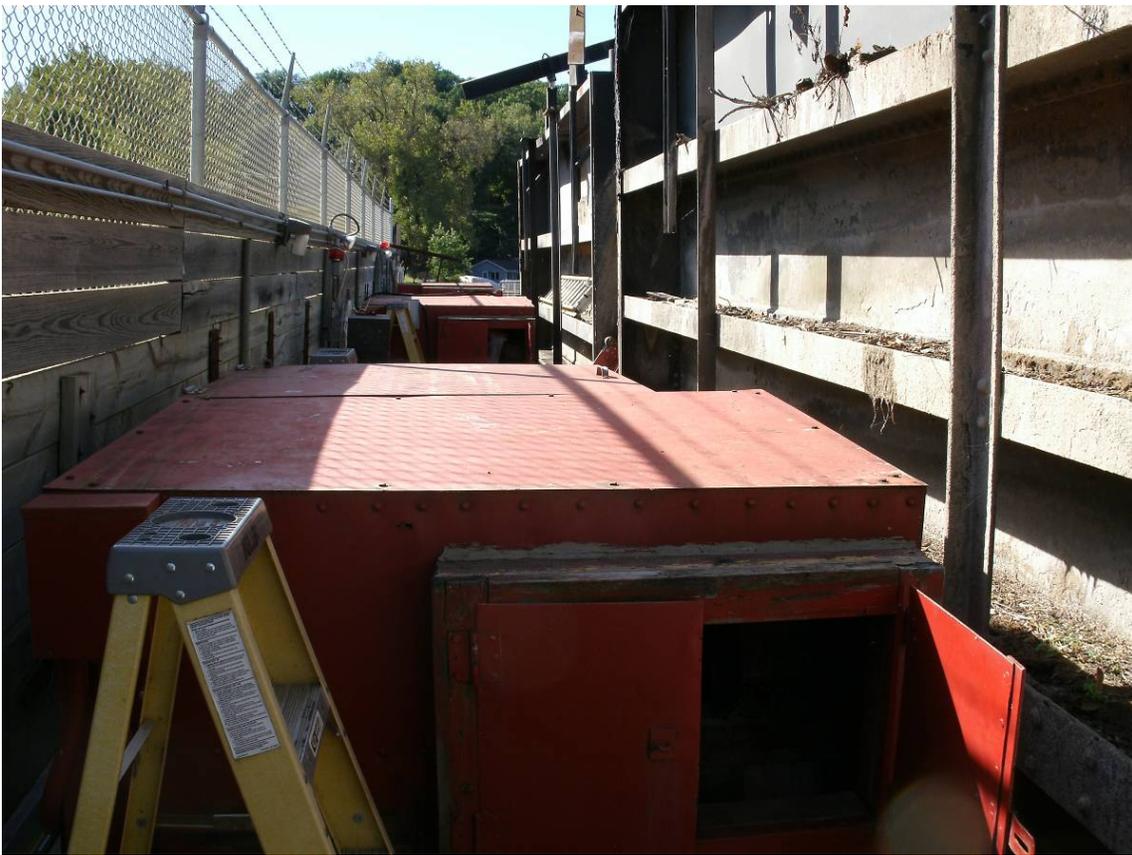
This picture shows the three gate machinery housings. The housing covers the motor, gate controls, and cable drums.

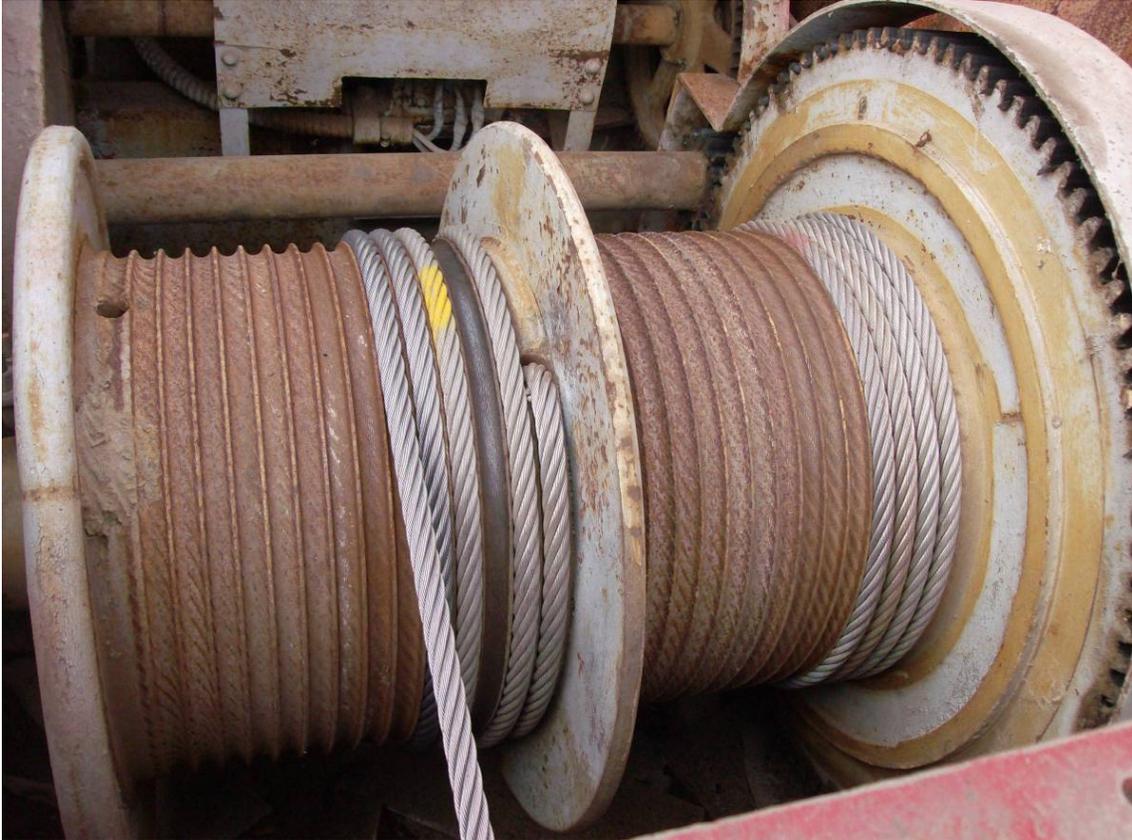
This picture shows the cable drums inside the machinery housing. There are two lift points on each spillway gate.

The cables from each drum extend out from opposite sides of the machinery housing.

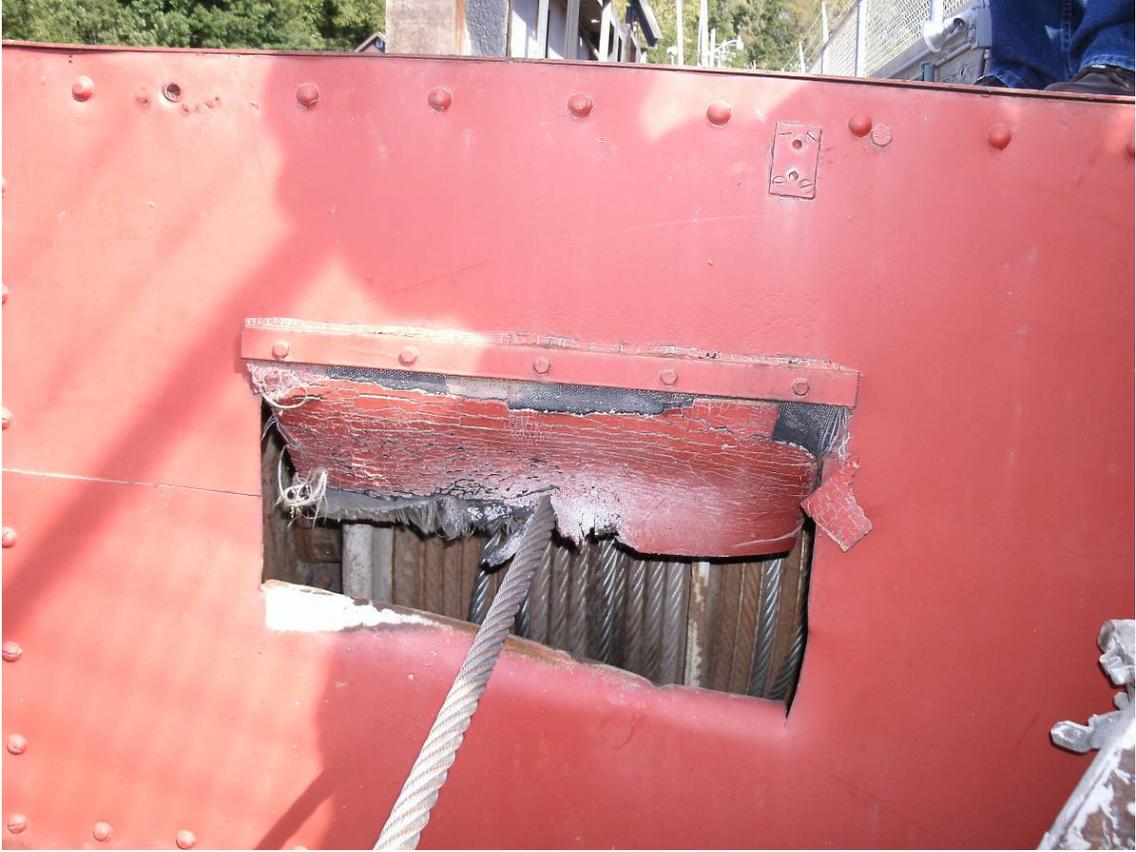
This picture shows the wire rope extending from the cable drum and the housing.

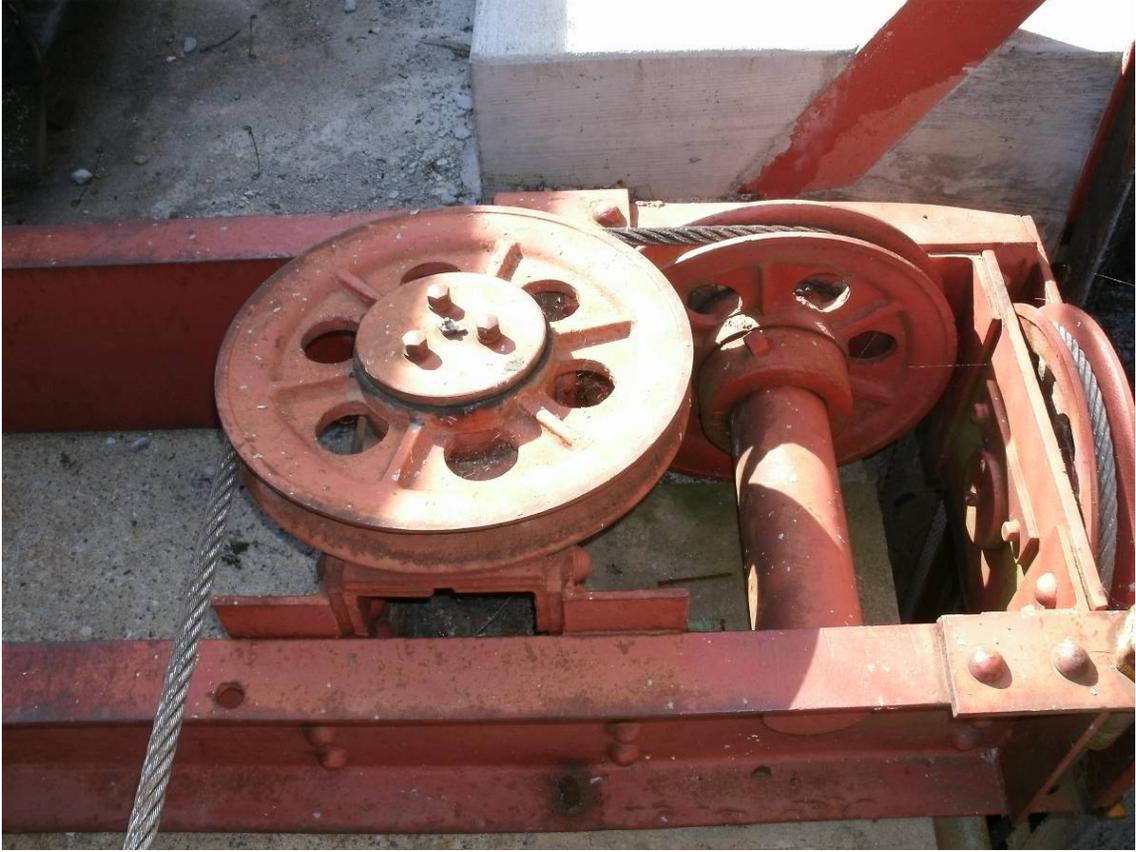
This picture shows the reeving details for the wire rope and the multiple wire rope sheaves.

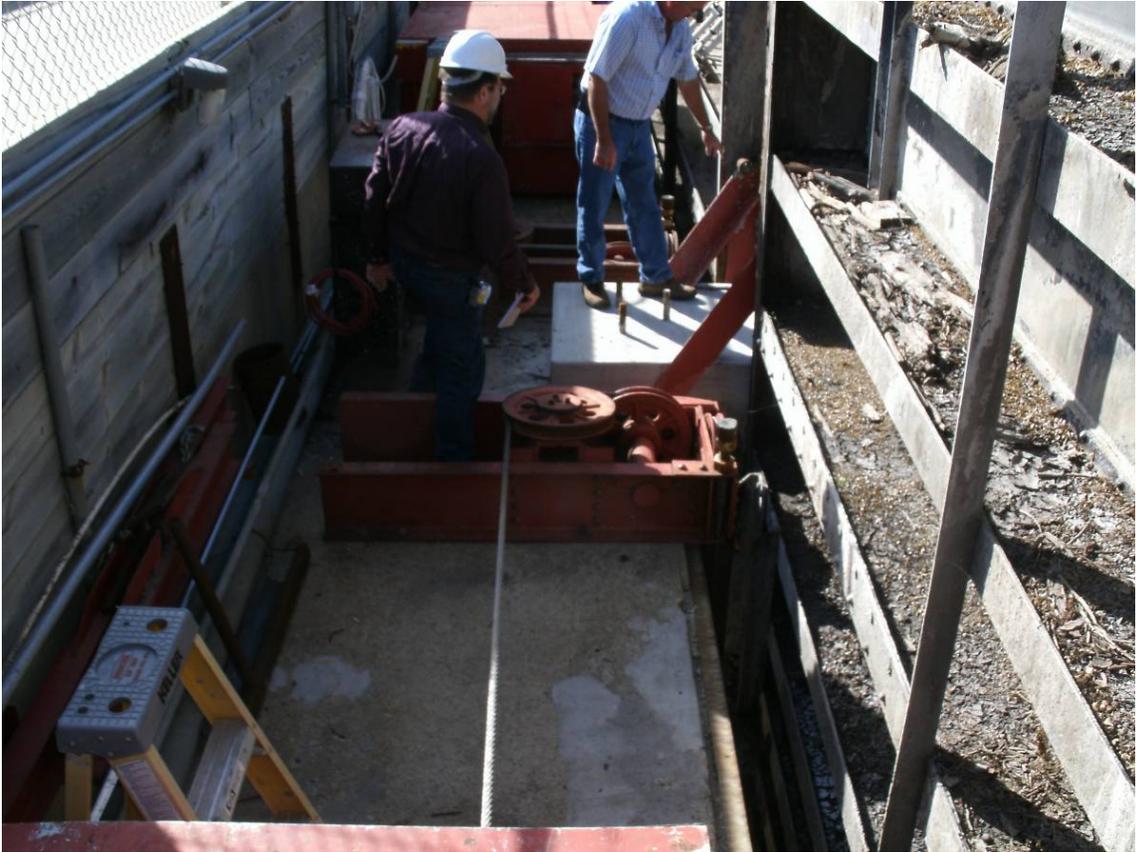
Another picture showing the wire rope extending from the machinery housing to the wire rope sheaves.

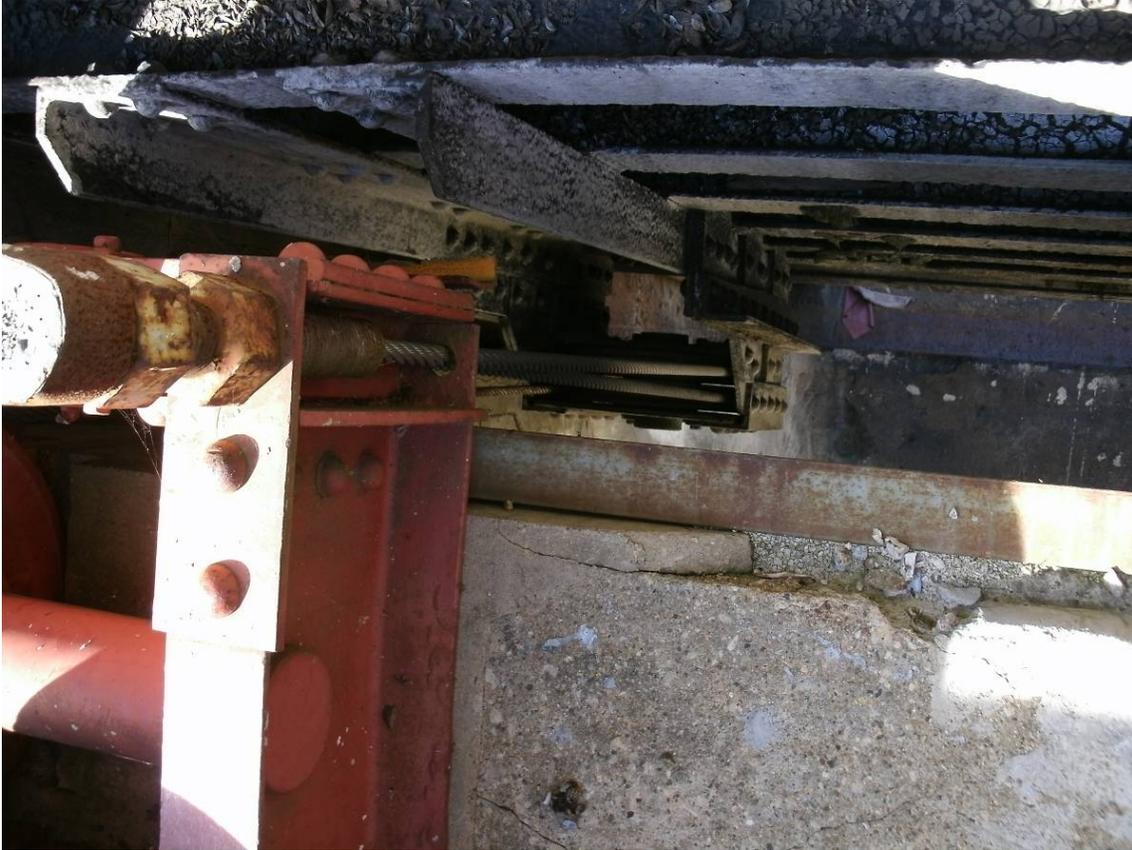
View of Gate 1 wire rope looking from top and showing the connection to the vertical lift gate.

Again, each vertical lift gate has two lifting points or pick points. The reeving details and connections details are identical between the two sides of the gates.

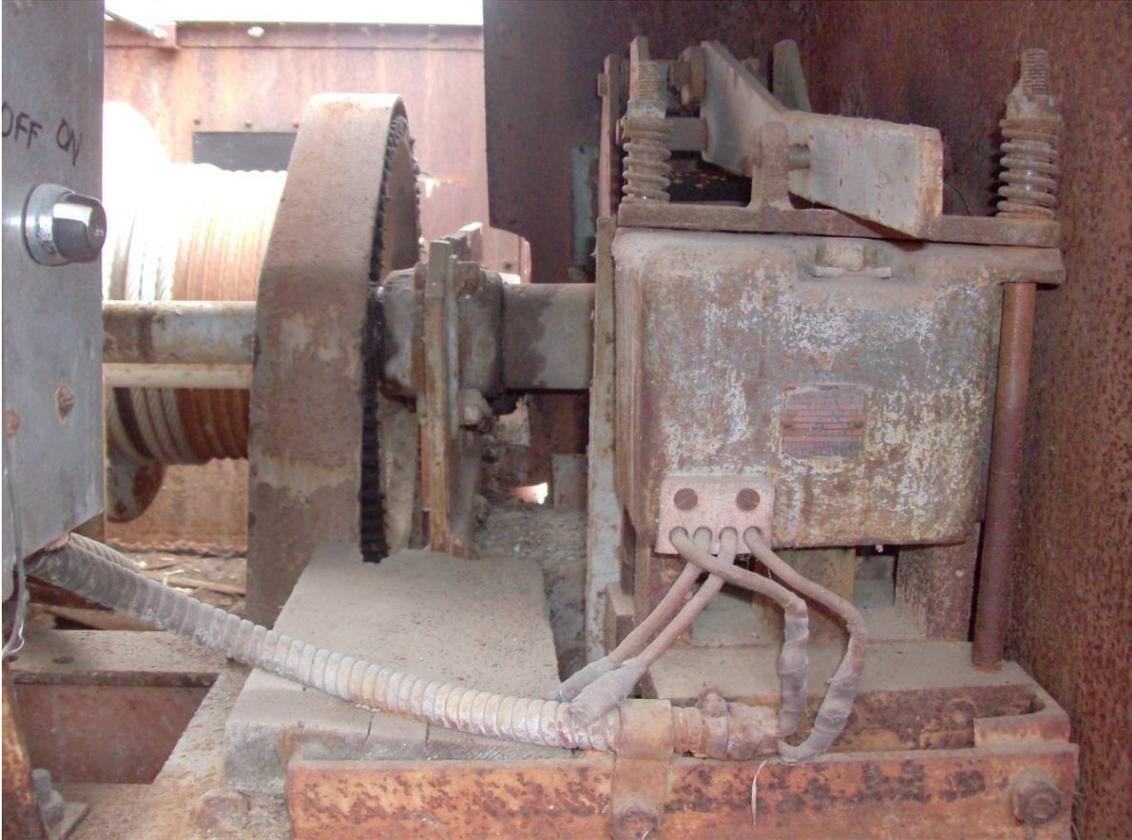
This picture shows the inside of the machinery housing. Note the cable drum, motor, brake, and controls.

The electric motor is designed to run on 3-phase, 208 volts. The motor is original and has not been rehabilitated. Data on the motor as follows:

Mr. Fink thought the brushes in the motors may have been replaced otherwise they are original.

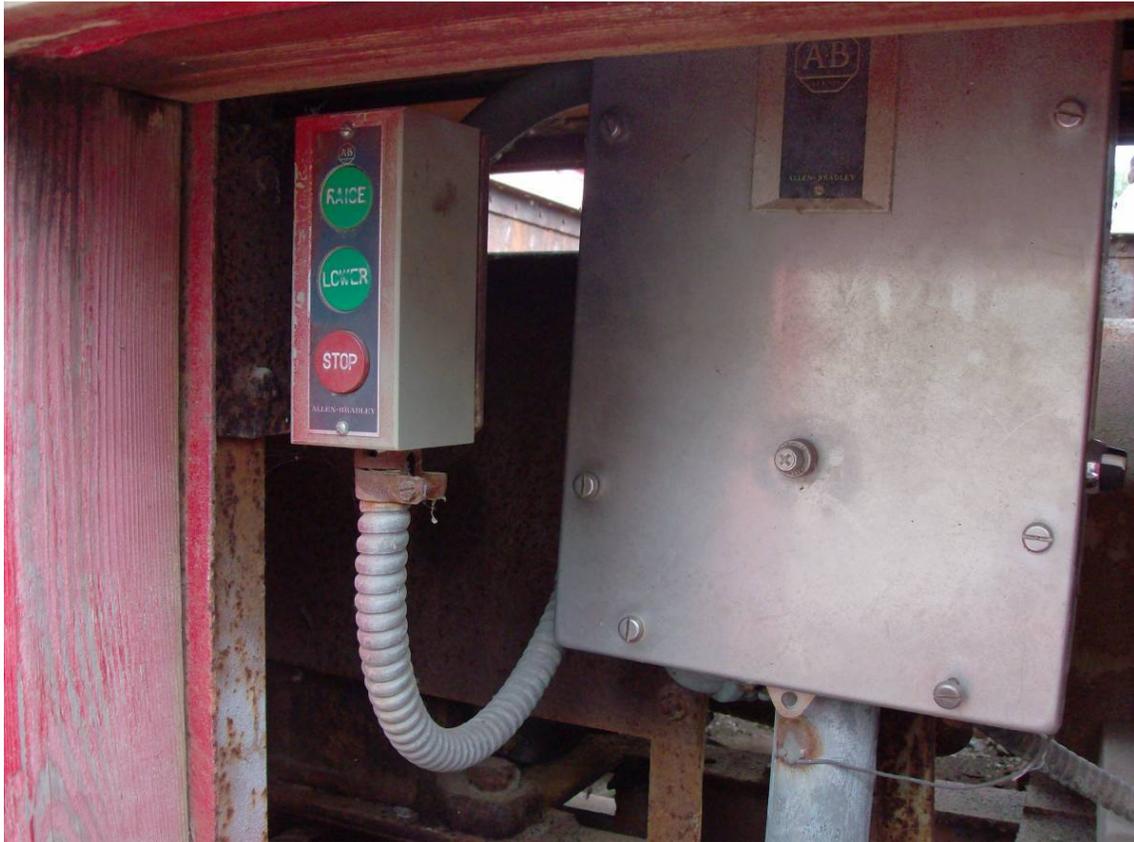
This picture shows the push button station for operating the gate machinery.

This is all locally controlled at the machinery. The push buttons themselves have been replaced otherwise all the control equipment is original.

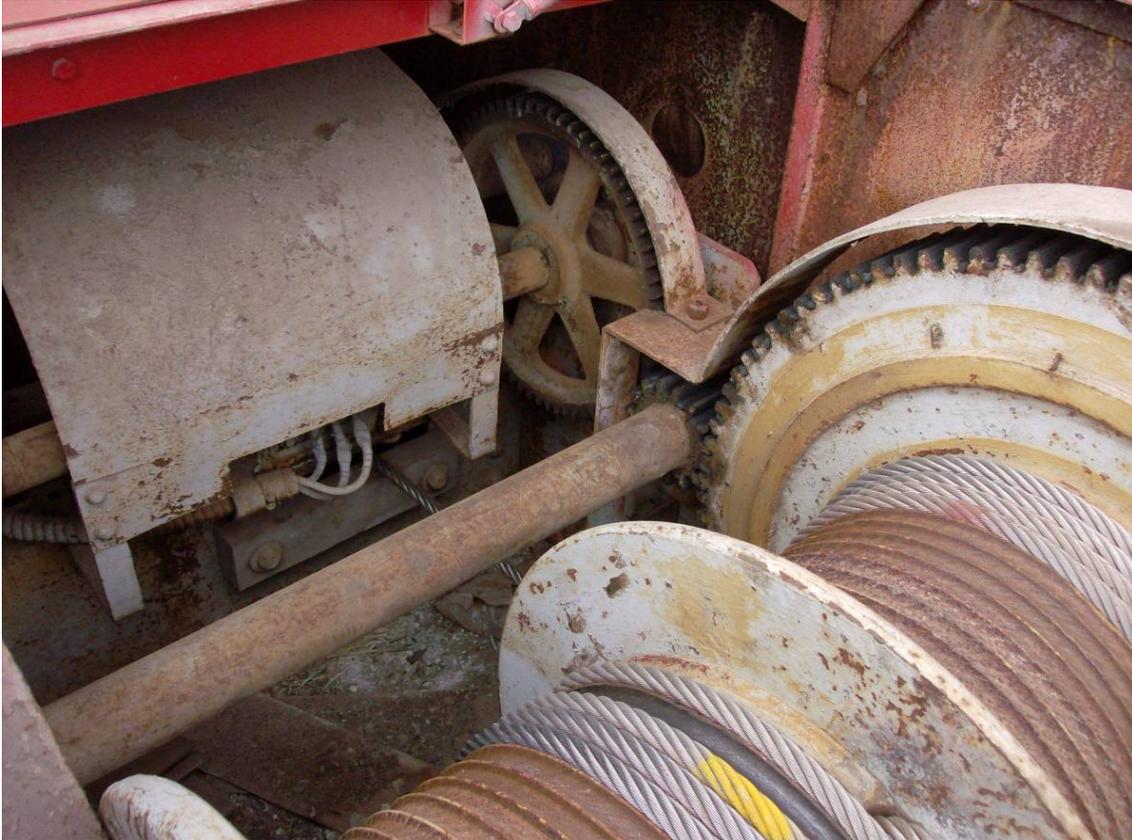
This picture shows a better detail of the gearing for the machinery units.

The cable drum gear and pinion gear are shown in this photo.

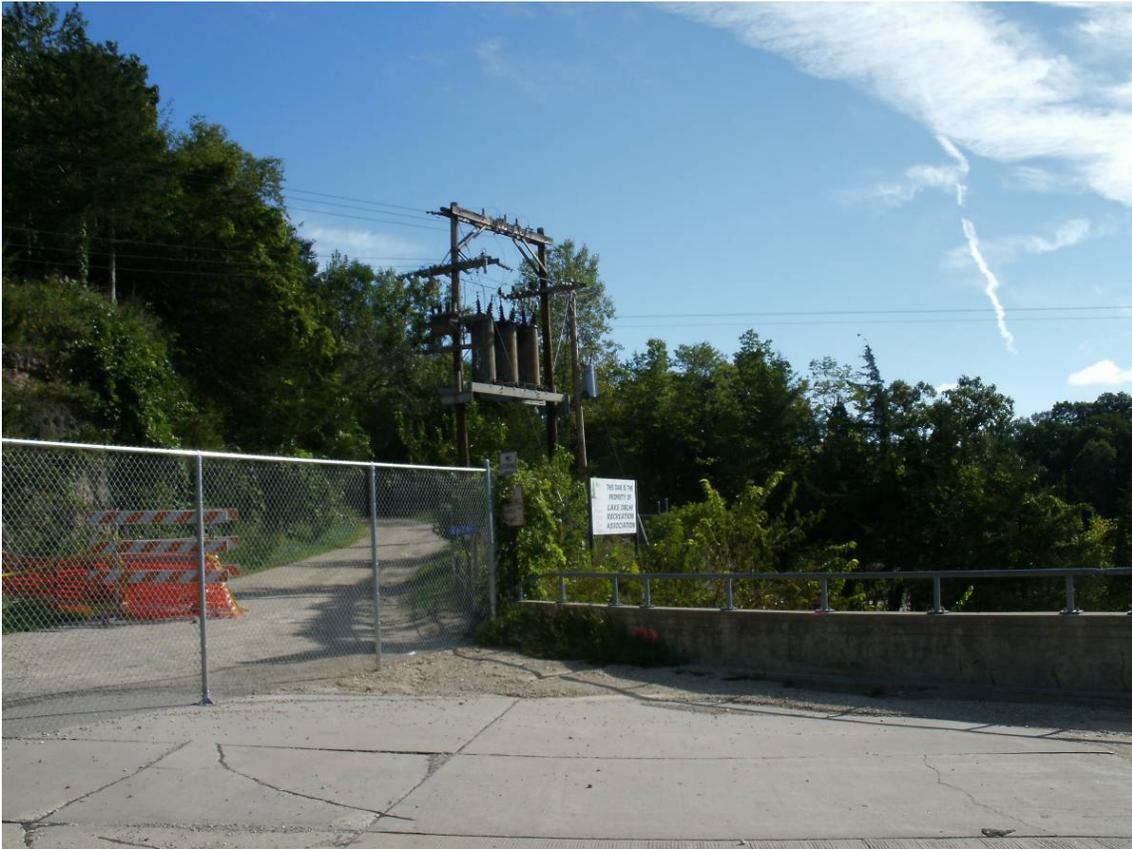
Commercial power is the primary power to the site. The site operations staff indicated the commercial power is fairly reliable. Outages were noted to be very brief.

It was reported the current electrical system utilizes 480 volt, 3 phase power. The circuit breakers are located in the hydropower house. The 208 volt system has been disabled. The 208 volt system was damaged and submerged during the July flood event and was not restored. The 480 volt system was repaired.

Power line and transformers to dam structure
