IOWA HIGH HAZARD DAM ASSESSMENTS

Dam Risk Reviews and Rankings

Iowa DNR Dam Safety

August 11, 2023
Section 1
Des Moines, IA

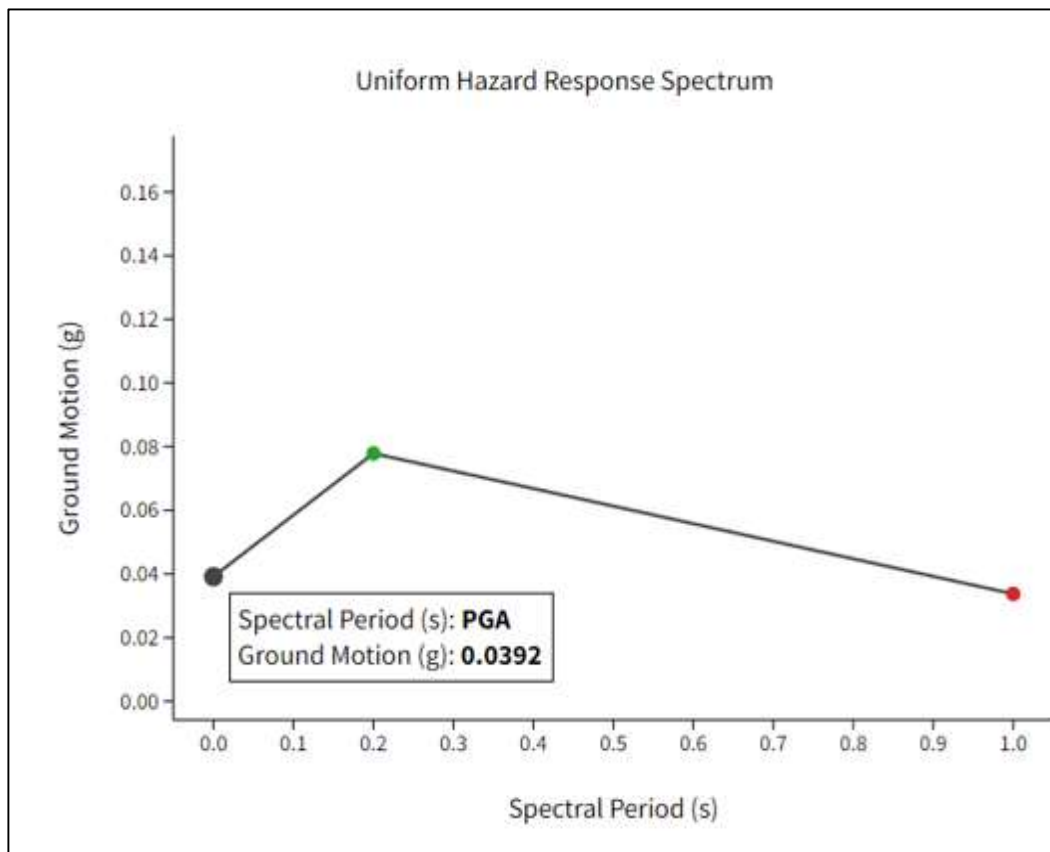
Seismic Assessment - Bacon Creek Watershed Site A-1-1

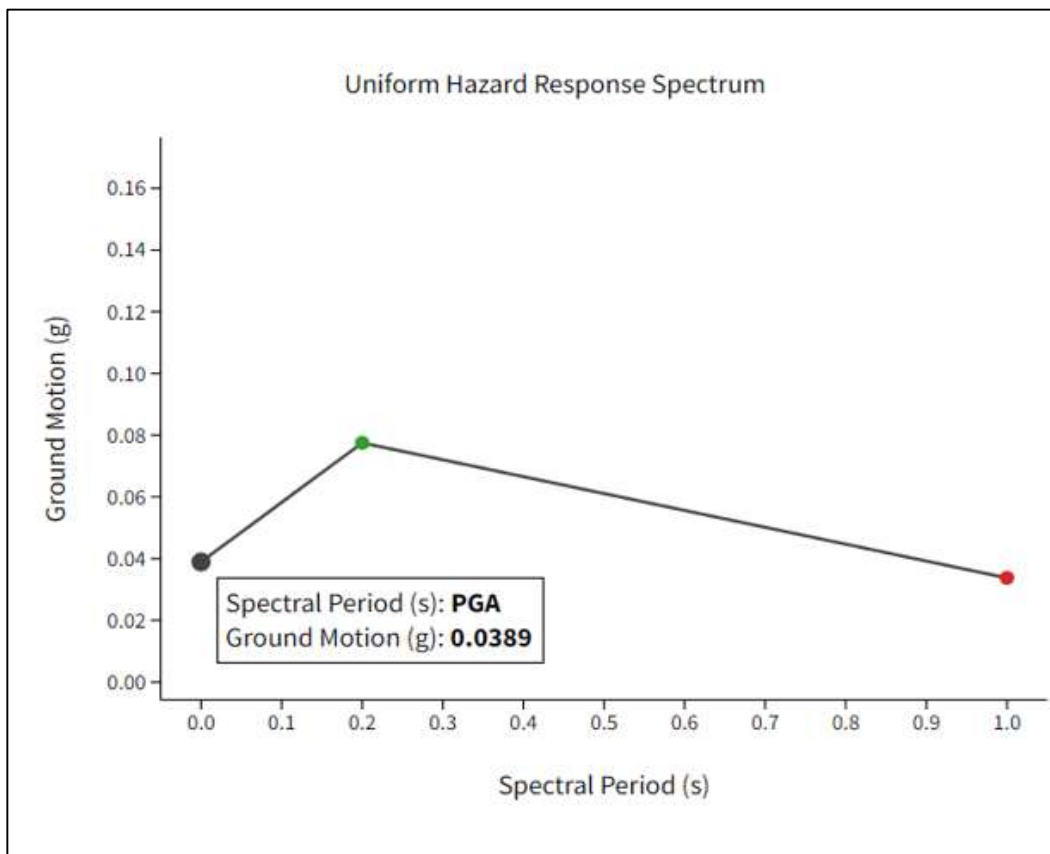
Seismic Assessment - Bacon Creek Watershed Site A-2-4
