## **SHELLER GLOBE/ UNITED TECHNOLOGIES**

(Grimes Property Keokuk, Iowa)

### **GENERAL DESCRIPTION**

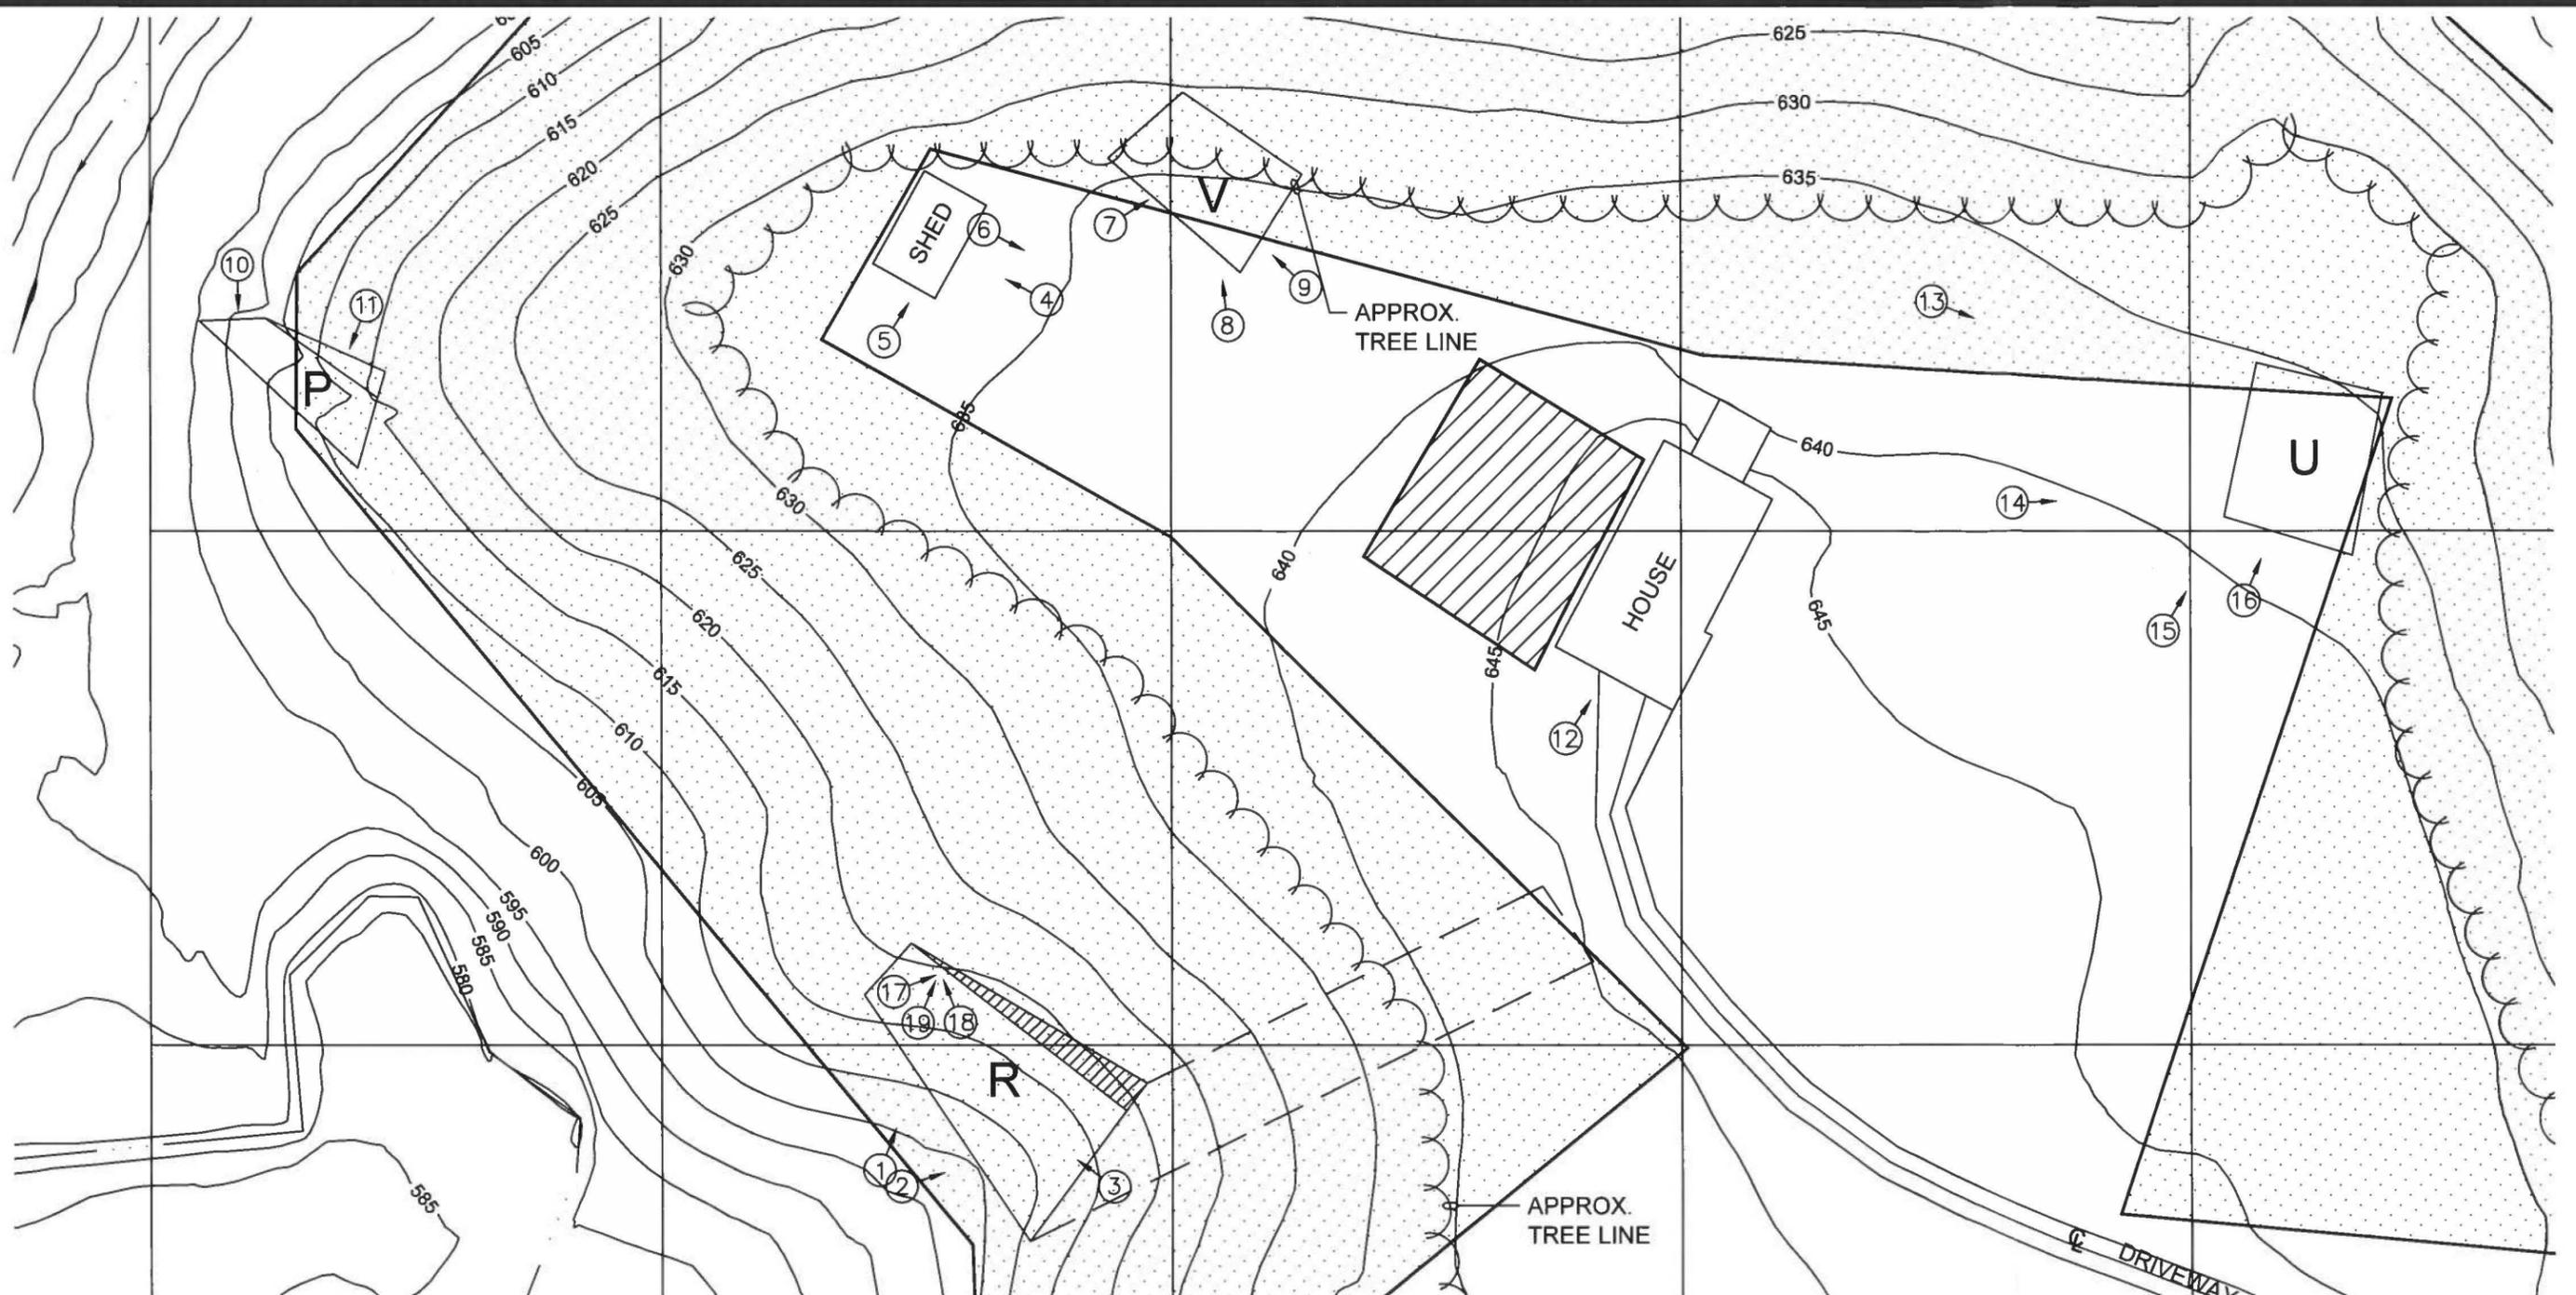
AREAS OF EXPOSED ASH WITH ELEVATIONS LISTED AT EACH CORNER OF GRID AS IDENTIFIED IN THE RI/FS
-

ADDITIONAL AREA OF EXPOSED ASH COVERED WITH TOPSOIL
-

AREA SUFFICIENTLY COVERED WITH TREES AND VEGETATION.
-

ESTIMATED HORIZONTAL EXTENT OF WASTE MATERIALS (MIXTURE OF SOIL, RUBBER, ASH, SLUDGE, DRUMS)
-

PHOTOGRAPH NUMBER AND DIRECTION OF PHOTOGRAPH TAKEN APRIL 27, 2015
