Stage 1 VRS Damage and Anchoring:

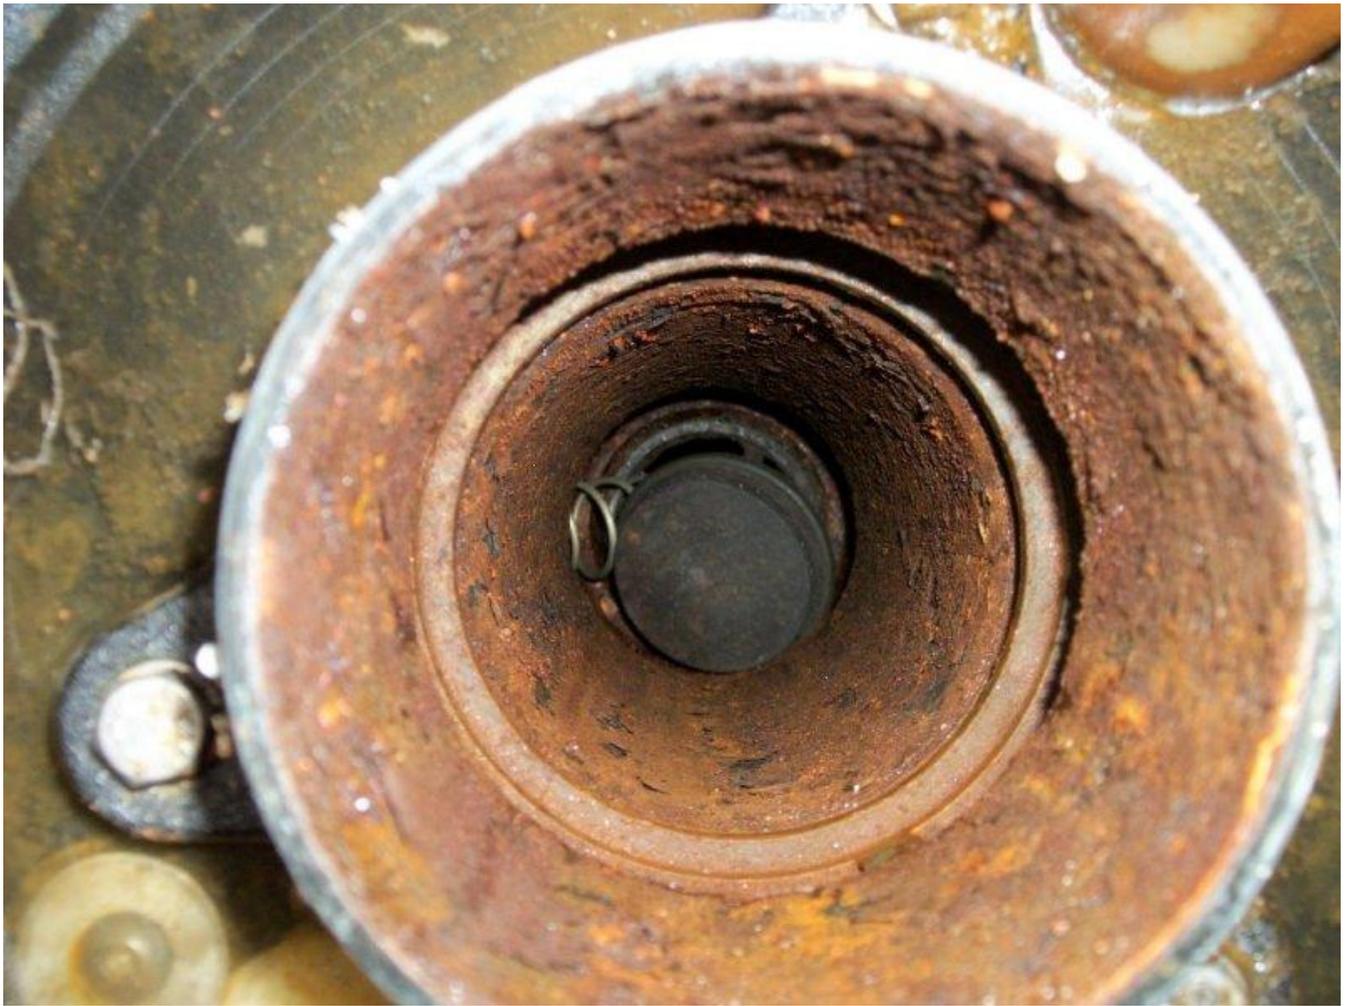
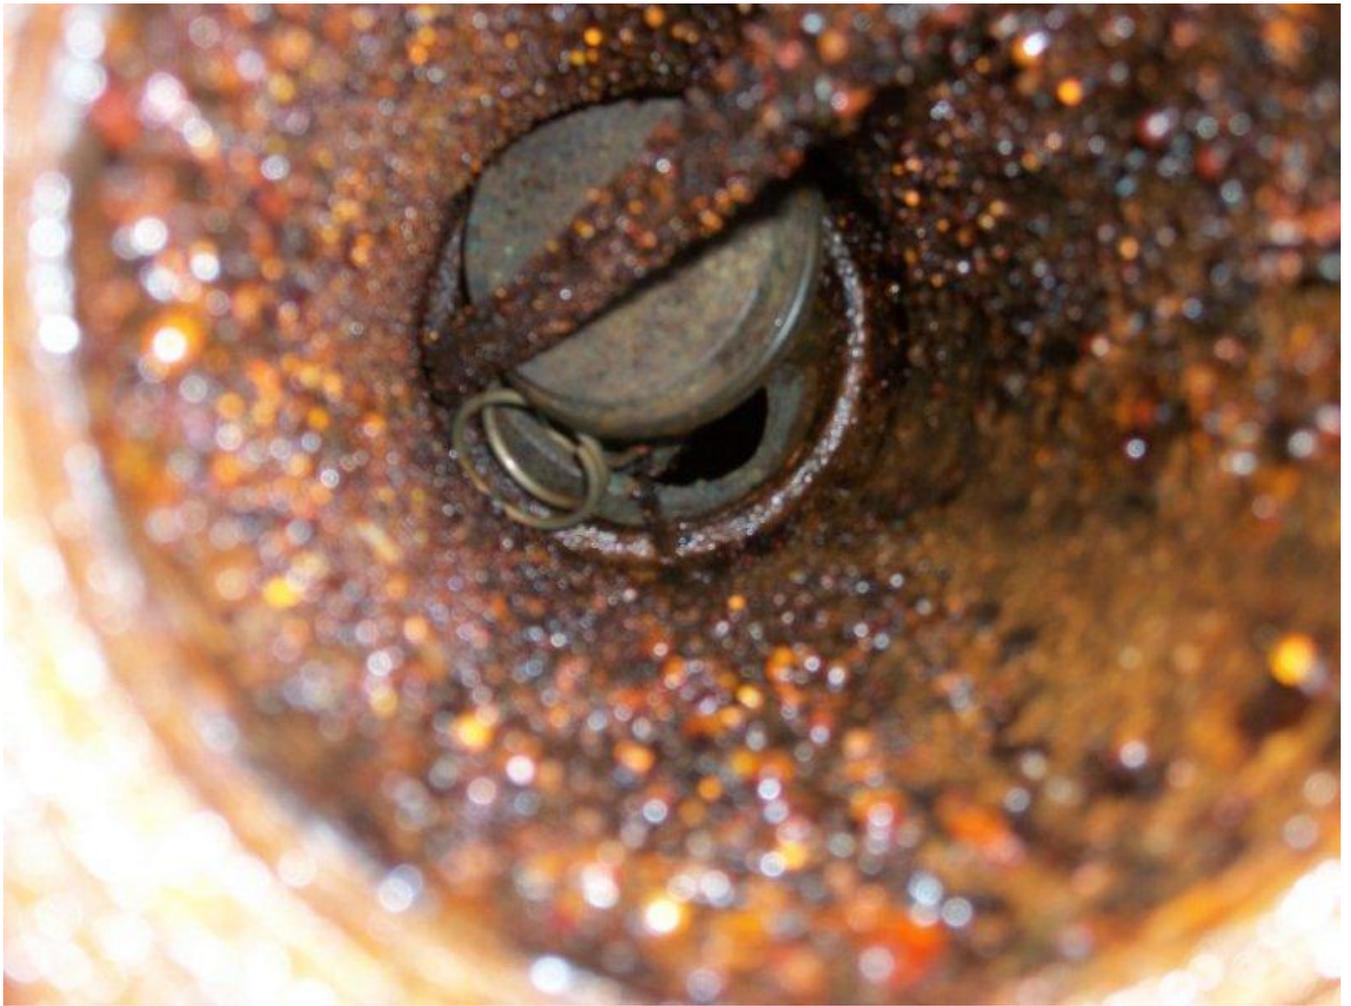
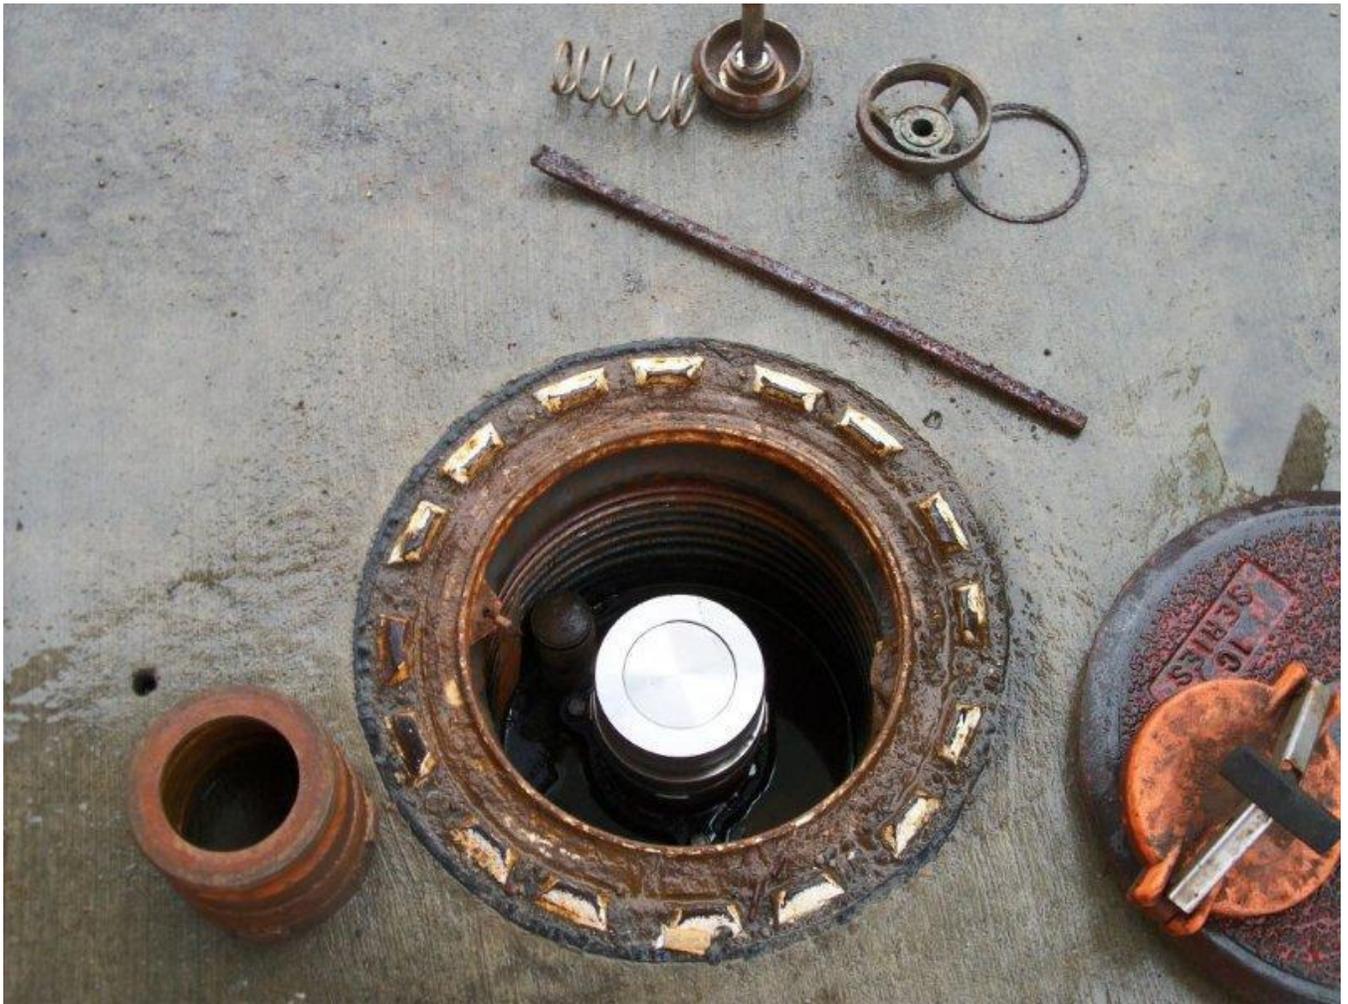
- 2) A few months ago, we sent a notice to compliance inspectors describing what to look for during Stage 1 Vapor Recovery System (VRS) inspections. If they found any single or dual-point systems that appeared to be tampered with they were told to contact us. The pictures above are among the first to be reported. A transporter pried open the Dry Break, damaging it in the process, to expedite delivery. It is hard to believe that someone would destroy equipment just to speed delivery. Further enforcement is in store for the company including a fine and/or penalty. The owner of the UST system has also contacted the transporter, and among other things, required the transporter to pay for the replacement Dry Break. If you should observe damaged VRS equipment, take photos and contact us.
