# JBS SWIFT PORK

## PROJECT BACKGROUND

JBS Swift Pork utilizes water for a number of different cooling applications and systems throughout their production processes. The aim of this project was to conduct a full water usage analysis for plant cooling systems, identify water savings and reuse opportunities and to recommend feasible solutions. A goal of reducing water consumption by 11 gallons per unit harvested was established. Seven projects, with varying capital input and water savings, were recommended.

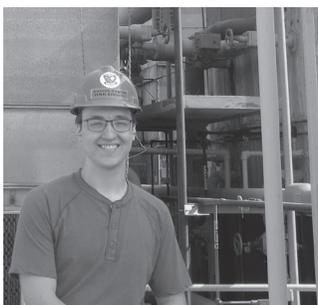
### Reuse Spray Chiller Water:

Chilled water is sprayed onto the hogs within the carcass bays to preserve product quality. The drained chilled water has the potential to be used as second-pass water within the plant's hot vapor air scrubbers. Elevated temperatures within scrubber

systems can pose significant scaling risk and reduced system efficiency. Filtration and reuse of the chilled water within the rendering air scrubbers will help maintain lower internal temperatures, improve odor control, and generate water savings. Quotes for implementation and filtration have been forwarded to management for final approval.

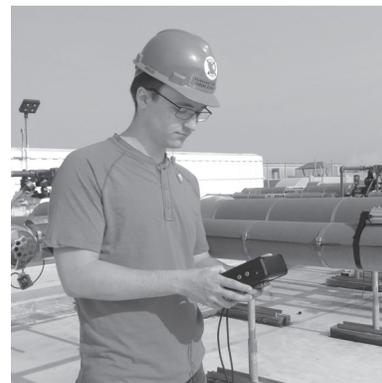
### Spray Chiller Nozzle

**Redesign:** The spray chiller within the carcass bays uses a series of nozzle rows to maximize chilled water coverage on the product. The current deflection nozzles lining the outer rows of the bays produce nearly twice the flow with half the spray angle required. Installing a more efficient

nozzle tip on the edge rows poses significant water savings. An associated energy savings may also be realized by decreasing the need to chill water, especially during warm months.
