Use Attainability Analysis

1 Water Body Name	Unnamed Tributary to Iowa River
2 Segment Description	Mouth to storm sewer outlet
3 Segment Length (mi)	0.28
4 Drainage Area (sq. mi.)	0.54
5 Segment Start Latitude, Longitude (DD)	42.06633, -92.90410
6 Segment End Latitude, Longitude (DD)	42.06318, -92.90588
7 Route of Flow (Next Downstream Adopted Designated Use)	Unnamed Tributary (A1, BWW1, HH, proposed) to Iowa River (A1, BWW1, HH)
8 NPDES Facility and Permit Number (If Applicable)	Bruin Manufacturing Co., Inc. (6400113)
9 Sample Site ID(s)	1, 2, 3
10 Segment County Name(s)	Marshall
11 Field Work Date(s)	9/16/2025

12 Aquatic Life Use Attainability Analysis - Conclusion

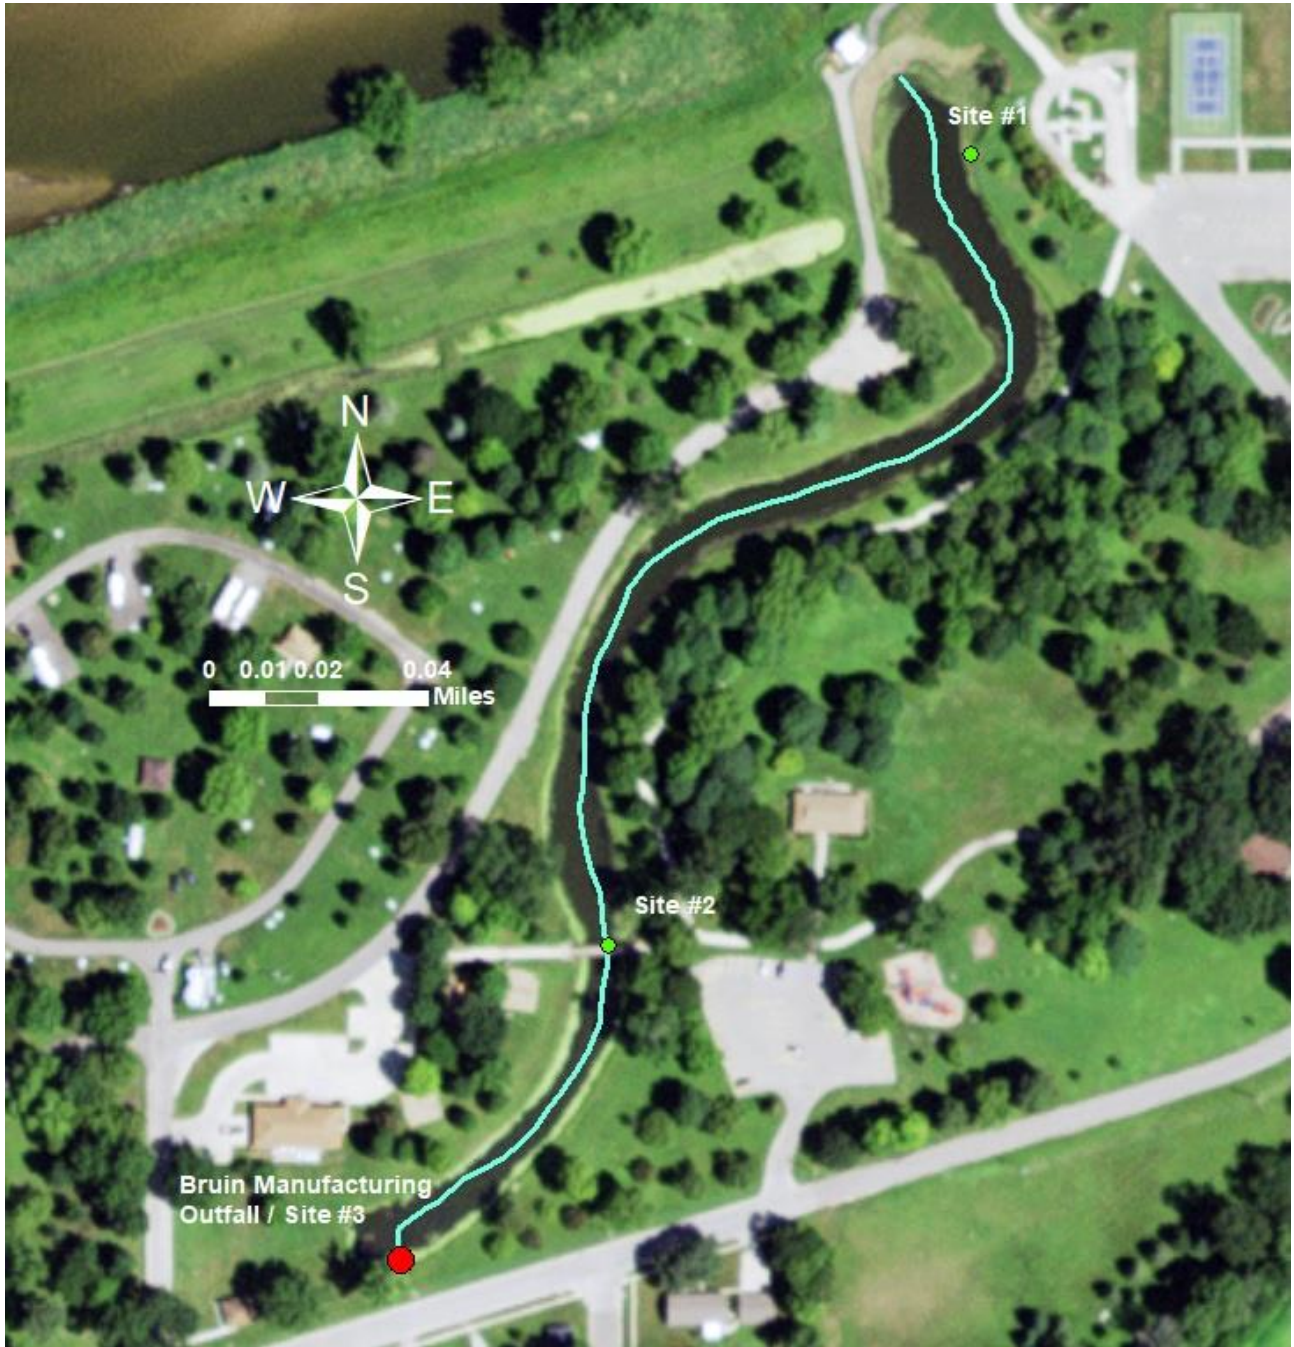
28 Map of Segment, Outfall, and Site(s)

Bruin Manufacturing discharges into a storm sewer that daylights in the area being designated. The pool was created by an impoundment that is part of a flood control structure. A city employee stated that the pool is known locally as “the lagoon” and fishing and recreation do occur there.

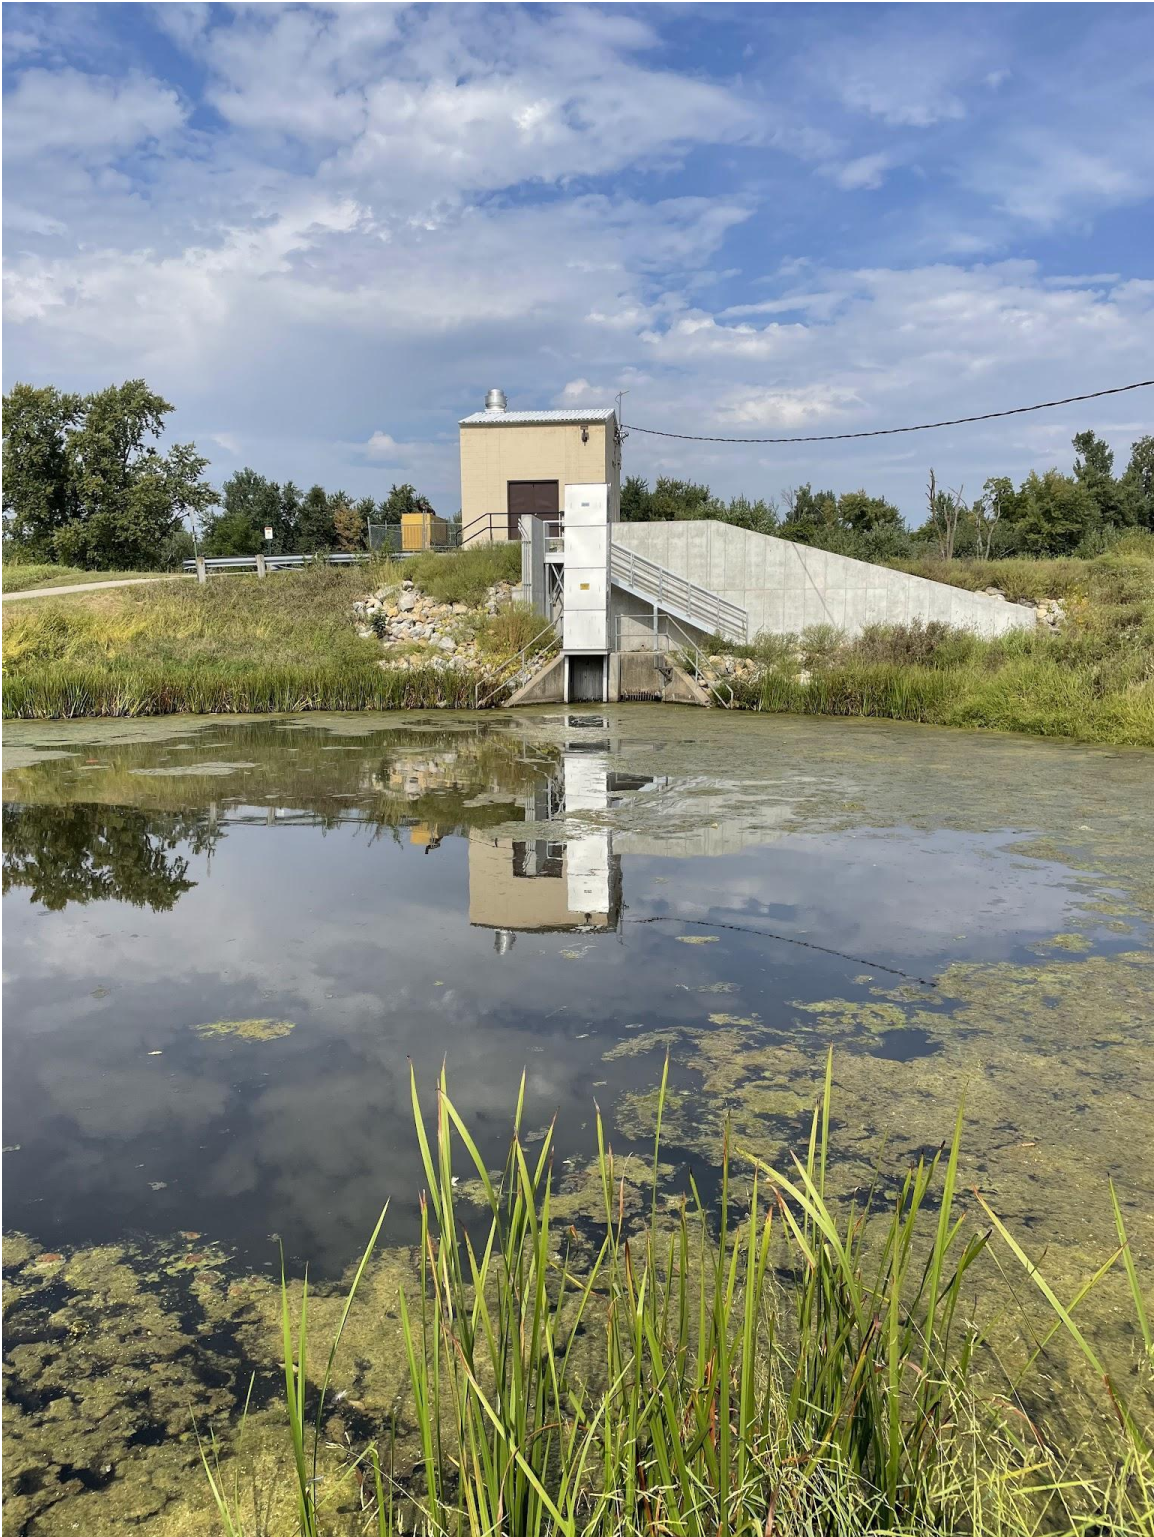
Use	Site parameter	Site ID #1
AL only	20 Non-Game Fish Present and Counts (Species: Number)	Not sampled
	21 Game Fish Present and Counts (Species (Size Range): Number)	Not sampled
	22 Stream Habitat (See also: #29 Site Photos)	Pool created by impoundment with little to no flow.
R only	23 Evidence of Use for Primary Contact Recreation? (Yes*/No)	Yes
	24 Evidence of Use by Children? (Yes*/No)	Yes
	25 Evidence of Use for Secondary Contact Recreation? (Yes*/No)	Yes
AL/R	26 Additional Description	Large pool located in a city park.

Figure 1. Site #1 looking downstream at the flood control structure.

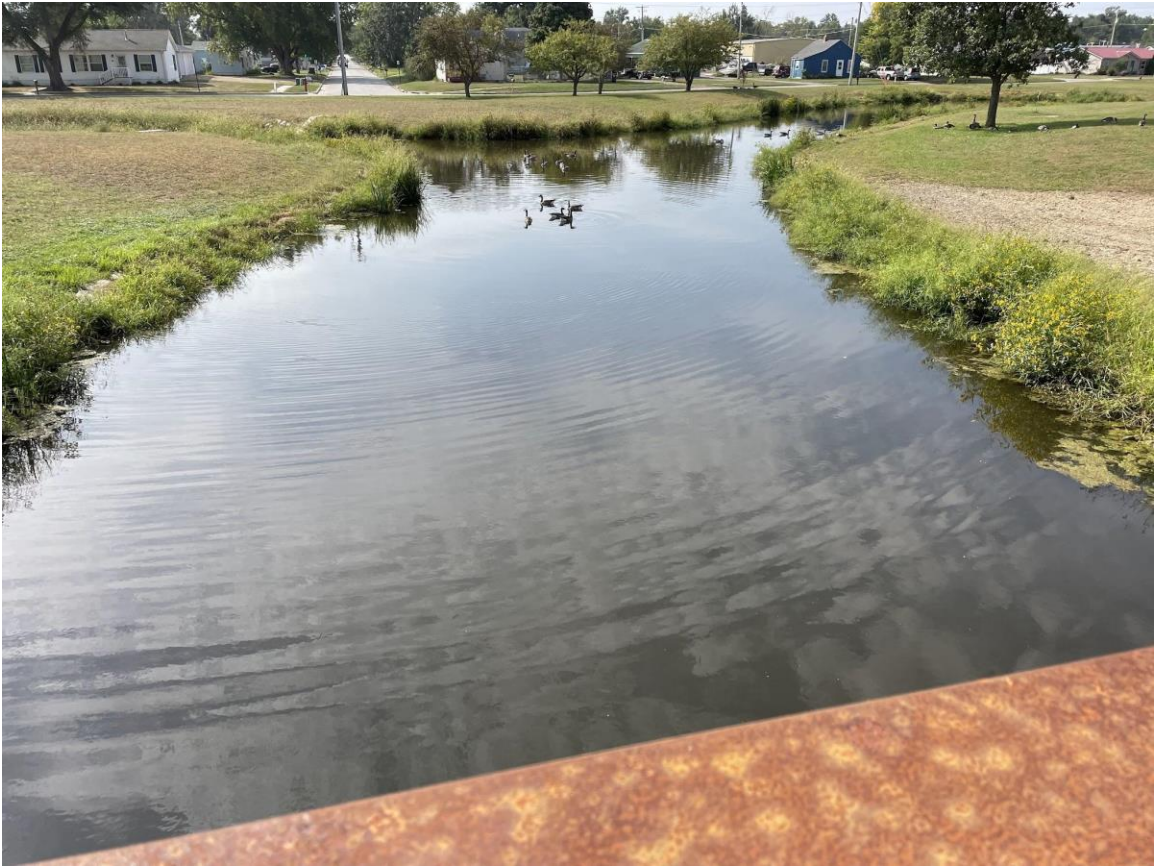
Use	Site parameter	Site ID #2
AL/R	15 Latitude, Longitude (DD)	42.06403, -92.90515
AL/R	16 Average Depth (in)	Not measured
AL/R	17 Maximum Depth (in)	48
AL/R	18 Stream Width (ft)	55
AL/R	19 Pools Observed?	Yes
AL only	20 Non-Game Fish Present and Counts (Species: Number)	Not sampled
	21 Game Fish Present and Counts (Species (Size Range): Number)	Not sampled
	22 Stream Habitat (See also: #29 Site Photos)	Pool created by impoundment with little to no flow.
R only	23 Evidence of Use for Primary Contact Recreation? (Yes*/No)	Yes
	24 Evidence of Use by Children? (Yes*/No)	Yes
	25 Evidence of Use for Secondary Contact Recreation? (Yes*/No)	Yes
AL/R	26 Additional Description	Large pool located in a city park.

Figure 2. Site #2 looking upstream from a bridge.

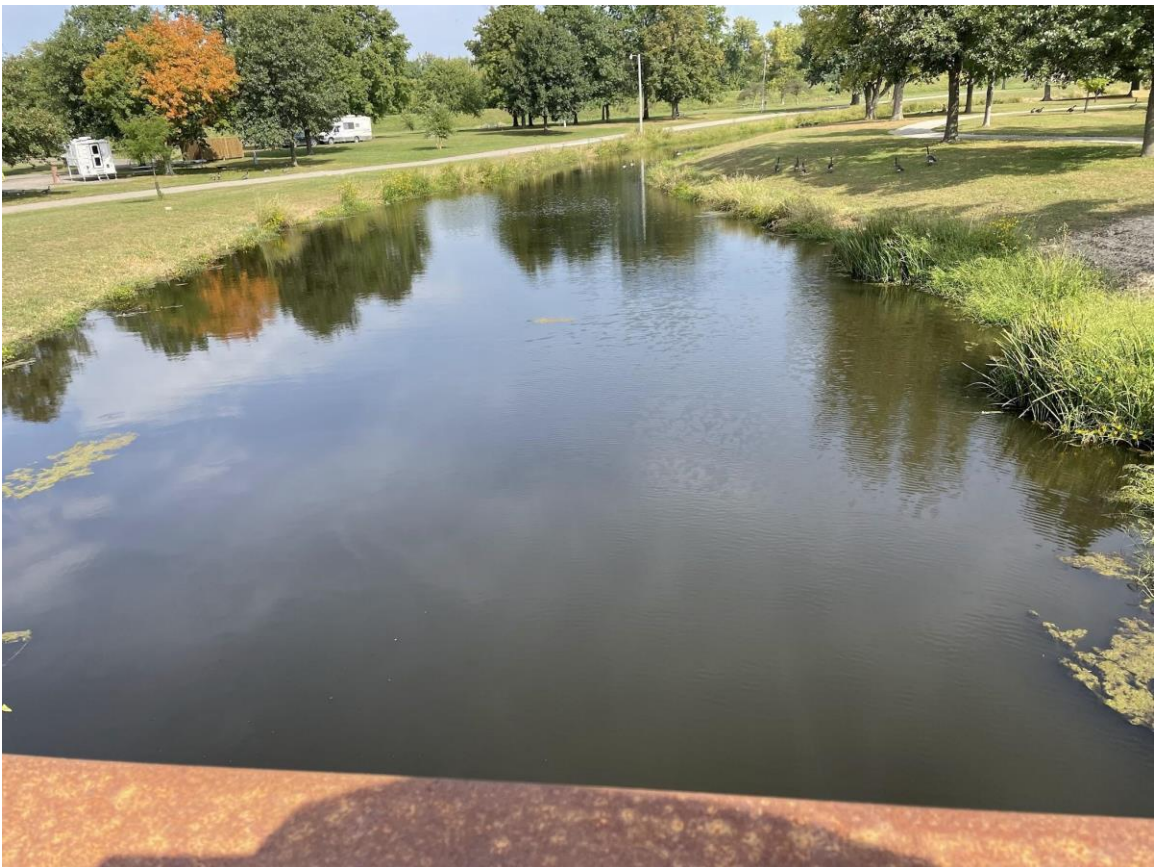
Figure 3. Site #2 looking downstream from a bridge.

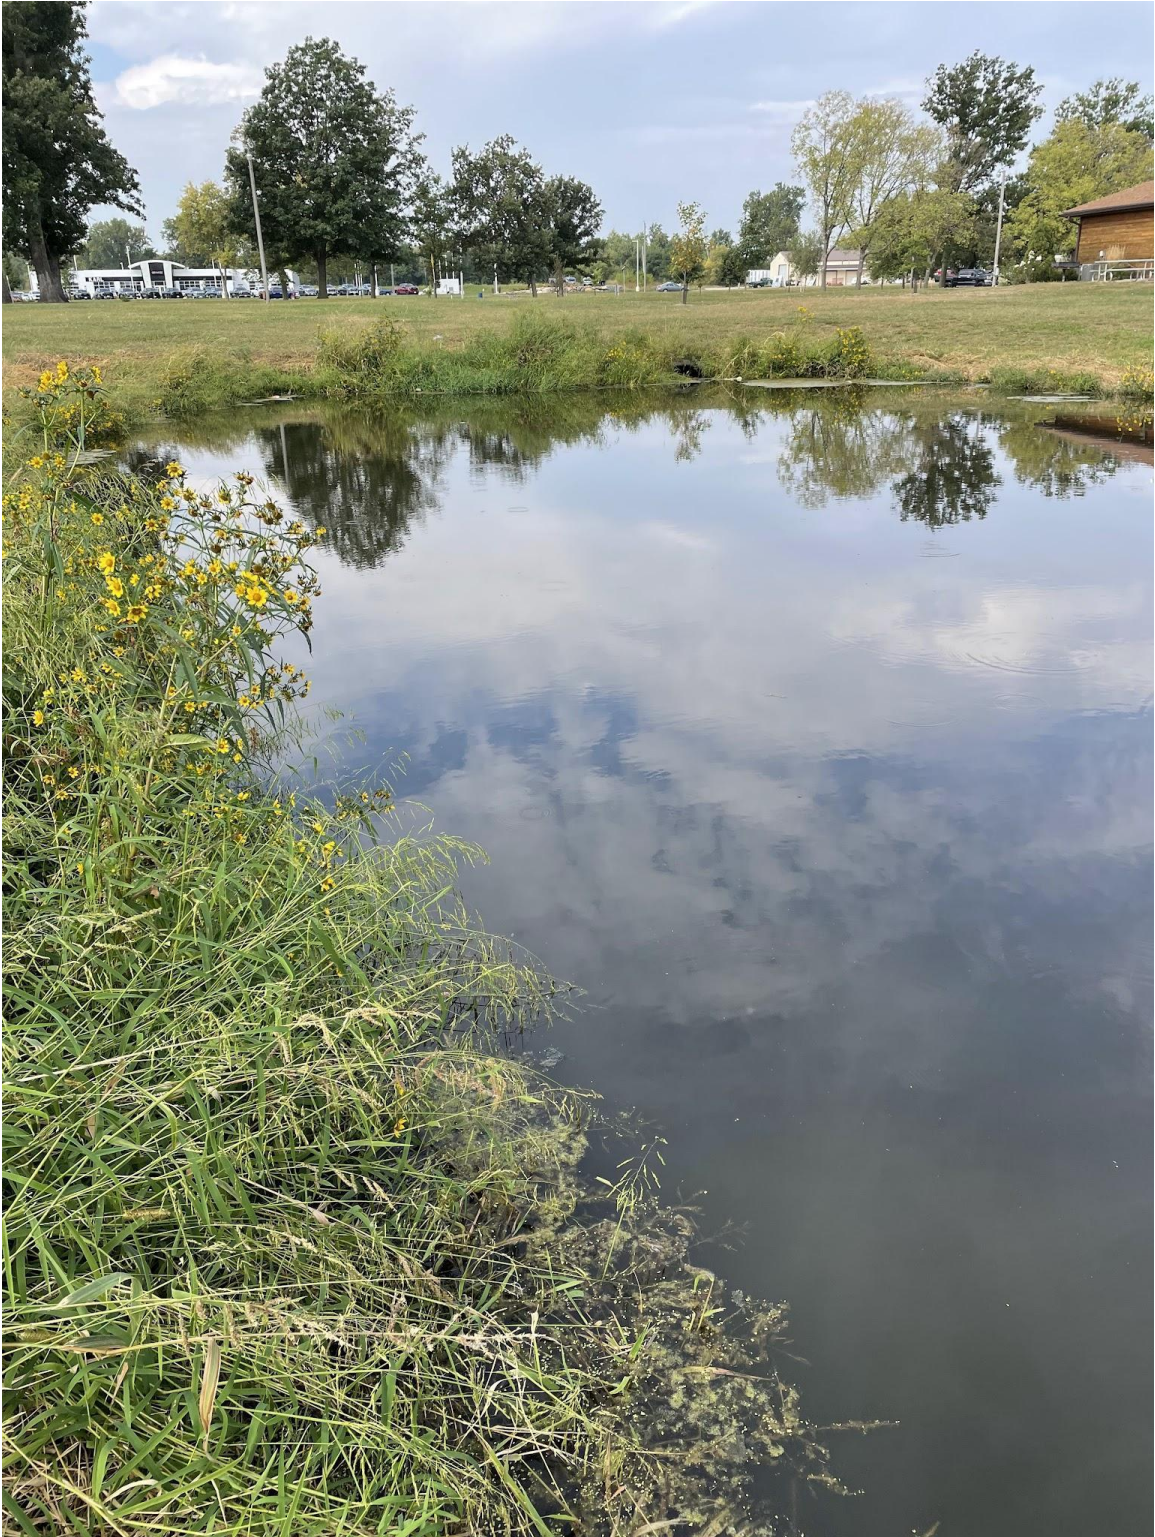
Use	Site parameter	Site ID #3
AL/R	15 Latitude, Longitude (DD)	42.06318, -92.90588
AL/R	16 Average Depth (in)	Not measured
AL/R	17 Maximum Depth (in)	Not measured
AL/R	18 Stream Width (ft)	56
AL/R	19 Pools Observed?	Yes
AL only	20 Non-Game Fish Present and Counts (Species: Number)	Not sampled
	21 Game Fish Present and Counts (Species (Size Range): Number)	Not sampled
	22 Stream Habitat (See also: #29 Site Photos)	Pool created by impoundment with little to no flow.
R only	23 Evidence of Use for Primary Contact Recreation? (Yes*/No)	Yes
	24 Evidence of Use by Children? (Yes*/No)	Yes
	25 Evidence of Use for Secondary Contact Recreation? (Yes*/No)	Yes
AL/R	26 Additional Description	Large pool located in a city park.

Figure 4. Site #3 looking upstream towards the outfall.
