General Use Field Evaluation

NPDES Facility and Permit Number	Iowa DOT Rest Area #34 I35 Lamoni (2700902)
NPDES Outfall Latitude, Longitude (Decimal Degrees)	40.65928, -93.85714
Water Body Name	Unnamed Tributary to Grand River
Segment Description	Mouth to Iowa DOT Rest Area #34 I35 Lamoni outfall
Segment Length (ft)	136
Segment Start (Downstream) Latitude, Longitude (Decimal Degrees)	40.65927, -93.85714
Segment End (Upstream) Latitude, Longitude (Decimal Degrees)	40.65892, -93.85727
Number of Sites	2
County Name(s)	Decatur
Field Work Date(s)	9/25/2025

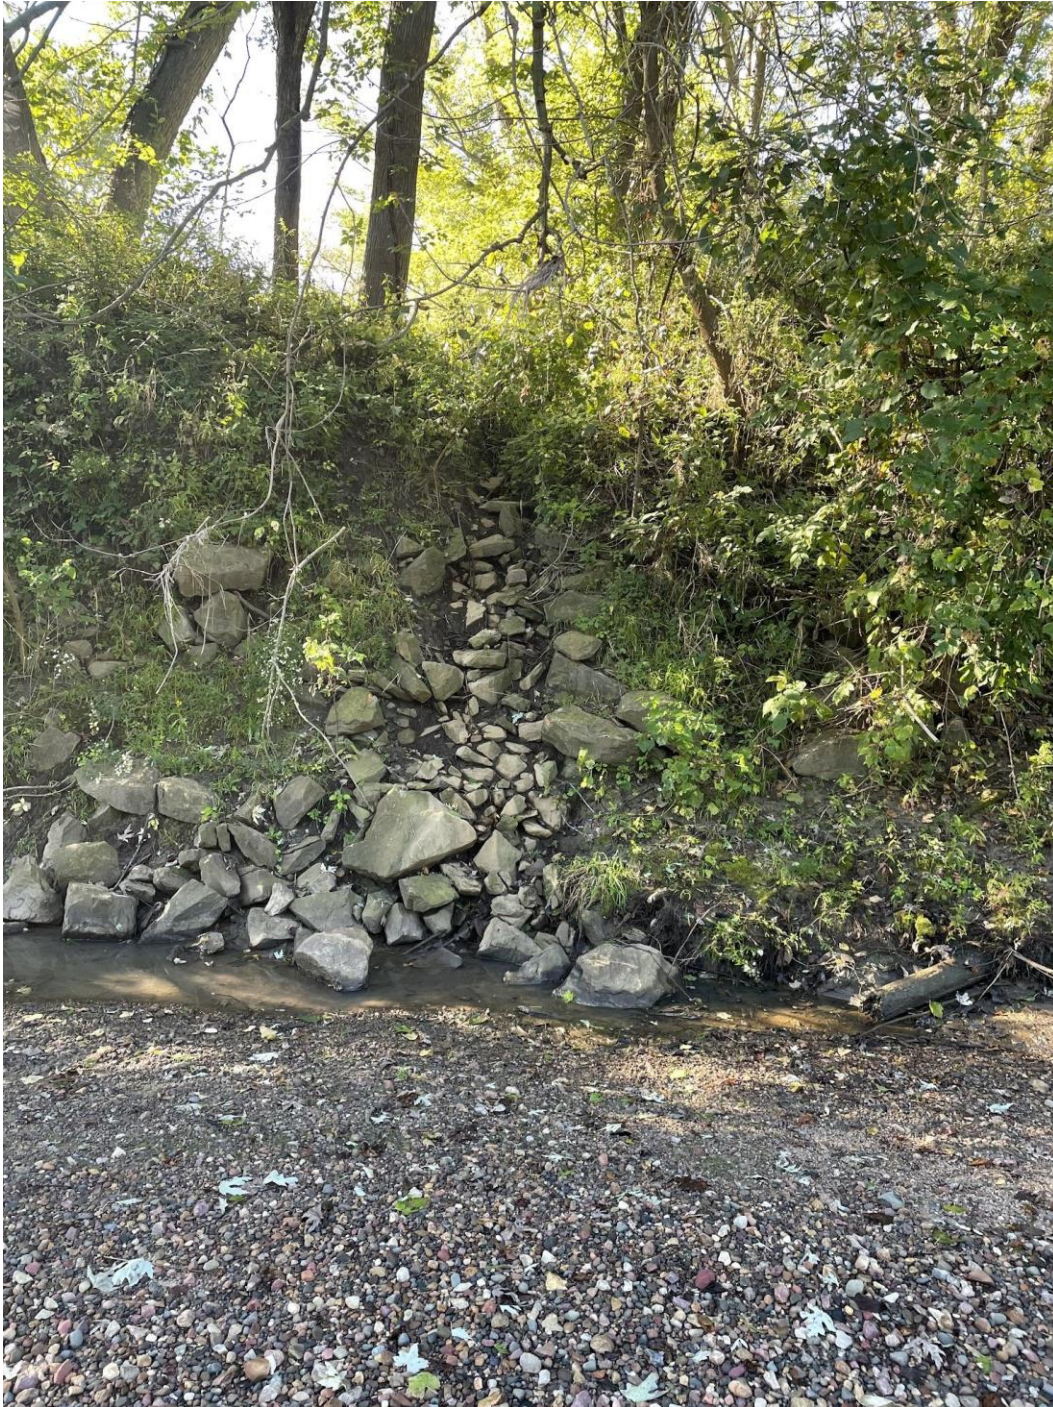
Site # 1

Description/location	40.65927, -93.85714
Water conditions	Very small amount of flow. All water present appeared to be discharged effluent.
Average/max depths	Not measured
Aquatic life present	None observed
Unusual conditions	None
Channel description	Small, manmade channel leading from outfall to receiving stream.
Physical barriers/objects of significance	None
Human activity/evidence of recreation	Not easily accessible to the public.

Figure 1. Site #1 showing the confluence of the segment being designated with the receiving stream.

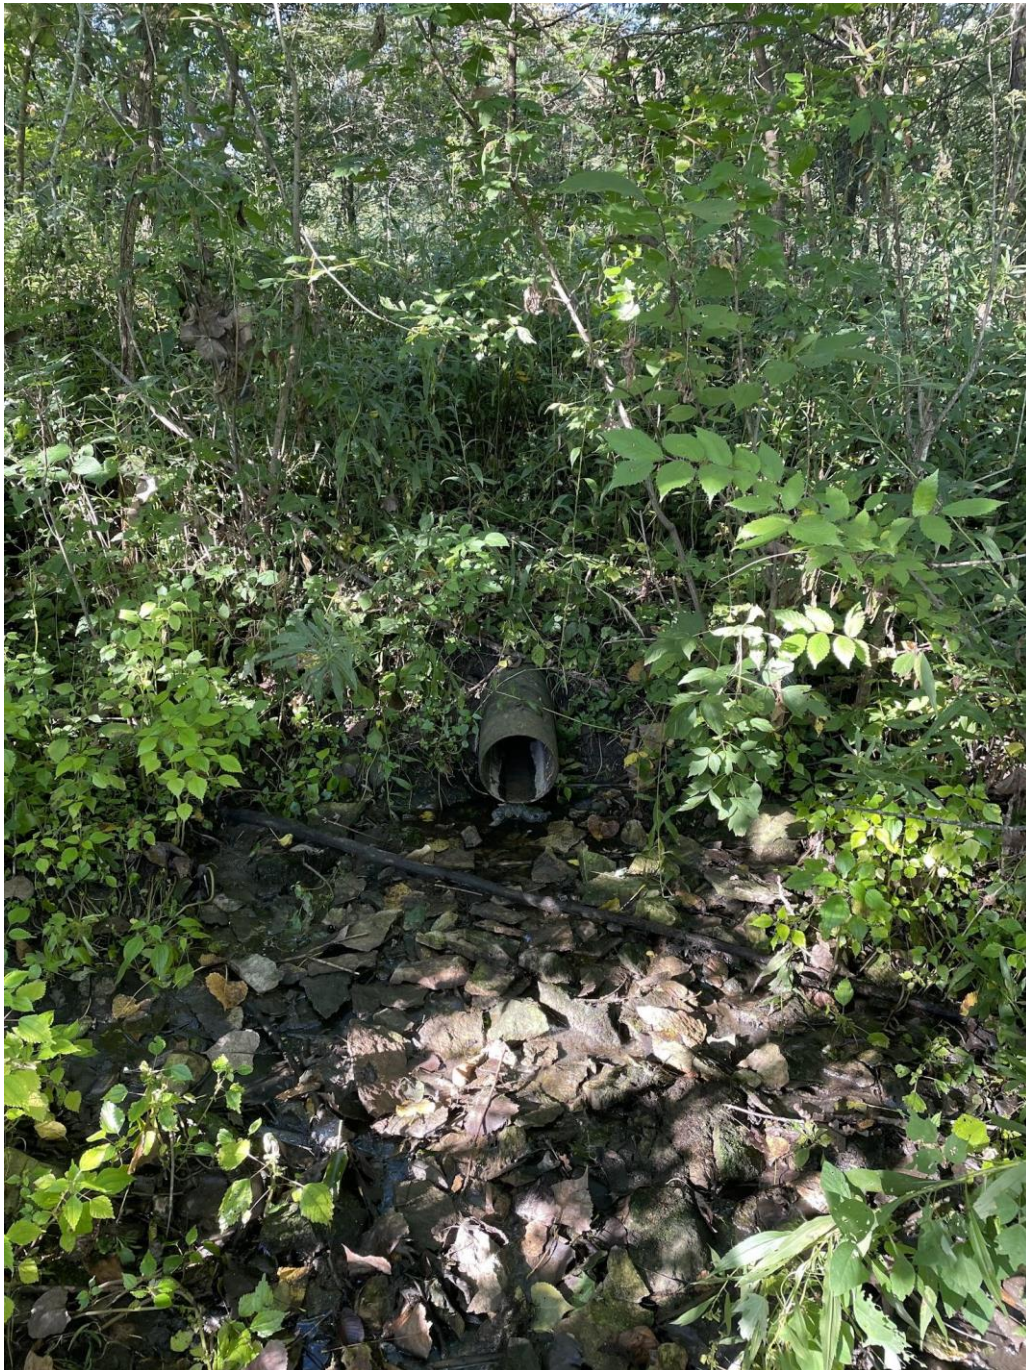
Description/location	Outfall 40.65892, -93.85727
Water conditions	Very small amount of flow. All water present appeared to be discharged effluent.
Average/max depths	Not measured
Aquatic life present	None observed
Unusual conditions	None
Channel description	Small, manmade channel leading from outfall to receiving stream.
Physical barriers/objects of significance	None
Human activity/evidence of recreation	Not easily accessible to the public.

Figure 2. Site #2 looking upstream at the outfall.

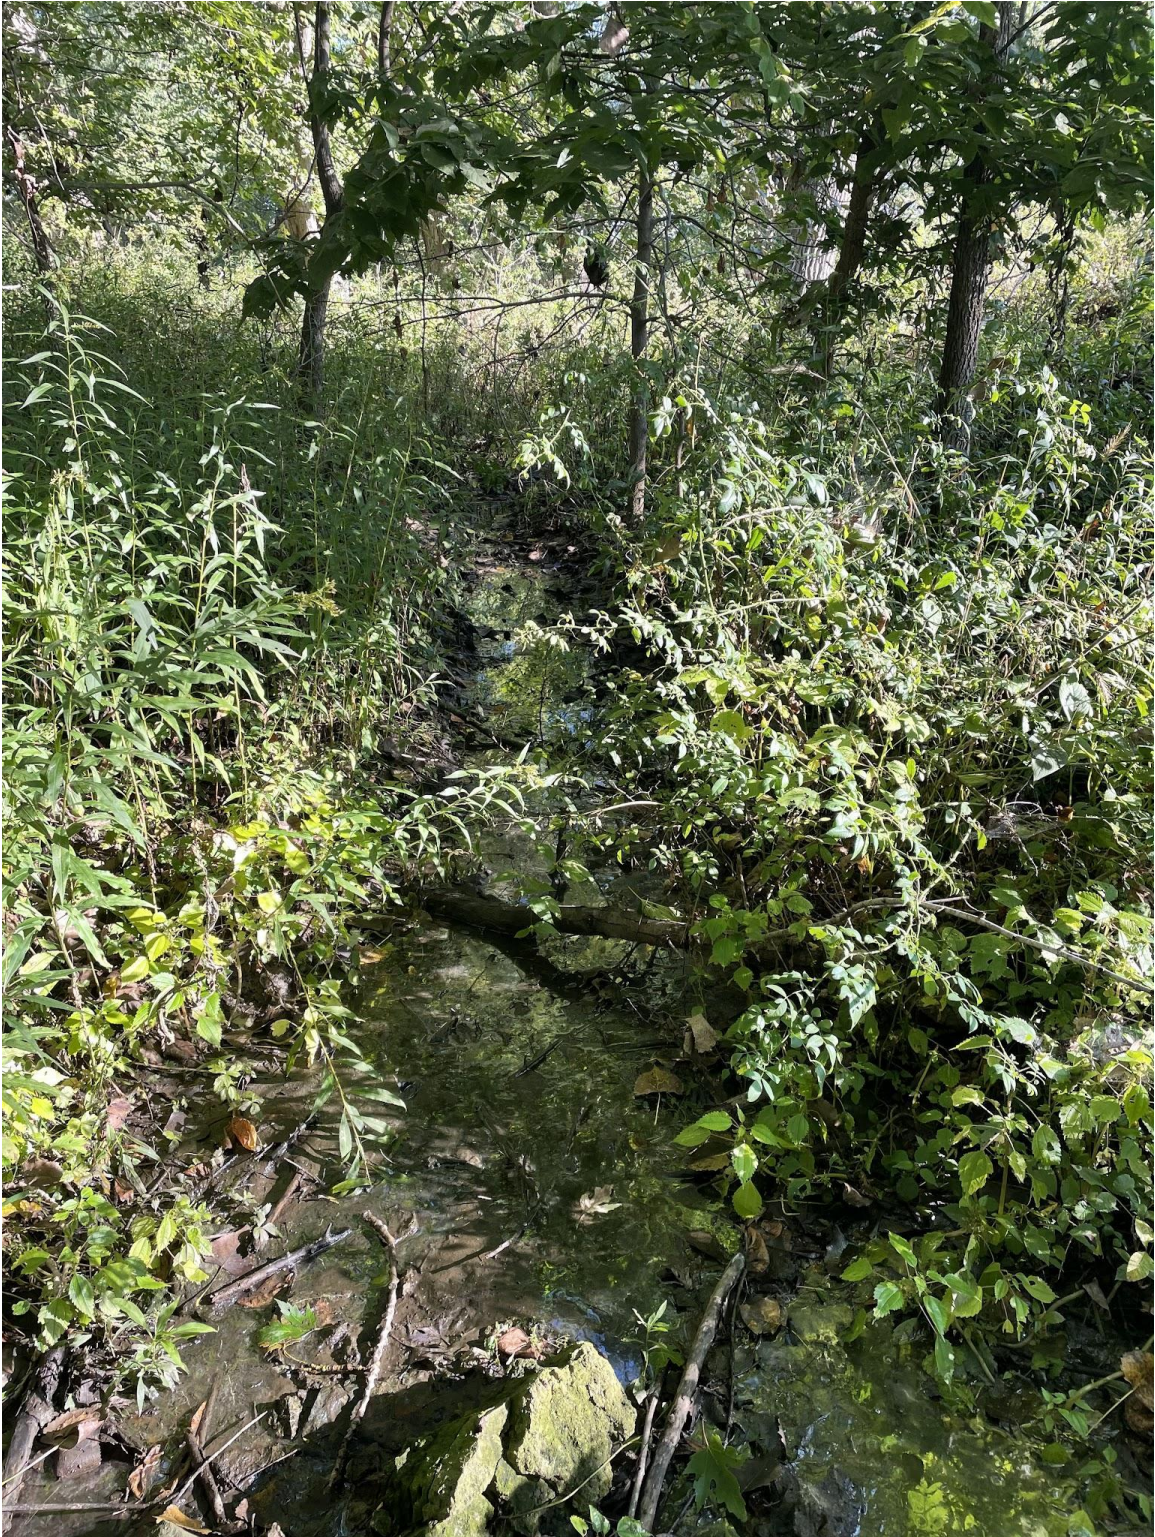
Figure 3. Site #2 looking downstream from the outfall
