General Use Field Evaluation

NPDES Facility and Permit Number	Granada Gardens Mobile Home Park (3100605)
NPDES Outfall Latitude, Longitude (Decimal Degrees)	42.56528, -90.72278
Water Body Name	Unnamed Tributary to Little Maquoketa River
Segment Description	Mouth to Granada Gardens MHP outfall
Segment Length (ft)	2350
Segment Start (Downstream) Latitude, Longitude (Decimal Degrees)	42.56354, -90.71721
Segment End (Upstream) Latitude, Longitude (Decimal Degrees)	42.56527, -90.72277
Number of Sites	2
County Name(s)	Dubuque
Field Work Date(s)	9/24/2025

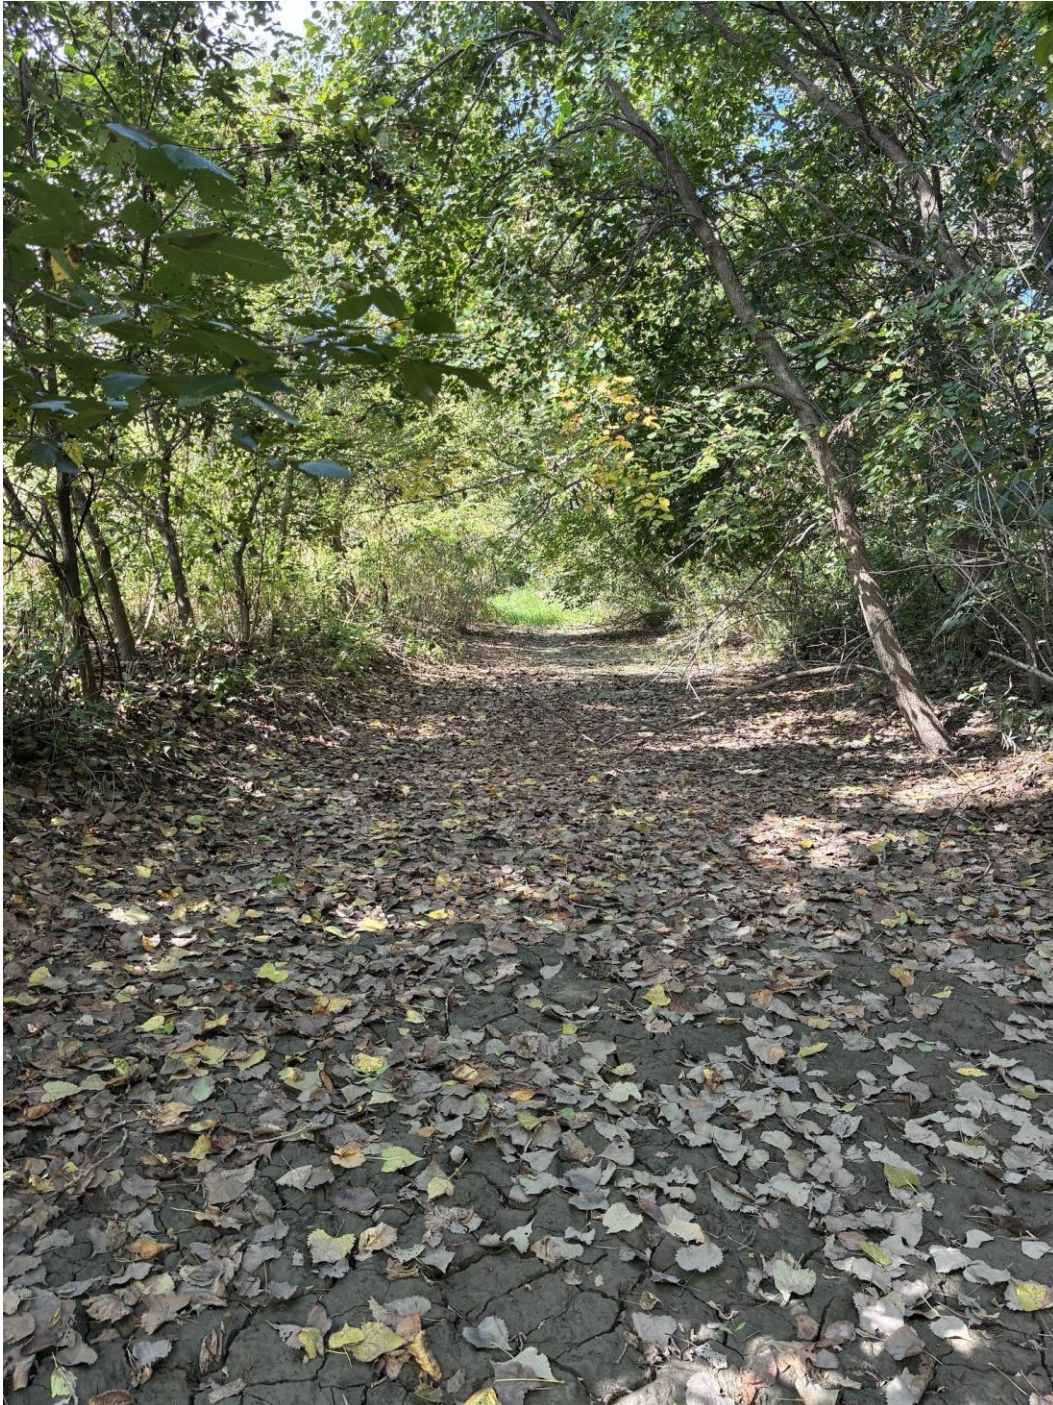
Description/location	Downstream site 42.56543, -90.71828
Water conditions	None
Average/max depths	None
Aquatic life present	None
Unusual conditions	None
Channel description	Dry, sandy stream bed.
Physical barriers/objects of significance	None
Human activity/evidence of recreation	None

Figure 1. Site #1 looking upstream.

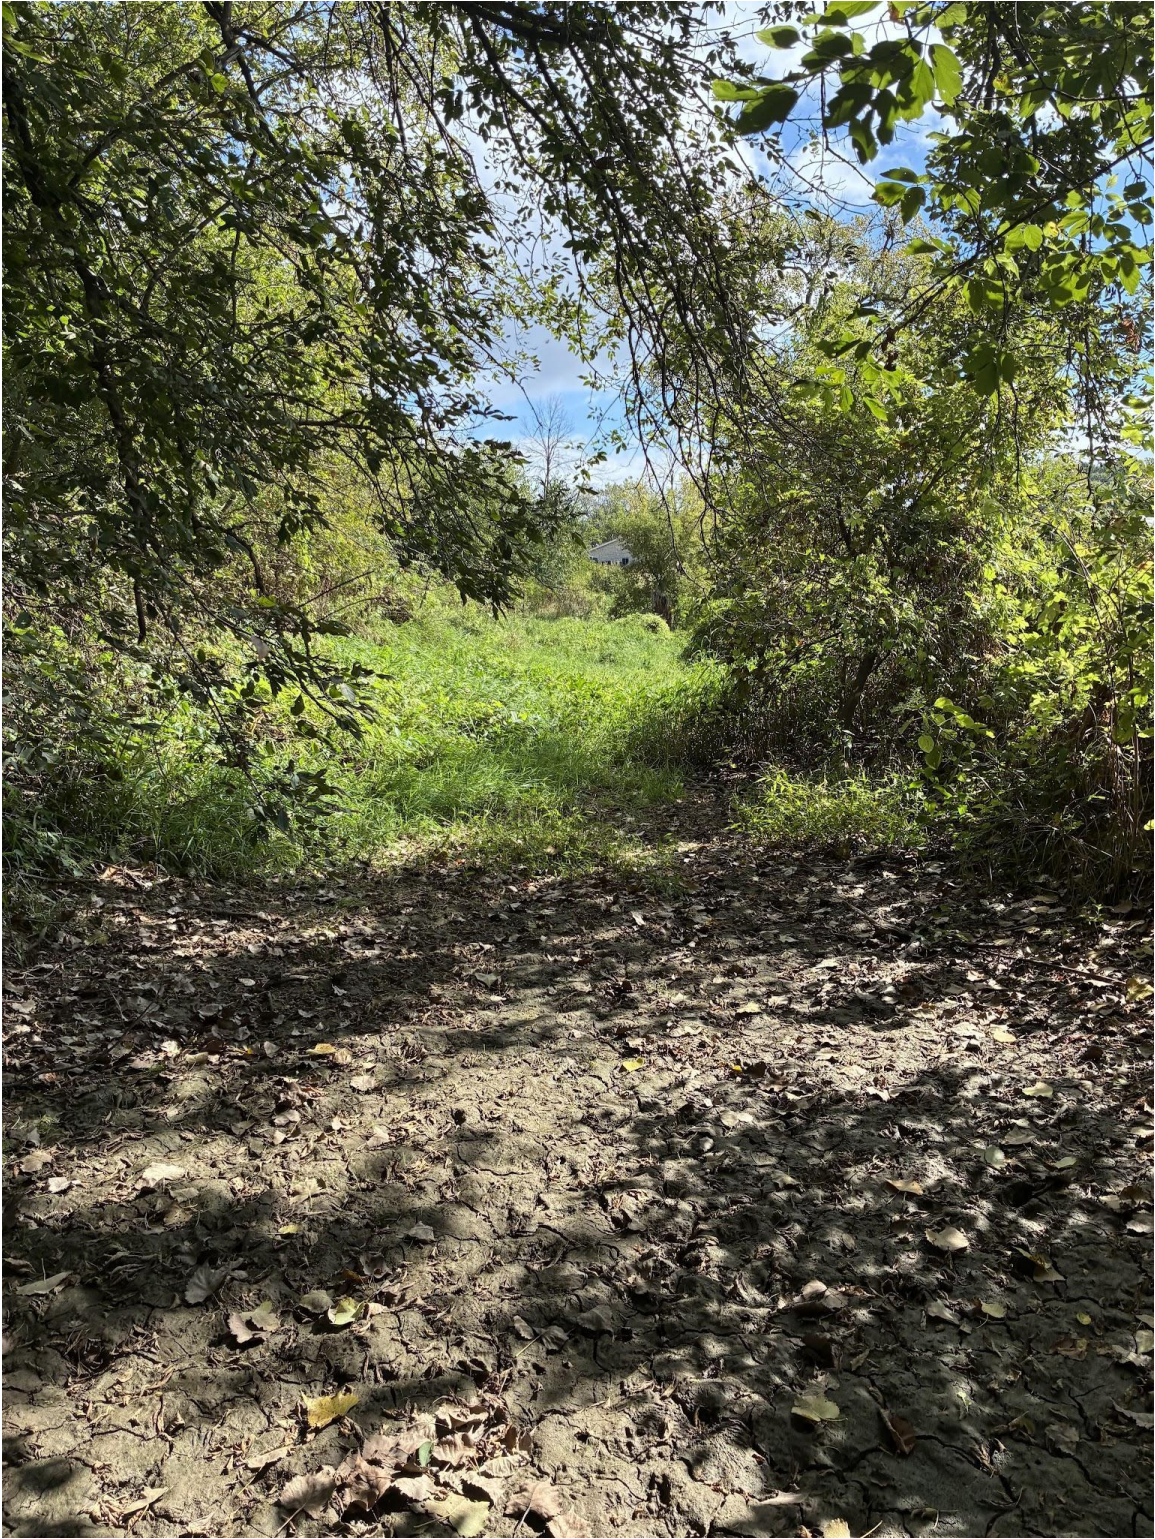
Figure 2. Site #1 looking downstream.

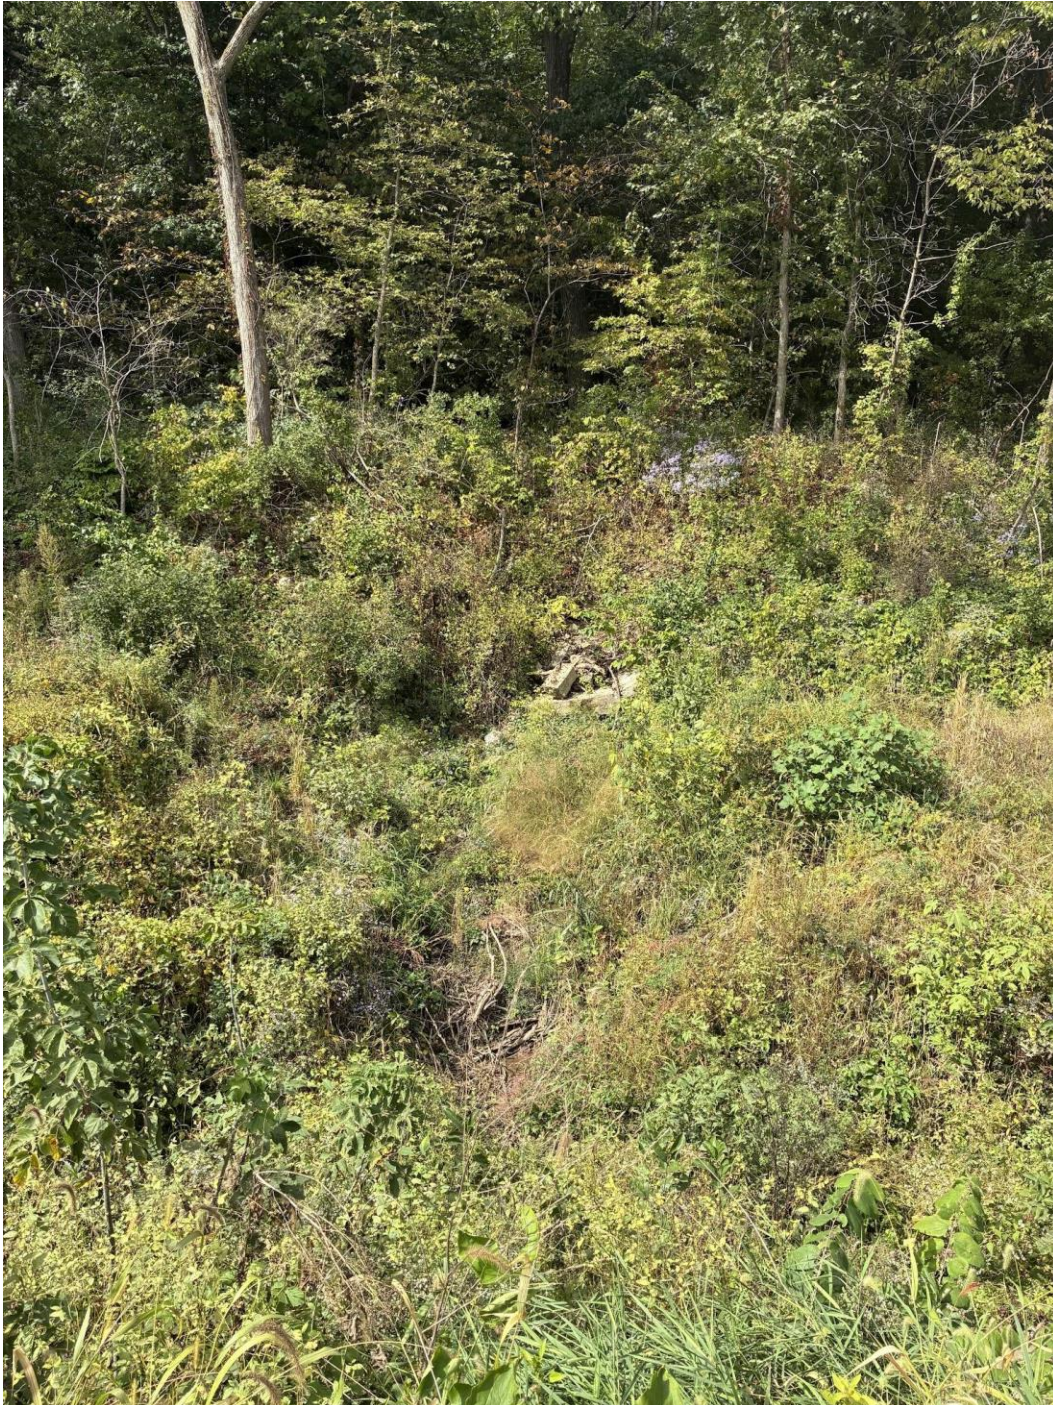
Description/location	42.56465, -90.72255
Water conditions	Small pool
Average/max depths	Not measured
Aquatic life present	None
Unusual conditions	None
Channel description	Small pool of water near the culvert. Water did not flow out of it.
Physical barriers/objects of significance	The segment goes under a highway through a box culvert.
Human activity/evidence of recreation	None

Figure 3. Site #2 looking upstream.

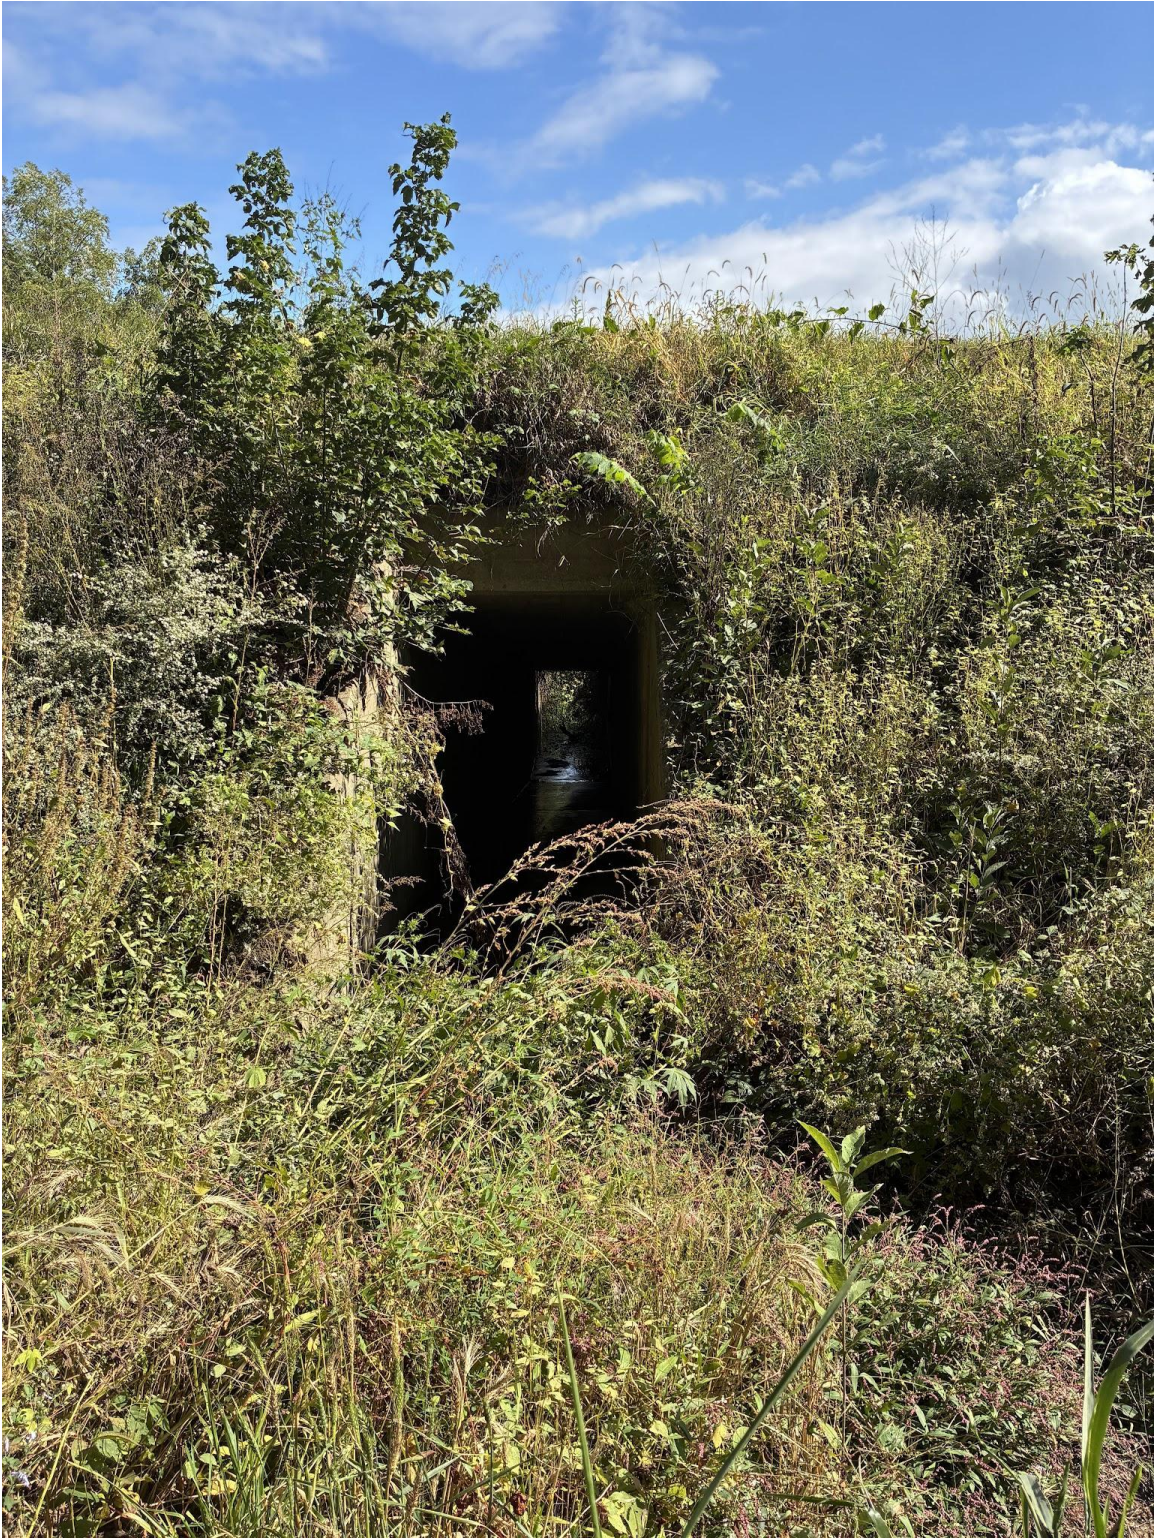
Figure 4. Site #2 looking downstream.
